Southend-on-Sea Flooding on the 20th July 2014

Flood Investigation
Report

Final

March 2015

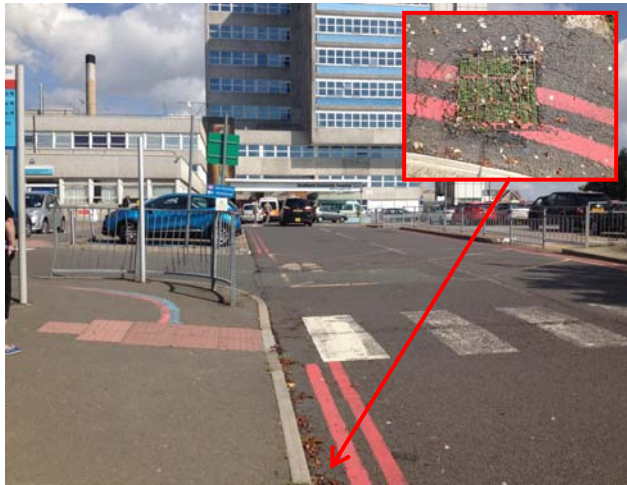
During the site walkover on the 28th August 2014, it was observed that many of the road gullies draining the hospital car park were silted, therefore their potential to drain surface water would have been compromised (Photographs 3-1 and 3-2). The flooding of the car park is likely to have been a result of water not being able to enter the drainage network. Due to the topography of the area, surface water would have flowed towards Prittlewell Close at a lower elevation.

Photograph 3-1: Entrance to Southend A & E (looking north), detail of gully at entrance.

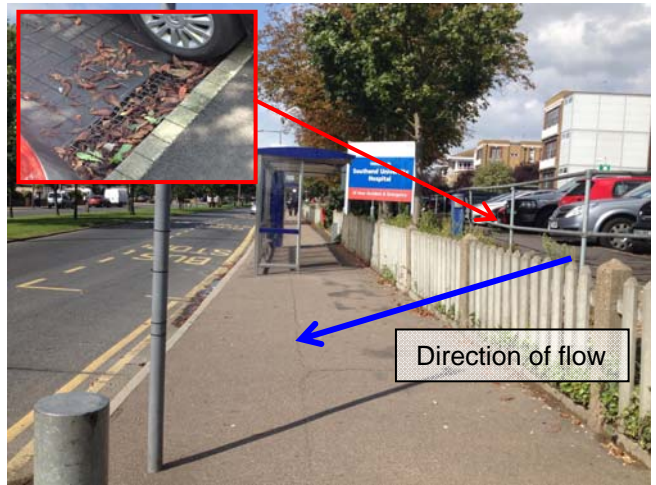
Photograph 3-2: Car park and Prittelwell Close (looking west) including detail of car park drainage

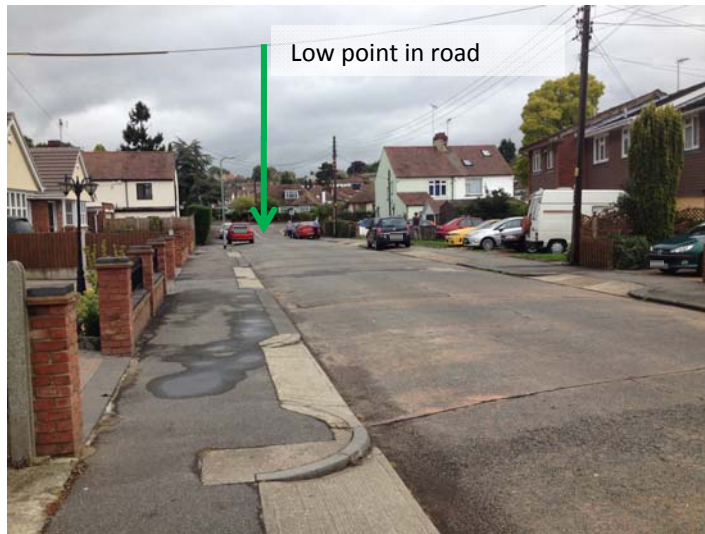
There is a further reported incident of flooding towards the centre of Glenwood Avenue. The topography of the area suggests that this flooding was likely to be a direct result of flood water emerging from the river channel. The surface water sewer on Glenwood Avenue however falls in a northerly direction to meet the culverted watercourse at the junction with Rayleigh Road. Therefore, it is possible that the standing water present at the low point of Glenwood Avenue caused the sewer system to become surcharged. As a result, rainwater falling on Glenwood Avenue would have been unable to enter the sewer system and therefore ponded in local depressions along the carriageway. Due to the fall of many driveways along Glenwood Avenue, standing surface water could have flowed towards properties on the western side of the road.

Photograph 3-3 –Looking north along Glenwood Avenue to junction with Rayleigh Road.

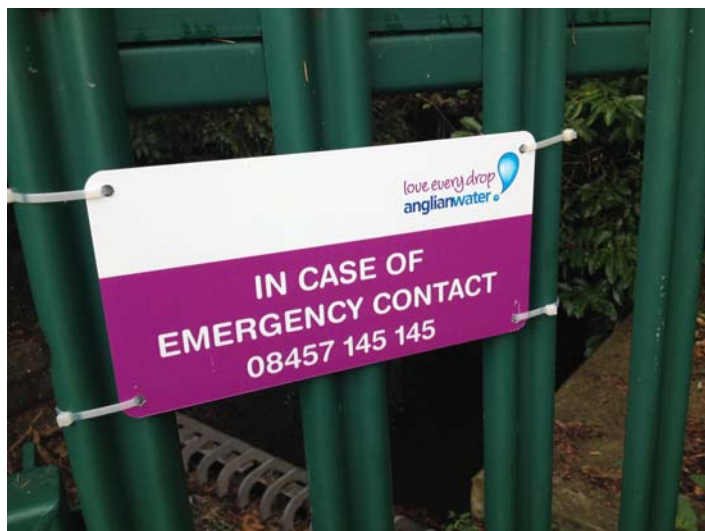
Since the flood incidents occurred, AW has replaced fencing surrounding the trash screen to prevent dumping of rubbish directly onto the screen. Photograph 3-4 shows the sign now present at the time of the site visit on the fencing which provides the public with contact details for AW to report any problems noticed with the channel, screen or culvert.

Photograph 3-4 –New sign providing Anglian Water emergency contact details

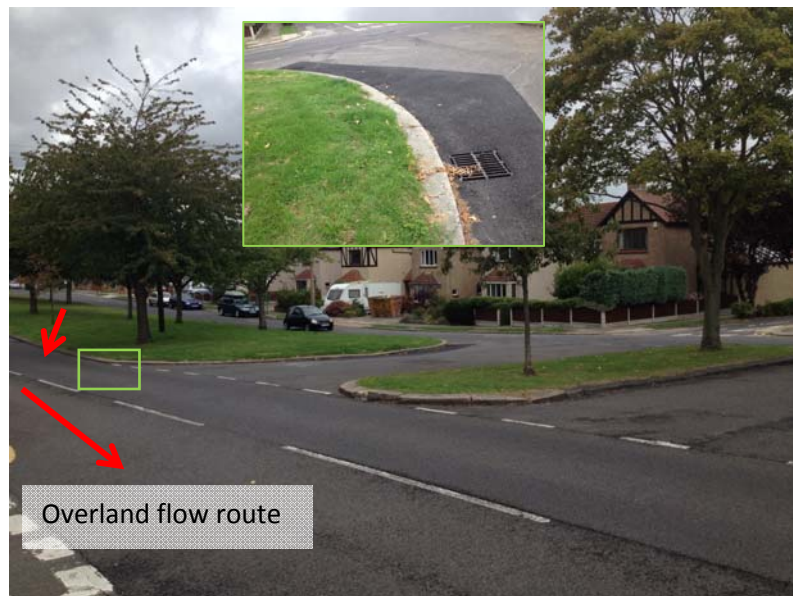
As shown in Figure 3-4 and Photographs 3-5 and 3-6, Highlands Boulevard slopes in a northerly direction towards the river channel of a tributary of Prittle Brook. There is a second dip in the elevation as the road bends to the north, where flooding was observed.

Photograph 3-5: Crossing at Highlands Boulevard at the junction of Adalia Crescent and Walker Drive (looking south). Detail of new gullies.

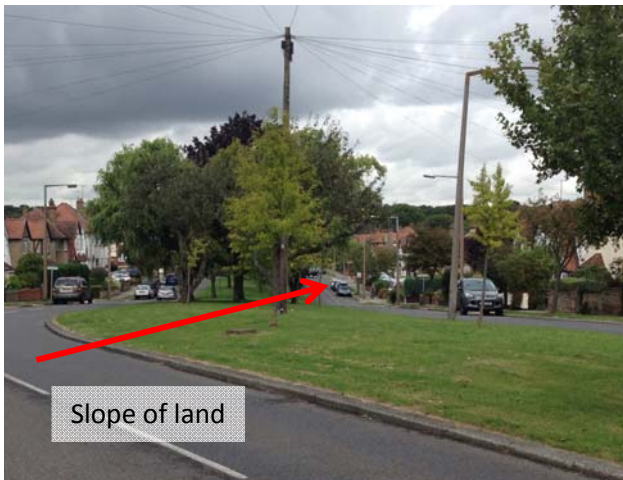
Photograph 3-6: Drop in elevation along Highlands Boulevard (looking north).

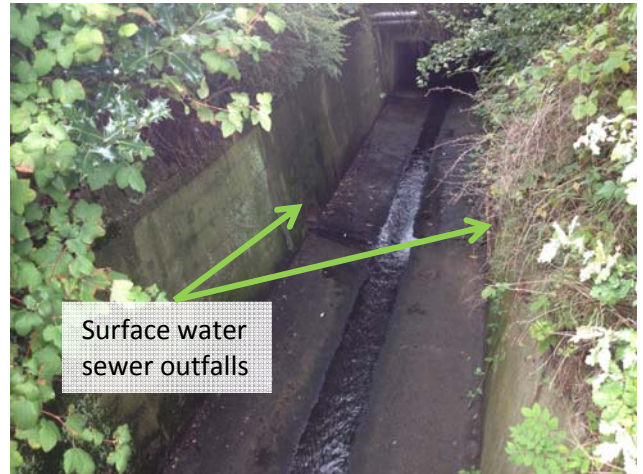
The surface water drainage network within this area consist of a 375 mm diameter pipe that runs within Highlands Boulevard, and discharges to the river channel (as shown in Photograph

Photograph 3-7: Surface water outfalls to the tributary of Prittle Brook

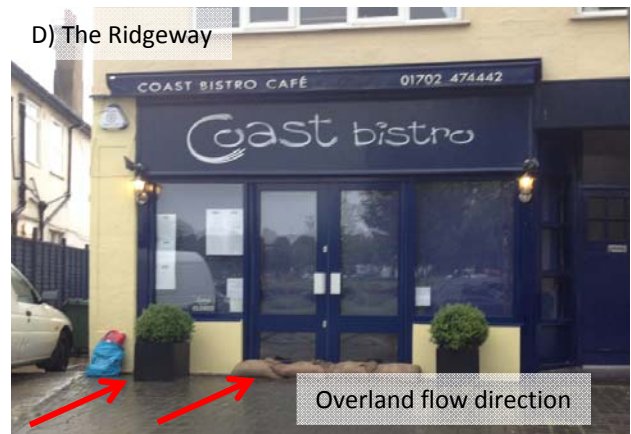
Photograph 3-11: The Ridgeway (looking south)

The record of flooding along The Ridgeway (point D) does not detail a source, however, during the site visit it was observed that a cafe had flooded internally. At this point along The Ridgeway, the road follows the contour of the slope. There is therefore the potential for water, running off the higher land to the north, to accumulate behind structures that obstruct the flow. This is confirmed by residents observations. In this instance, flood waters which exceeded the capacity of the road channel would have continued towards the properties on the southern side of the road. During the site visit it was noted that there were a number of road gullies along the road. These would have been vital in ensuring the drainage of the water, should these have been blocked, and the capacity would have been reduced. Photograph 3-11 shows that sandbags had been placed across the entrance to the building.

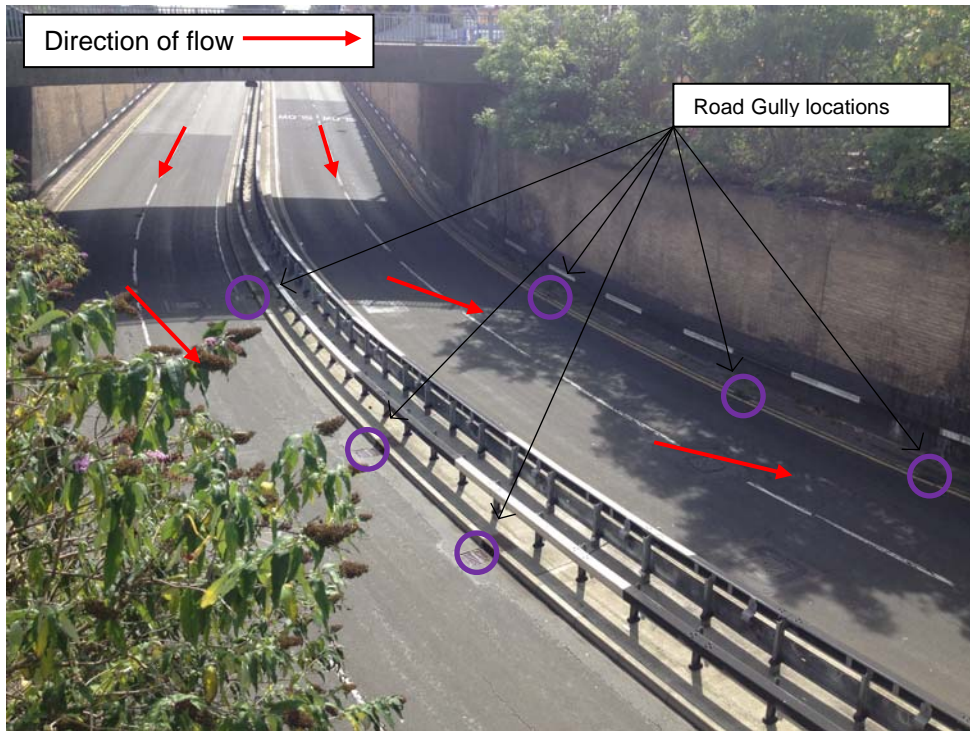
Observations during a site walkover on the 28th of August 2014 suggest that the problems within this area are likely to be caused by debris within the gullies causing blockages. Photos 3-12 and 3-13 show the location of road gullies and observed conditions.

Photograph 3-12: Photograph showing the number and location of road gullies within the Queensway underpass (looking south)

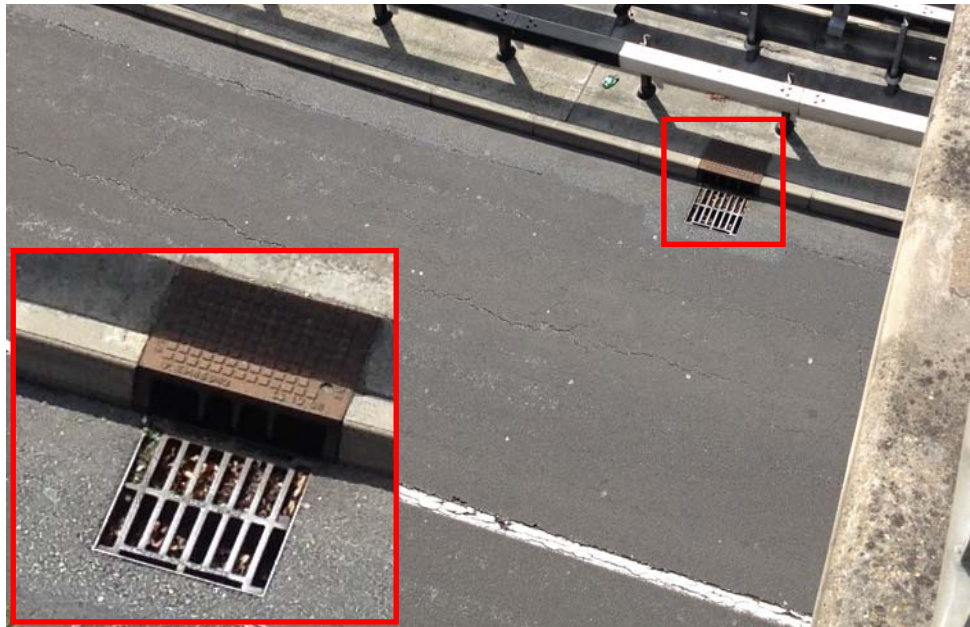
Photograph 3-13: Photograph showing the blockage of a road gully at the low point of the Queensway underpass (observations from the 28th August 2014 site walkover).
