Southend-on-Sea
Flooding 24th
August 2013

Flood Investigation
Report

Final

October 2014

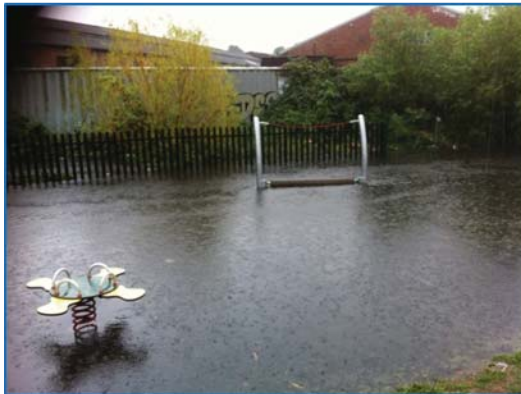
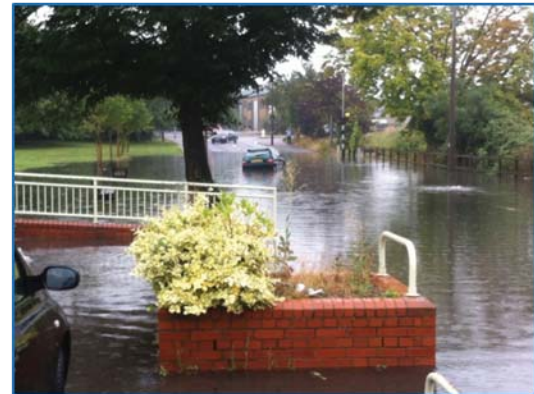
Flooding adjacent to the Barge Pier Ditch at Jena Close and Campfield Road (Photographs provided by residents)

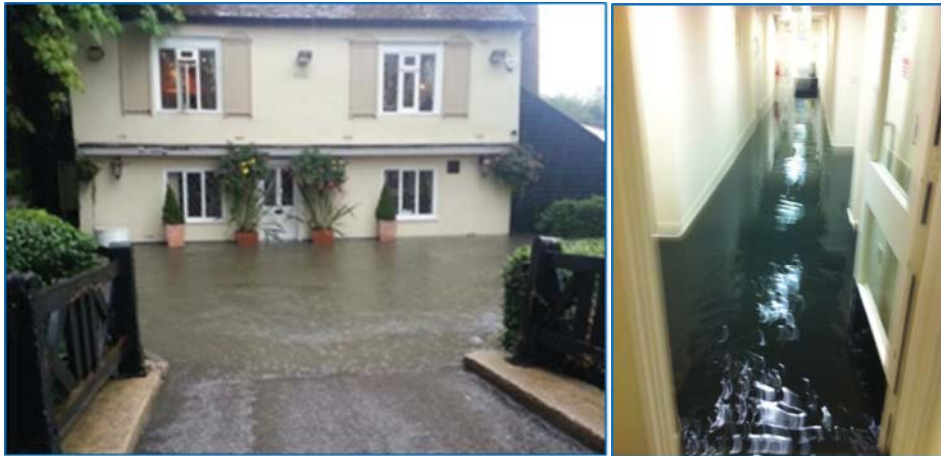
Flooding within the areas adjacent to Eastwood Brook was extreme and highly hazardous. Photographs taken at the time by residents suggest that water reached a depth of approximately 0.8 – 0.9m (almost covering the bonnet of a small car).

It should be noted that Photograph 4-2 is of flooding within the corridors of Nestuda House which provides sheltered accommodation. The 16 residents of this property were evacuated.

External and internal flooding of properties within the Eastwood area (Photographs provided by residents)

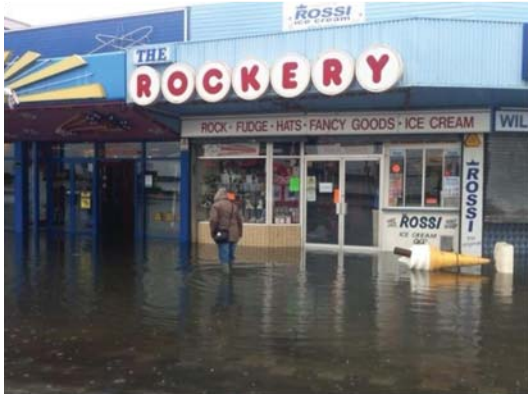
Photograph 5-1

*Flooding at Marine Parade and surcharging sewers at Hartington Road
(Photographs provided by residents)*

The flooding at Hartington Road was caused by surcharging of the sewer network resulting in sewer flooding. Due to the high tide conditions, these sewers were not able to discharge, causing water to backup within the system. Surcharging at the manhole is most likely resulted from the culmination of high flows from the rest of the catchment overwhelming the sewer capacity. The flood waters from the sewer contributed to the flooding of Marine Parade and Hartington Road and the adjacent properties.

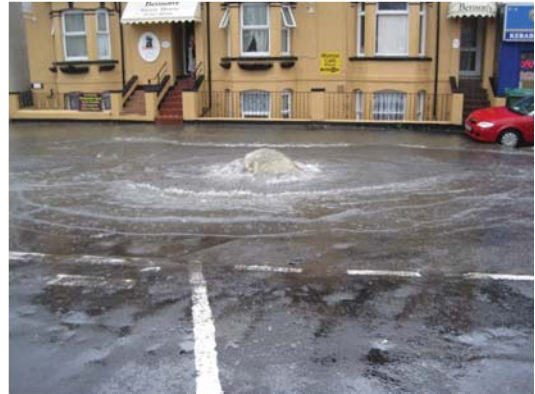
Photograph 5-2

The most notable instance of flooding from the sewer network is around the Hartington Road area, where there is also a record of a lifted manhole cover. CCTV footage in this area shows water surcharging between 14:54 and 17:00 hours, shortly after the peak rainfall.

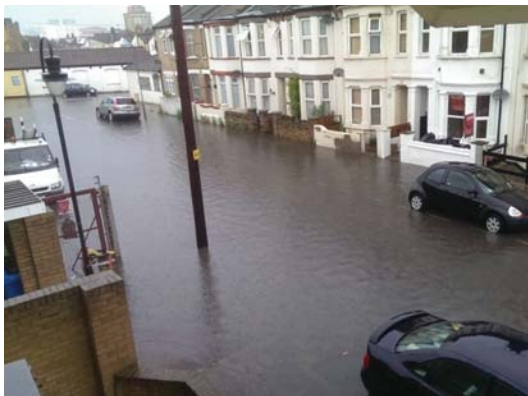
Photograph 5-3

Photographs 5-1 to 5-4 below show examples of flooding within the Marine Parade and Eastern Esplanade area.
