Technical note

Project:	Southend-on-Sea Road Safety Services	To:	Adrian Watling
Subject:	Maya Road junction with A13 Ness Road	From:	Samantha Moores
Date:	5 Apr 2018	cc:	Mark Gregory

MAYA CLOSE / WATERLOO ROAD JUNCTION WITH A13 NESS ROAD, SHOE BURYNNESS

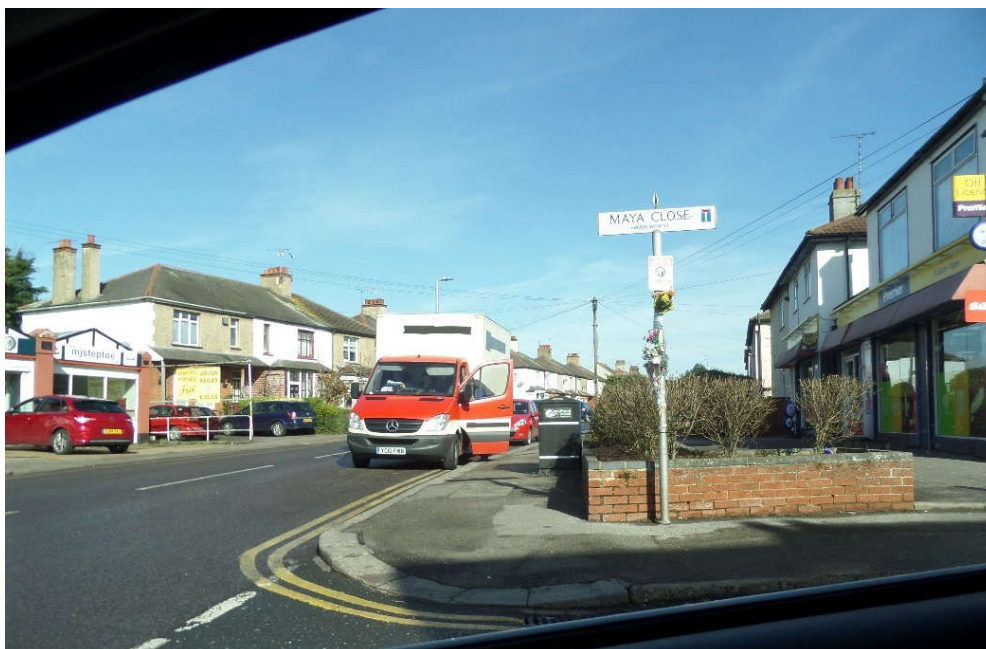
The site was visited on Thursday 29th March 2018 at approximately 10:00. Multiple vehicles were observed parking on the double yellow lines to the north of Maya Close on the eastern side of Ness Road during the site visit. This restricted visibility to the right for road users exiting Maya Close. This visibility was further reduced by the right-hand bend and the litter bin located next to the brick built planted area.

Image 1 – view to right exiting Maya Close

2. Build-out at junction – provide a build-out to bring forward the give-way line from Maya Close to improve visibility. This measure would be relevant to accidents 2 and 3.

6. Parking enforcement – monitor non-compliance of parking restrictions in the vicinity of Maya Close / Waterloo Road. Provide enforcement to deter unsafe parking.

7. Relocate street furniture – relocate the litter bin to the other side of the brick built planter to improve visibility to the right from Maya Close. This measure would be low cost and relevant to accident 3.

8. Trim vegetation in planter – at the time of the site visit (early spring) the vegetation in the planter did not restrict visibility from the junction. However, with spring /summer growth this could also impinge visibility. This measure is low cost and relevant to accident 3.

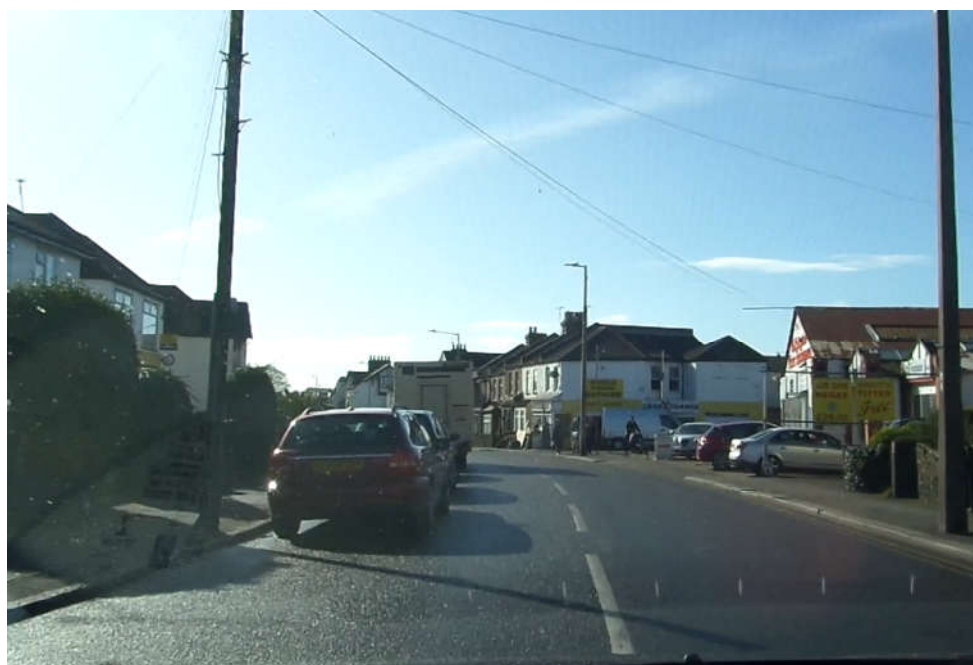
Image 2 – view southbound along Ness Road approaching Maya Close

1. Junction ahead warning signs – provide a staggered junction ahead warning sign on each approach to the junction on Ness Road. This measure would be relatively low cost and relevant to accidents 1 and 3.

5. 'SLOW' road markings – provide 'SLOW' road markings adjacent to the junction ahead warning signs. This measure would be relatively low cost and would support the signing.
