DEVELOPMENT CONTOL COMMITTEE SUPPLEMENTARY AGENDA - APRIL 2024 APPENDIX B

SURVEY DATA SHEET & DECISION GUIDE

TPO Ref (if applicable): 24/00185/NTPOR Tree/Group No: 1 Species: London Plane (Platanus x hispanica

Owner (if known): Southend City Council Location: Footpath close to the junction of Chichester Road with

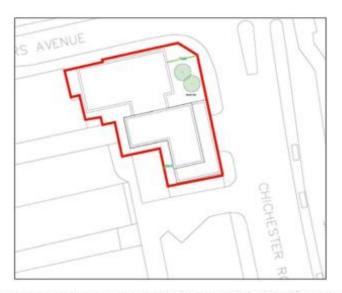
PIC1. Taken from the planning application freely available on the planning portal Shows the area to NW of the site to be proposed for public realm use.

I would strongly advise the Council and developer to explore the aforementioned suggestion of utilising space created through development to be utilised to give required clearance of the tree ensuring minimum foot path width is maintained as when looking at the construction plans there is minimal biodiversity gains that I could see and as a result of the Environment Act all development sites are required to provide net gain of at least 10% with the tree removal I would campaign that the removal of said tree should contribute to the impact of the development thus be included in any mitigation measures as a result.

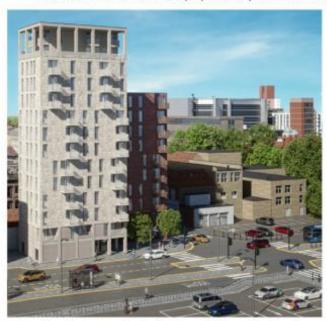
PIC2. Taken from the planning application freely available on the planning portal shows again the area to accommodate public realm

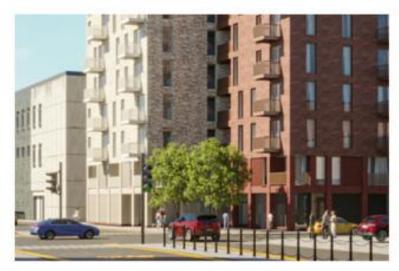
PIC3. Taken from the planning application freely available on the planning portal shows again the area to accommodate public realm.
