**613-619 SOUTHCHURCH ROAD,
SOUTHEND**

**PRELIMINARY BAT ROOST
ASSESSMENT**

Report No: RT-MME-155176-04

Date: June 2021

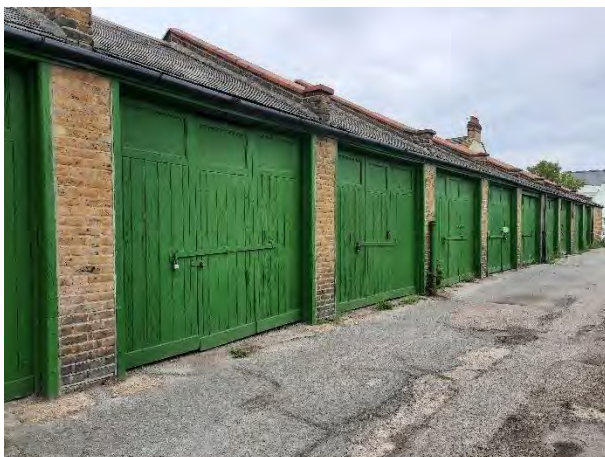
Building 1 consisted of 22 single storey brick-built garages with a pitched slate tiled roof (Plate 4.1, 4.2 and 4.3). The garages were in use at the time of the survey for storage. It is understood the garages were individually rented. The majority of the garages were in relatively poor condition at the time of the survey. However, the roof of the garages located at the western edge had recently been replacement and these were tightly sealed and in good condition as shown in Plate 4.3.

Plate 4.1: Southern Elevation

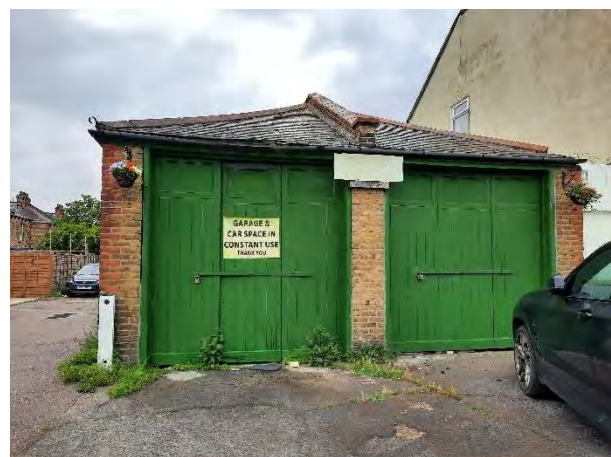
Plate 4.2: Eastern Elevation

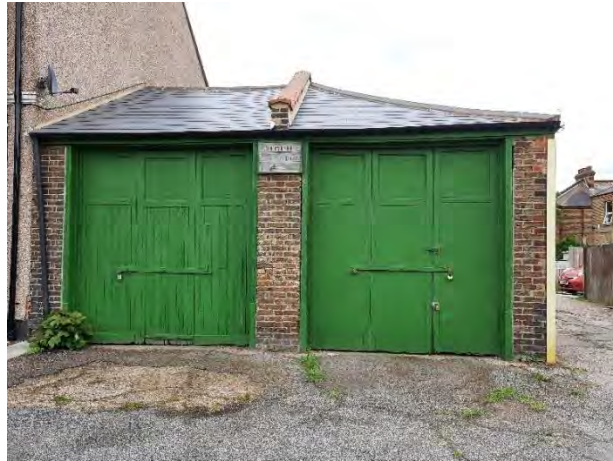
Plate 4.3: Western Elevation

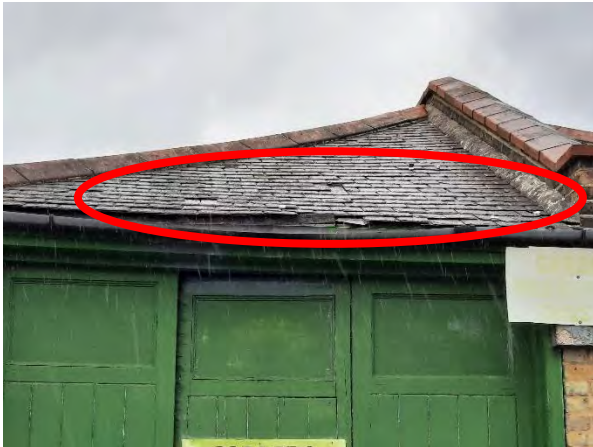
A survey of the roof of the building was conducted from ground level. Across many of the garage roofs there were multiple missing, slipped and lifted roof tiles as shown in Plates 4.4, 4.5, 4.6 and 4.7. The missing, slipped and lifted slate roof tiles created gaps which provide potential access into the internal areas of the building as well as providing suitable crevices for roosting bats.

Plate 4.4: Missing and Slipped Roof Tiles

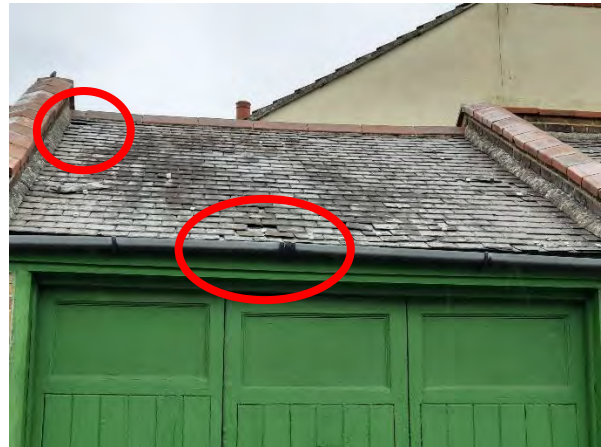
Plate 4.5: Missing and Lifted Roof Tiles

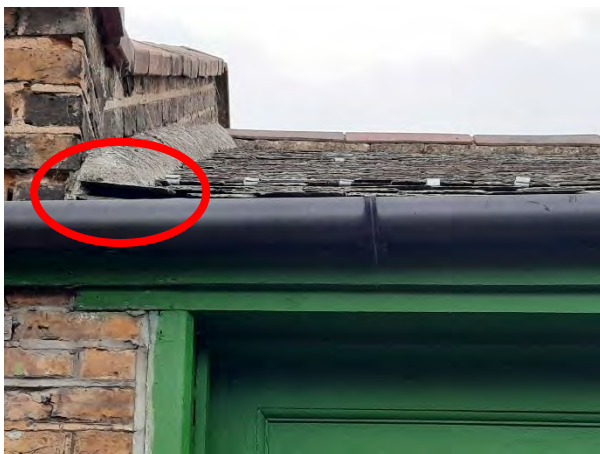
Plate 4.6: Lifted Roof Tile

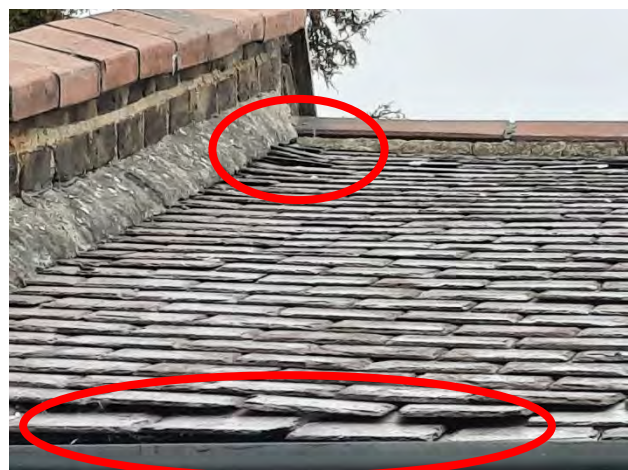
Plate 4.7: Lifted Roof Tiles

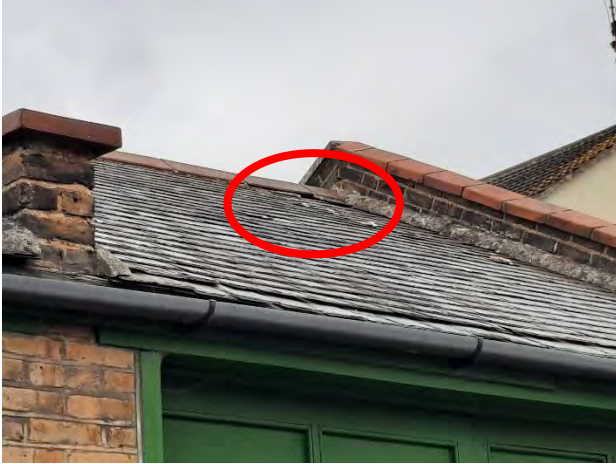
In addition to the gaps and crevices created under the roof tiles there were also multiple areas across the roofs of the garages where there were gaps underneath the ridge tiles as shown in Plates 4.8, 4.9 and 4.10. These gaps under the ridge tiles provide potential access into the internal areas of the building as well as

Plate 4.8: Gap Underneath the Ridge Tile

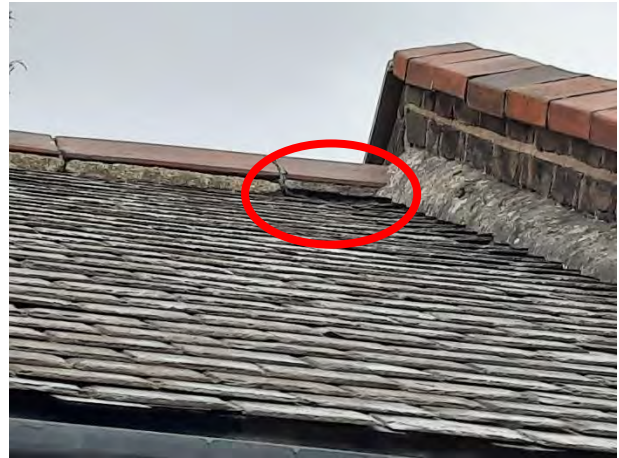
Plate 4.9: Gap Underneath the Ridge Tile

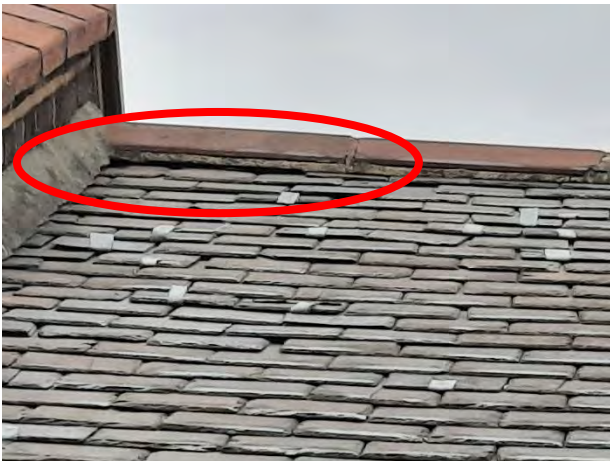
Plate 4.10: Gap Underneath the Ridge Tile

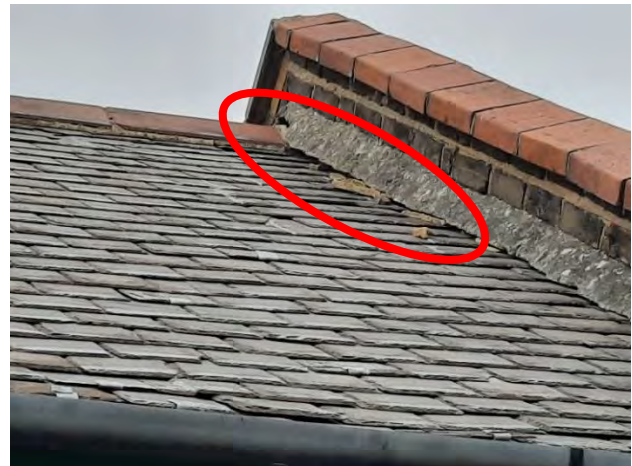
providing suitable crevices for roosting bats. Gaps were also noted along the edge of the roofs as shown in Plate 4.11.

Plate 4.11 Gap Underneath the Cement

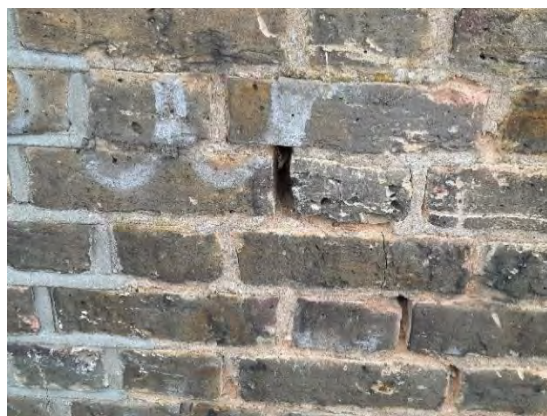
The majority of the brick walls were in relatively good condition. However, there was a single gap within the brick wall noted where the mortar was missing as shown in Plate 4.12. This gap was fully inspected at the time of the survey and no evidence of roosting bats was noted. Other gaps within the brickwork were noted surrounding the edge of the door frames where there was missing mortar as shown in Plates 4.13 and 4.14. Again, these gaps could be fully inspected at the time of the survey and no evidence of roosting bats, e.g. droppings, urine staining, feeding remains or scratch marks, was recorded.

Plate 4.12 Gap Within the Brick Wall

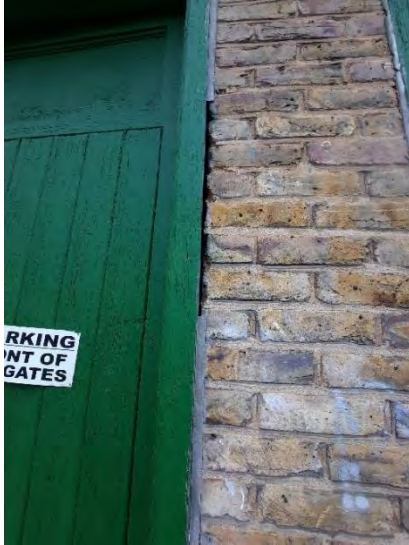
Plate 4.13 Gap Between the Wall and the Garage Door

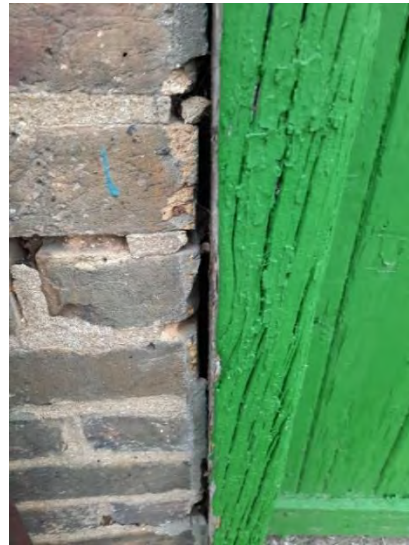
Plate 4.14 Gap Between the Wall and the Garage Door

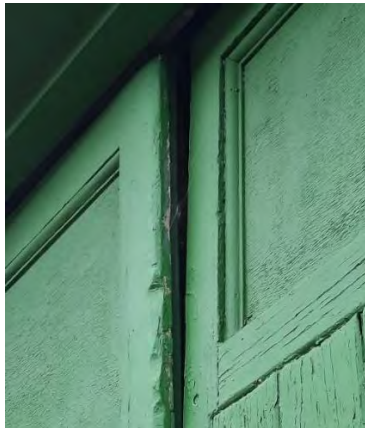
Further access points into the internal areas of the building were noted. Many of the garage doors did not close completely and therefore were not tightly sealed. The gaps between the doors and the door frames provide a gap which bat could use to enter the internal areas of the building (Plate 4.15 and 4.16). In addition, one of the garage doors had a lifted wooden panel which also provide a potential crevice for roosting bats as shown in Plate 4.17.

Plate 4.15: Gap Where the Garage Door is Ajar

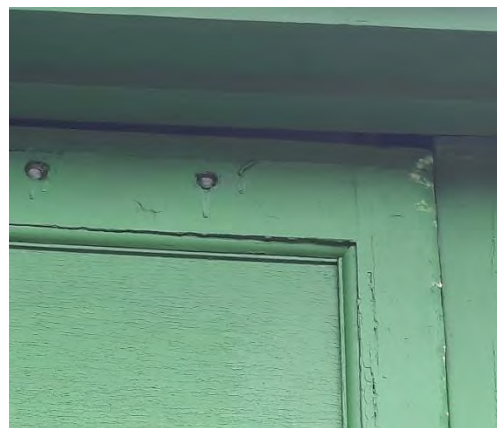
Plate 4.16: Gap Where the Garage Door is Ajar

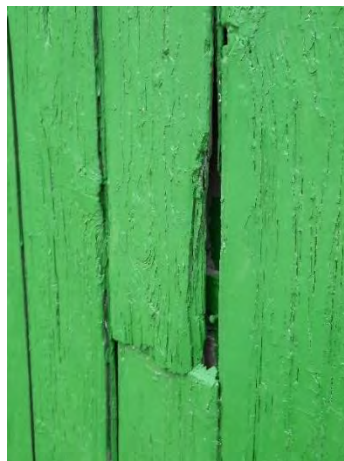
Plate 4.17: Broken Garage Door Panel

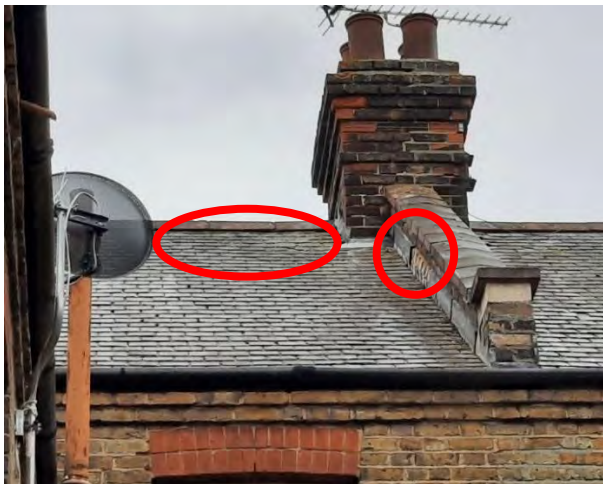
A survey of the roof of the building was conducted from ground level. Across the pitched roof there were multiple gaps noted which could provide potential access into the internal areas of the building as well as providing suitable crevices for roosting bats. These gaps were identified underneath the ridge tiles (Plate 4.21) as well as underneath lifted lead flashing as shown in Plate 4.21 and 4.22. Gaps within the roof were also identified where roof tiles have been damaged (Plate 4.23) or have slipped as shown in Plate 4.24 and 4.25.

Plate 4.21: Gap Under Ridge and Lifted Lead Flashing

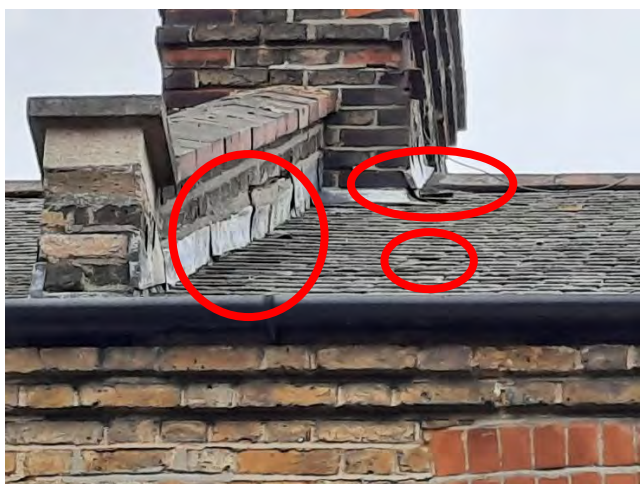
Plate 4.22: Lifted Lead Flashing and Gap Under a Tile

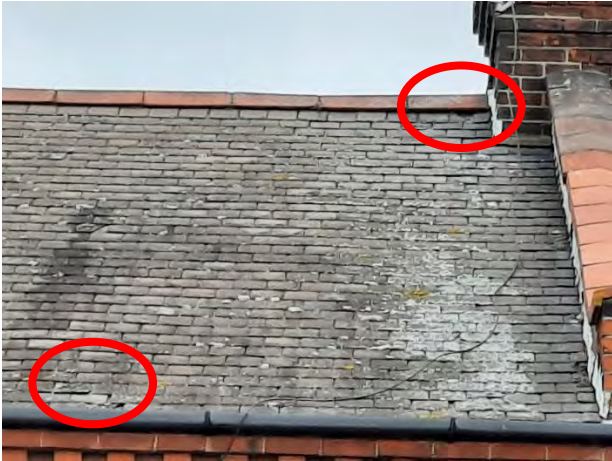
Plate 4.23: Damaged Tile and Gaps Under Tiles

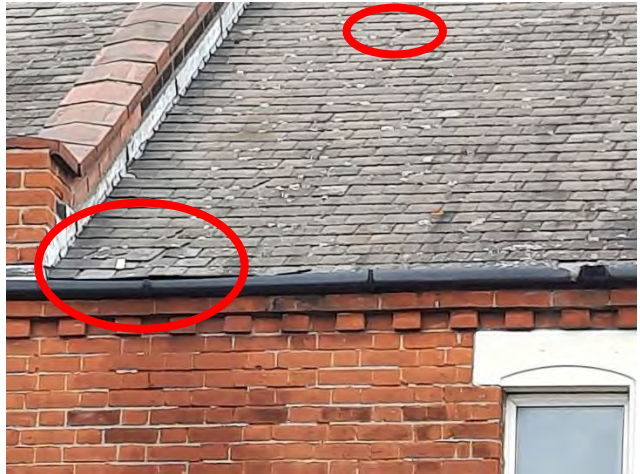
Plate 4.24: Slipped Roof Tiles

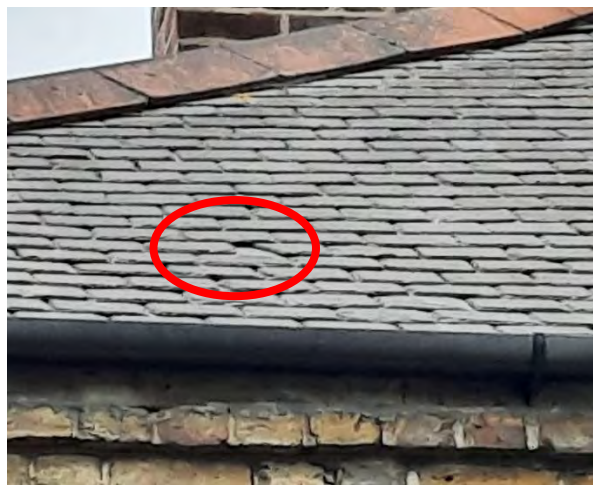
Plate 4.25: Slipped Roof Tile

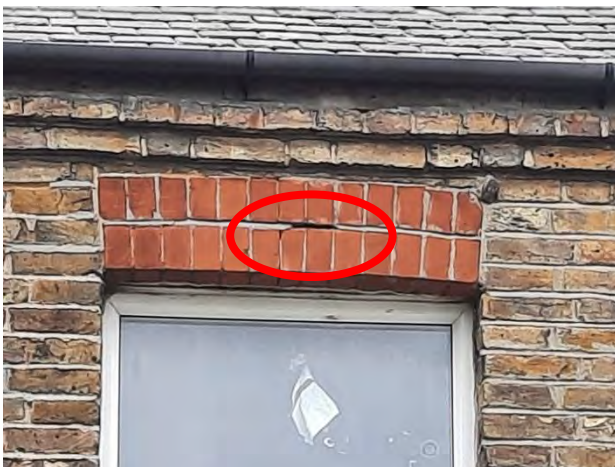
Within the brickwork of the building gaps were identified where the mortar was missing within the brickwork over a window (Plate 4.26) which provides a potential crevice for roosting bats. Access points into the internal areas of the building were also notes around pipes (Plate 4.27) and where external vents have been broken (Plate 4.28) as well as gaps within the door (Plate 4.29).

Plate 4.26: Gap within the Brickwork Above the Window

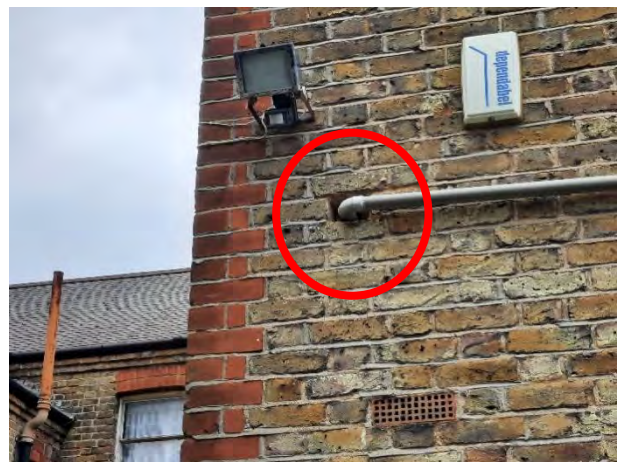
Plate 4.27: Gap Around the Pipe

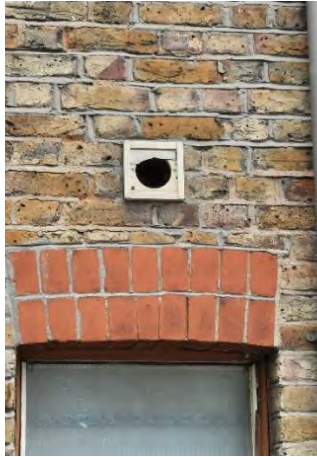
Plate 4.28: Gap in the External Wall

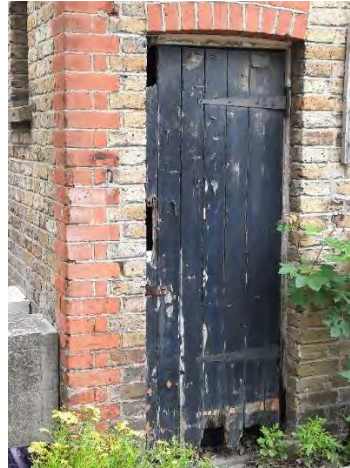
Plate 4.29 Gaps Within the Door
