Eastern Esplanade Conservation Area Appraisal

Southend-on-Sea: Eastern Esplanade Conservation Area Appraisal

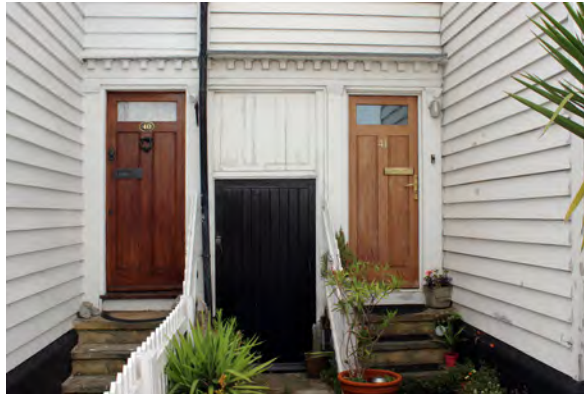
Nos.40-41 are the only pair without a recessed porch (York stone steps remain)

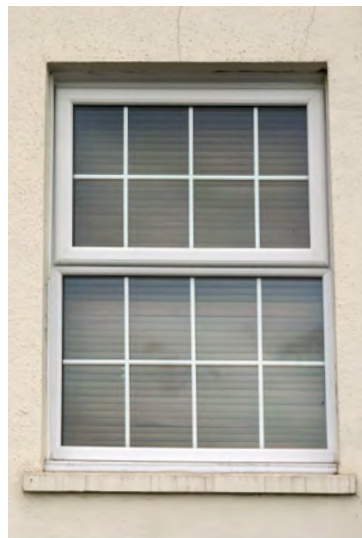
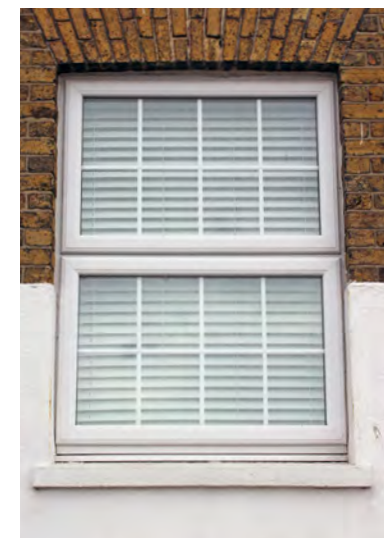
Examples of Inappropriate Windows

5.1.6 Front elevation windows were originally eight-pane sliding timber sashes to the ground and first floors with a pair of small side-hung casement windows to each basement. Many of these remain. However, the original fenestration at the eastern end of the terrace (Nos.54-57) has been much altered, with uPVC replacements and alteration of original window shape. No.55 bears an insensitive canted bay uPVC window and the squat uPVC units at No.56 do not retain the historic outline of the former sash windows, otherwise retained across the terrace. Non-original, hinged timber window shutters feature on some of the buildings (Nos.43 and 46). The modern shopfront window occupying the ground floor of No.48 has replaced former historic features (porch and sash windows), which are characterful across the terrace. The modern glazing also draws attention to the anomalous non-domestic function of this building. The associated fascia board is also oversized and inappropriate in the context of the Conservation Area, which otherwise is purely residential. The upper floor windows have also been replaced with insensitive modern units. Further details regarding inappropriate window alterations are found in Section 6.3.6.

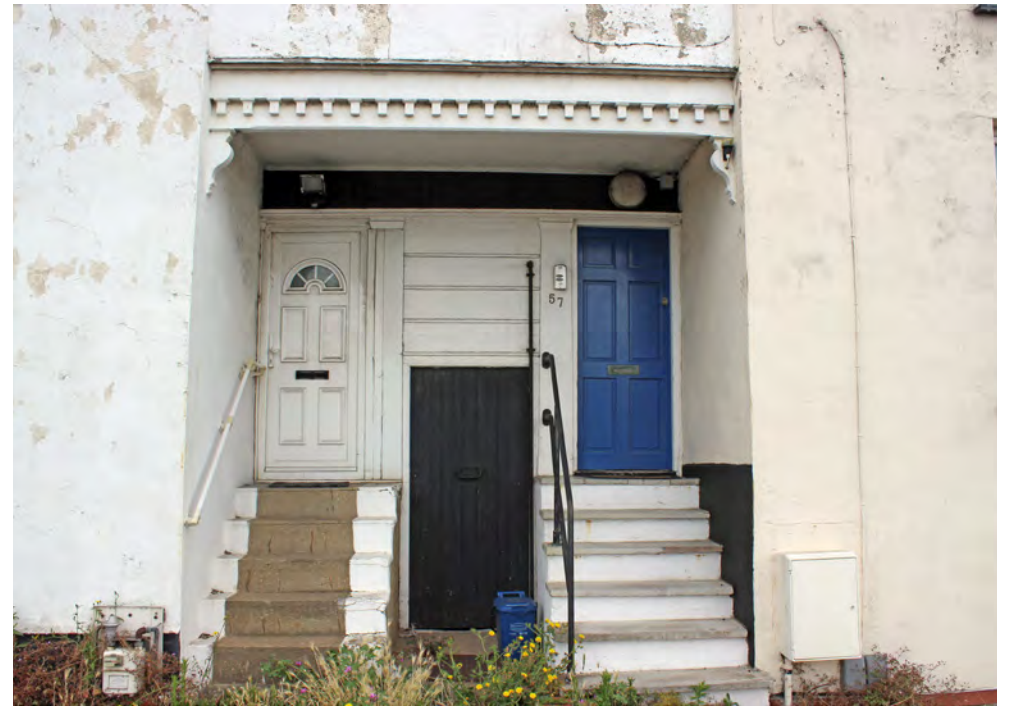
Replacement doors in 'off-the-peg' styles less appropriate to the character of the buildings

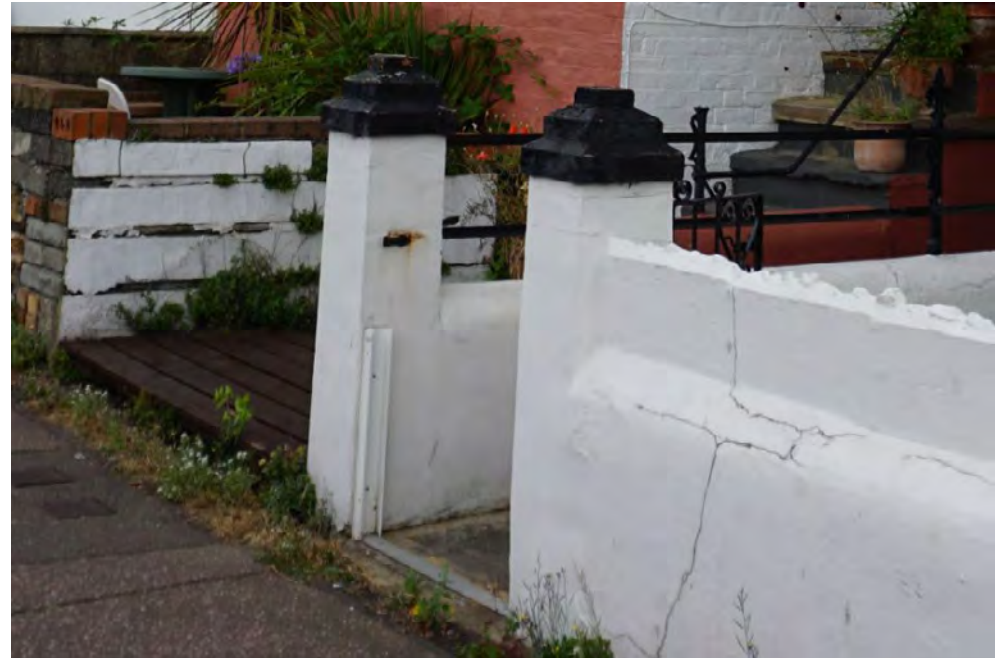
6.3.13 The Conservation Area is within a flood risk zone and property has been damaged due to flooding in the past. This is likely to lead to pressure to install flood prevention measures, such as barriers, which could harm the character and appearance of the area. Any flood prevention measures will need to be designed carefully so that they are as visually unobtrusive, and involve as little alteration of historic fabric, as possible. For example, relatively discreet rails into which a panel can be inserted to prevent water flow have been installed at the gate in the boundary wall of No.45.

Aluminium rails for flood prevention barrier installed at the gate of No.46

- 6.3.14 Flood prevention measures within the Conservation Area should be sensitively designed to minimise harm to its character.
- 6.3.15 Incorporating discreet flood barriers into boundary walls is a solution which minimises physical intervention into the Listed or Locally Listed Buildings themselves.

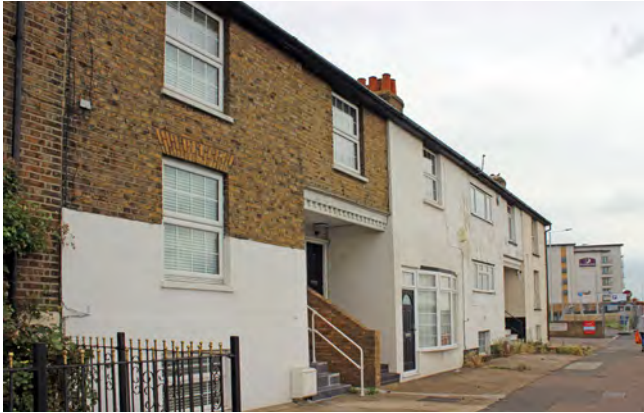
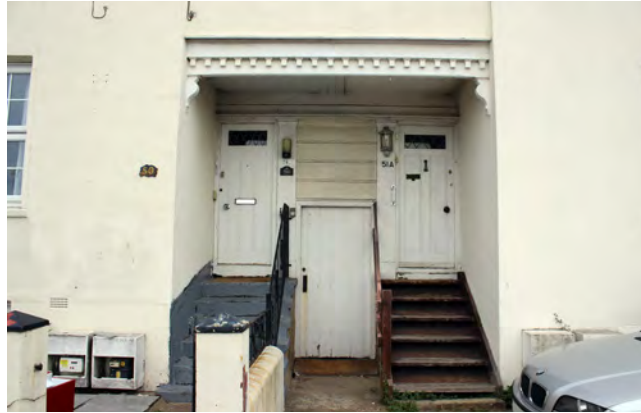
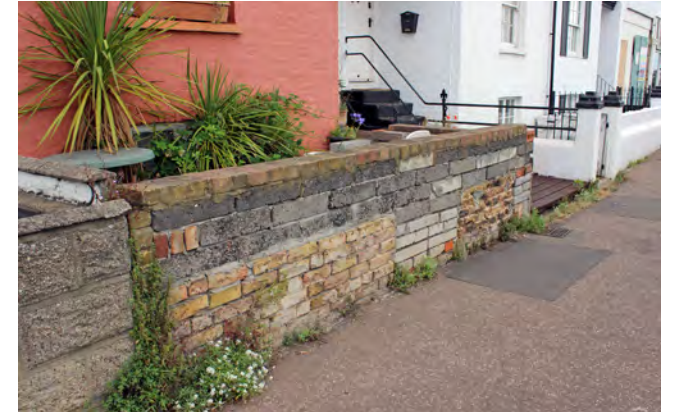
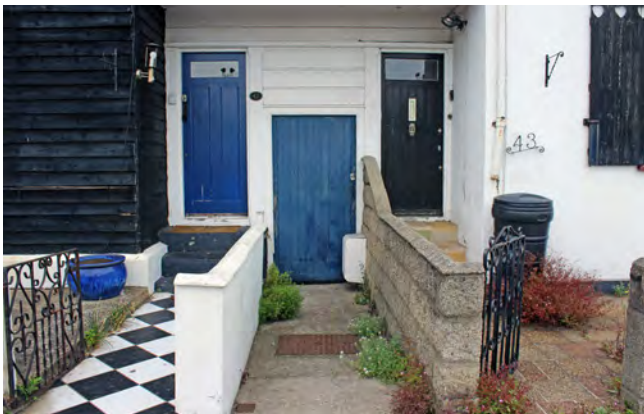
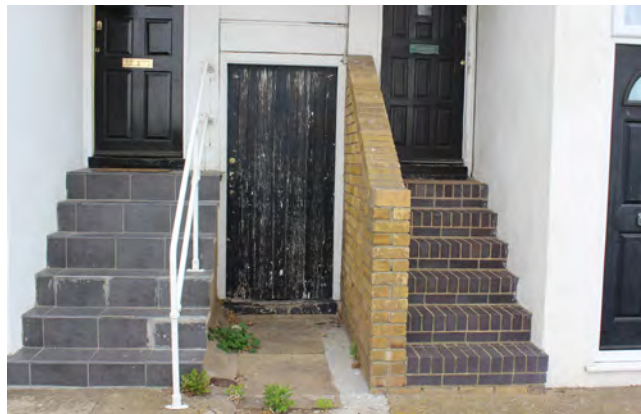
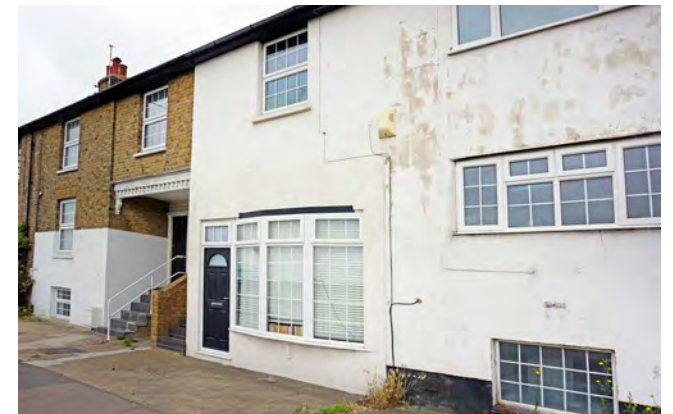
6.3.16 The Conservation Area features inconsistencies in boundary treatment and, in places, erosion of boundary demarcation, particularly towards the east end of the Conservation Area. The boundary enclosures comprise a mixture of metal railings, concrete block, posts and rope, hedges and rubble wall. Some properties have had their front gardens replaced with hardstanding and are used as driveways. This has begun to erode the character and appearance of the street. The consequential loss of planting, trees and shrubbery, exposes the terrace and further detracts from the character of the Conservation Area. The properties exhibit diverse balustrades and access steps (materials, height and styles) This detracts from the order, rhythm and coherence of the Conservation Area, as well as the loss of the original stone steps in places.

Examples of inappropriate boundary treatments, loss of boundary walls and replacement of original stone steps

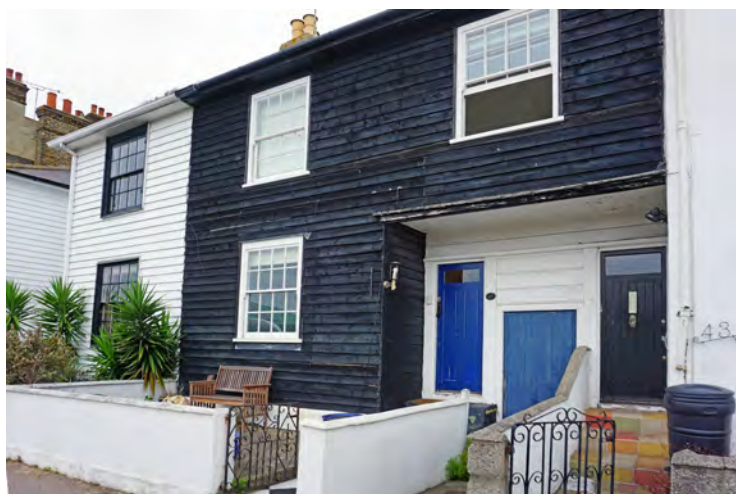
Address	Value	Designation
43 Eastern Esplanade	Positive* Boundary wall negative	N/A

See list description. Mid-19th century. Timber framed two-storey house. One window range. Originally weatherboarded but now rendered. Doorway recessed on ground storey, under an open porch. Timber door with glazed pane at top, probably modern as it has vertical planks rather than panels, though not inappropriate, accessed up tiled steps. The tiled steps are an inappropriate material and reinstatement with stone would be beneficial. Double hung timber sash windows with glazing bars and modern timber shutters, which are harmful to the character of the terrace. Slate roof. Yellow brick chimney shared with No.44. Front garden enclosed by block wall. The garden would benefit from the addition of planting. Modern decorative metal gate not in keeping. A low timber gate is likely to be more appropriate.

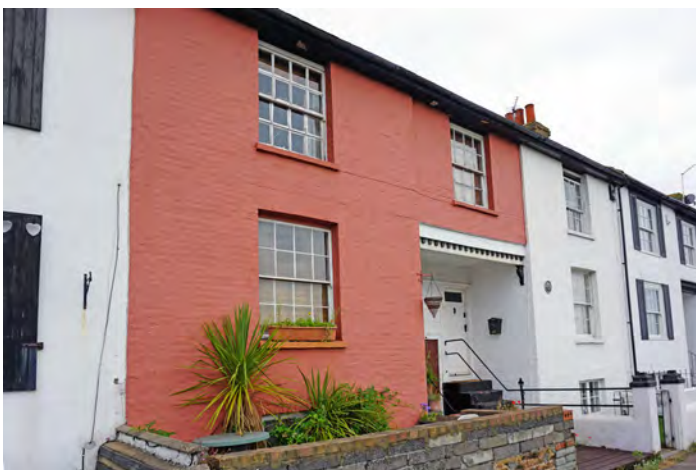
Address	Value	Designation
45 Eastern Esplanade	Positive	N/A

See list description. Mid-19th century house. One window range. Originally yellow facing brick now painted. Painting of brickwork is unfortunate and would benefit from removal if possible without damaging the bricks, though repainting in white would also be acceptable. Two-storeys plus semi-basement. Doorway recessed on ground storey, under an open porch, with dentil detail cornice and scroll brackets. Timber door, possible an early replacement as it has vertical planks rather than panels, with glazed pane at top, accessed up concrete steps. Concrete steps are inappropriate and would benefit from reinstatement with stone. Double hung timber sash windows with glazing bars. Slate roof. Yellow brick chimney stack shared with No.46. Front garden enclosed by rendered wall with thin top panel. Modern decorative metal gate not in keeping. A low timber gate is likely to be more appropriate. Discreet aluminium rails have been installed at the gate into which a barrier can be inserted for flood prevention. Garden would benefit from planting.

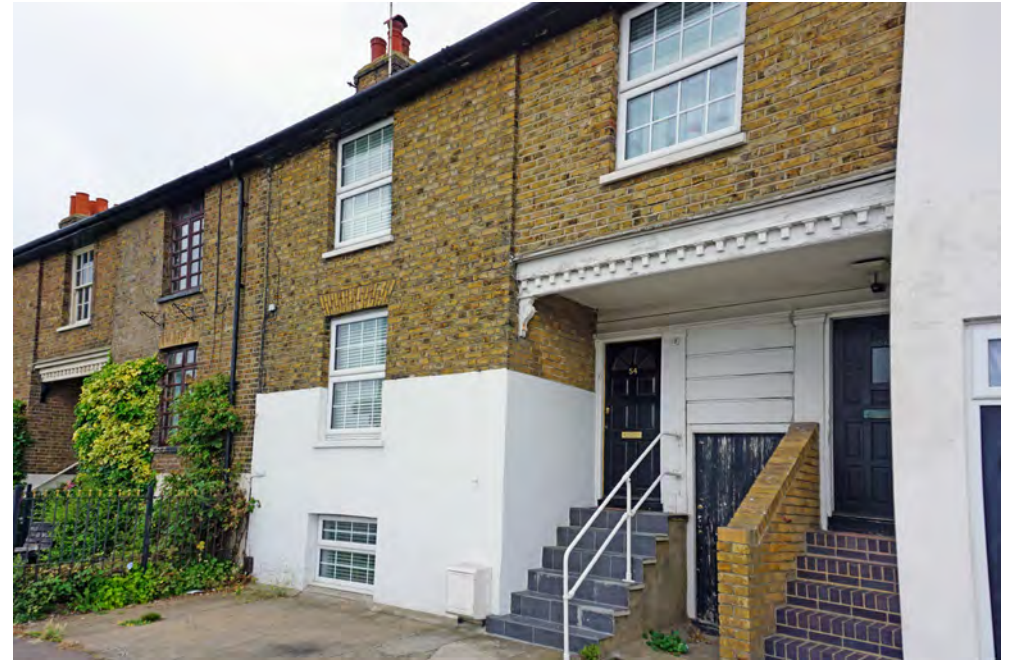
Unattractive concrete forecourt with boundary removed which has a negative impact and would benefit from reinstatement of a planted front garden with a boundary wall. Utility meter box to front elevation is unattractive. Rear boundary wall blockwork.

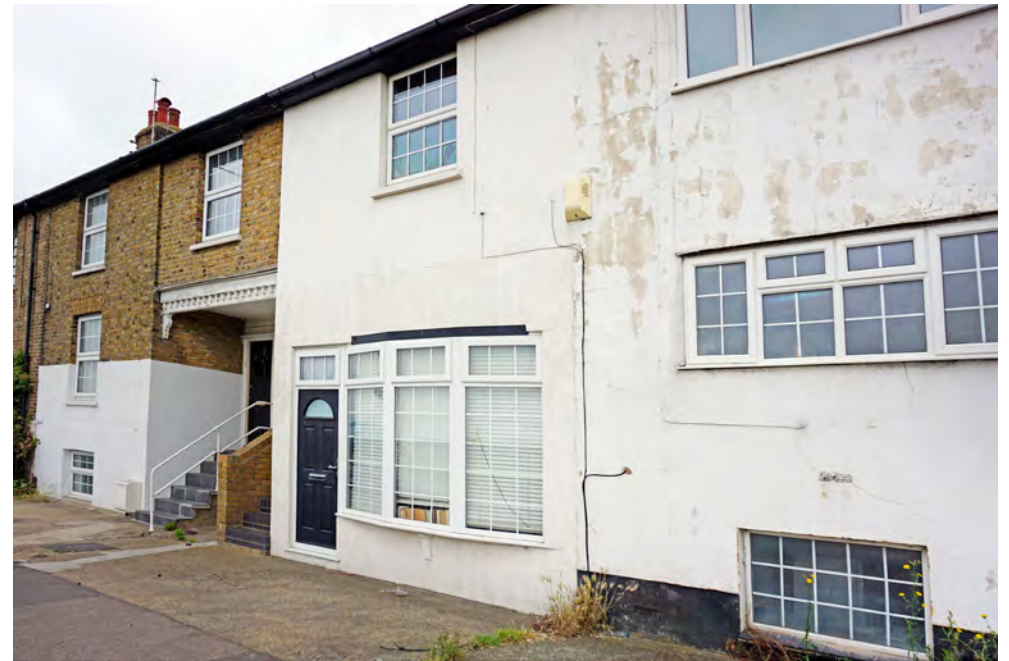
Mid-19th century two-storey house. One window range. Ground floor formerly converted into a shop, now in use as two flats. Ground floor window replaced with particularly inappropriate uPVC bay window and door. Door opening under recessed porch has unsympathetic modern panelled door, accessed up inappropriate brick steps which would benefit from replacement with stone, with inappropriate brick handrail. Porch has dentil detail cornice, scroll brackets lost. Original yellow facing brick now rendered. Rendering of brickwork is inappropriate and would benefit from removal if possible without damaging the bricks, though this is unlikely so repainting in white would also be acceptable. uPVC windows to first floor are also inappropriate. All uPVC windows would benefit from replacement in timber to match the original design and proportions. Slate roof replaced with unsympathetic concrete tiles. Yellow brick chimney stack shared with No.56. Unattractive concrete forecourt, boundary removed has a negative impact and would benefit from reinstatement of a planted front garden with a boundary wall. Rear boundary wall blockwork.

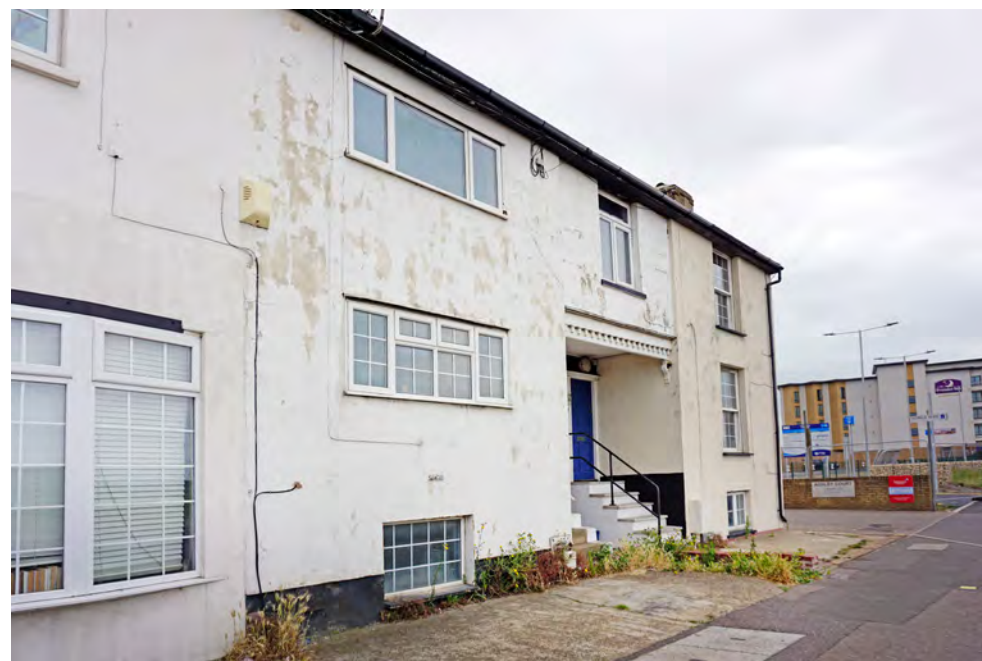
Mid-19th century house. Two-storeys plus semi-basement. Two window range. Originally yellow facing brick now rendered and in poor condition. Rendering of brickwork is inappropriate and would benefit from removal if possible without damaging the bricks, though this is unlikely so repainting in white would also be acceptable. Paintwork in poor condition and requires repainting. Doorway recessed on ground storey, under an open porch, with dentil detail cornice and scroll brackets. Sash windows replaced by inappropriate uPVC casement windows in altered openings, which would benefit from replacement with timber to match the original materials, design and proportions. Inappropriate uPVC entrance door would benefit from replacement in timber to match the original design, accessed up unsympathetic concrete steps with metal handrail. Steps would benefit from replacement with stone. Timber plank door to rear access with timber plank panelling above. Slate roof replaced with inappropriate concrete tiles. Yellow brick chimney stack shared with No.55. Unattractive concrete forecourt and unsightly utility meter boxes to front elevation. Front boundary removed which has a negative impact and would benefit from reinstatement of a planted front garden with a boundary wall. Forecourt would benefit from reinstatement of a planted front garden with a boundary wall. Rear boundary wall blockwork.

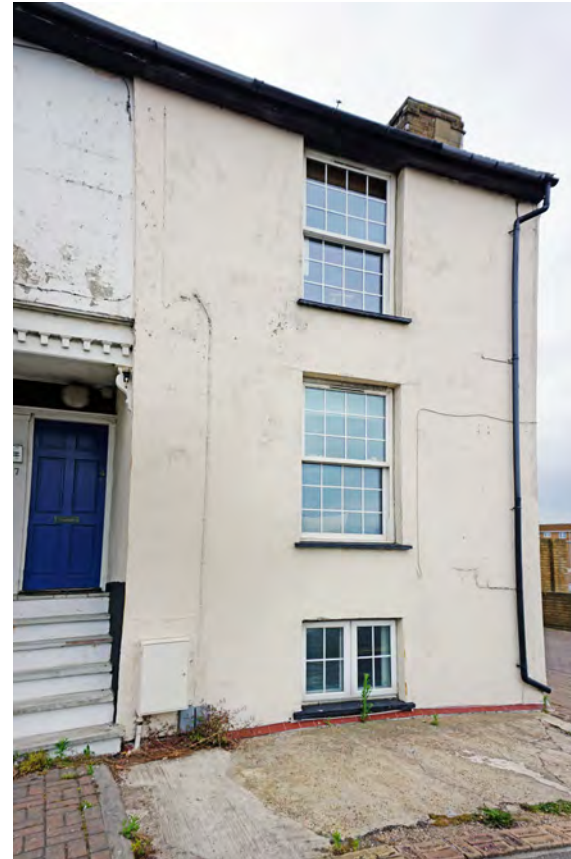
Mid-19th century house converted into two flats. Two-storeys plus semi-basement. One window range. Originally yellow facing brick now rendered, including side elevation. Rendering of brickwork is inappropriate and would benefit from removal if possible without damaging the bricks, though this is unlikely so repainting in white would also be acceptable. Doorway recessed on ground storey, under an open porch, with dentil detail cornice and scroll brackets. Inappropriate modern panelled door accessed up unsympathetic concrete steps with metal handrail. Would benefit from a replacement door in timber to match the original design and replacement of the steps in stone. Inappropriate uPVC sliding sash windows with glazing bars. uPVC casements to basement also inappropriate. Slate roof replaced with unsympathetic concrete tiles. Yellow brick chimney stack. Unattractive concrete forecourt and unsightly utility meter boxes to front elevation. Front boundary removed. Forecourt would benefit from reinstatement of a planted front garden with a boundary wall. Rear boundary wall blockwork.
