Prittlewell Conservation Area Appraisal

Southend-on-Sea: Prittlewell Conservation Area Appraisal

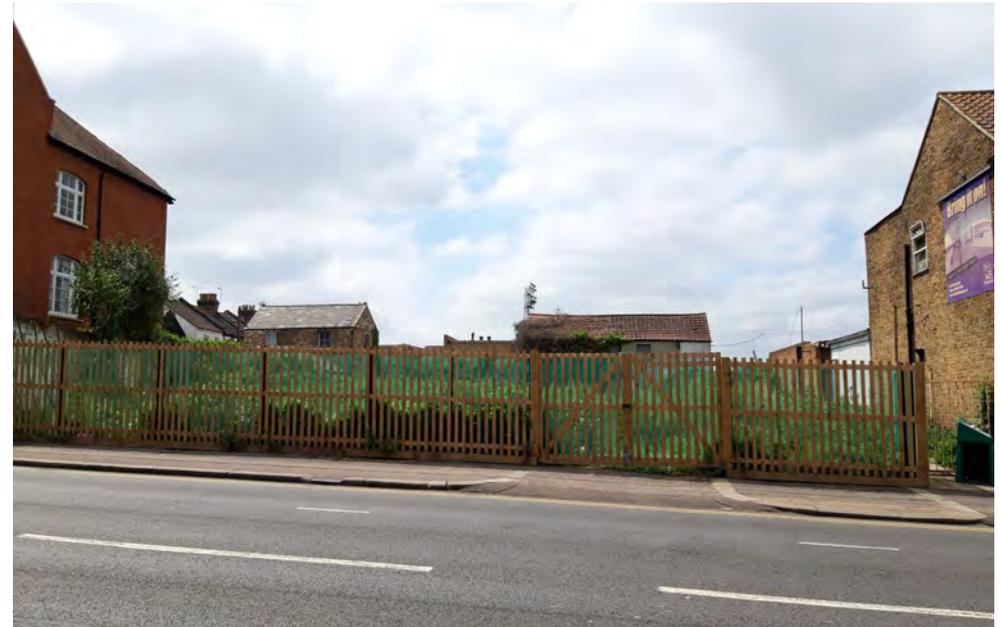
5.2.5 Removal of buildings in the 20th century has left several vacant plots, such as on Victoria Avenue, east of Roots Hall football stadium. Some parking areas between or in front of buildings have also created gap sites, which are generally unattractive within the streetscape.

Vacant plot on Victoria Avenue

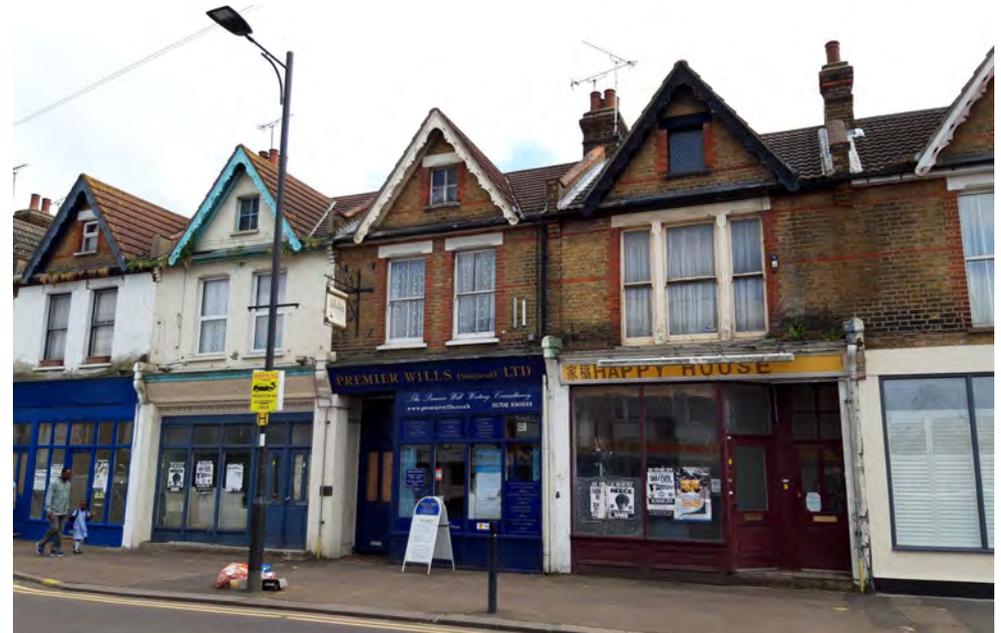
6.3.1 Some buildings in the Conservation Area are in poor condition. Often poor condition is linked to vacancy (see below for more details). Poor condition is sometimes purely decorative, and a refresh of paintwork would assist in improving the building's appearance and prevent further deterioration, for example to timber windows where paintwork provides a protective layer for the wood underneath. However, in some cases other issues are apparent. Vegetation growing out of gutters, for instance, demonstrates that gutters are blocked allowing plants to grow. This in turn means poor shedding of water away from the building and water ingress into the building. Regular maintenance would ensure that problems do not occur.

Issues with condition, such as poor decorative repair and problems with damp, indicated by vegetation growing out of blocked gutters.

- 6.3.2 Keeping buildings in good condition will ensure the area is an attractive and desirable place to live and work.
- 6.3.3 Undertake regular maintenance and checks to prevent problems from occurring and protect original features. This will also ensure small problems do not become bigger, more costly issues to fix.
- 6.3.4 Follow guidance in section 6.4 to ensure repairs and alterations are carried out in an appropriate manner.

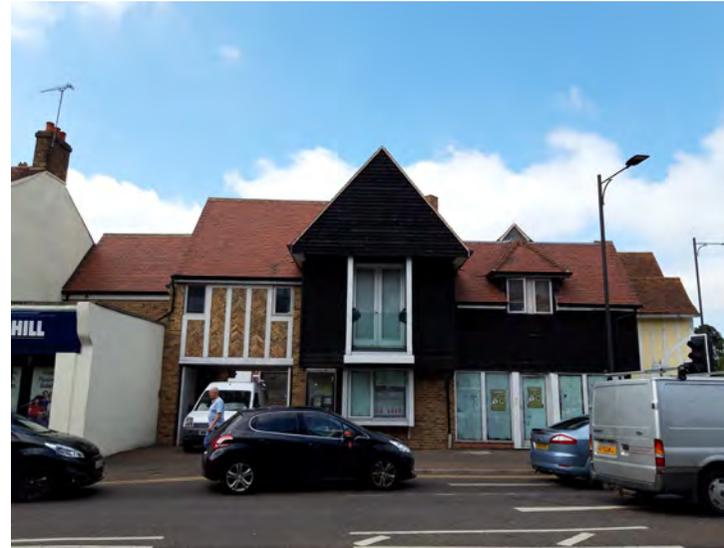
- 6.3.5 There are several buildings within the Conservation Area, particularly around the busy main junction, which are vacant, either fully or the shop vacant with residential accommodation occupied above. Vacant buildings look unattractive and give an air of neglect to the Conservation Area. Vacancy can also lead to issues with condition as without regular inspections of the building small problems go unnoticed and can turn into larger issues. Vacant buildings can also be a target of vandalism.
- 6.3.6 Encouraging positive changes to gradually improve the area could lead to a reduction in vacancy as the area will become a more attractive place to live and work. There may be opportunities to pursue grant funding and regeneration schemes specifically targeted at high streets to assist with the improvement of the area.

Building on a prominent corner site at the main junction with vacant shop on ground floor

- 6.3.7 Local communities could explore opportunities such as grants and high street schemes to bring about enhancements.
- 6.3.8 Encourage good design and the maintenance of buildings in good condition, as well as take enforcement measures against inappropriate change, in order to bring about positive change gradually which will enhance the area and bring in more businesses.
- 6.3.9 Enhance the area by making it more pedestrian friendly and with a more attractive street scene in order to bring in more businesses.

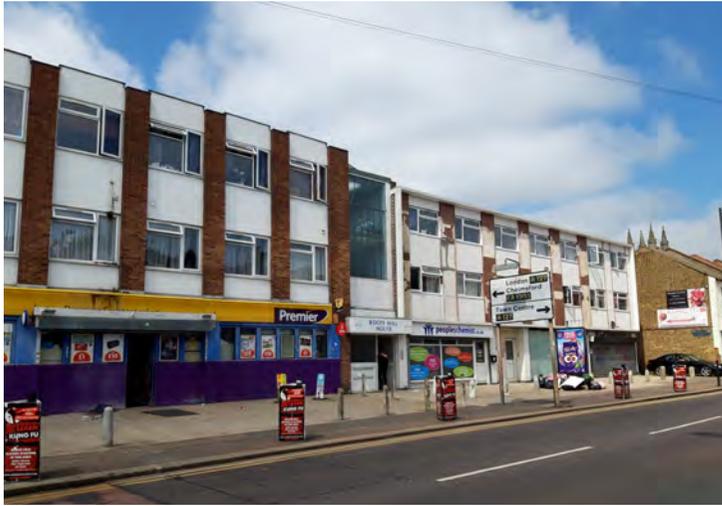
Poor quality buildings in the setting of the Conservation Area

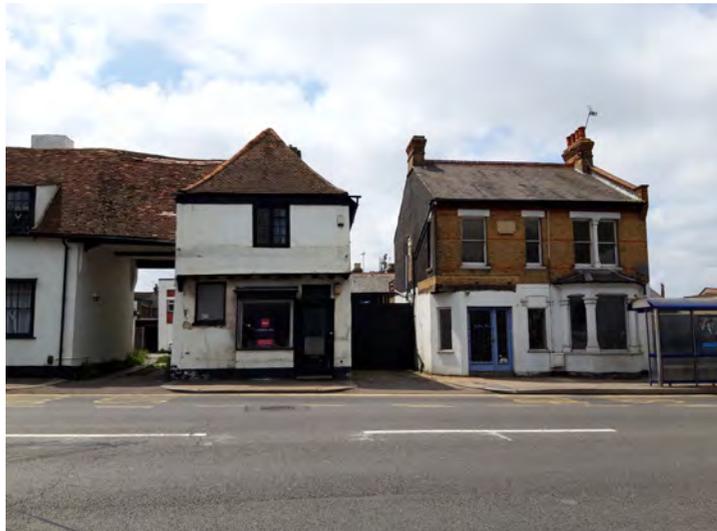
Two vacant buildings on Victoria Avenue where issues with condition are visible, including poor decorative repair and cracking to plasterwork

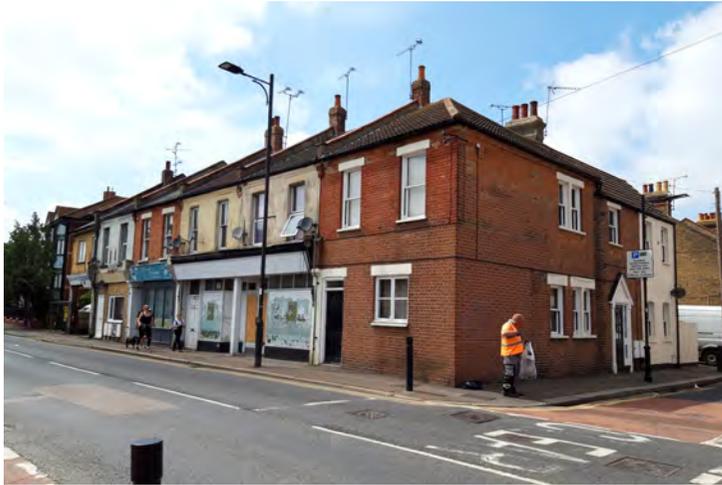
Two shop fronts in this terrace have been converted into residences with windows of an inappropriate scale and proportions for the building. Brickwork has also been rendered and the larger shop is vacant

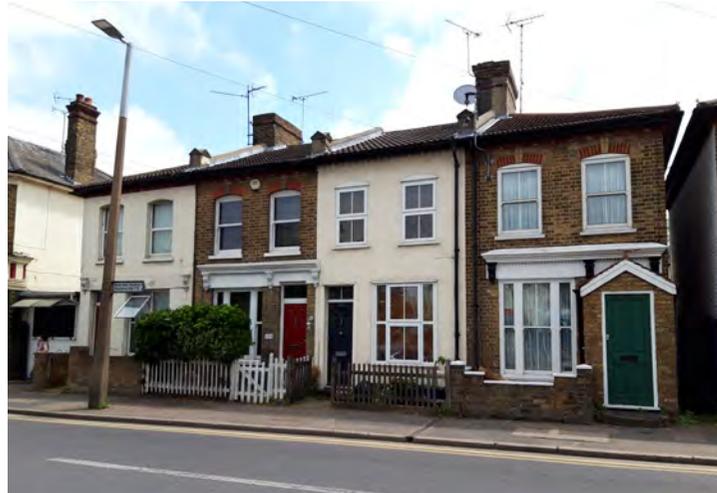
uPVC windows and replacement doors to most of the houses in this terrace. Those in sash form are more appropriate than top hung casements. Two houses have been rendered and have lost their decorative cornices. One has had a porch added.

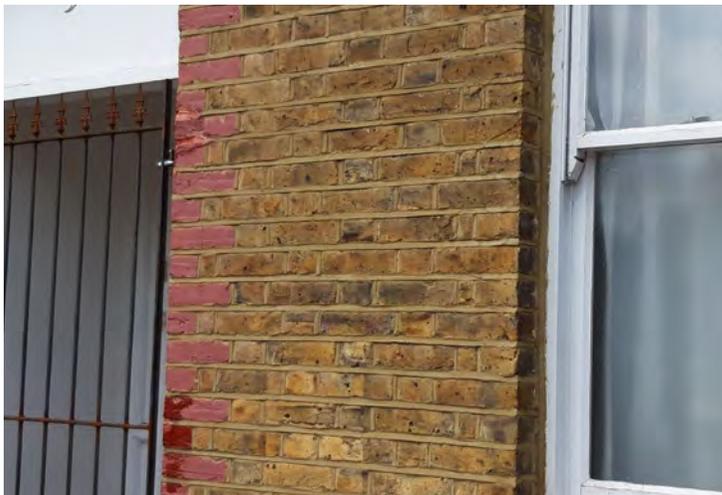
Example of cement pointing to historic brickwork

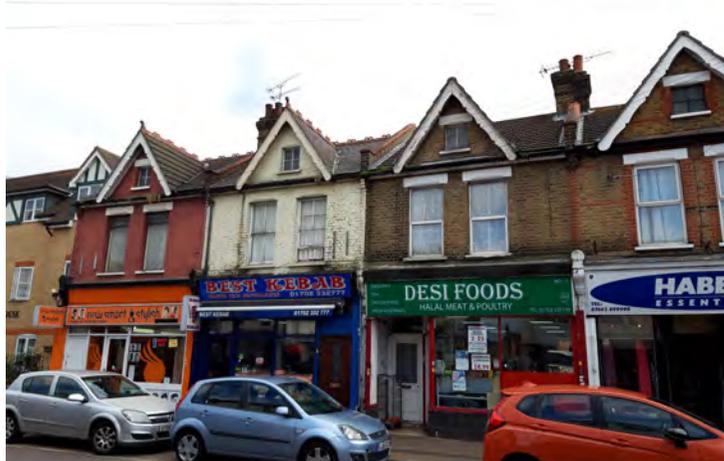
Oversized and garish shop fronts, plus painted brickwork and inappropriate replacement windows. The white painted building does have historic timber sash windows, though in poor decorative repair

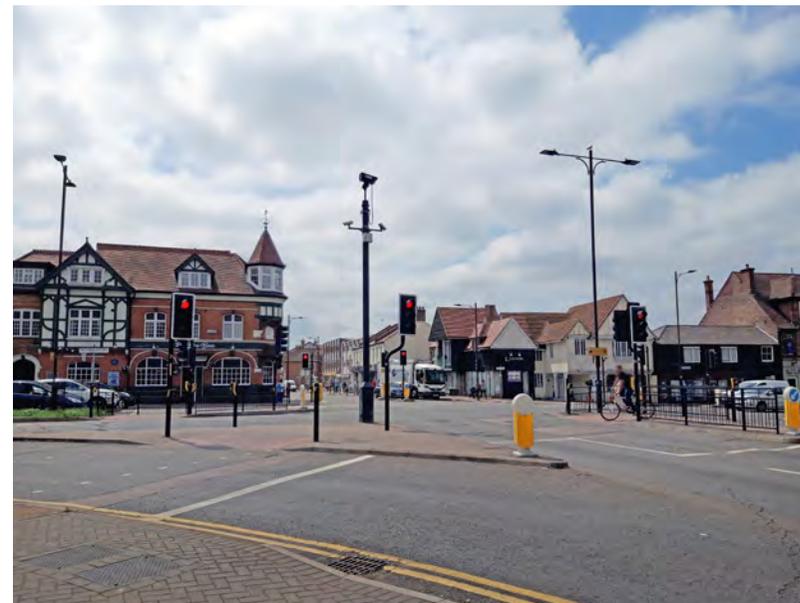
Abundance of traffic lights and institutional street furniture at the busy junction

- 6.3.27 Enhance the junction to make it more pedestrian friendly.
- 6.3.28 Improvements to standards of street furniture should be made, with bespoke designs where possible.
- 6.3.29 Reduce street clutter and signage at the junction to the minimum needed for safety.
- 6.3.30 Improve surfacing of pavements.
- 6.3.31 Where necessary, road markings should be the minimum necessary for safety and yellow line road markings should be 50mm wide in primrose.
