Leigh Cliff Conservation Area Appraisal

Southend-on-Sea: Leigh Cliff Conservation Area Appraisal

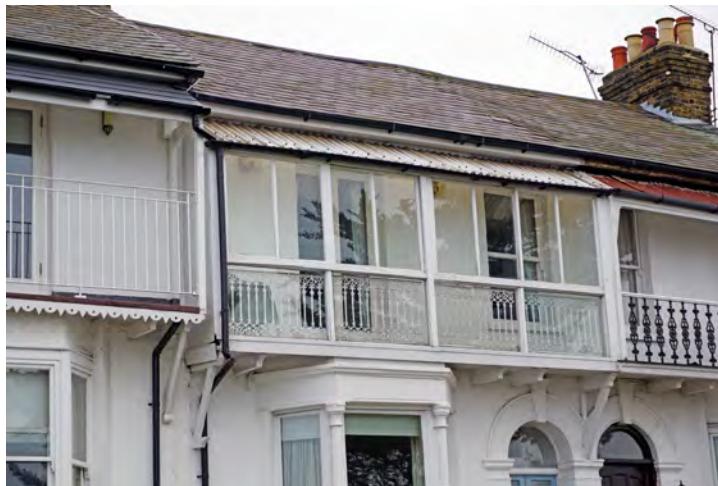
Glazed in balcony

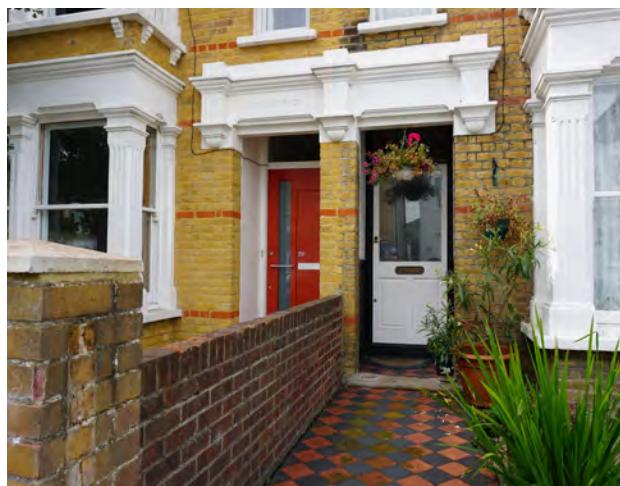
Replacement doors

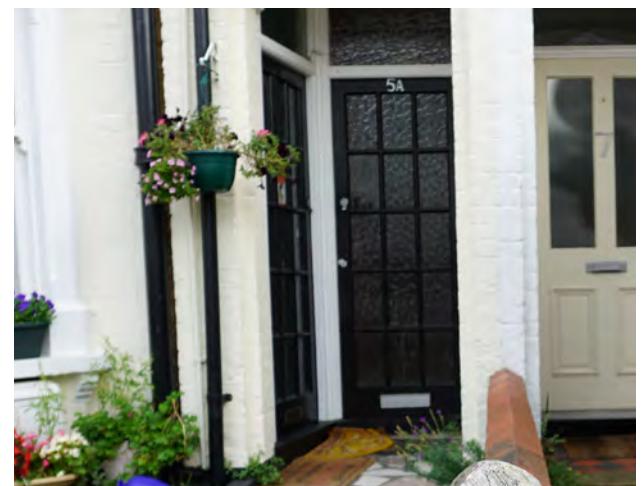
Additional door inserted within a recessed porch for the conversion of a house to flats

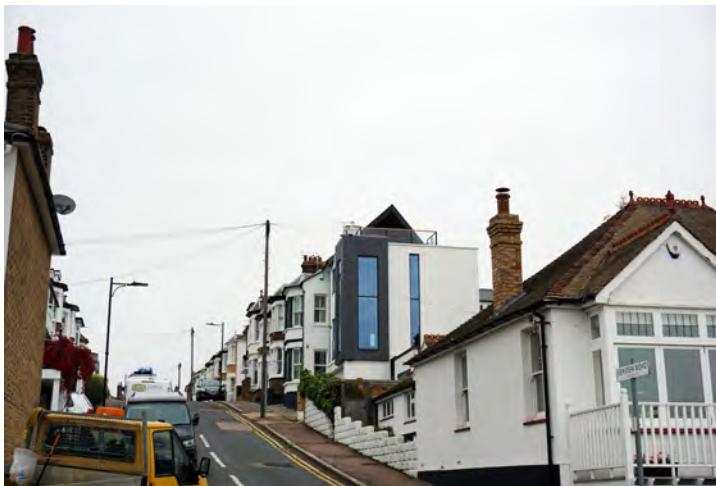
Boxy side extension (built c1980s, remodelled in 21st century) which does not relate well to the rhythm of the buildings around it

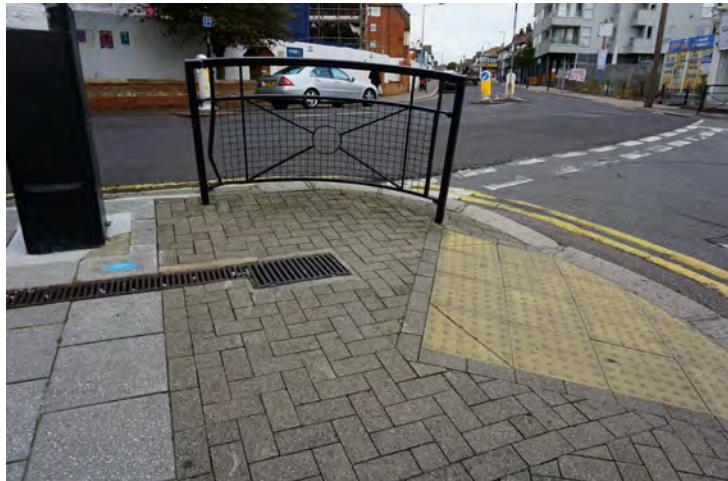
Damaged railings on Broadway

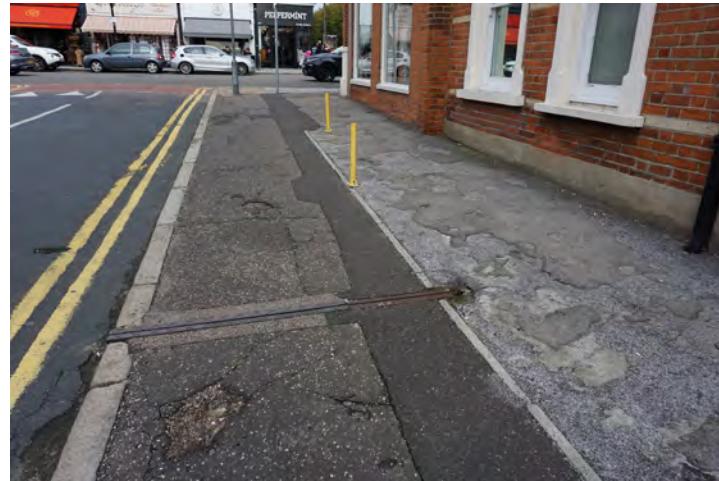
Poor surfacing and dominant yellow lines

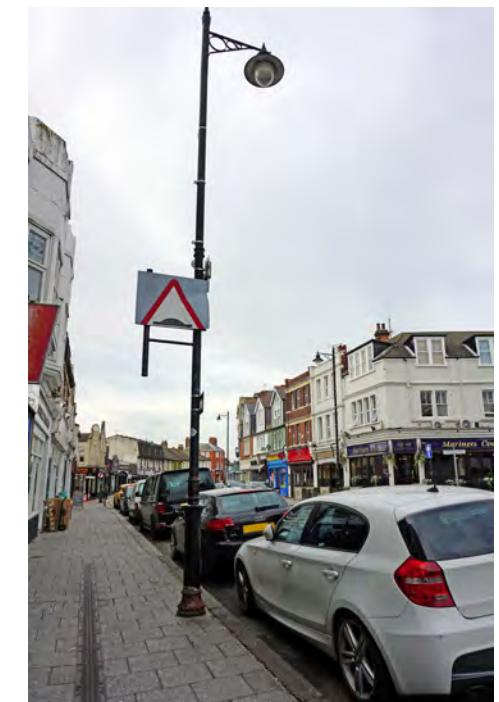
Good traditional lamppost on Broadway but with a damaged and intrusive sign attached

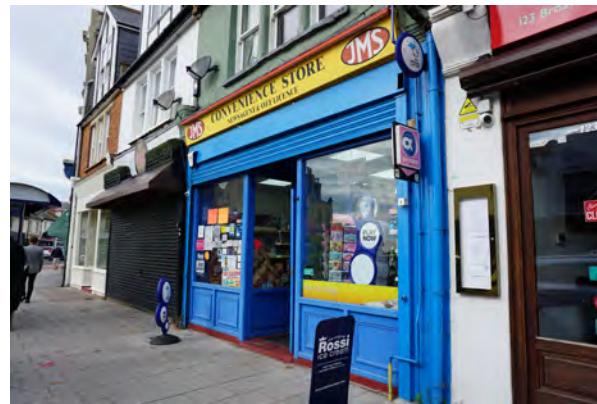
Unsightly roller shutter and garish colours and signage to a shop front

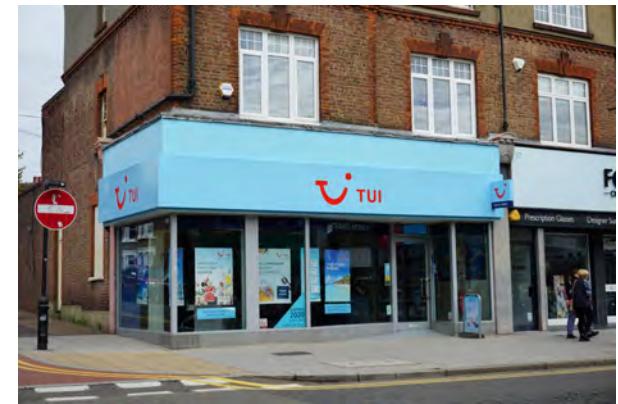
Oversized and brightly coloured fascia

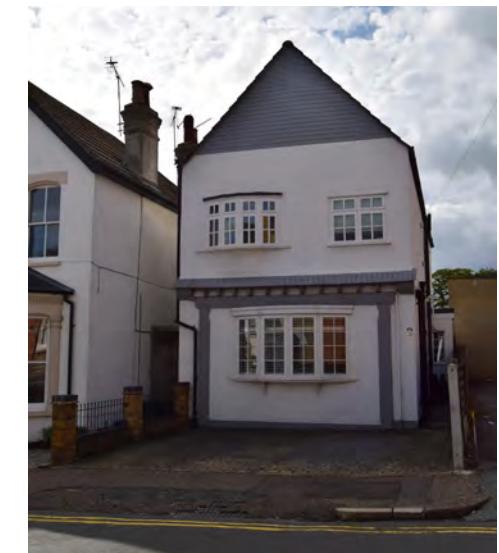
A curious detached building presenting a gable to the street, dating from between the wars, originally a workshop, with false timber framing and inappropriate uPVC windows on the first floor. The ground floor windows are replacement timber frames. Concrete tiles. Now painted white and grey. Parking on the pattern impressed concrete in front of it, which would benefit from upgrading to a more appropriate material.

Would benefit from landscaping or planting to soften the appearance.

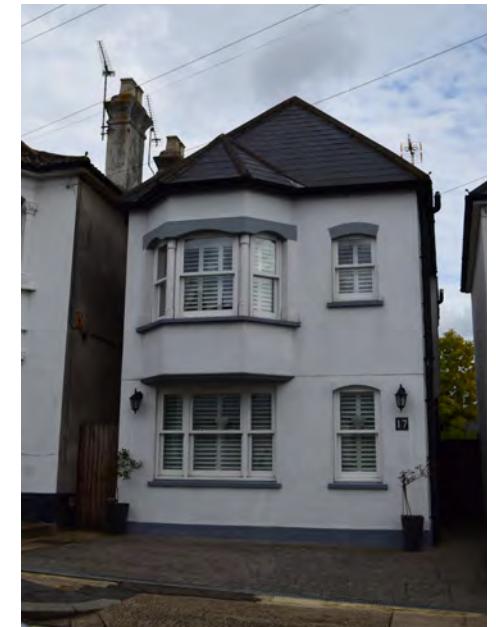
A post-War infill house, which has been recently renovated to give it some references to the surrounding Victorian properties. Originally yellow brick, now rendered and painted white and grey, with modern replacement sash windows. Upper front completely remodeled with new bay window at first floor, not echoed at ground floor. The ground floor bay has been sacrificed for parking, the building lacks detailing and the proportions are odd.

Frontage is block paved to allow for car parking, which could be improved and softened with planting or sympathetic landscaping.

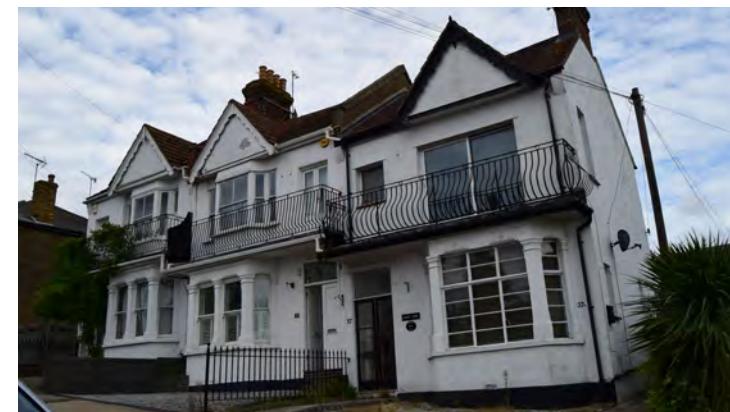
Currently all three in poor state of repair would benefit from repainting and maintenance.
