# Milton Conservation Area Appraisal

# Southend-on-Sea: Milton Conservation Area Appraisal

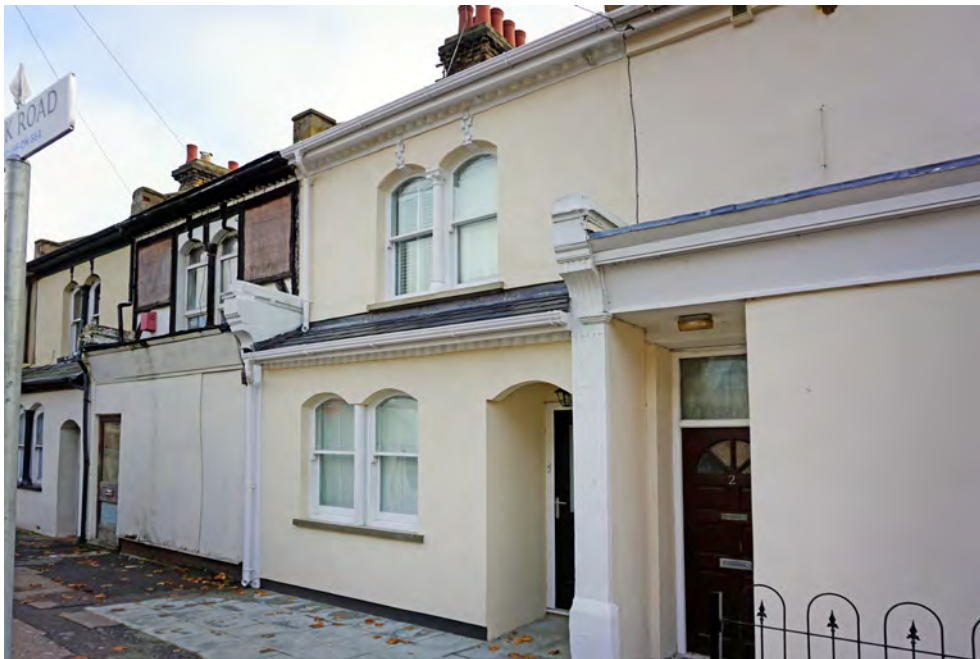
Park Road shopping parade, now residential with some units in need of repair and renovation.

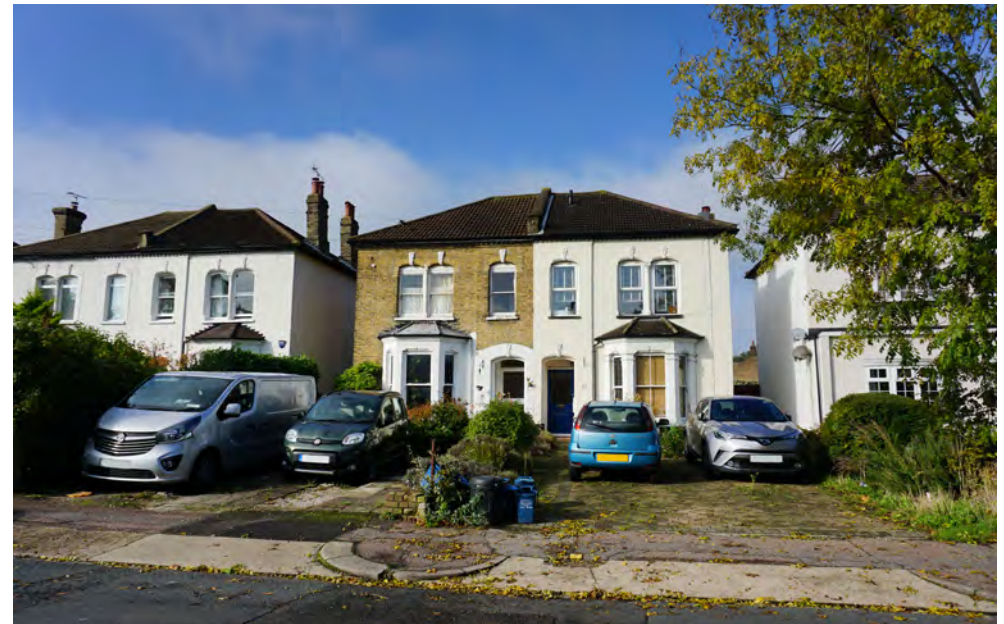
Conversions of single dwellings to flats can lead to detrimental impacts, particularly loss of front gardens

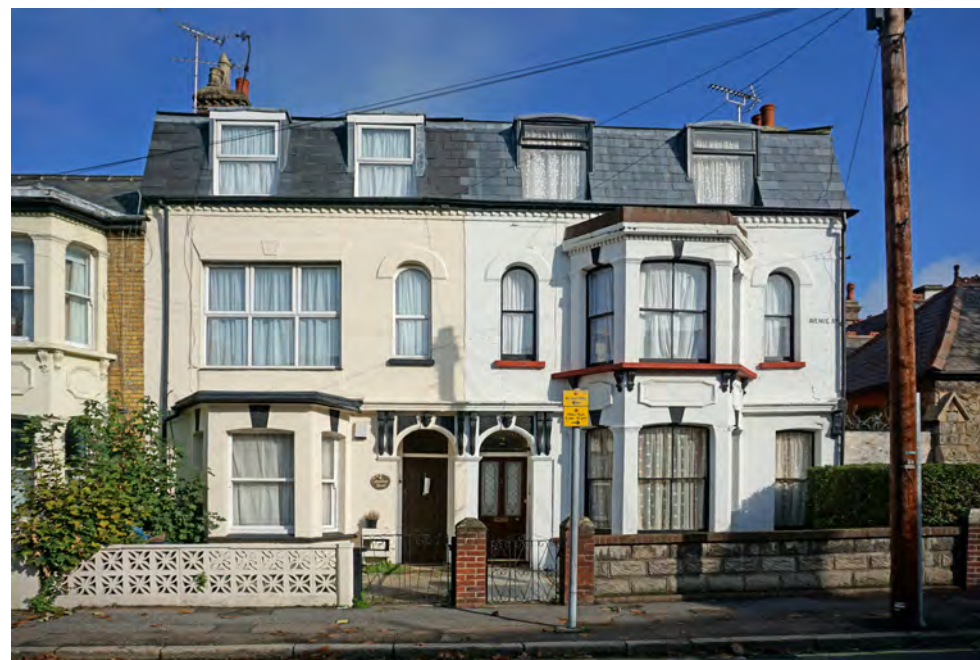
Divided into flats. Painted brickwork. Upper section of canted bay missing and replaced with large rectangular flat window. uPVC windows. Boundary wall replaced with decorative concrete blocks which are rather conspicuous in the streetscene. Front garden paved. A third storey contained within a mansard roof, which appears on historic photographs so may be original or early in construction. However, this style of roof is generally out of character with the rest of the street and would not be encouraged.

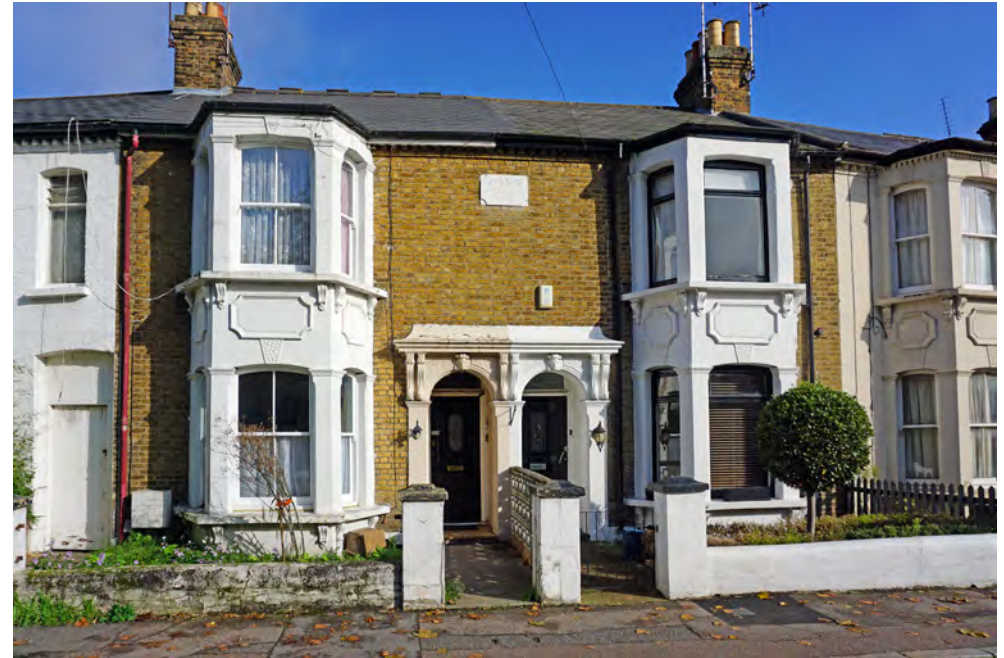
No.12 has replacement timber sash windows. Original low boundary wall retained but painted and with railings lost. Wall dividing Nos.10 and 12 is unattractive modern pierced concrete blocks. Divided into flats. Would benefit from maintenance to front garden and boundary wall.

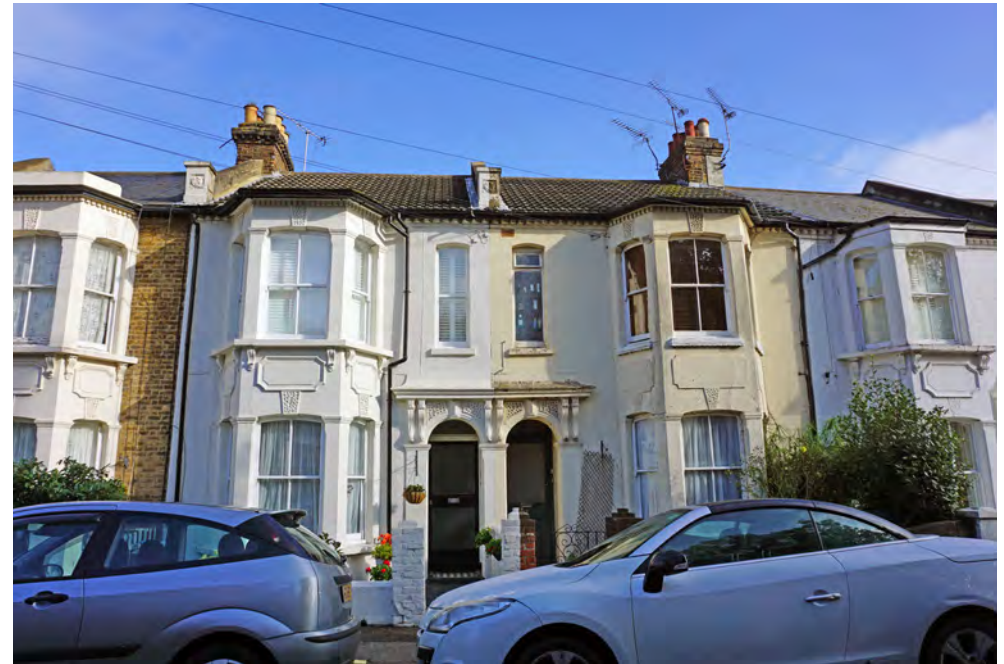
Divided into flats. Original brickwork has been rendered and painted. Slate replaced with concrete tile. Original sashes remain. First floor window above porch. Original boundary wall although pier to southern end may have been rebuilt and railings are lost.

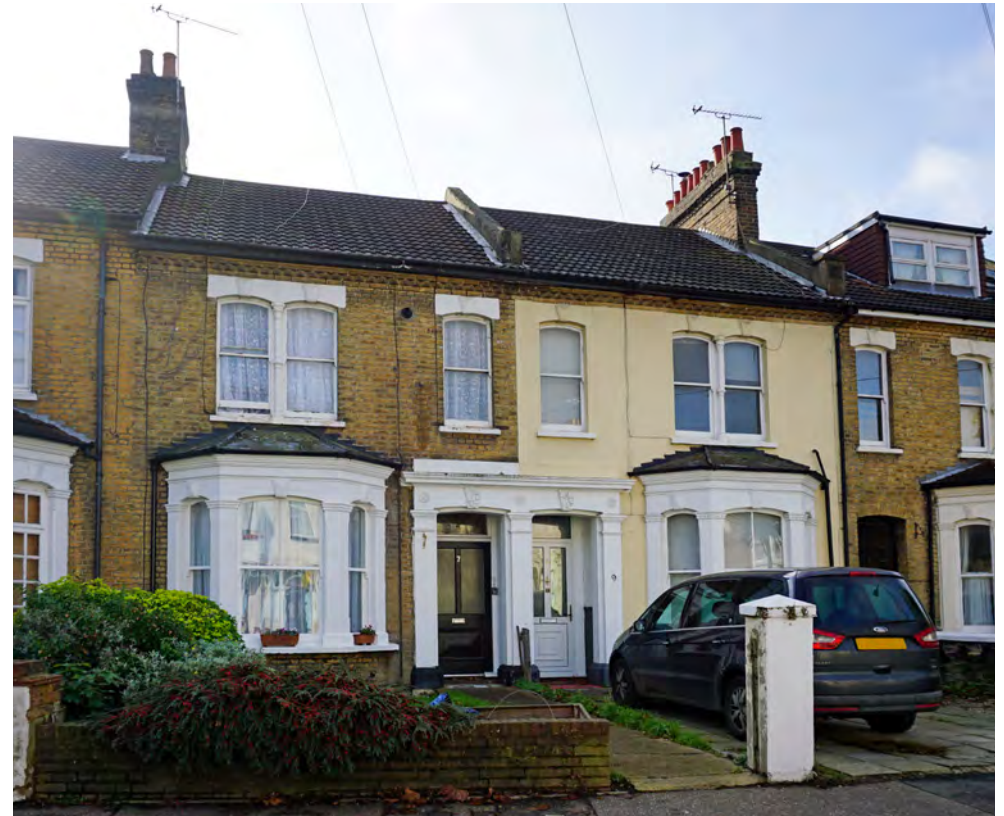
Timber sash windows retained. Brickwork has been rendered. Slate replaced with concrete tile. uPVC door. Boundary wall has been removed and frontage has been paved which is detrimental to the street. Concrete tile roof which would benefit from replacement with slate.

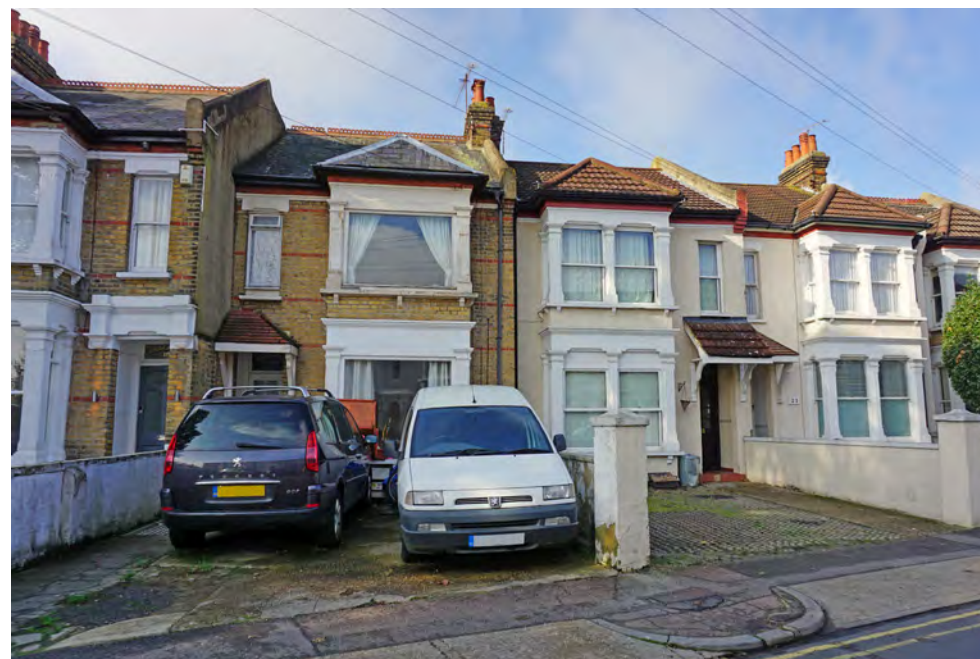
Converted to flats. Timber sash windows replaced with uPVC sashes, brickwork rendered and slate replaced with concrete tile. Unsympathetic mono pitch porch. Front garden appears to be grasscreted but this has failed so has limited softening impact. Front boundary wall missing although front side boundary wall with tall piers remains dividing the frontage from the neighbour.

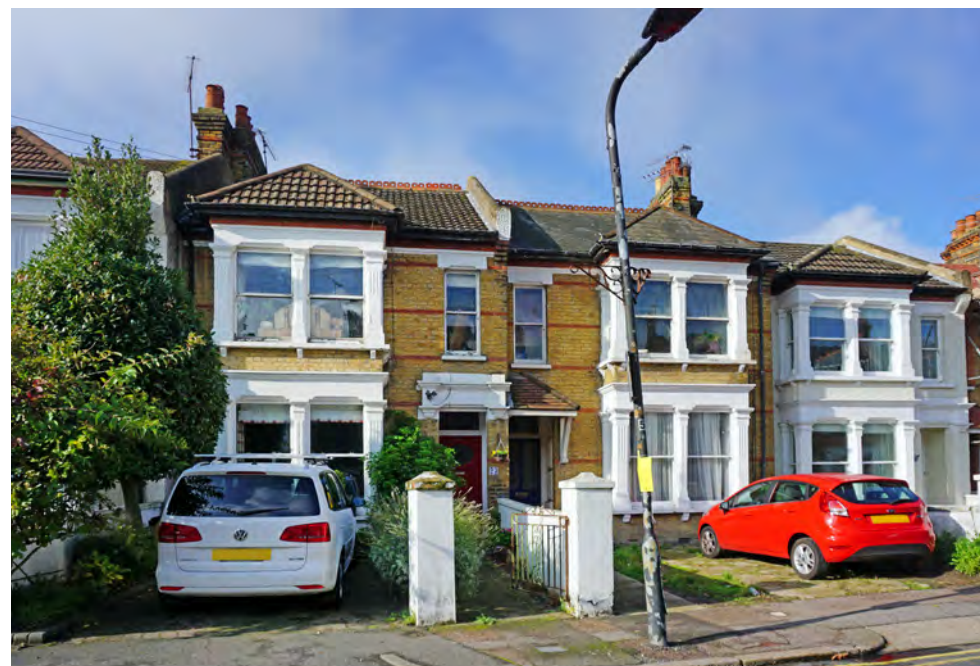
Converted to flats. Property intact. Sash windows would benefit from repainting. Hipped porch. Front garden has been concreted and is untidy. Front boundary wall missing although front side boundary wall with tall piers remains dividing the frontage from the neighbour.

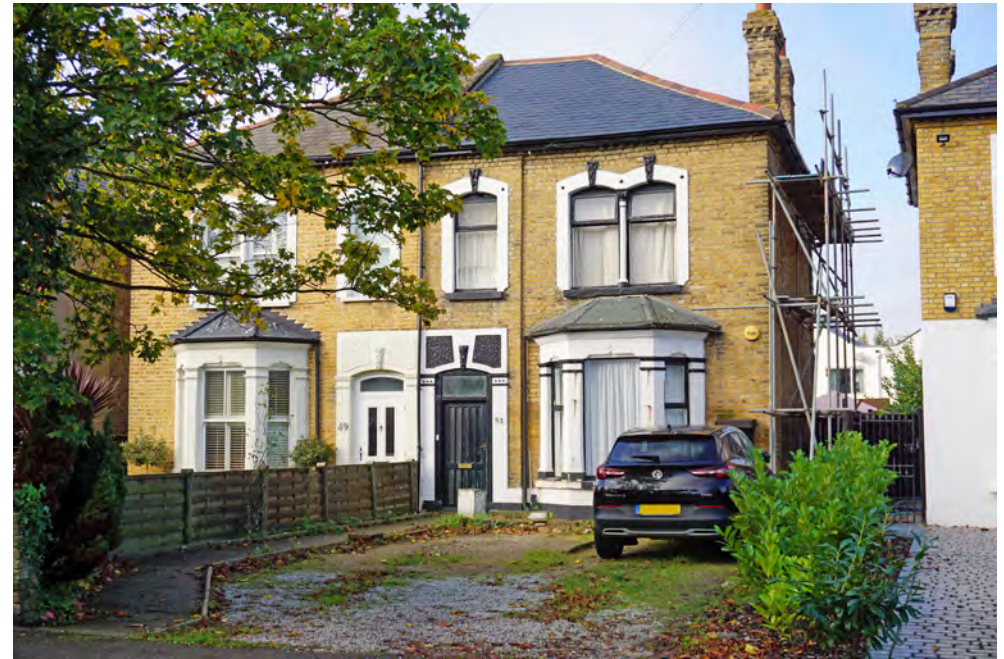
Original sash windows replaced with timber top hung casements. Original open porch enclosed by modern door which is detrimental to its character. Small section of boundary wall to front provides important enclosure and tree in forecourt important to the streetscene. Front garden hard surfaced and would benefit from higher quality materials and planting.

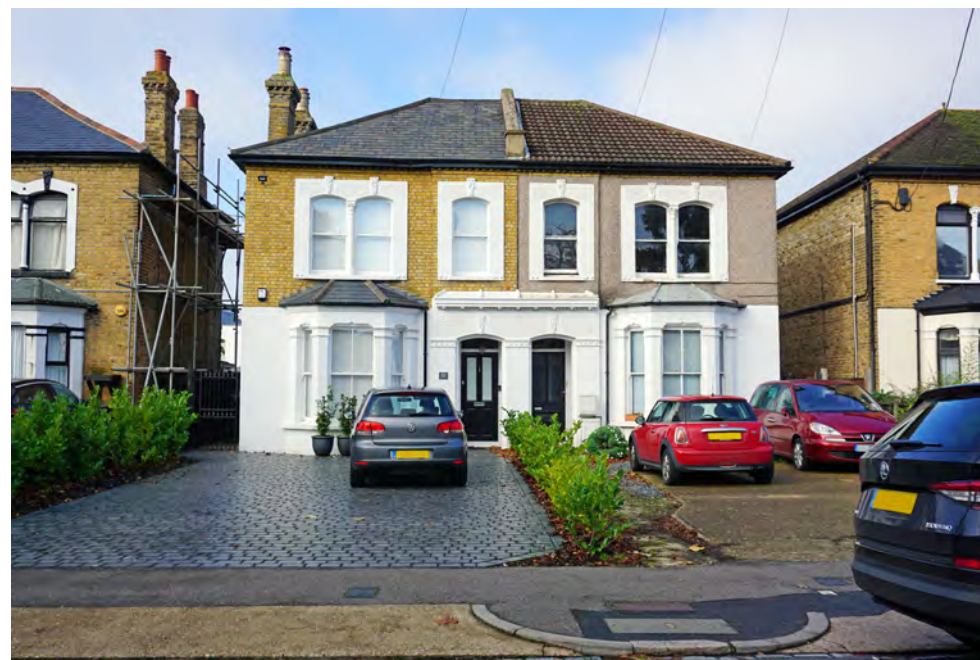
Divided into flats. Brickwork rendered at ground floor and pebble dashed above. Slates replaced with concrete tile. Original timber sash windows remain. Chimney missing. Front boundary missing and garden has been hard surfaced mostly with concrete which is detrimental to the street.

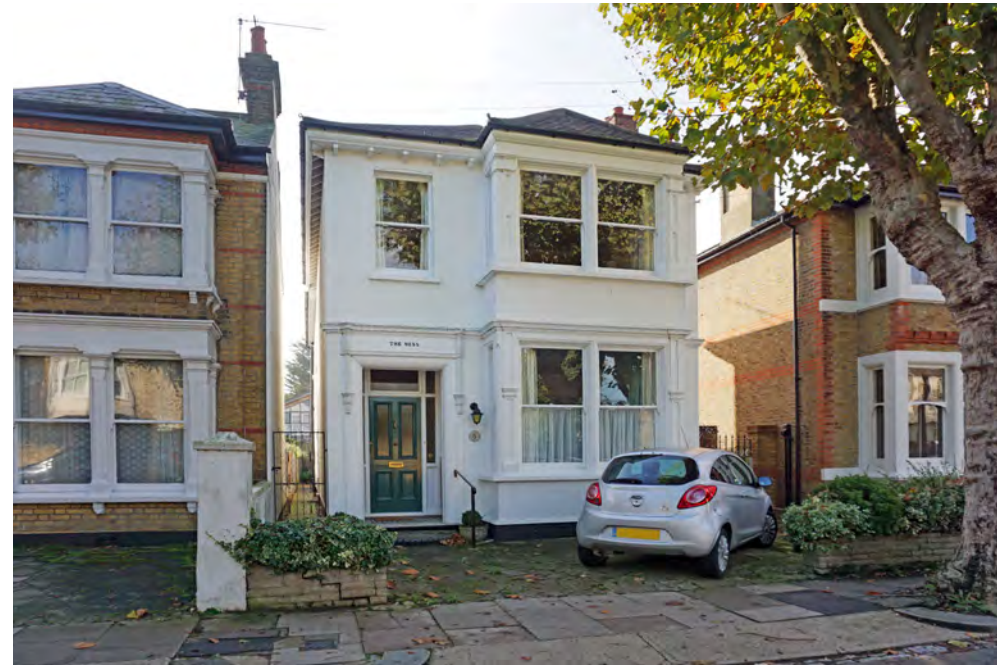
Regrettably the majority of the front boundary wall has been lost and the garden covered with hard surfacing. There is a limited amount of planting within the wall, but it would benefit from more landscaping to soften its appearance.
