The Leas Conservation Area Appraisal

Southend-on-Sea: The Leas Conservation Area Appraisal

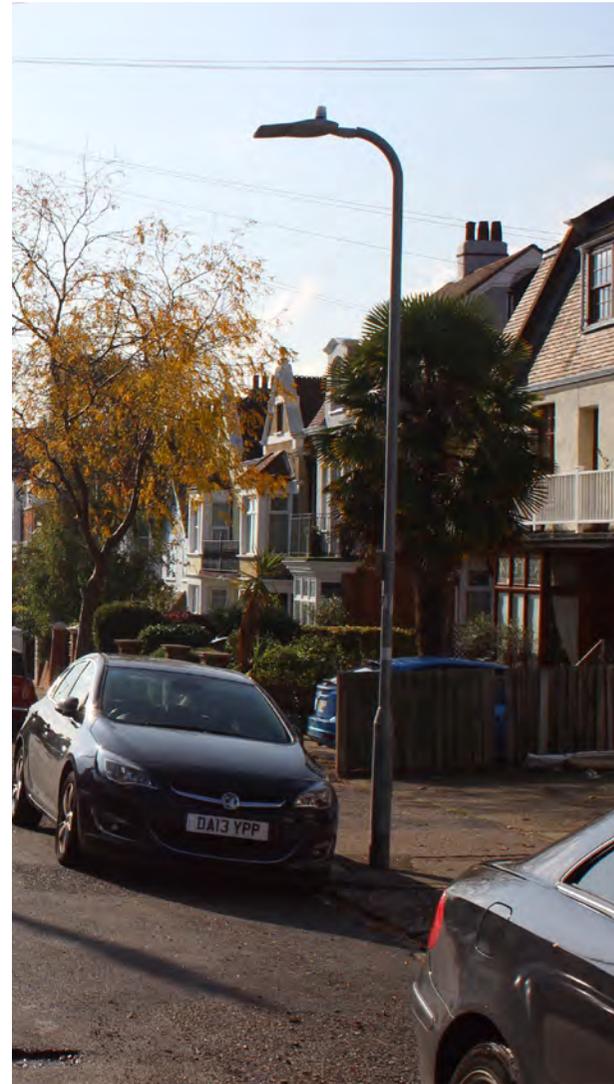
Modern streetlights

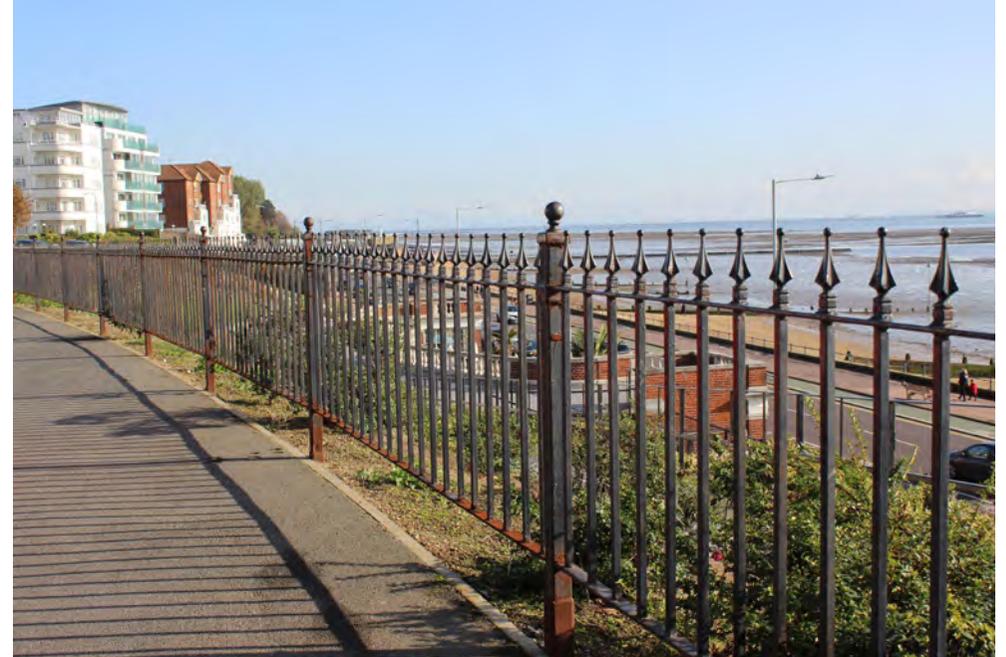
Rusted railings along the south side of Clifton Drive

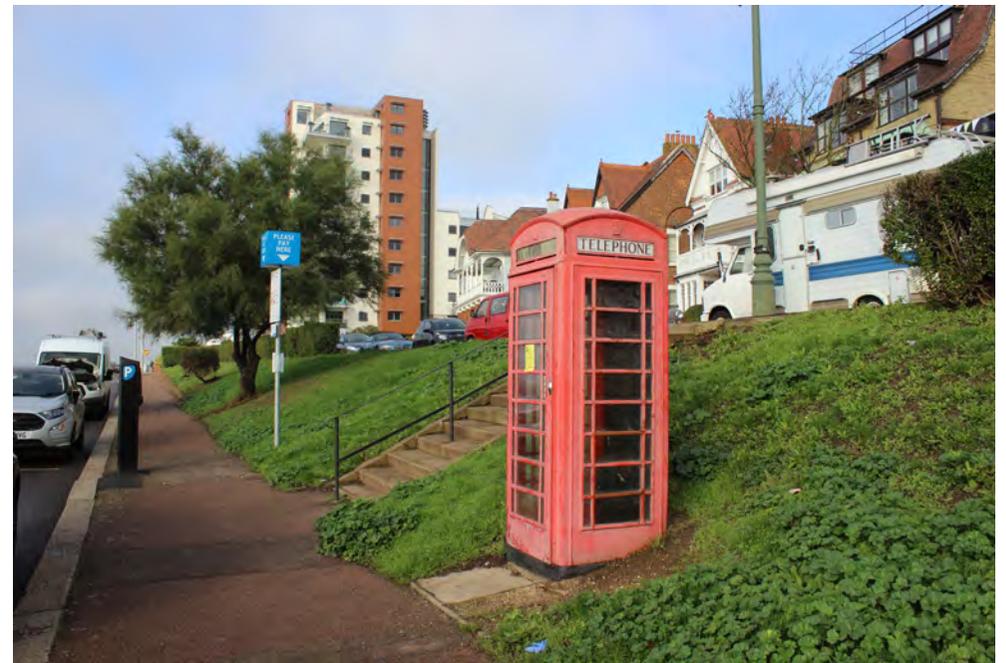
5.3.18 Street furniture, such as a disused telephone box, would benefit from repairs and repainting; in good condition these would add character to the Conservation Area.

Disused telephone box in need of repainting

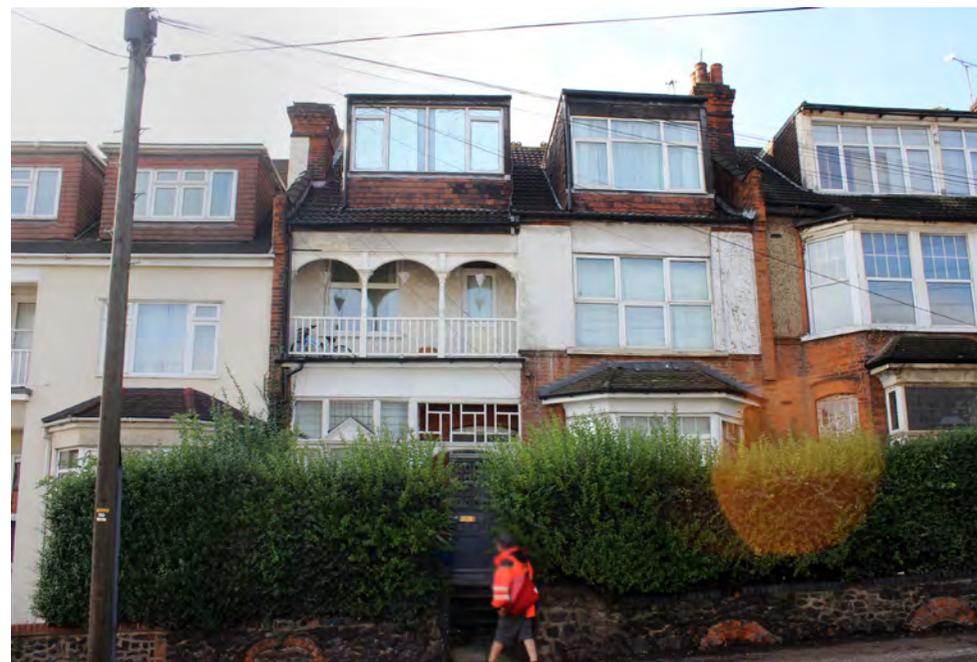
Two storey house with attic floor. Red brick to ground floor remains exposed, painted rough cast render to first floor. Roof replaced with concrete tiles, though a few decorative ridge tiles remain. Red brick chimneys shared with Nos.102 and 106. Single storey canted bay window to ground floor. All windows replaced with uPVC units, except for Venetian window to left of front door which features a small pediment with leaded glass above. The two added dormers are poorly proportioned, though hung tile cladding is an appropriate material. The original front door survives, which is a timber double door with small stained-glass panes to the upper halves. It is set in a recessed porch with a distinctive lattice panel above. Attractive stone wall with red brick capping and arch detail retains enclosure and the garden is planted. The house is generally in need of maintenance as the decorative condition is poor.

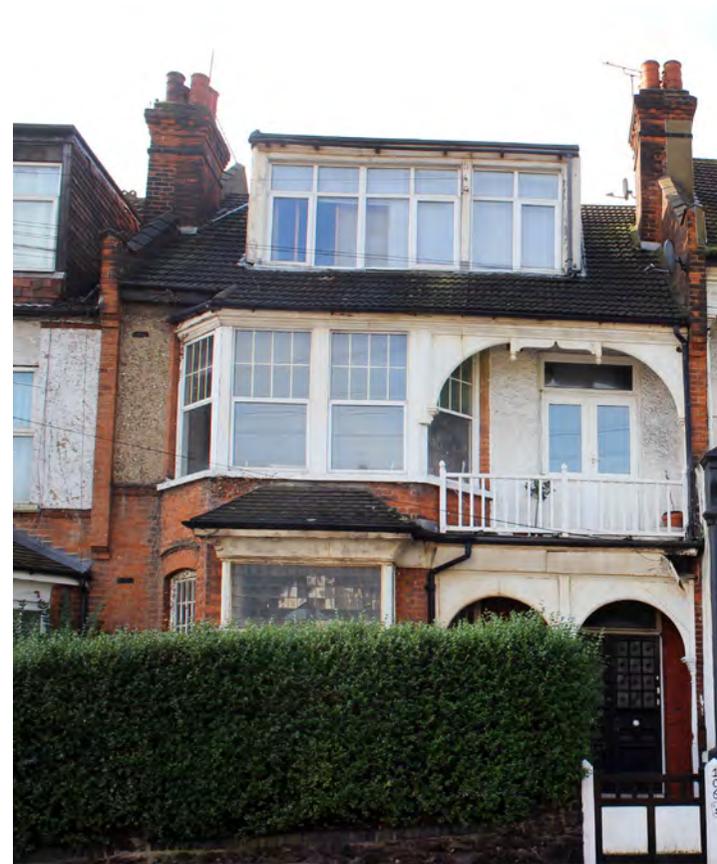
Two storey house with attic floor. floor. Red brick to ground floor remains exposed, painted rough cast render to first floor. Roof replaced with concrete tiles. Red brick chimneys shared with Nos.104 and 108/110. Two storey canted bay window to left-hand side. Replacement dormer window to roof. Windows to first floor and dormer replaced with unsympathetic uPVC. Timber sash and leaded casement windows to ground floor bay. The original front door survives, which is a timber double door with small stained-glass panes to the upper halves. It is set in a recessed porch with arched timber frame with column and low balustrade. Original balcony survives with timber balustrade and arched timber frame to upper part. Door to balcony has been replaced with unsympathetic uPVC. Attractive stone wall with red brick capping and arch detail, plus timber gate, retains enclosure and the garden is planted. The house in generally in need of maintenance as the decorative condition is poor.

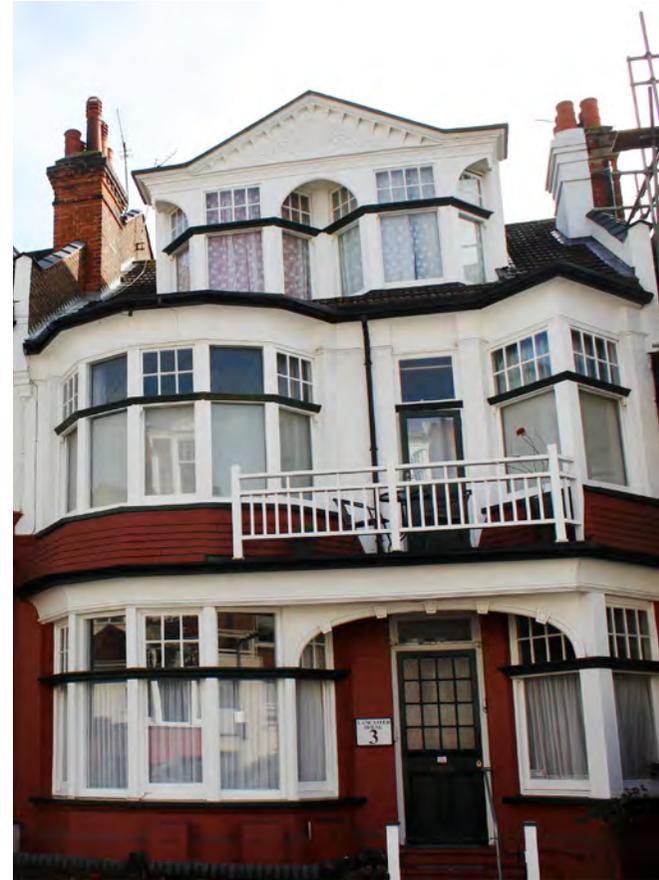
- The roof has been replaced with concrete tiles, which are not in keeping with the area.
- The brickwork has been painted red, which is inappropriate for the building and removal of this paint would improve the appearance of the brickwork.

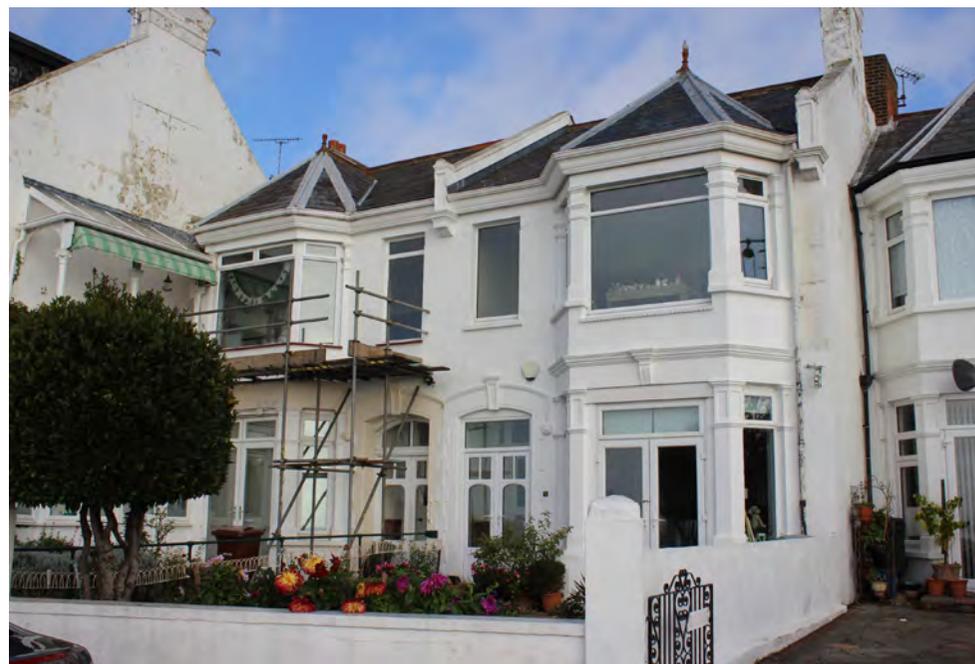
- Most windows have been replaced by insensitive uPVC units.
- The central bay window has lost its mullions and has been replaced with a large picture window, as has the window above the door. This results in overly large expanses of glazing that are inappropriate for a property of this period. The porch has been filled in with inappropriate uPVC doors (though the original door may survive beyond).
- The ground floor has inappropriate uPVC French windows.
- The render to the side elevation is in need of repair.

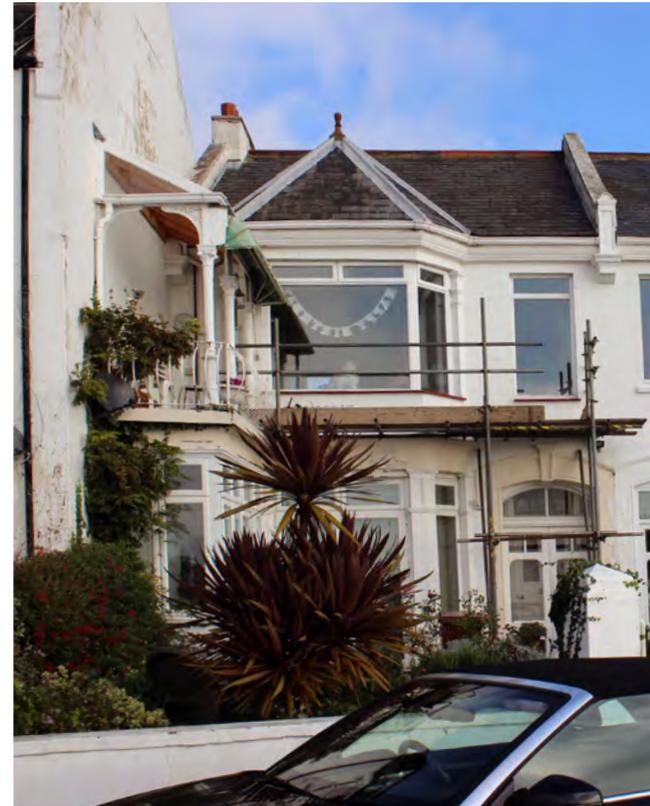
- The windows have been replaced with uPVC units, including picture window to first floor bay.
- The ground floor bay has uPVC French doors added.
- The two-storey extension has inappropriate uPVC windows at ground floor and unattractive canopy.
- The porch has been filled in with inappropriate uPVC doors (though the original door may survive beyond).
- The render to the exposed side elevation of No.3 is in need of repair.

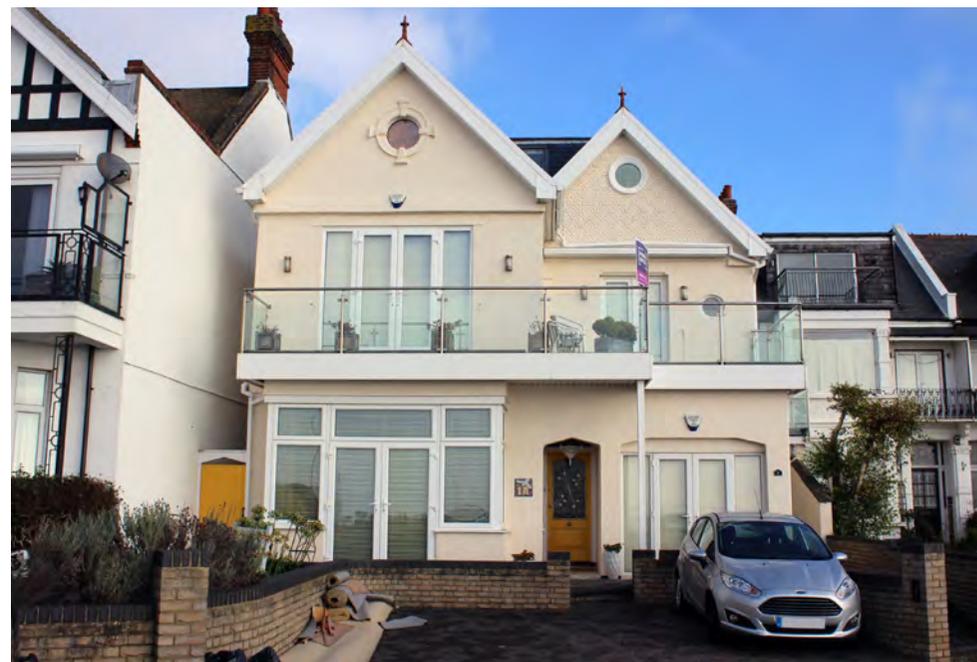
- Complete replacement of all windows with uPVC.
- Installation of roof lights.
- The brick walls have been covered in cream render resulting in the loss of almost all the decorative detail.
- The decorative moulding in the left-hand gable has been painted.
- Additional roundel window (right range gable).
- The modern glazed balcony wrapping around the whole of the front of the first floor with metal supports and handrails is intrusive to the original design of the building.
- The property has lost most of its front boundary and hard surfacing for the drive has reduced the amount of soft landscaping in front of the house.

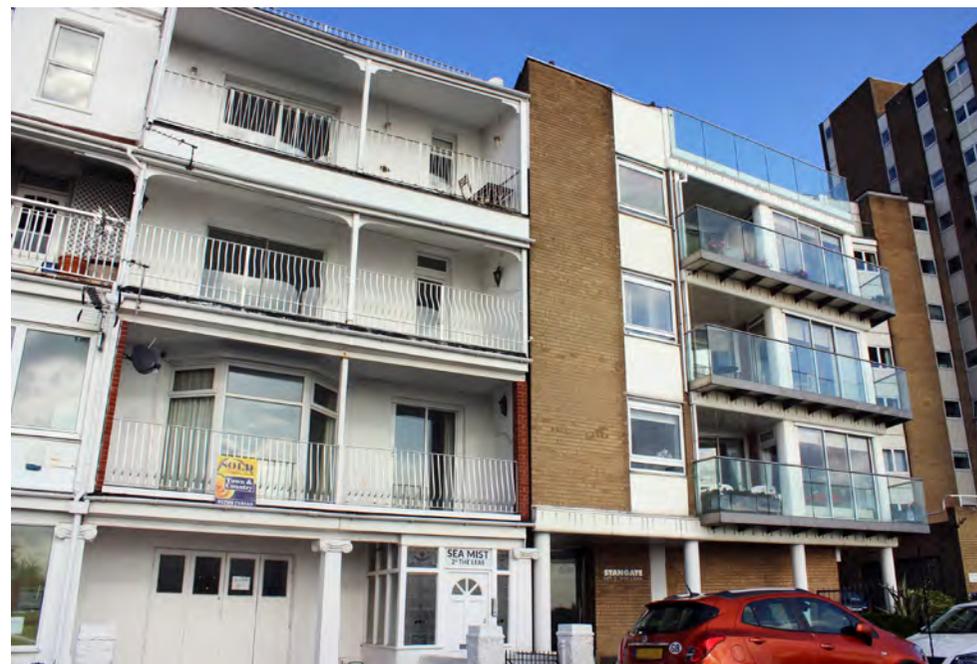
- The windows have been completely replaced, mostly by large inappropriate modern sliding patio doors.
- All original ornamentation has been lost and the façade retains hardly any attractive features apart from the balconies and some pretty decorative glass on either side of the front door.

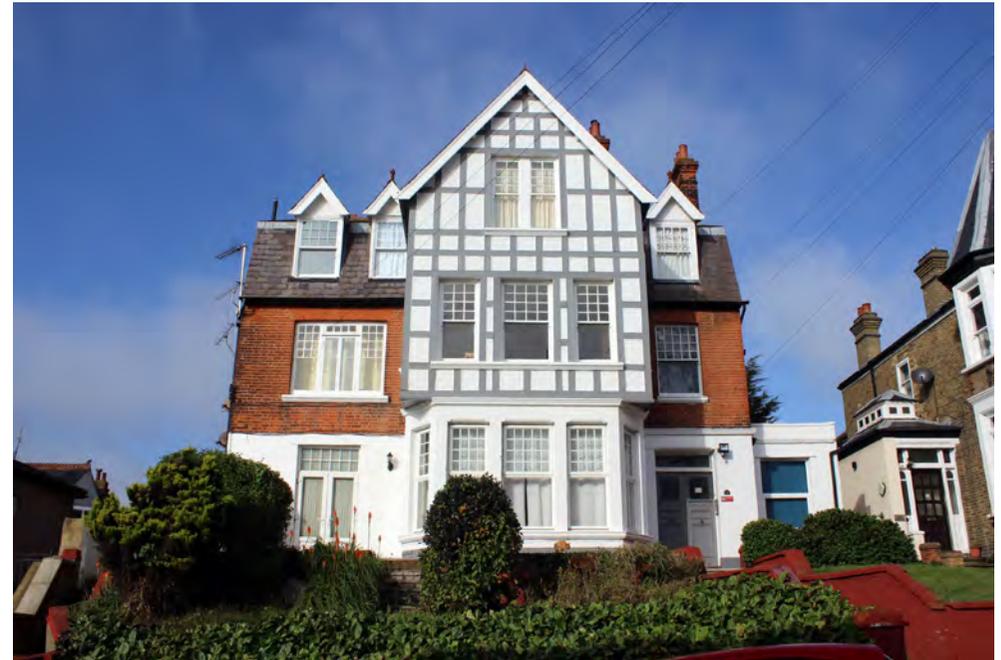
- The side of the house has a proliferation of satellite dishes, which detracts from the appearance of the side but the location is far better than on the front, where they would badly interrupt the composition of the façade.
- The wall to the garden steps is collapsing.

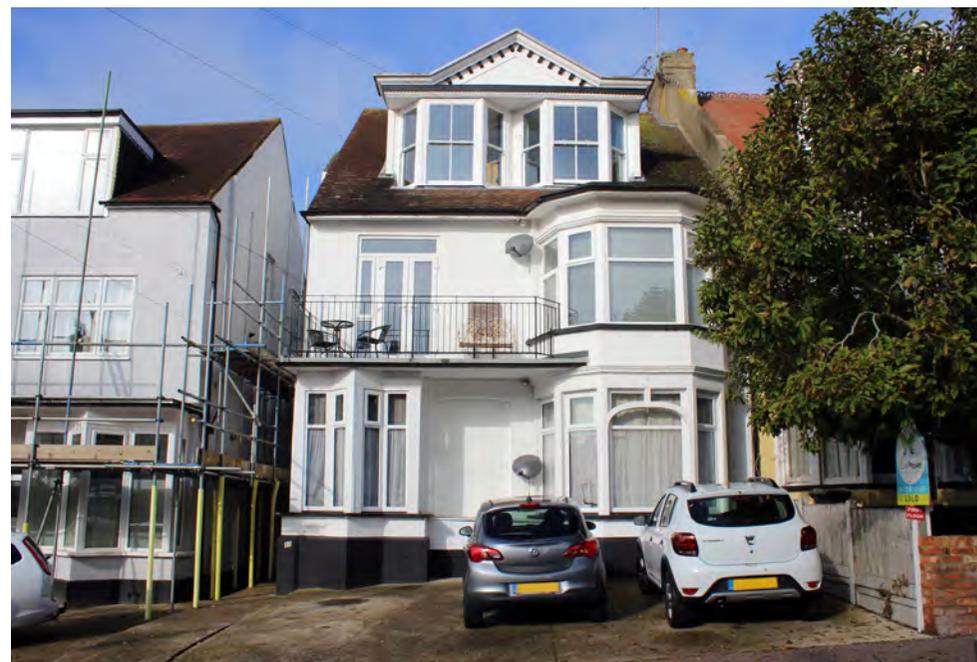
- The boundary wall has been lost and the front garden area concreted over and used for parking. It would benefit from the front garden being landscaped and reinstating the boundary wall would also enhance its quality.

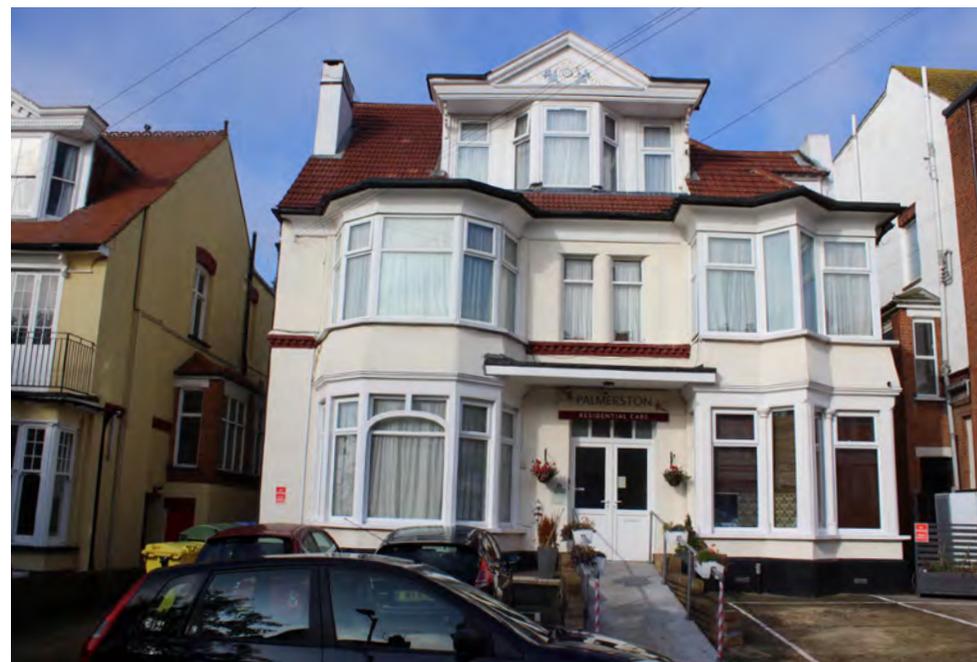
- The boundary wall has been lost and the front garden area concreted over and used for parking. It would benefit from the front garden being landscaped and reinstating the boundary wall would also enhance its quality.
- The disabled access ramp is a temporary structure and unsightly; it should be replaced with a better-quality structure, preferably permanent.
