Reference:	TPO 4/22	
Ward:	Shoeburyness	
Proposal:	Tree Preservation Order Confirmation	
Address:	Cantel (UK) Ltd Site, Campfield Road, Shoeburyness, Essex SS3 9BX	
Consultation Expiry:	10 th August 2022	
Expiry Date:	20 th December 2022	
Case Officer:	Abbie Greenwood	
Plan Nos:	N/A	
Recommendation:	CONFIRM TREE PRESERVATION ORDER with modifications

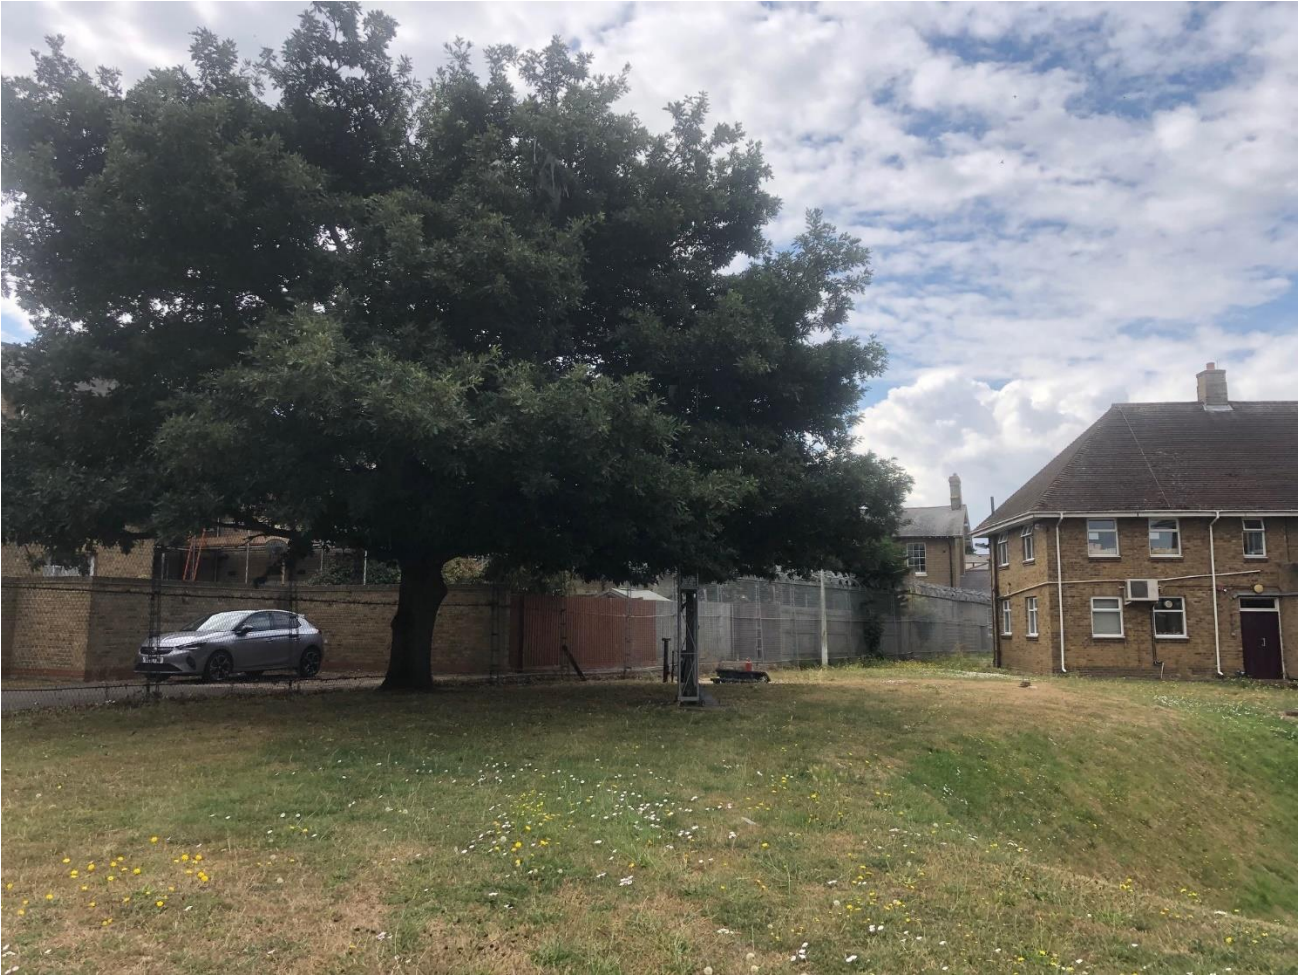
- T1- The species for T1 is mistakenly listed as Sycamore. This should be amended to Turkey Oak. This tree has a very good form and is significant in its setting abutting the conservation area. As with G1 there is visibility from a number of properties, (approx 17 plus staff at Cantel Medical). These trees (T1 and G1) also screen the view from the conservation area, reducing any negative visual impact of the Cantel building. The tree is clearly visible to

Figure 1 below shows T1, Turkey Oak, on east boundary on the boundary of the site

- The species for T1 shall be corrected from Sycamore to Turkey Oak.

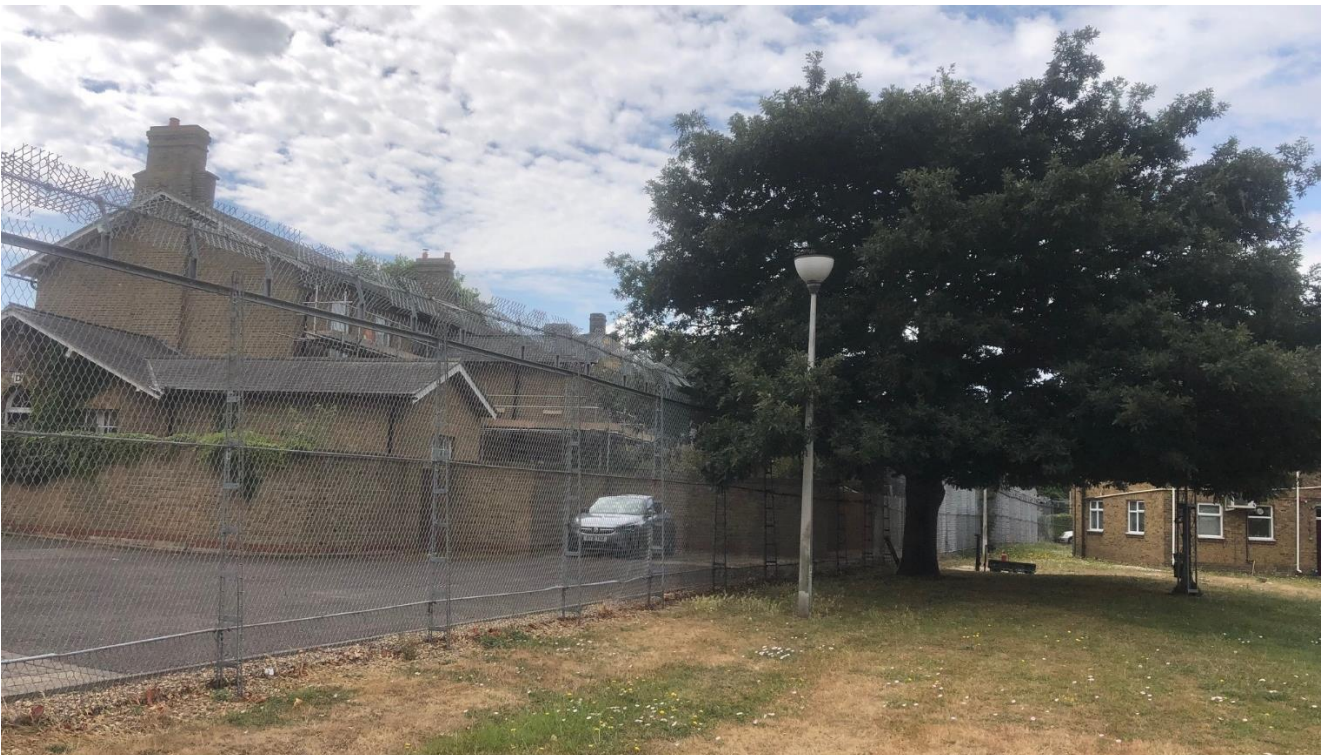
enough people to provide public amenity. TEMPO score not amended and remains at 17. [See Fig 2 and 3 in Appendix 1 for views towards and from the Conservation Area]

Figure 2 below shows relationship of T1 to the listed properties in Horseshoe Crescent

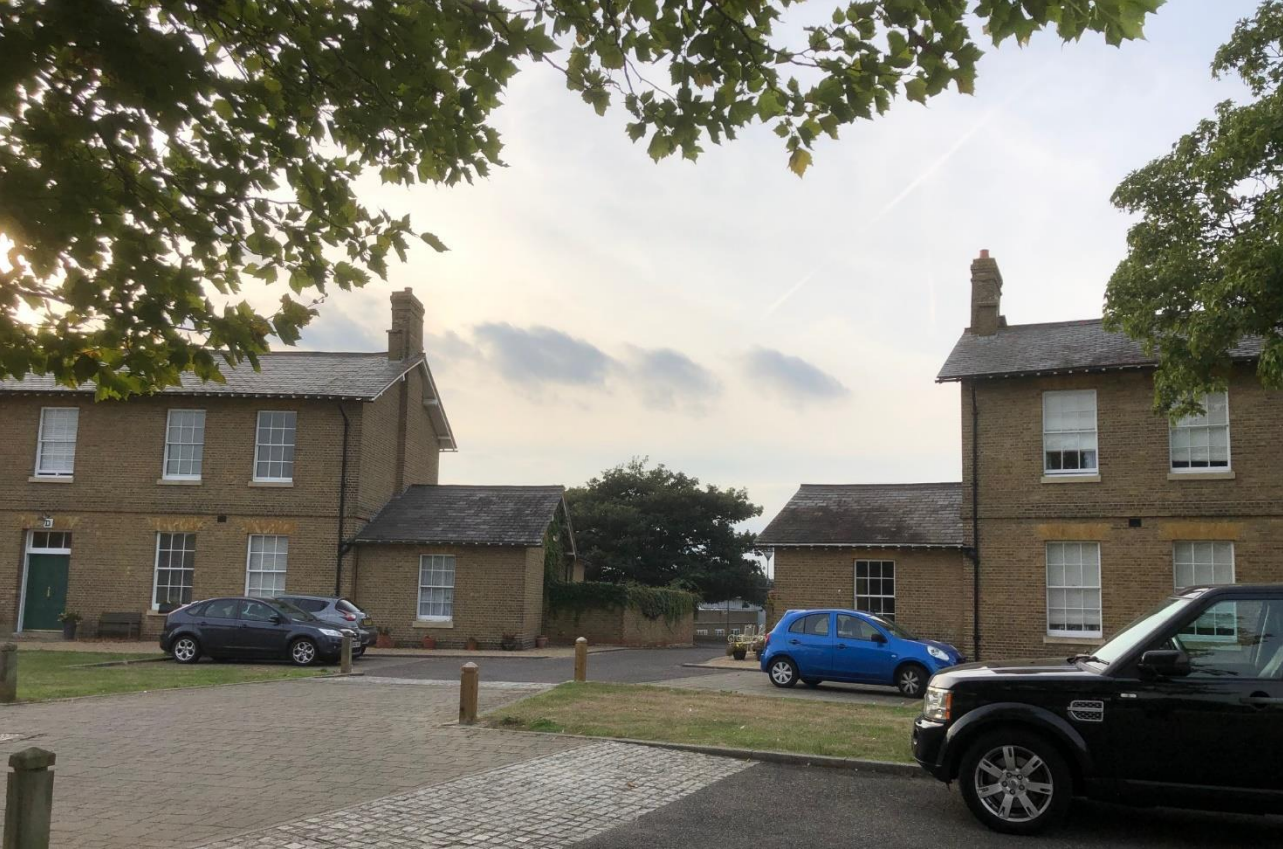
Figure 3 below shows T1 as seen from Horseshoe Crescent within Shoebury Garrison Conservation Area

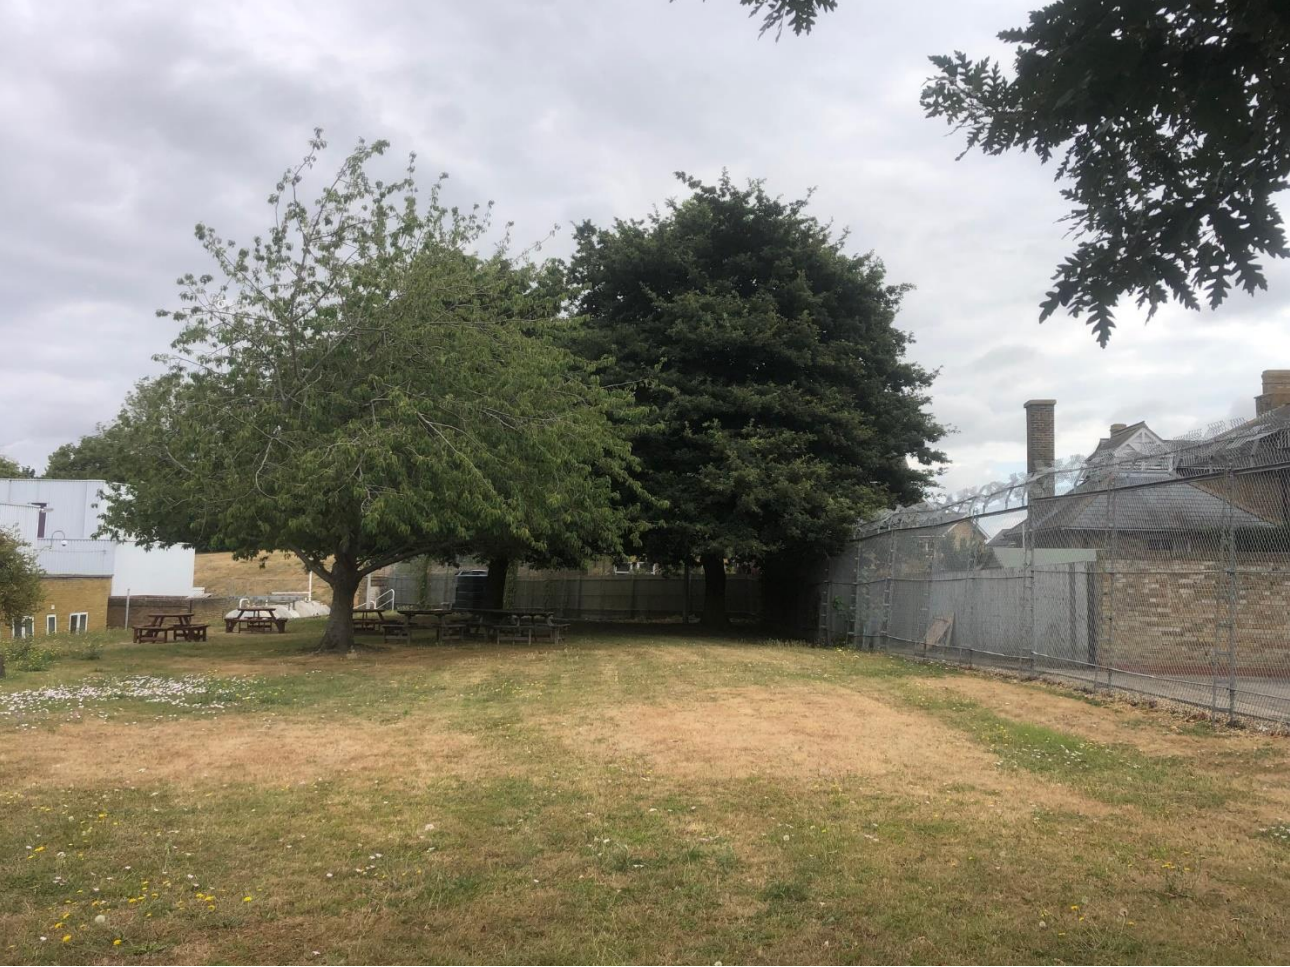
- T8 Norway Maple – TEMPO score not amended and remains at 15 - TPO defensible.
- G1 2 x Turkey Oaks on east boundary –These Turkey Oaks are significant in their current setting with clear views from approx. 18-20 properties, Staff at Cantel and limited view from Campfield Road. They directly abut the Garrison Conservation Area and screen the Cantel premises, lessening its impact on the conservation area. The TEMPO score for G1 is therefore not amended and remains at 19 – TPO definitely merited.

Figure 4 below shows G1, 2 x Turkey Oaks, also on east boundary (fruit tree to left not included in TPO)

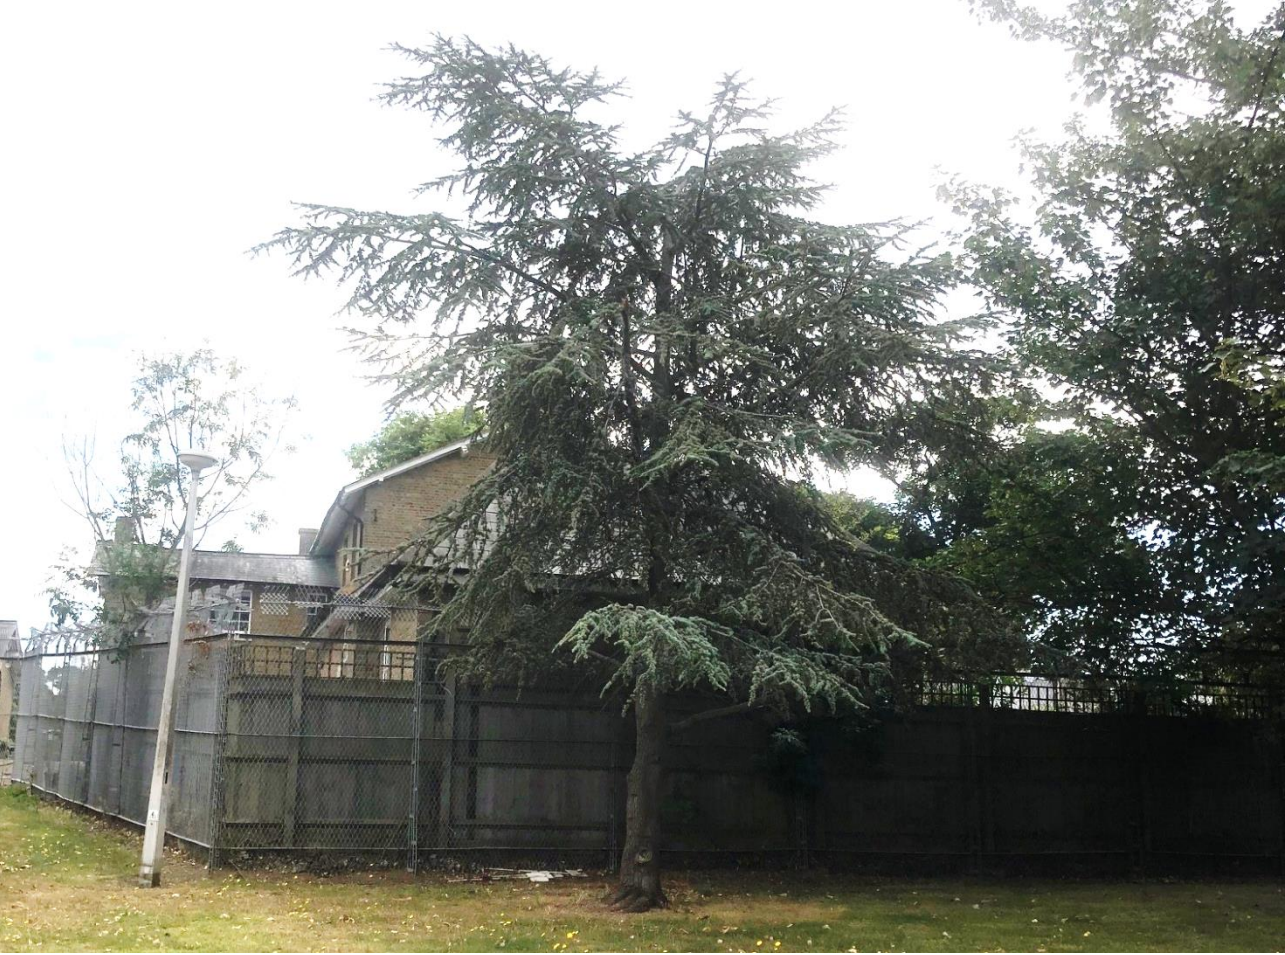
- T2 Atlas Cedar – Although from Chapel Road the tree is situated behind T3 Sycamore, it is still clearly visible and being evergreen, it will be more so during Autumn/Winter when T3 has no leaves. However, the category for retention span has been amended from 40 to 100 years to 20 to 40 years due to current condition - the tree is showing less signs of vigour than the other atlas cedars – The TEMPO score amended from 15 to 13 but a TPO still defensible at this score.

Figure 5 below shows T2, the smallest of the Atlas Cedar group on the south boundary

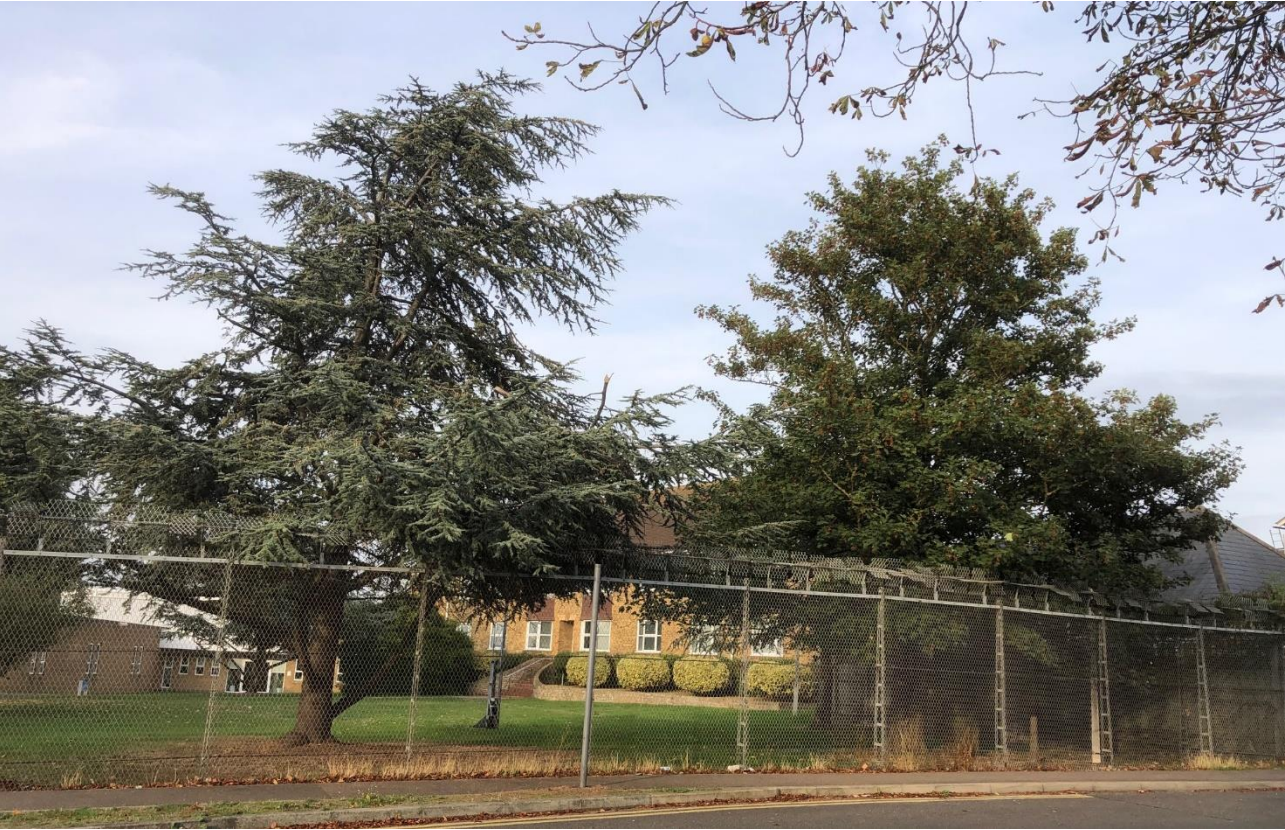
- T3 Sycamore - On closer inspection T3 has some bark inclusions and a central cavity which may be a potential point of weakness however it has an upright form and the crown is not overly large or spreading. These points may affect its longevity so its TEMPO category for retention span has been amended from 40 to 100 years to 20 to 40 years. This has resulted in the TEMPO score being amended from 15 to 13 but TPO still defensible.

Figure 6 below shows T3, sycamore (right) and T4 atlas cedar (left) from Chapel Road, part of the grouping on the south boundary opposite the listed church

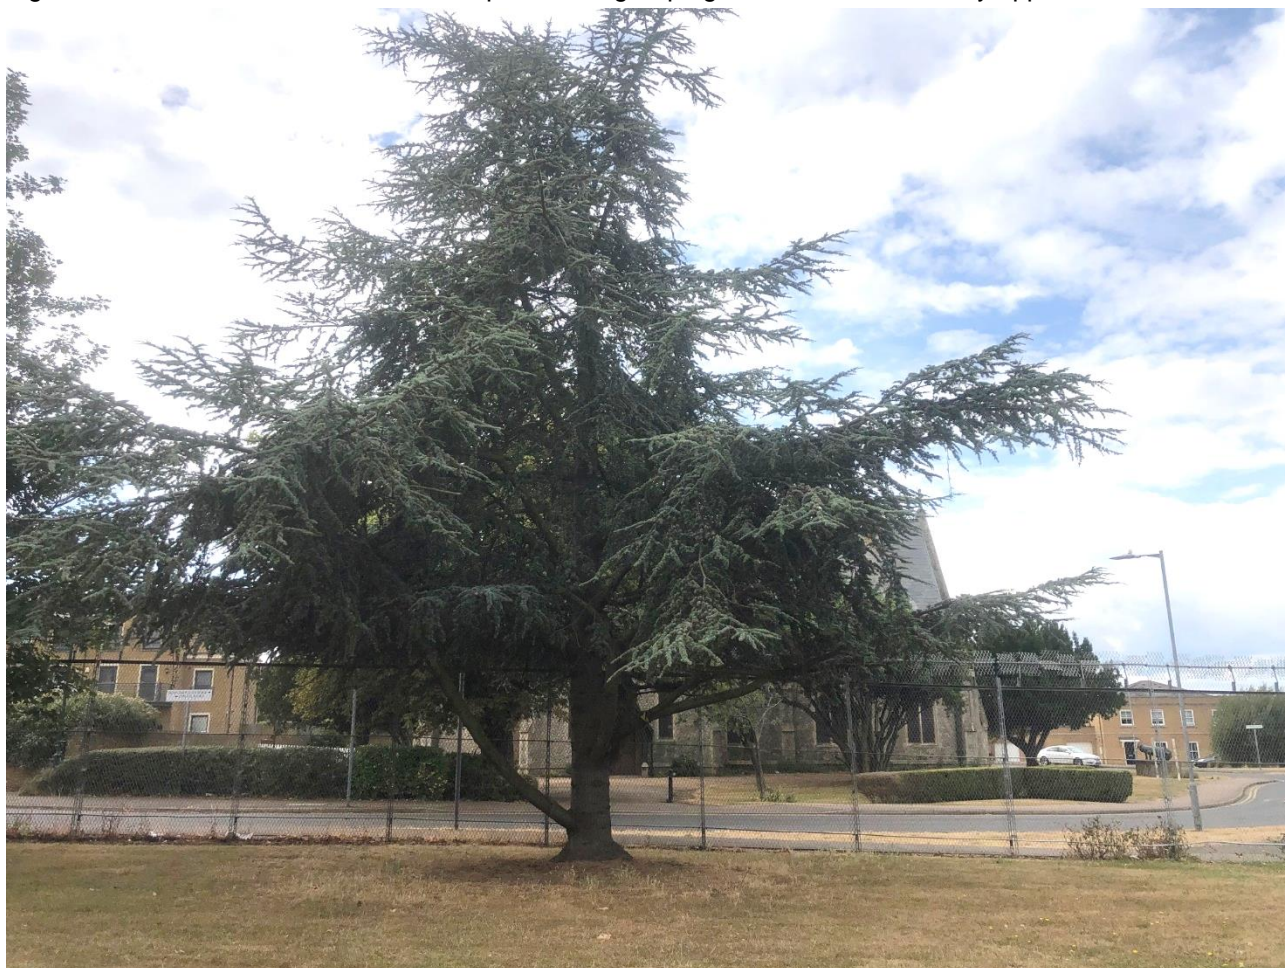
Figure 7 below shows T4, Atlas Cedar, part of the grouping on the south boundary opposite the listed church

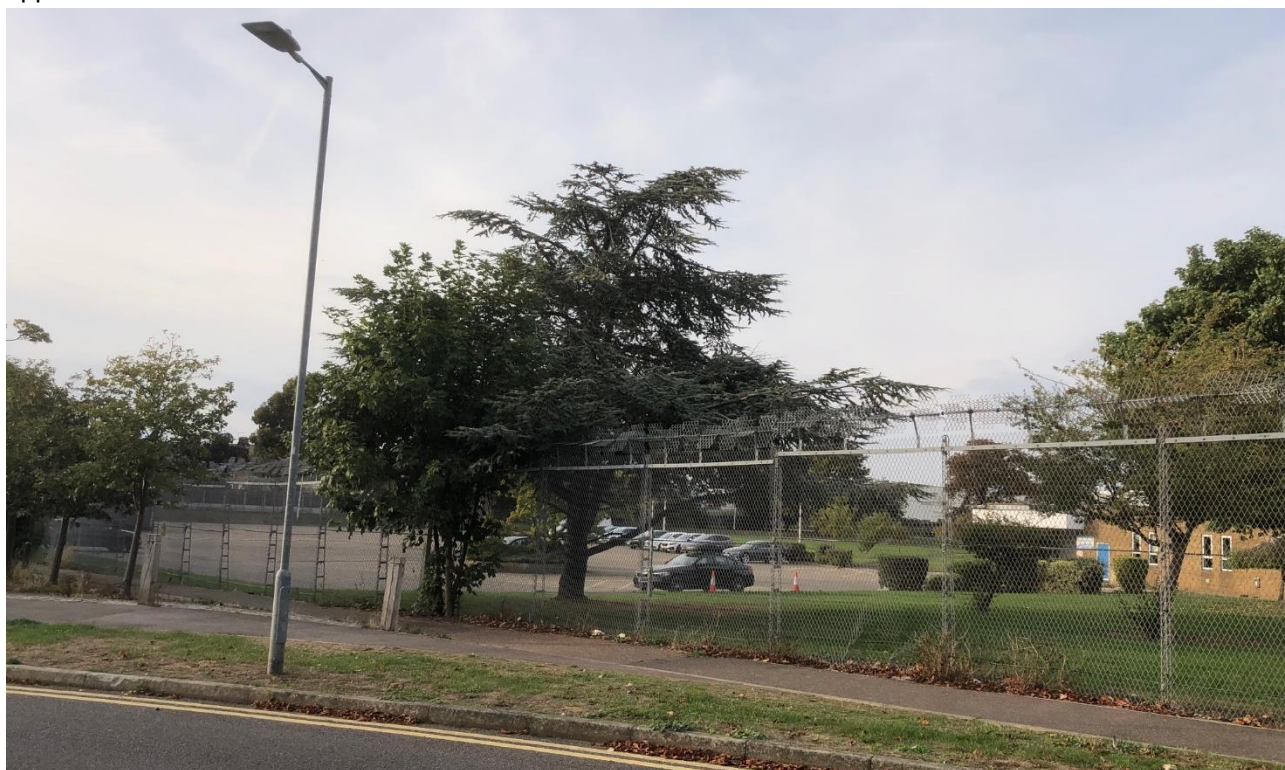
- T4 Atlas Cedar - TEMPO score not amended and remains at 15 TPO defensible.
- T5 Atlas Cedar - Retention span amended due to current condition including the torn branch on the west side of the crown. – TEMPO score amended from 13-15 but TPO still defensible.

Figure 8 below shows T5 Atlas Cedar on the south boundary part of the grouping on the south boundary opposite the listed church

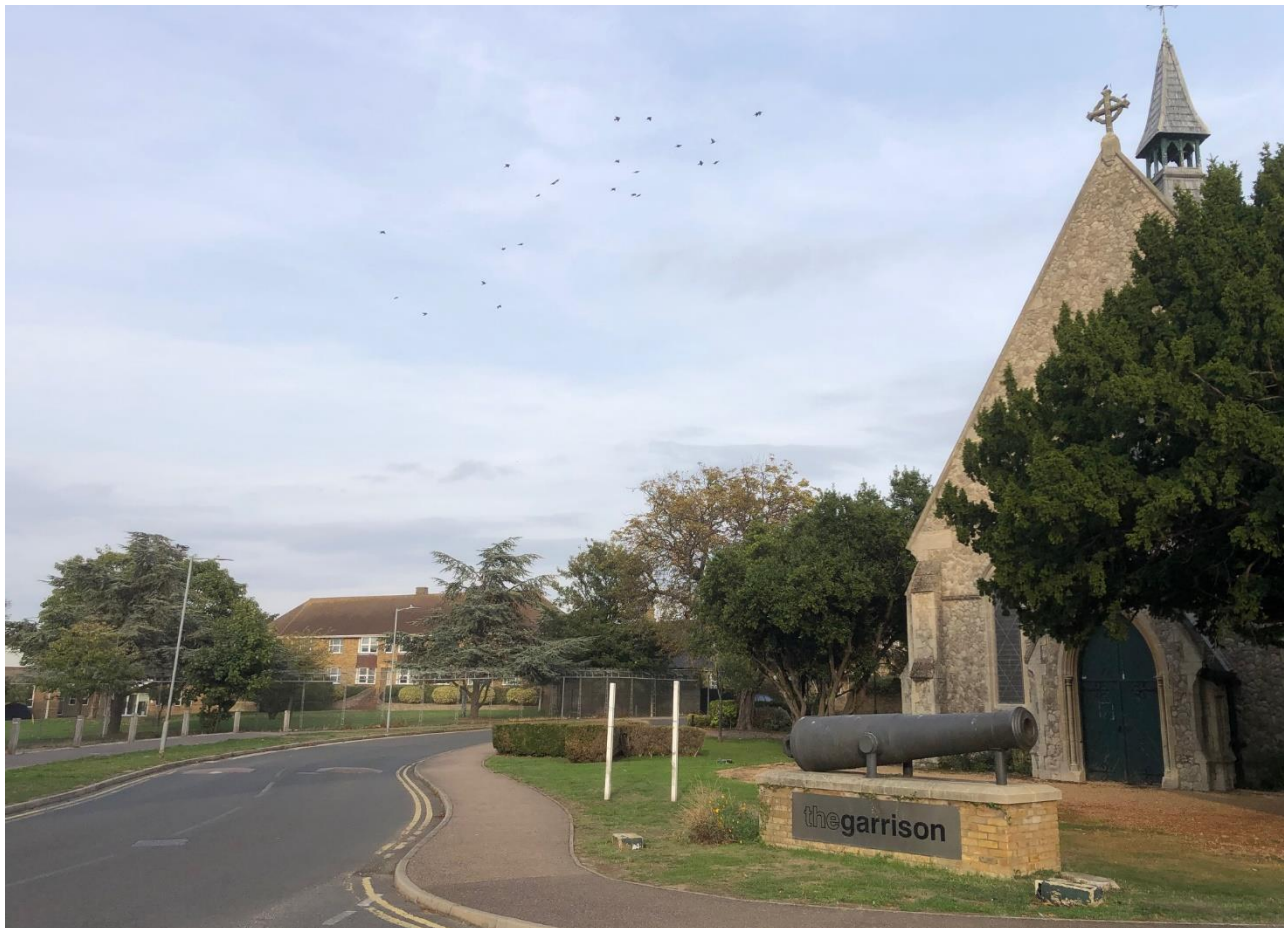
Figure 9 below shows the group of trees T2, T3, T4, T5, G2 on the south boundary in context with the listed church

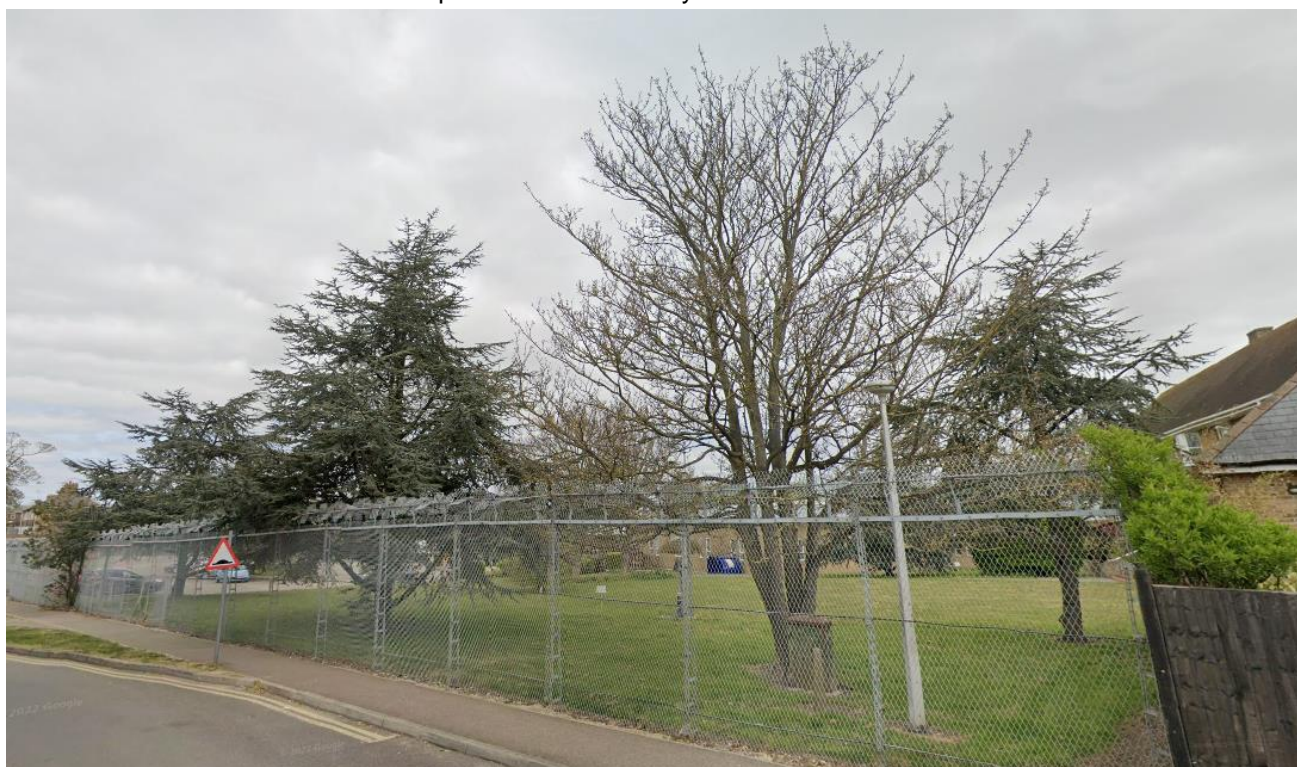
Figure 10 below from Google Streetview April 2021 shows the enhanced visibility of T3 (far right) during colder months when T4 (sycamore) has no leaves. This image also shows the relationship with the other Atlas Cedars T4 and T5 as seen from Chapel Road in Shoebury Garrison Conservation Area

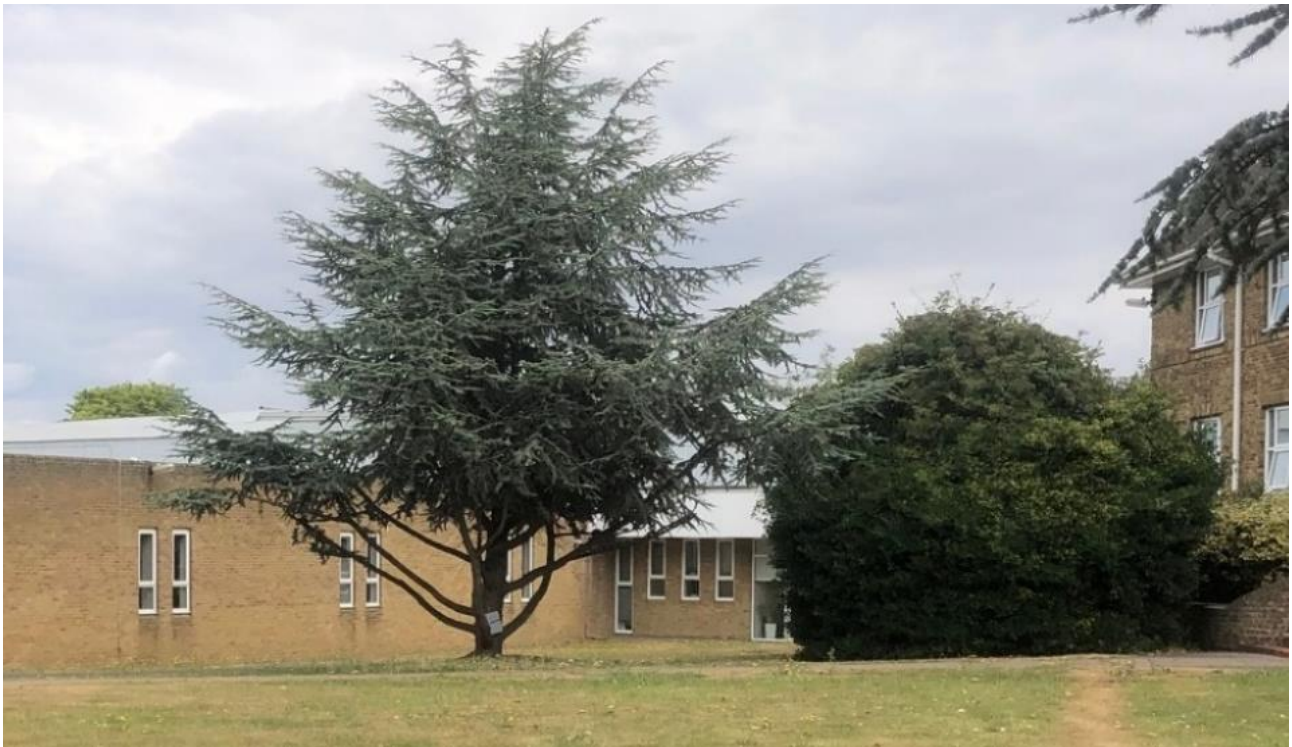
Figure 11 below shows T6 Atlas Cedar set in from the south site boundary

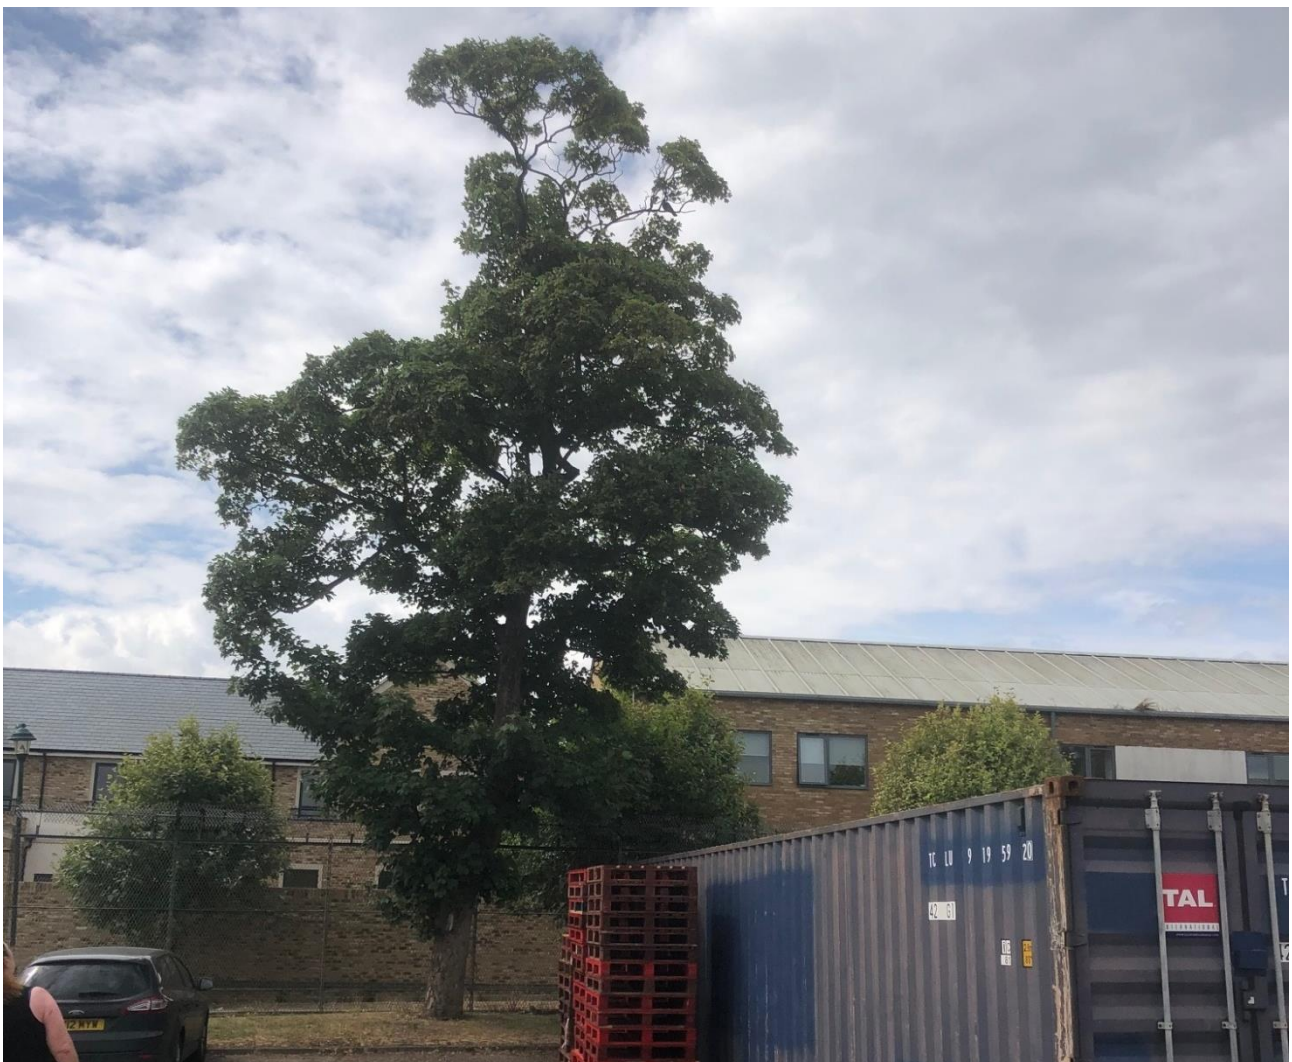
T7 and T8 were both in fair condition and were considered to be of moderate retention value. Both trees had areas of included bark at branch unions in their crowns and the canopy of T7 contained deadwood. Both T7 and T8 scored high enough in the TEMPO assessment to warrant a TPO. The remaining trees (T2 and T3) and groups (G2 and G3) were all considered unsuitable for the TPO. T2, whilst considered to be of moderate retention value, displayed poor vigour, exhibited signs of stress and offered limited visibility to the public realm. T3 was clearly visible from the public realm and was considered to be of moderate retention value. The condition of T3 was found to be fair, however, the multi-stemmed form was structurally poor due to the presence of included bark at the stem union that is likely to limit the trees future potential. Two sycamore trees forming G2 were considered to be of moderate retention value and were found to be in fair condition despite bark inclusions at the branch unions in their crowns. The trees forming G2 offered limited visibility from the public realm.

Figure 12 below shows T7 Sycamore on south boundary in context to the new build and converted properties to the south

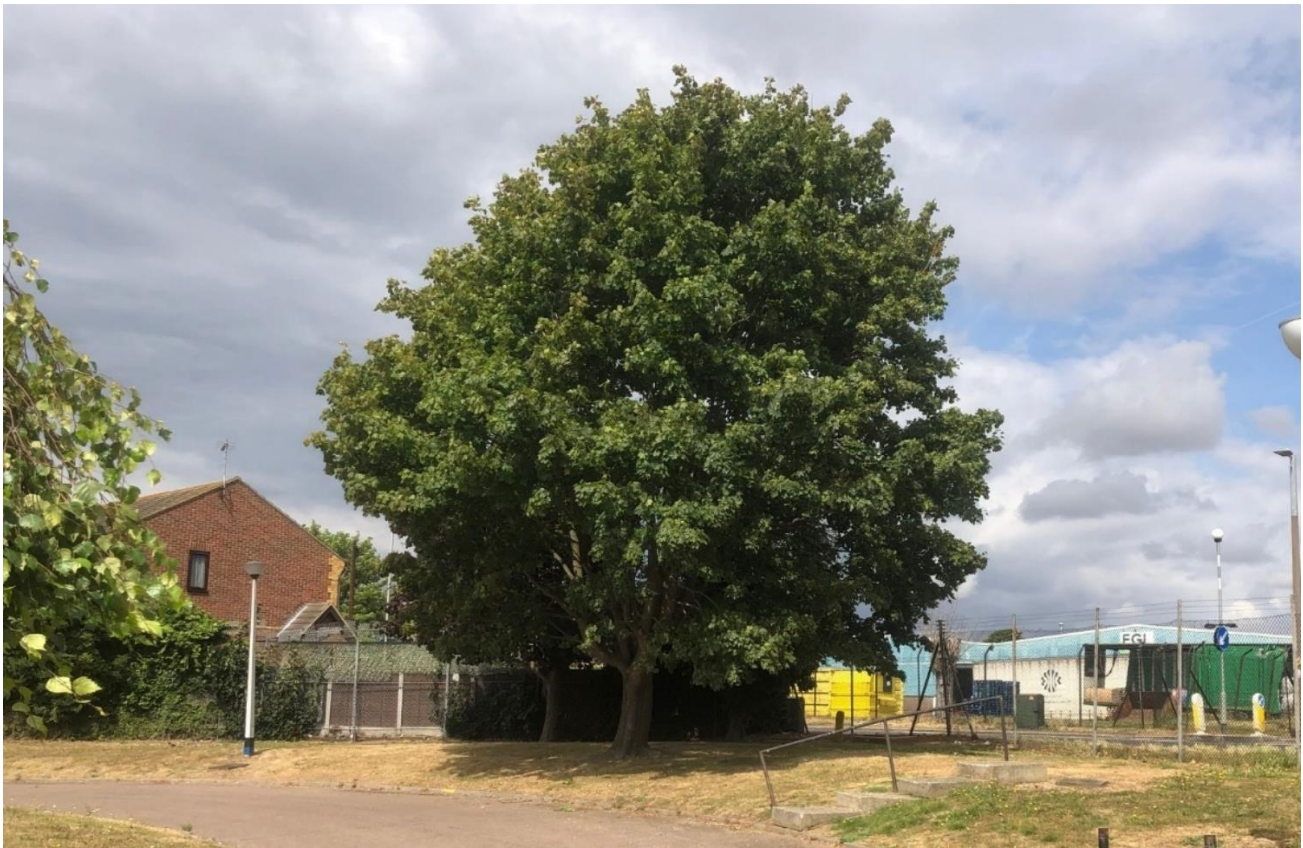
- 6.11 T8, the Norway maple in the northwest corner of the site facing Campfield Road, is isolated from the other trees on the site which affords it prominence in the streetscene on this key frontage. The objector's TEMPO score for this tree is slightly lower than that of the Council's Arboricultural Officer but a TPO remains defensible in both cases.

Figure 13 below shows T8 Norway Maple in the northwest corner of the site on Campfield Road

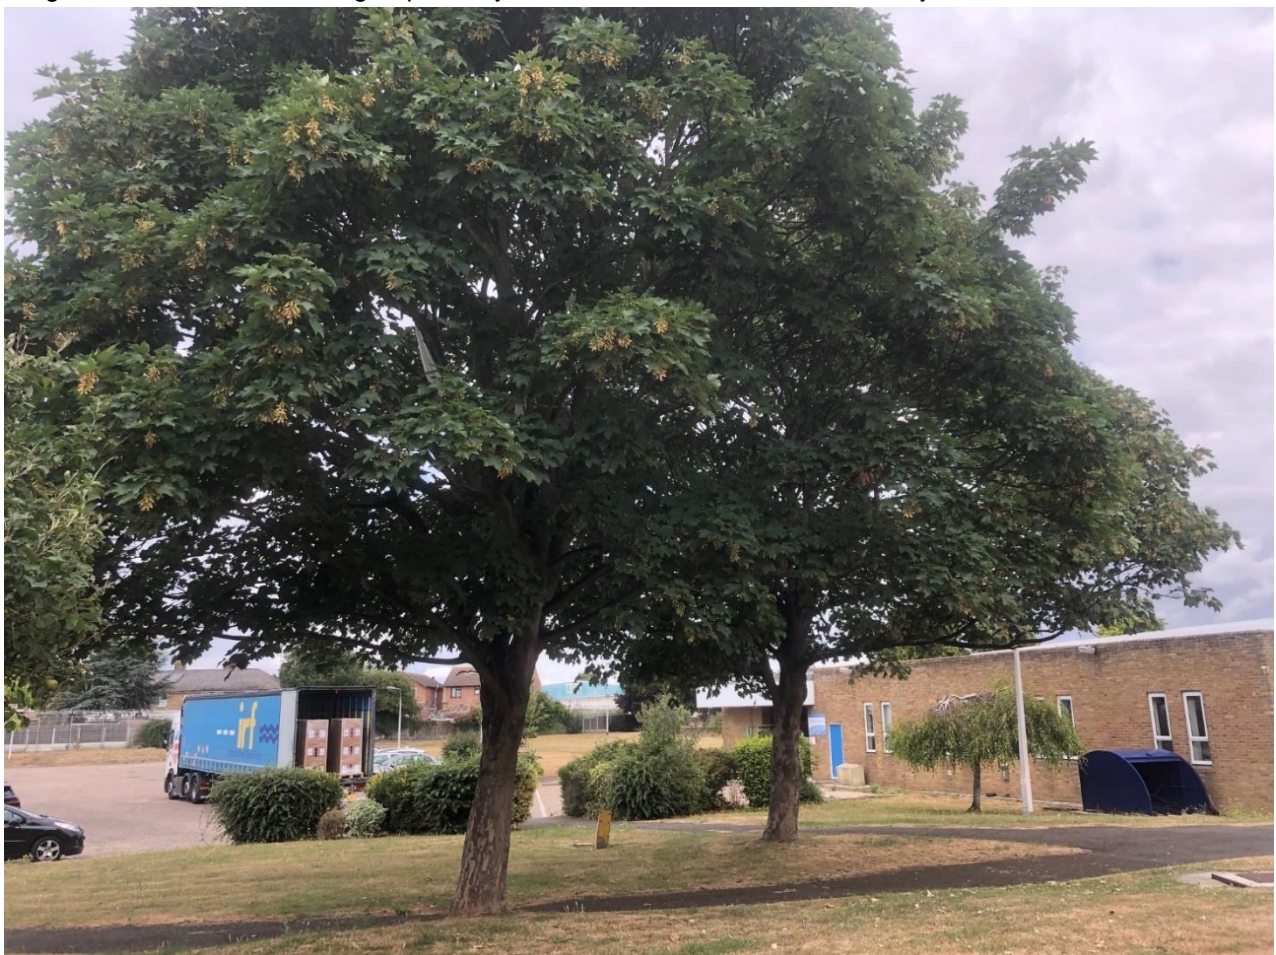
- G2 2 x sycamore - I disagree with the findings of the objector's report. Both trees are in good physiological condition with no sign of negative impact from the construction of the pavement that runs between them. They can be clearly seen from Chapel Road, albeit beyond the smaller trees on the Chapel Road boundary. Whether they were treated as a group as they have been, or two individuals, they would still qualify for TPO protection. The TEMPO score is therefore not amended and remains at 20 – TPO definitely merited. [See figure 15 in Appendix 1 for view from Chapel Road]

Figure 14 below shows G2 group of 2 sycamores set in from south boundary

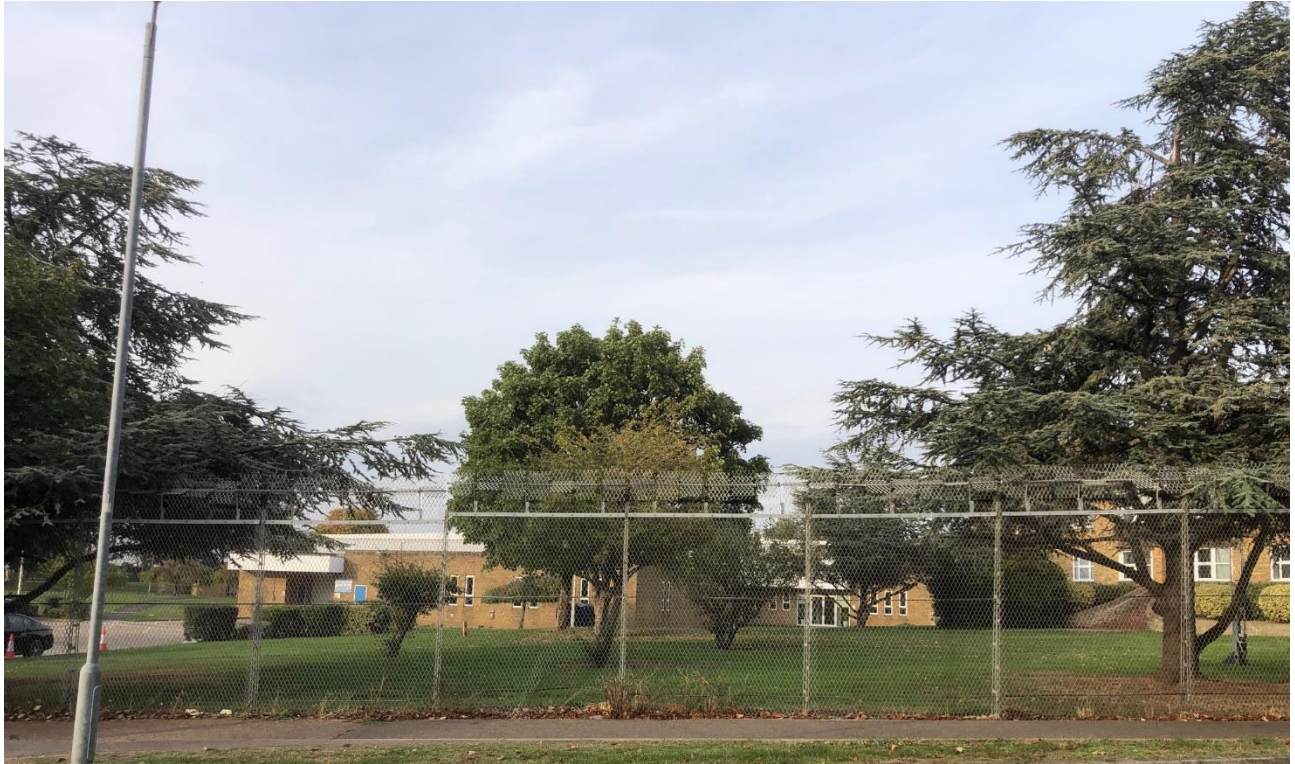
Figure 15 below shows visibility of G2 from Chapel Road to the south

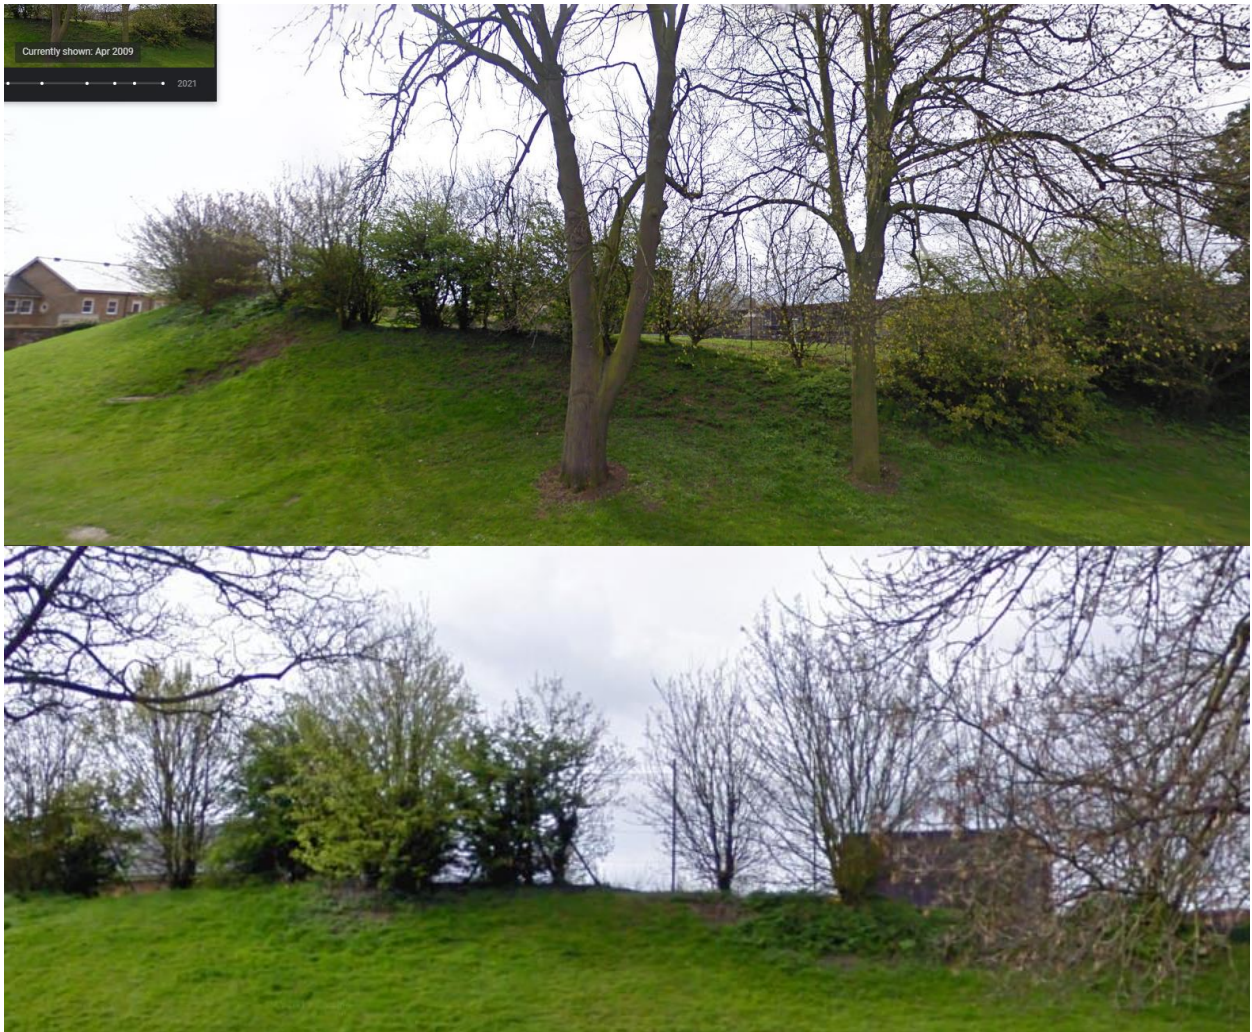
- G3 Acers and Hawthorns – The objection argues that G3 is a hedgerow and therefore does not qualify for protection under TPO legislation. These trees were probably planted as a row of whips (date of planting unknown) but they have not been managed as a hedge and have now grown to a linear group of small trees with stem diameters measured at 1.5m above ground level exceeding 75mm and, in some instances, exceeding 100m¹. Figure 16 in

Appendix 1 from 2009 Google Street view clearly illustrates the planting pattern with enough space between plants to enable them to develop into individual trees when left unmanaged as they have been. Google Streetview also has images from April 2009, August 2009, May 2012, September 2016, August 2018, May 2019, and April 2021 and none of these images show any evidence of hedgerow management, which would have resulted in a linear thicket of meshed crowns. This line of trees has individual structure and they meet or exceed the size requirements which would be covered by conservation area protection which is mirrored in the TEMPO scoring system (see footnote 1 above). The images in figures 18, 19 and 20 of Appendix 1 show the current size of these trees and their relationship to the road, to the existing TPO in this location and surrounding properties. Consequently, the TEMPO score has not been amended and remains at 20 - TPO definitely merited.

Figure 16 below shows 2 images of G3 from Google Streetview 2009 which show an open spaced tree planting not a close hedge planting arrangement

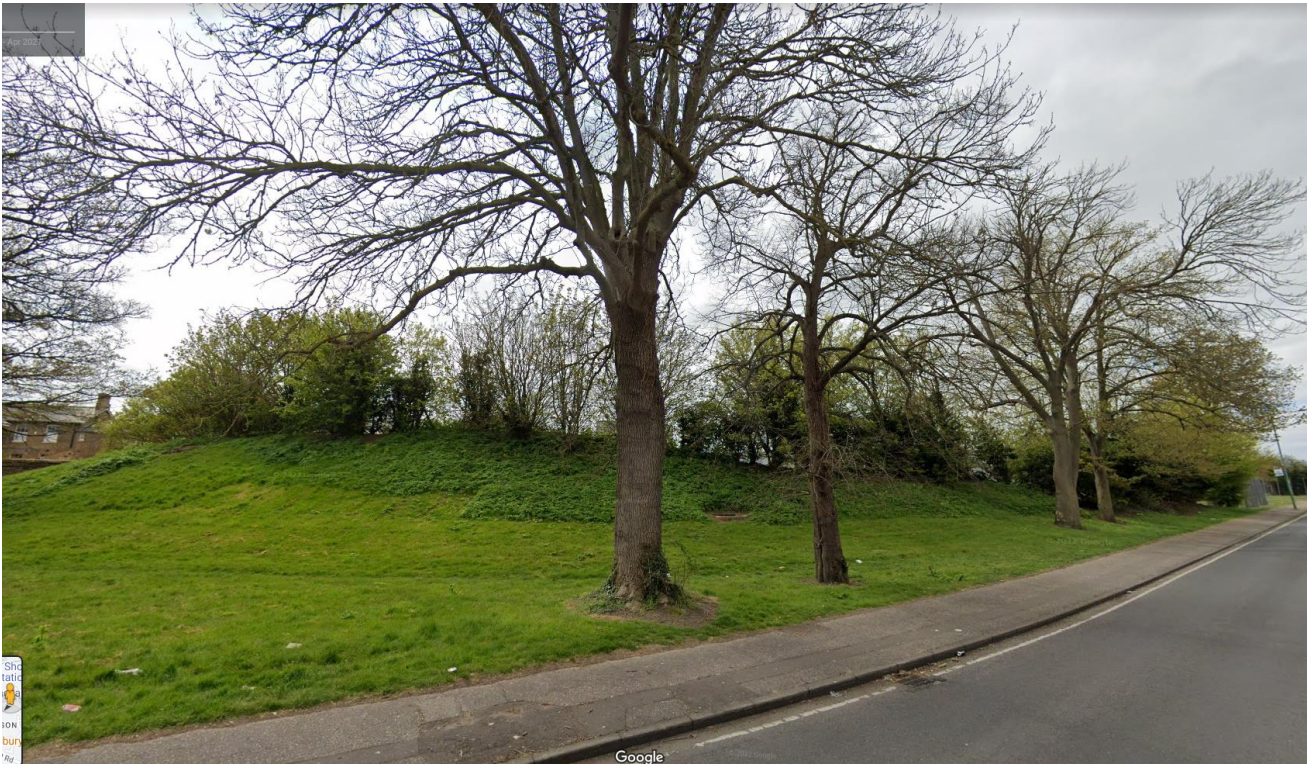
Figure 17 below shows G3 from Google Streetview 2021 - This is the exact image used in objectors tree report. As is the nature of Google Streetview images, the background features appear disproportionately smaller in contrast to those in the foreground due to the type of camera lens used.

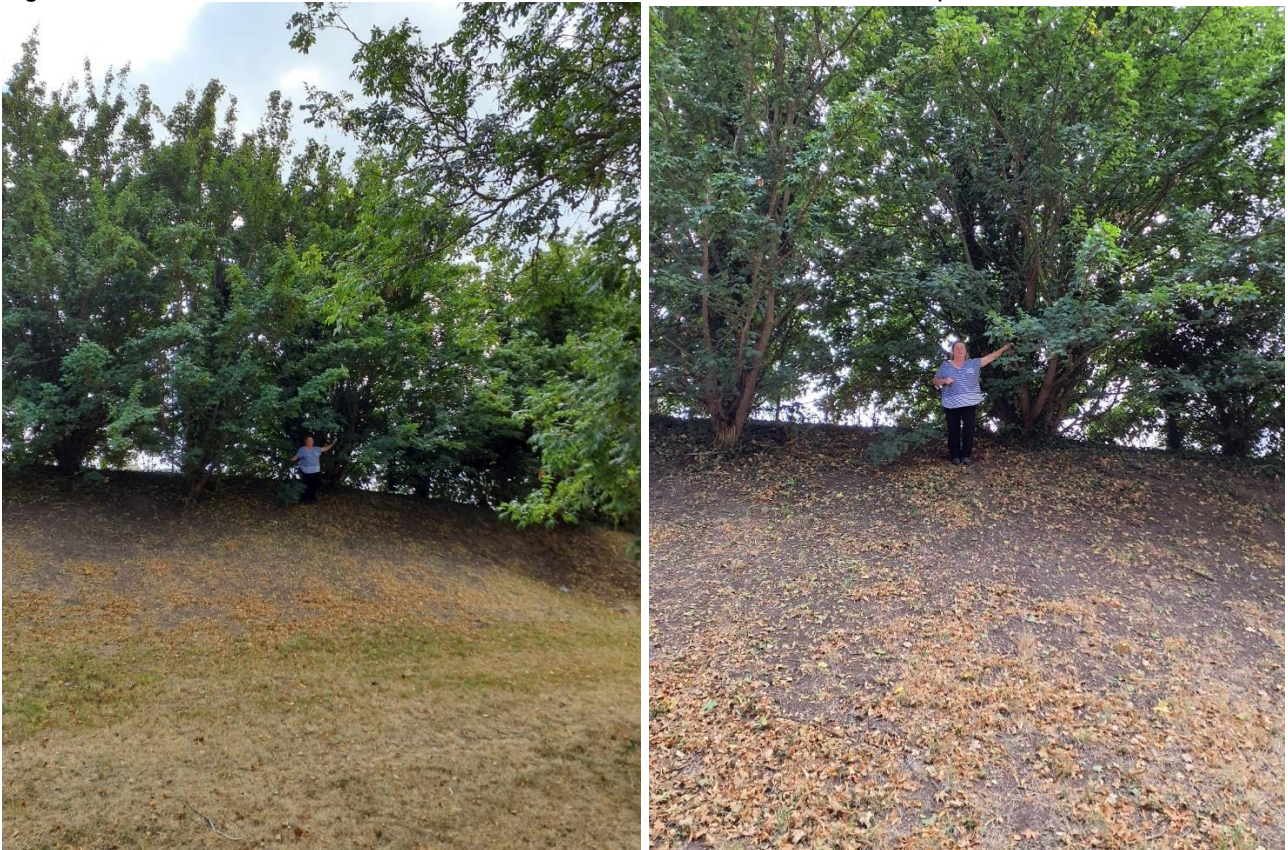
Figure 18 below shows the current size of the trees in G3 relation to scale of a person
