Reference:	TPO 4/22	
Ward:	Shoeburyness	
Proposal:	Tree Preservation Order Confirmation	
Address:	Cantel (UK) Ltd Site, Campfield Road, Shoeburyness, Essex SS3 9BX	
Consultation Expiry:	10 th August 2022	
Expiry Date:	20 th December 2022	
Case Officer:	Abbie Greenwood	
Plan Nos:	N/A	
Recommendation:	CONFIRM TREE PRESERVATION ORDER with modifications

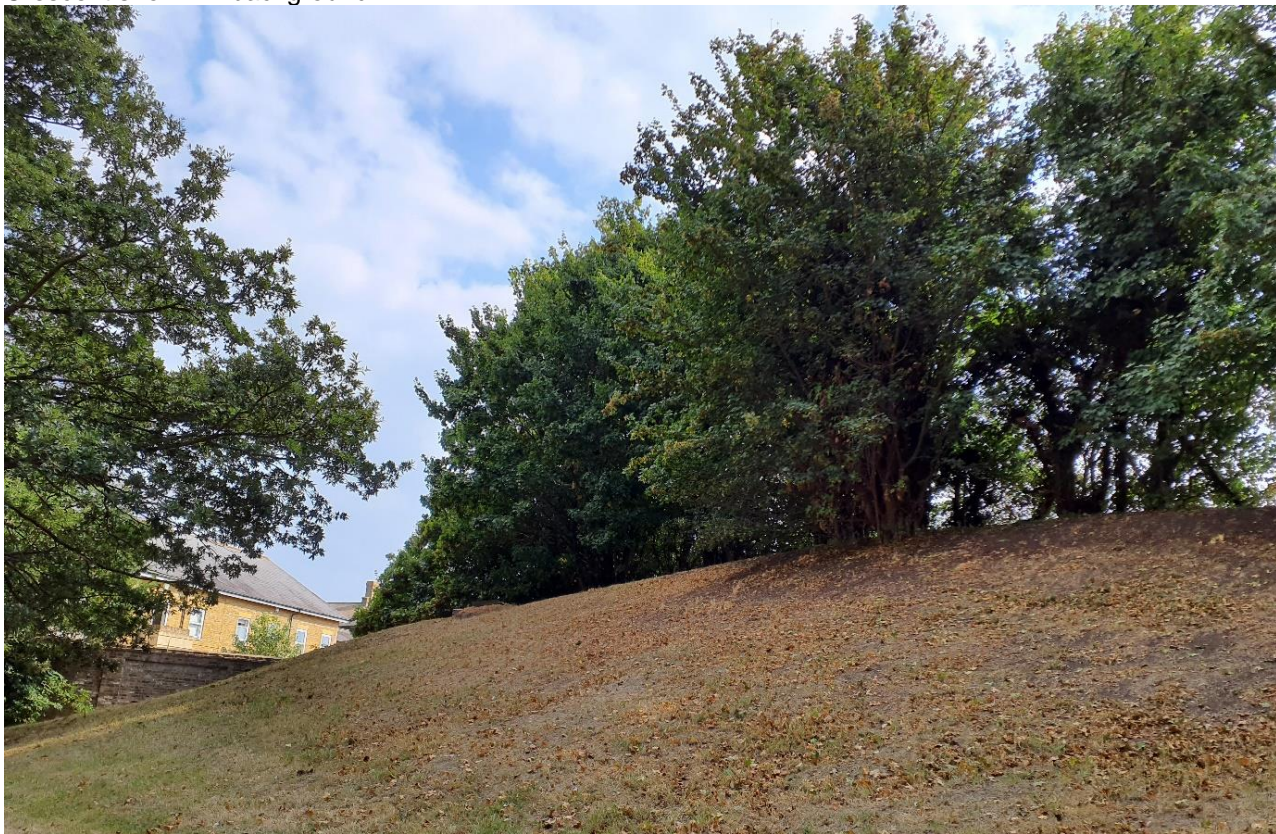
Figure 19 – Image below shows context of trees in G3 in relation to surrounding properties – Horeshoe Crescent shown in background.

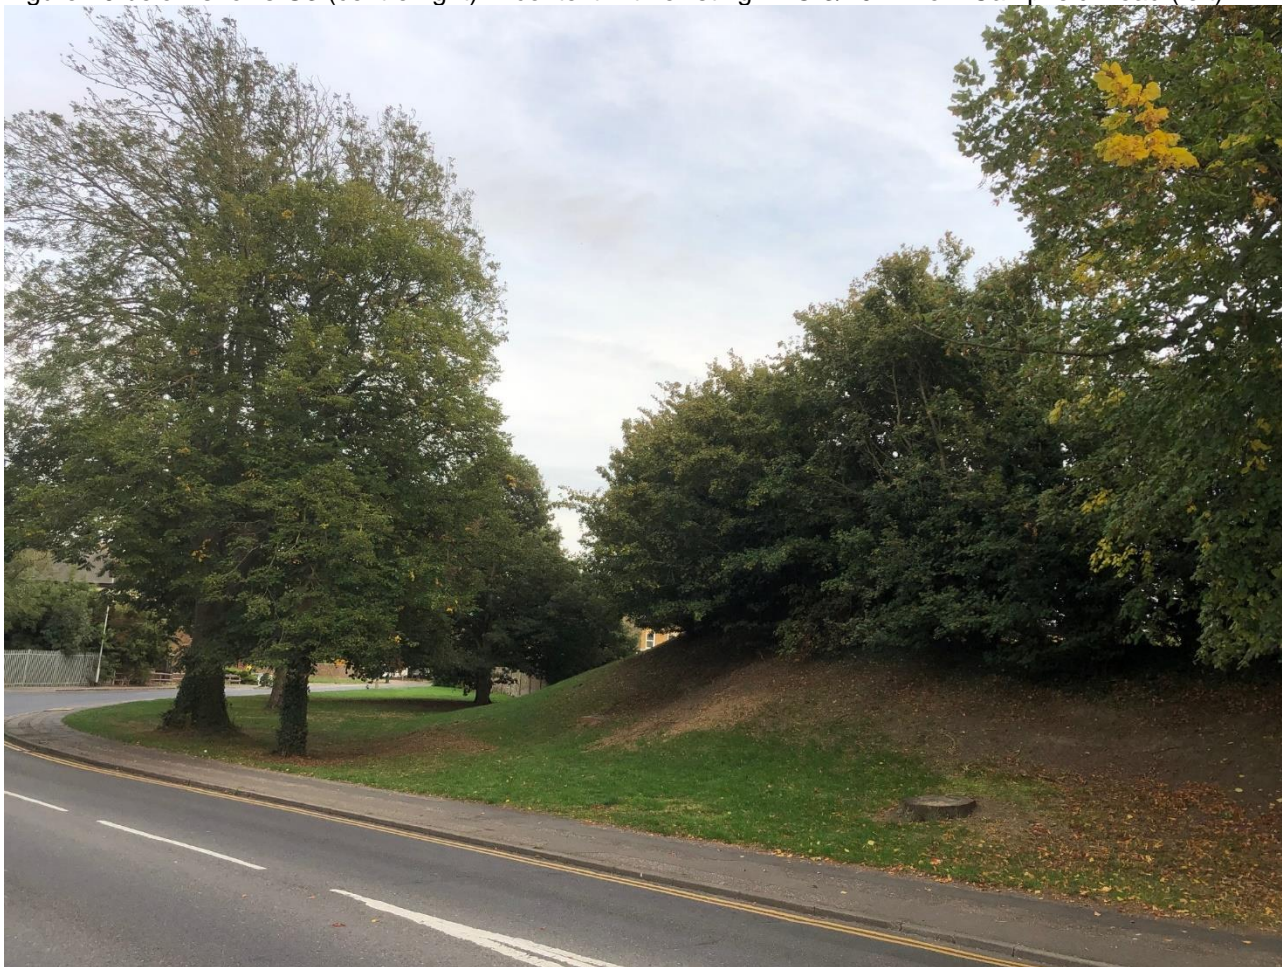
Figure 20 below shows G3 (centre right) in context with existing TPO 3/2012 from Campfield Road (left)
