1 Roof Lantern + Roof Top Access Detail 1:50

2 Existing + Proposed Balustrade Detail 1:20

3 Proposed Replacement Sash Window Detail 1:1

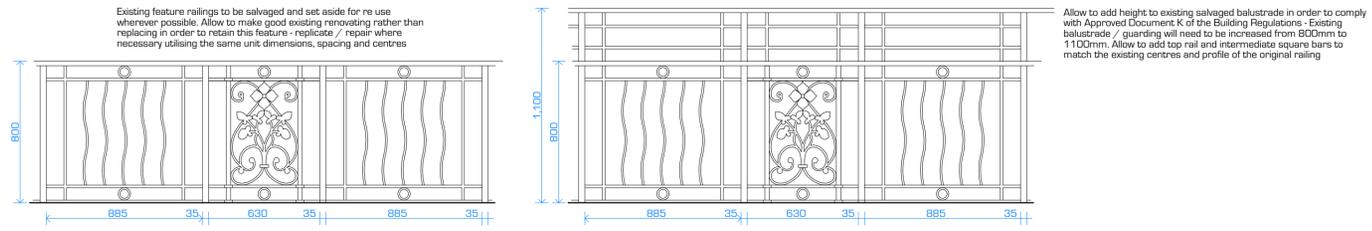
NOTE: Refer to Balustrade Condition Report forming part of this Planning Submission for further detail / photographs of current balustrade condition on site

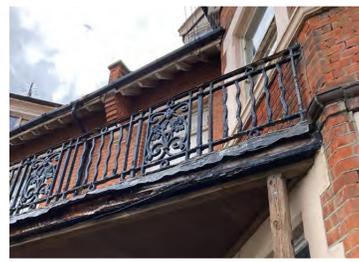
Site photograph detailing existing feature balustrade on site

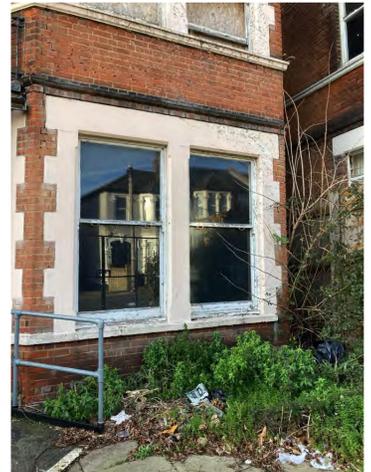
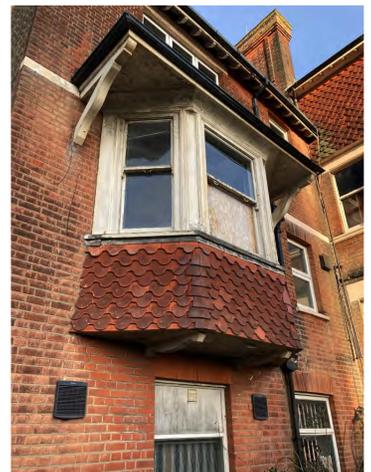
Site photograph detailing existing timber frame sash windows
