Southend-on-Sea Flooding on the 20th July 2014

Flood Investigation
Report

Final

March 2015

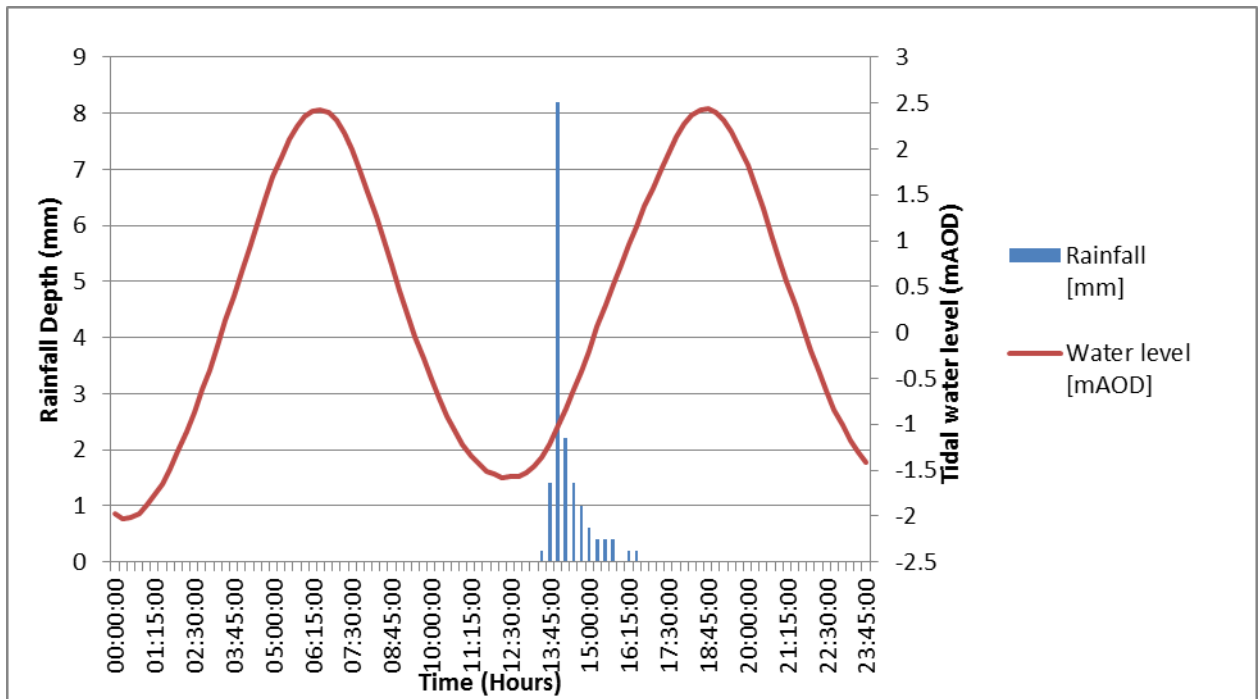
Within Southend-on-Sea, the EA tipping bucket rain gauge in Southchurch Park recorded a total depth of 16.6 mm to fall within 3 hours, between 13:30 and 16:30. At the peak intensity, 8.2 mm was recorded to fall within 15 minutes at 14:00 (Figure 2-1). The tide levels recorded at Southend Pier, show the tide level to be at its lowest just before the peak rainfall.

Figure 2-1: Recorded rainfall at Southchurch Park and tidal levels and Southend Pier on the 20th July 2014

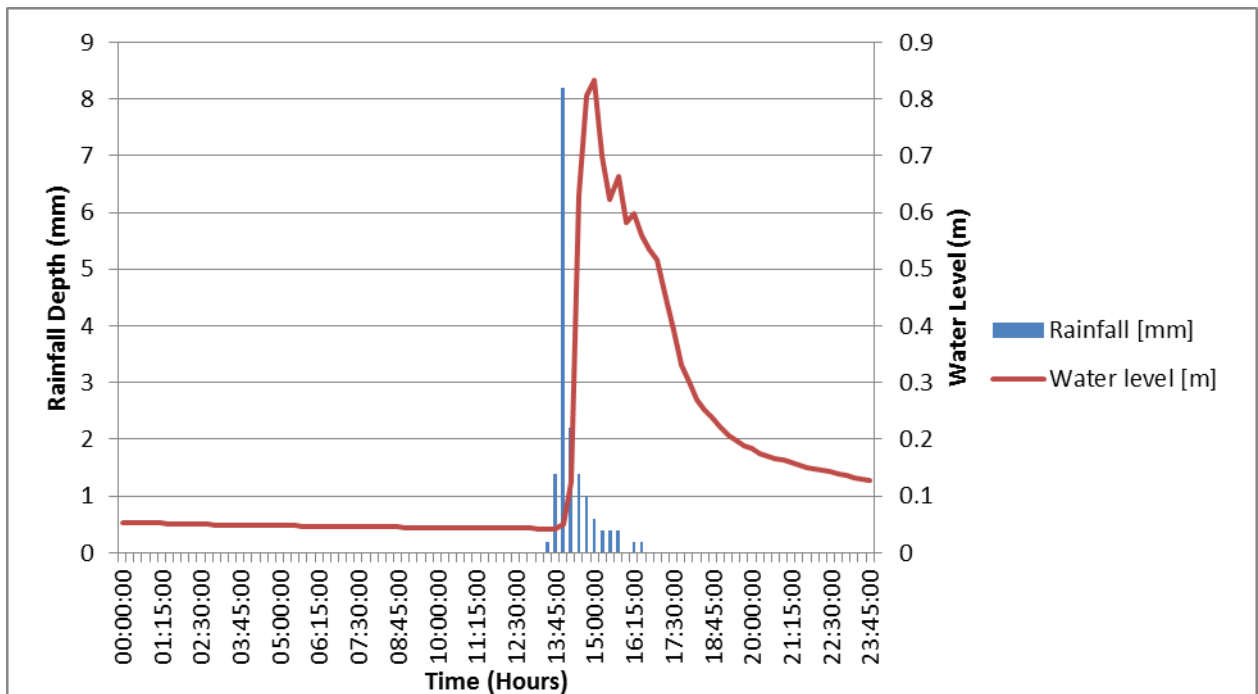
It should be noted that Prittle Brook drains from Hadleigh in Castle Point to the west of Southend-on-Sea. As the focus of the storm occurred to the west of Southend-on-Sea, the resultant flows within Prittle Brook through Southend-on-Sea are likely to have been of a greater magnitude than would result from the rainfall recorded at Southchurch Park.

Figure 2-5: Recorded rainfall at Southchurch Park and river levels at Belfrairs Park on the 20th July 2014

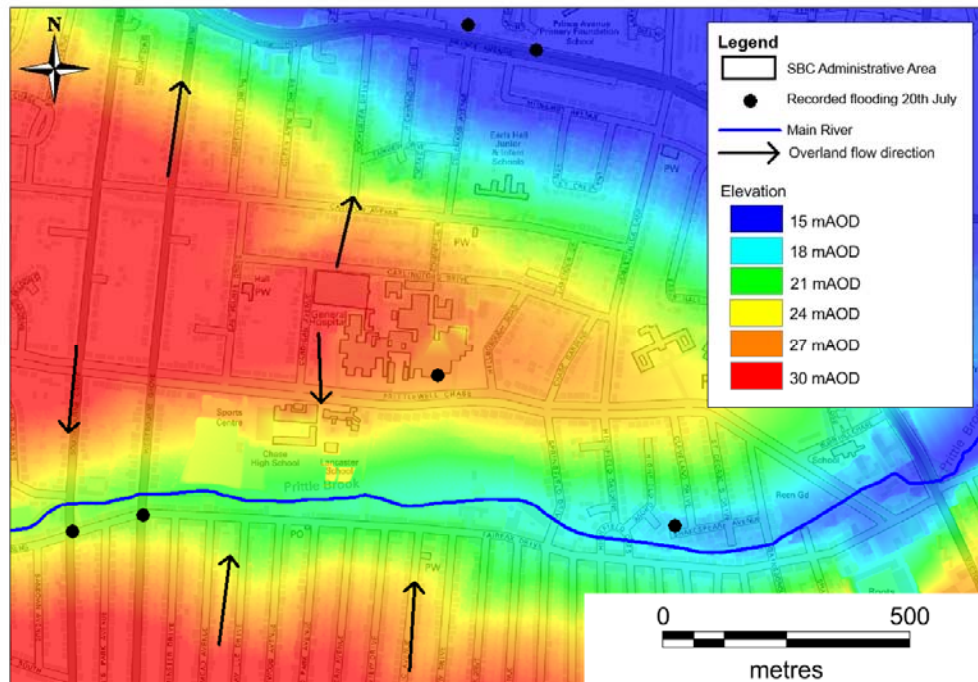
As shown in Figure 3-1, the hospital is at a relatively high elevation of approximately 27 mAO. The land to the north and south of the hospital falls to a lower elevation. Prittle Brook to the south is at a level of approximately 19 mAO.

*Figure 3-1: Topography around Southend General Hospital
Contains Ordnance Survey data © Crown copyright and database right 2014*

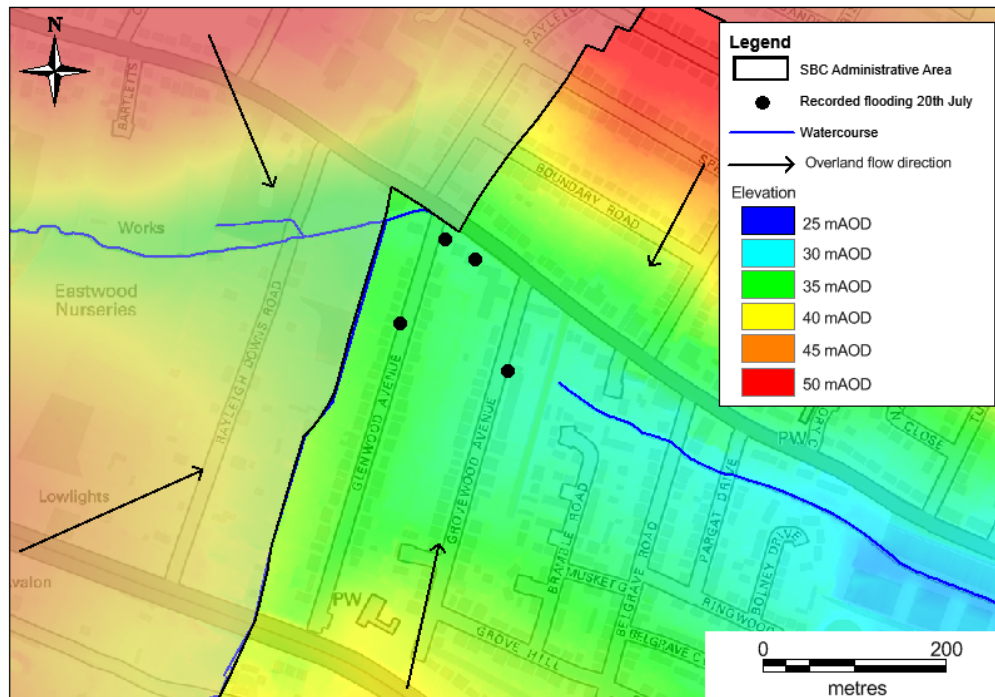
The topography around Glenwood Avenue is shown in Figure 3-2. The elevation of Glenwood Avenue falls in a northerly direction to its junction with Rayleigh Road. A low point in the carriageway is located at the northern end of Glenwood Avenue, highlighted in Photograph 3-3.

Figure 3-2: Topography of Glenwood Avenue
Contains Ordnance Survey data © Crown copyright and database right 2014

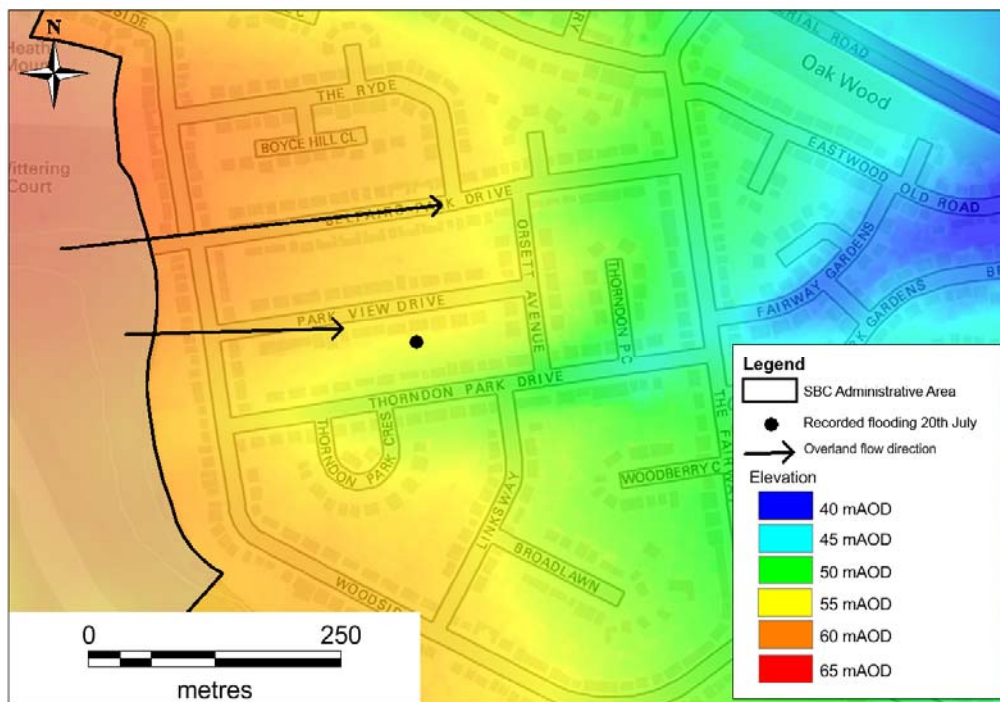
Figure 3-3 shows that the affected area lies on a relatively steep slope (1:35) in a predominantly residential area. A large percentage of the ground is covered by impervious drives and roadways, which combined with slope of the land, can lead to rapid runoff and surface water flooding.

Figure 3-3: Topography of Park View Drive and Thorndon Park Drive
Contains Ordnance Survey data © Crown copyright and database right 2014

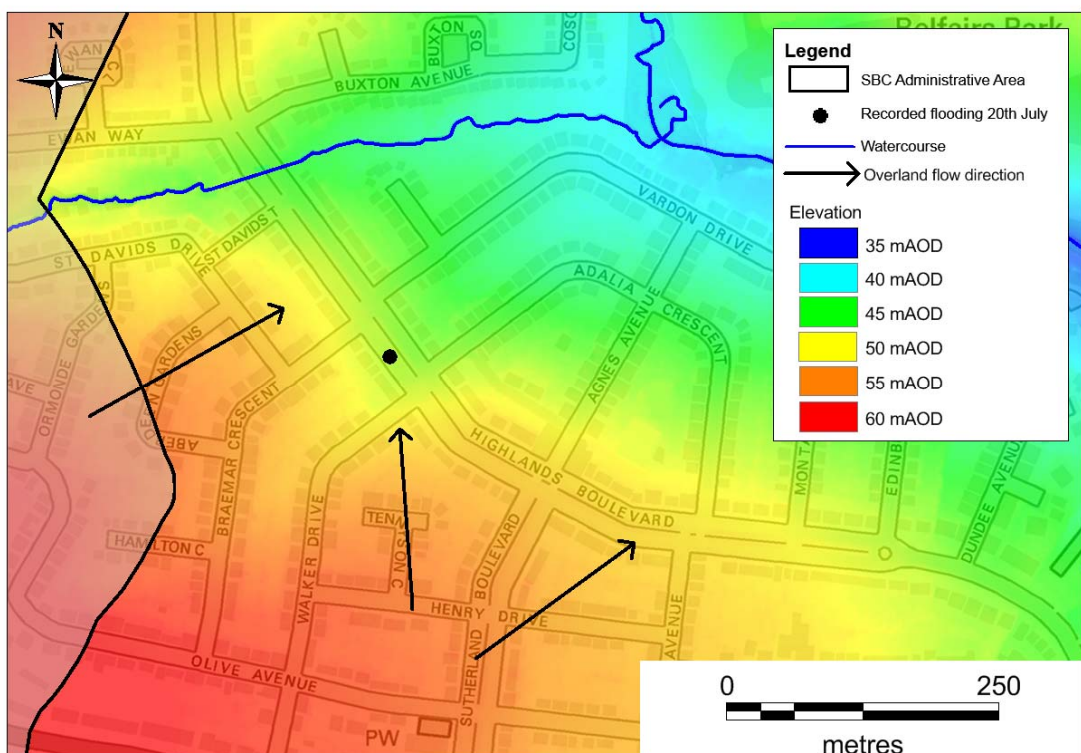
*Figure 3-4: Topography of Highlands Boulevard
Contains Ordnance Survey data © Crown copyright and database right 2014*

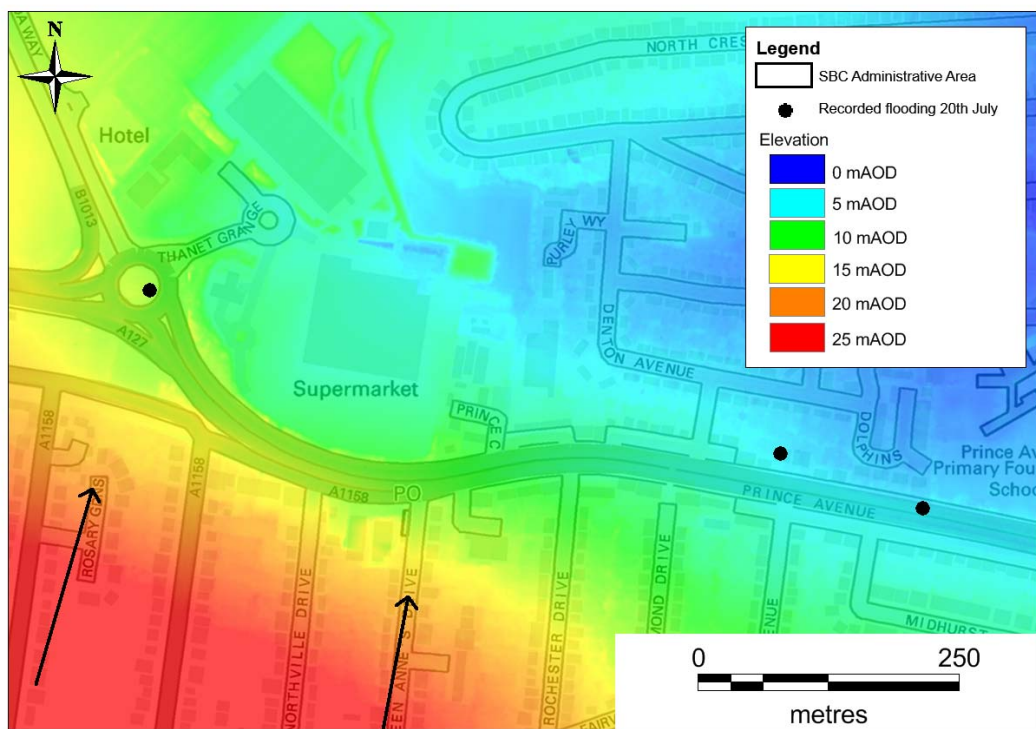
The topography in Figure 3-5 shows that there is a fall in elevation from the south towards Prince Avenue. There would therefore be a tendency for surface water to run, as overland flow, towards Prince Avenue. The public surface water sewer network, consists of a large surface water sewer (increasing from 675 mm to 900 mm) running in an easterly direction along the length of Prince Avenue. Surface water sewers from the lateral roads to the south join along the length of the sewer.

Figure 3-5: Topography of Prince Avenue (black arrows indicate the general overland flow route)
Contains Ordnance Survey data © Crown copyright and database right 2014

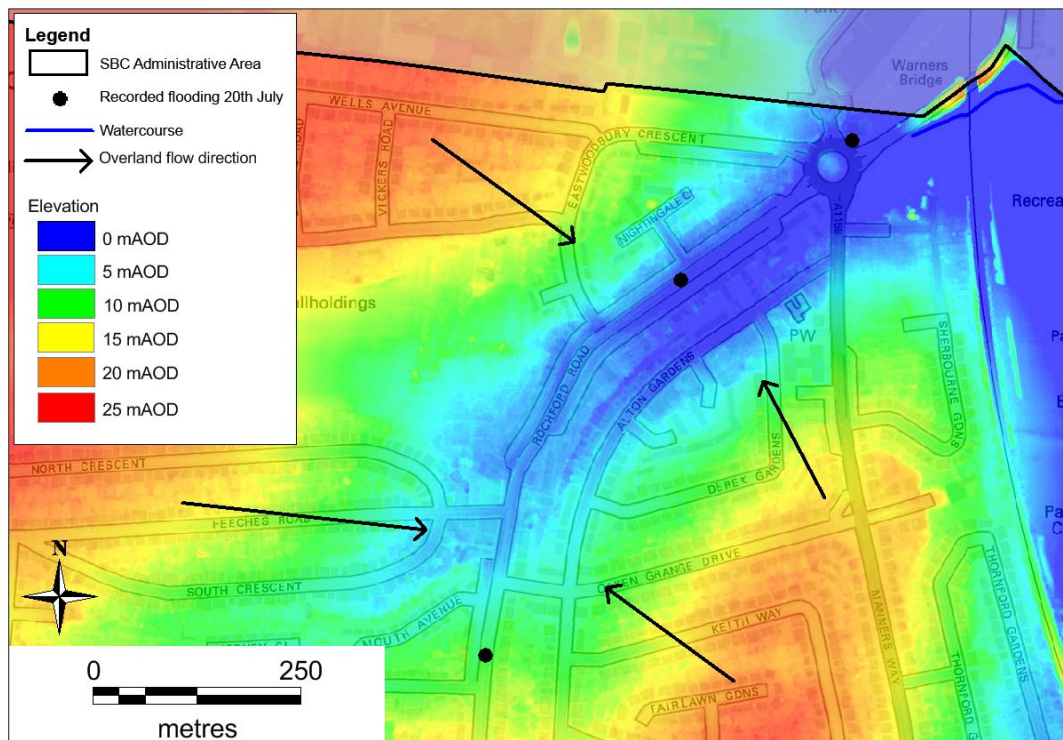
Figure 3-6 shows the local topography. It can be seen that the land to the south west and south east slopes towards Rochford Road and Harp House Roundabout. The topography of the land is associated with a watercourse, which is now culverted and classified as a surface water sewer. This discharges to a tributary of Prittle Brook to the south of Warners Bridge (where Rochford Road passes over the railway line). There are several lateral drains that connect into the culverted watercourse along the length of the surface water sewer.

Figure 3-6: Topography of Rochford Road
Contains Ordnance Survey data © Crown copyright and database right 2014

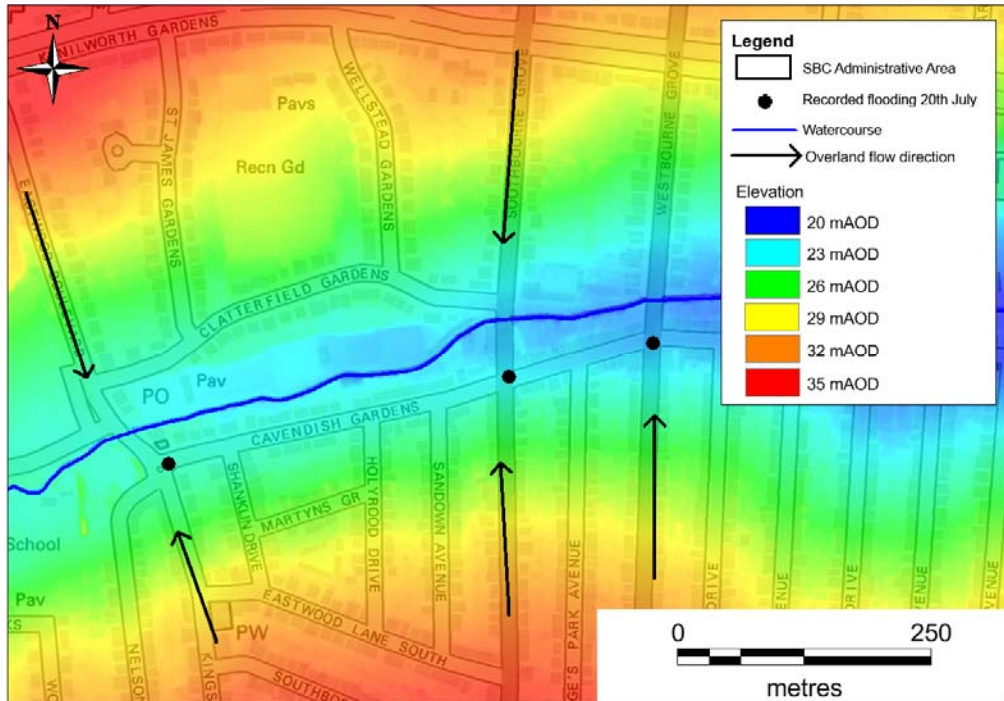
Figure 3-7 shows that the reported flood incidents are located at the bottom of a valley through which Prittle Brook flows in an easterly direction. The topography indicates that surface water flows would be directed towards Prittle Brook, and as a result Cavendish Gardens.

High level hydraulic calculations of the surface water network draining to Prittle Brook at the junction of Kingsway and Cavendish Gardens show that in the event of the outfall being completely restricted, the surface water network at the junction would reach capacity after 0.2 mm of rain, resulting in surcharging of the network after 9 minutes. Applying the same rainfall profile, but allowing a free discharge to Prittle Brook, the network would reach capacity after 13.7 mm of rainfall, resulting in flooding after 99 minutes. This therefore shows that the network is highly susceptible to the rate of discharge to Prittle Brook.

Figure 3-7 Topography in the vicinity of Cavendish Gardens.
Contains Ordnance Survey data © Crown copyright and database right 2014

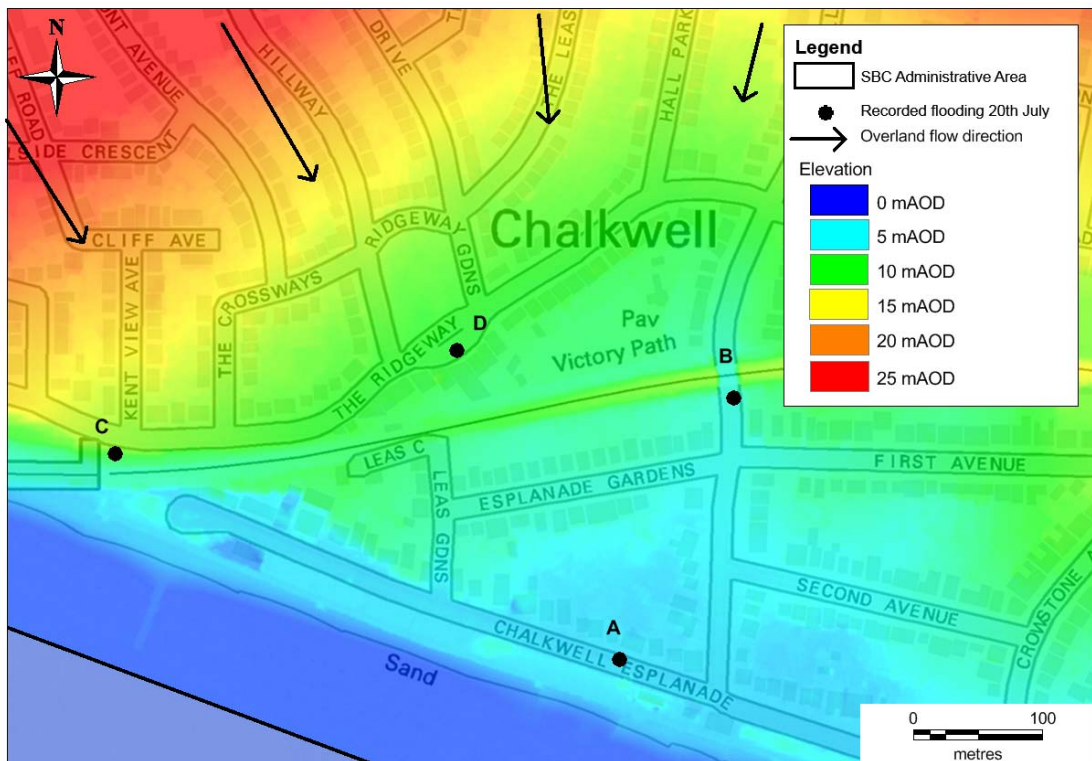
The topography of the Chalkwell area is shown in Figure 3-8. It can be seen that there is a considerable slope across the land from the north, around the Chalkwell area, towards the sea front. Overland flow would generally follow the gradient of the land and tend towards the sea front.

Figure 3-8: Topography of Chalkwell
Contains Ordnance Survey data © Crown copyright and database right 2014

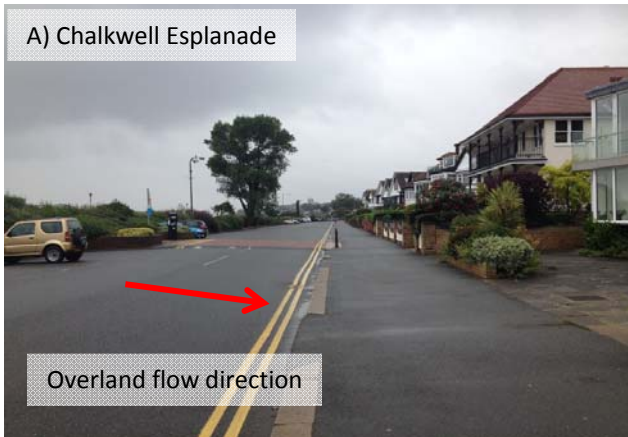
The flooding at Chalkwell Esplanade (point A) is recorded to be highways flooding. Observations from the site walkover completed on the 28th August 2014 noted that Chalkwell Esplanade is at a lower elevation than the surrounding area. In addition, there are a number of traffic calming measures and road gullies along the length of the road (as shown in Photograph 3-8). It is considered that highway flooding is a result of the reduced ability for water to enter the gullies, either as a result of the road structure impeding the flow of water, or the reduced capacity of the network.

Photograph 3-8: Chalkwell Esplanade (looking west)

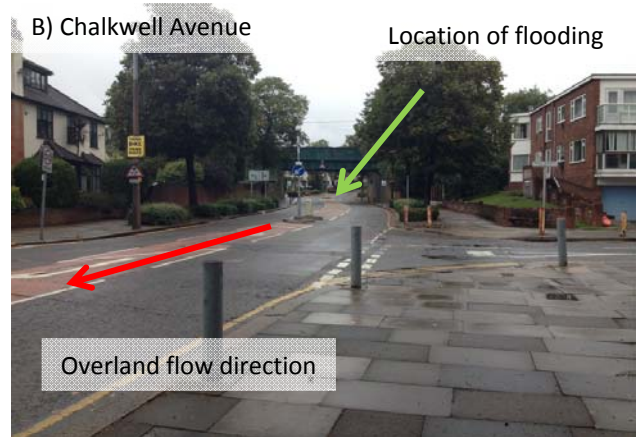
The record of flooding in Chalkwell Avenue (point B) states a manhole cover, located within the road as it passes underneath the railway line, was lifted. This implies that the capacity of the sewer network within this area was exceeded. The surface water drainage network within this area consists of four surface water drains (diameters ranging from 150 mm to 525 mm) converging into two networks beneath the railway line. Two sewers of 675 mm and 375 mm diameter drain to the south before discharging via the Chalkwell Pumping Station. As the tide was low at the time of flooding, surface water would have been able to discharge by gravity. It is considered that the capacity of the network may have been exceeded due to the rapid onset of heavy rainfall, accumulating within this junction. Water surcharging from the manhole would have followed the topography of the road and drained towards Chalkwell Esplanade (as shown in Photograph 3-9).

Photograph 3-9: Chalkwell Avenue (looking north)

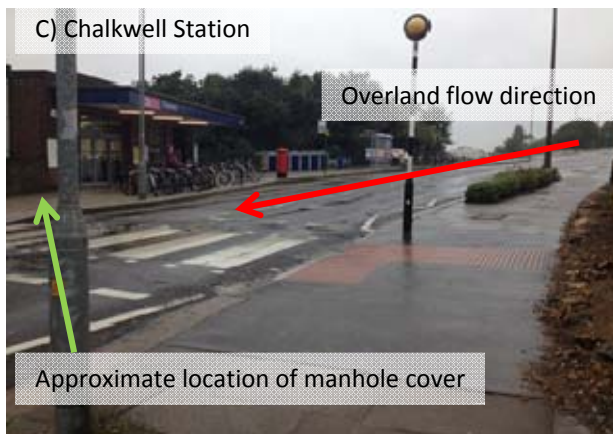
The flooding in the footway of Chalkwell Station (point C) was due to the manhole cover having lifted. The entrance to the train station is at an elevation of approximately 10 mAOD, 6 m above the level of Chalkwell Esplanade to the south. To the east of the train station, the previously described storm overflow protection tunnel (1200mm diameter), surface water sewer (375 mm diameter) and Prittle Brook flood relief channel cross beneath the railway line. The cause of flooding within this area may be attributed to a blockage or capacity issues within the network. AW has no record of flooding, and is not aware of capacity issues, within this area.

Photograph 3-10: Chalkwell Station (looking south)

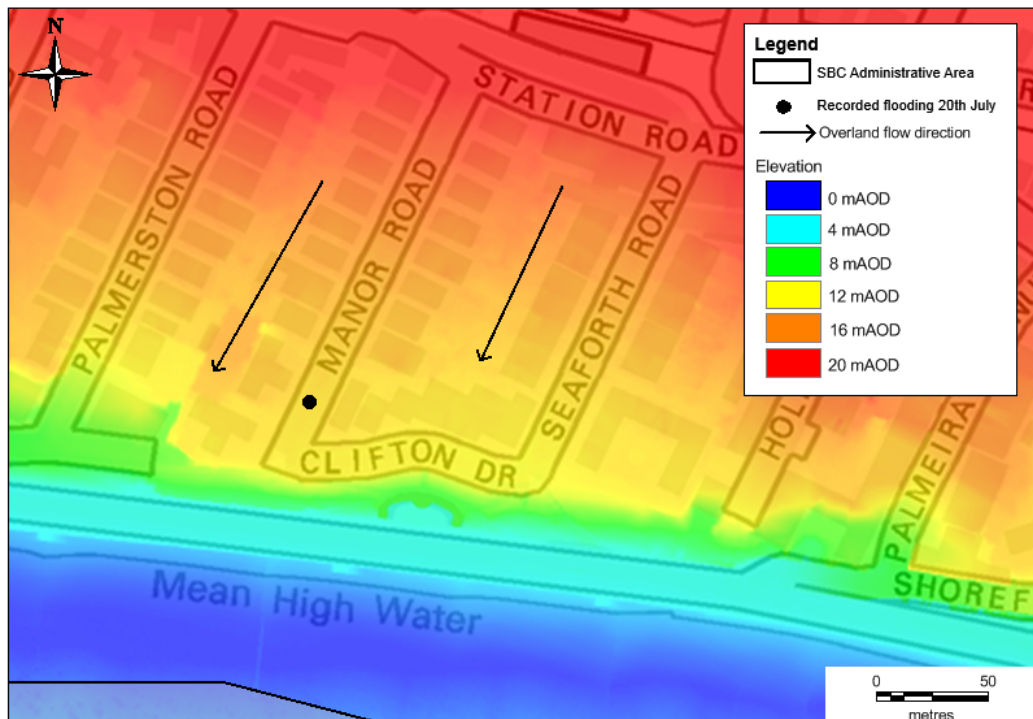
Manor Road is situated on a steep slope in a largely impermeable area. As a result, surface water runoff from the area is less likely to infiltrate into the ground and instead flows overland, largely within the road channels. Figure 3-9 shows the local topography and dominant flow routes in the area.

Figure 3-9: Topography of Manor Road and surrounding area
Contains Ordnance Survey data © Crown copyright and database right 2014

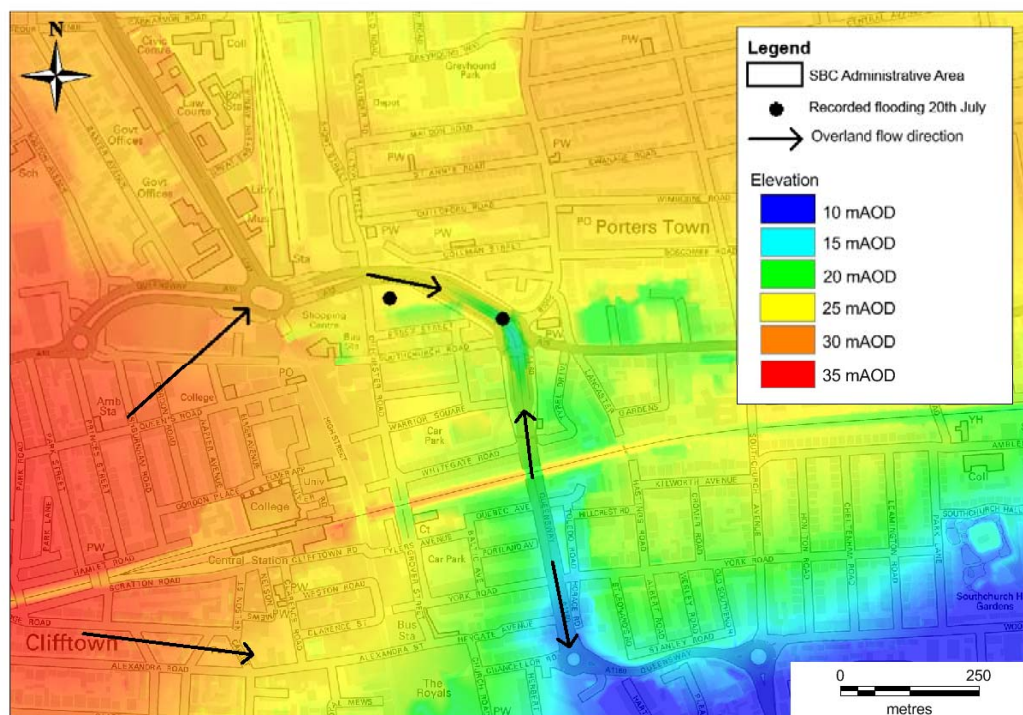
The ground level within the underpass is significantly lower (estimated to be 7m lower according to the LiDAR shown in Figure 3-10) than the surrounding areas. As a result, rainwater falling on the impervious road surface is directed towards the low point of the underpass. The ability of the road drainage to perform its function of removing rainwater from the surface is vital to prevent flooding of the underpass.

Figure 3-10: Topography at the Queensway underpass and surrounding area

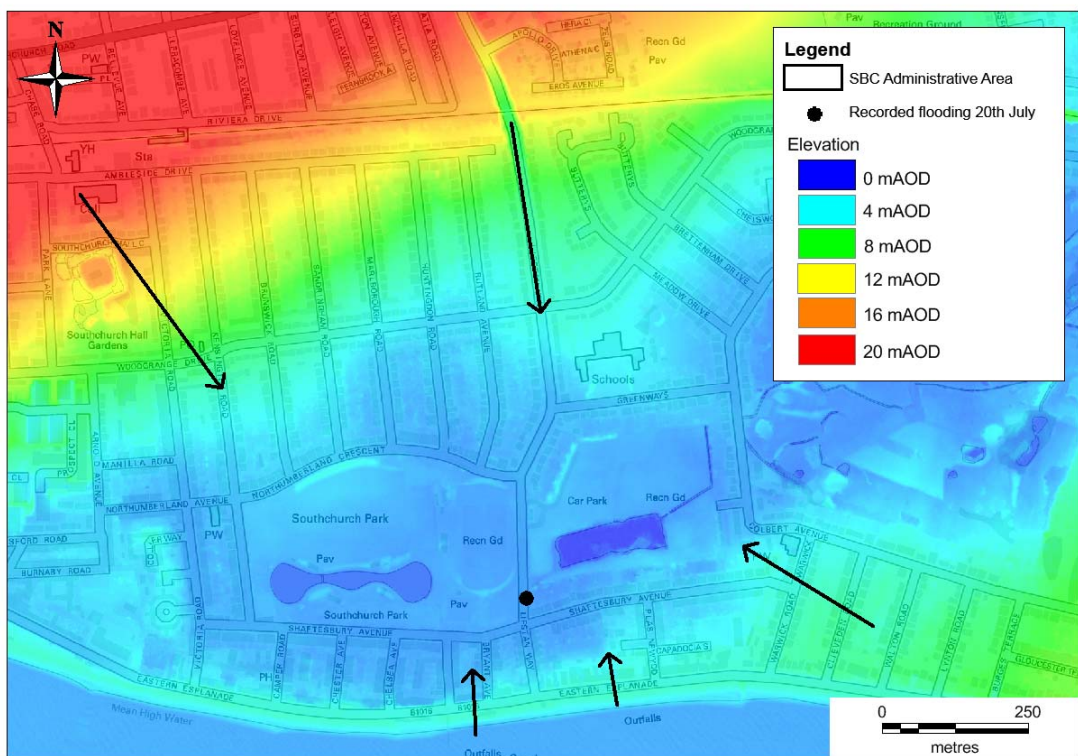
As shown in Figure 3-11, Lifstan Way is located at a low elevation of approximately 2 mAOD. The land to the north of Lifstan Way is at a higher elevation, resulting in the potential for overland flow to be generated and accumulate within the areas of lower elevation. More locally to Lifstan Way, the sea wall and land to the south east are at a greater elevation. Although to a lesser extent, there is also the potential for surface water runoff from these areas to accumulate within the low lying land around Lifstan Way.

Figure 3-11: Topography of Lifstan Way and surrounding area (black arrows indicate the general overland flow route) Contains Ordnance Survey data © Crown copyright and database right 2014

As a result of the topography, the surface water sewer network within this area is complex. Within Lifstan Way, adjacent to the location of flooding, there are two large surface water sewers. The first is a 750 mm diameter surface water sewer that is pumped to the outfall beyond Eastern Esplanade to the south. The second is a 900 mm outfall from the lake within

Southchurch Park East, which discharges via the Lifstan Way Pumping Station. There are no local surface water connections to these sewers at this point.

Observations from the site walkover show manholes to be located at the junction of Shaftesbury Avenue and Lifstan Way. From the information available it cannot be determined which section of the surface water sewer exceeded capacity to cause surcharging from the manhole.

ID	Action	Lead RMA (Support)	Area to be Implemented
6	Investigate the potential for flood storage within Southchurch Park to alleviate flood risk to Lifstan Way.	SBC (residents & businesses)	Lifstan Way
7	As several issues were associated with poor maintenance, it is recommended that more targeted maintenance is undertaken, especially for highways drainage.	SBC	Thorndon Park Drive, Queensway underpass. Flood Risk Areas generally.
8	SBC should consider methods of liaising with residents to ensure flood risk is understood. This would be beneficial in disseminating information and managing local flood risk.	SBC (EA, AW, residents, businesses)	Glennwood Avenue, Chalkwell Esplanade,
9	Property level protection: Residents should be provided with information and encouraged to consider implementing property level protection where necessary.	residents and businesses (SBC)	Borough wide.
10	Register areas with a single incident of flooding to help identify triggering criteria for future Flood Incident Reports.	SBC (EA, AWS)	Leigh View Drive, Rayleigh Road, Glendale Gardens, Shakespeare Avenue, Chichester Road and Newington Avenue

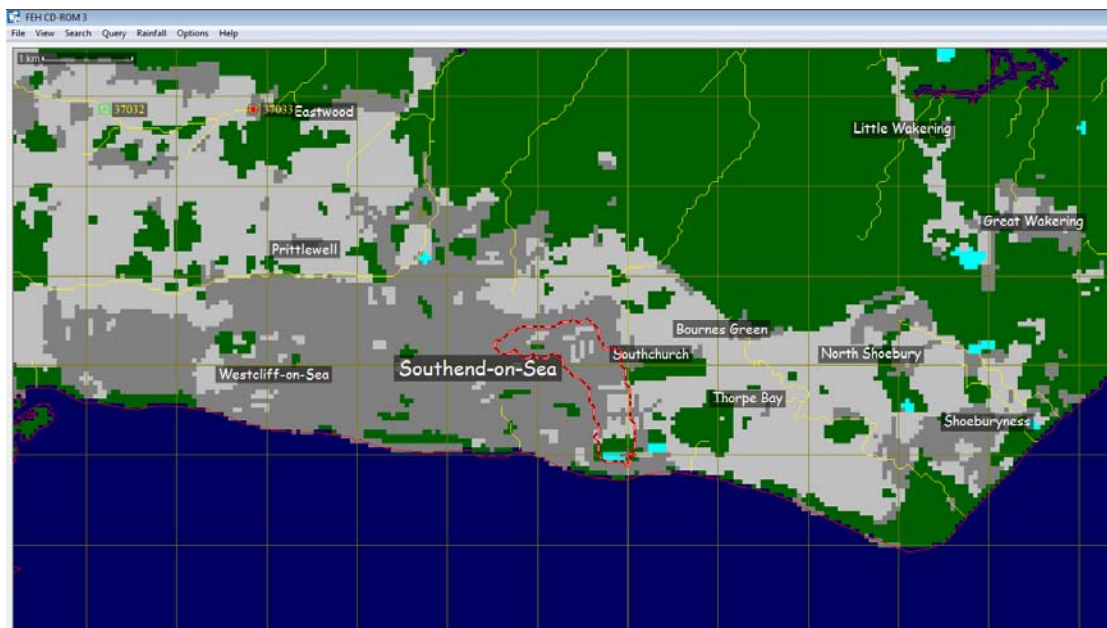
The assessment has found that for the 3 hour rainfall event, a maximum depth of 16.4 mm was recorded, equating to a 1 in 1.46 chance of occurrence in any given year. The greatest intensity recorded over a 1 hour period was 13.2 mm, the equivalent of a 1 in 1.74 chance of occurrence in any given year. Due to the limitations of the methodology used to determine this, it is considered that that the chance of this occurring should be considered to be less than 1 in 2 years.

The catchment associated with the Southchurch Park rain gauge is detailed in Figure A-1 below. The catchment descriptors of the 1km² area at the rain gauge location were used in these calculations.

Figure A-1 – Southchurch Park Catchment Area as shown in the FEH CD-ROM
