**613-619 SOUTHCHURCH ROAD,
SOUTHEND**

**PRELIMINARY BAT ROOST
ASSESSMENT**

Report No: RT-MME-155176-04

Date: June 2021

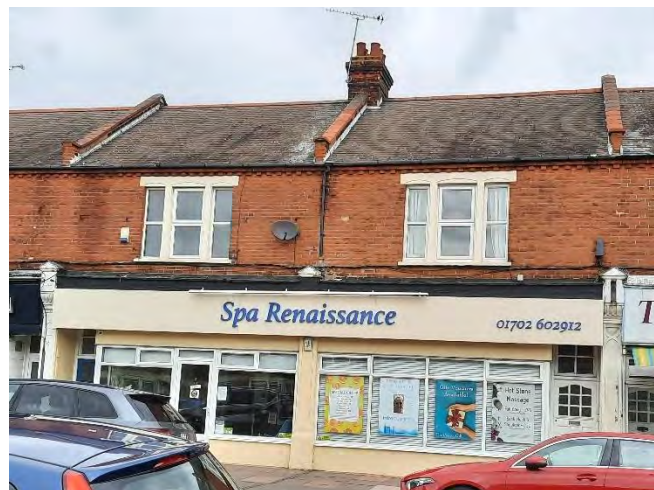
Plate 4.18: Southern Elevation

Building 2 (613-619 Southchurch Road) was a two-storey brick-built terrace with a pitched slate tiled roof as shown in Plate 4.18, 4.19 and 4.20. The ground floor of the building was in use for commercial purposes and the first floor was in use as a residential flats. The building was in relatively good condition at the time of the survey.

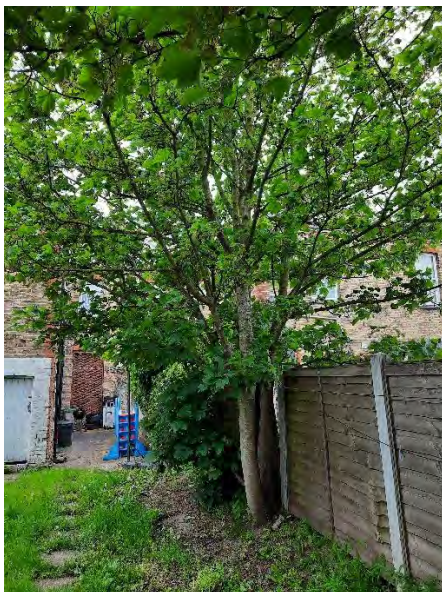
Plate 4:30 Sycamore Tree

Two semi-mature sycamore trees were identified within the application site (Plate 4.30 and 4.31). These trees did not have any suitable features for bats to roost within and therefore were assessed as having negligible potential for roosting bats.
