Eastern Esplanade Conservation Area Appraisal

Southend-on-Sea: Eastern Esplanade Conservation Area Appraisal

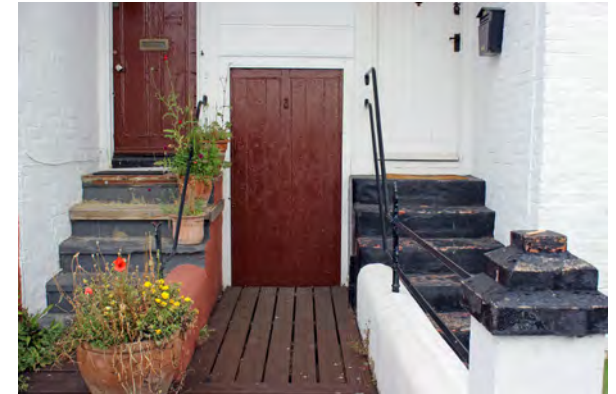
Parts of original railings remaining at No.44 (left) and No.45 (right)

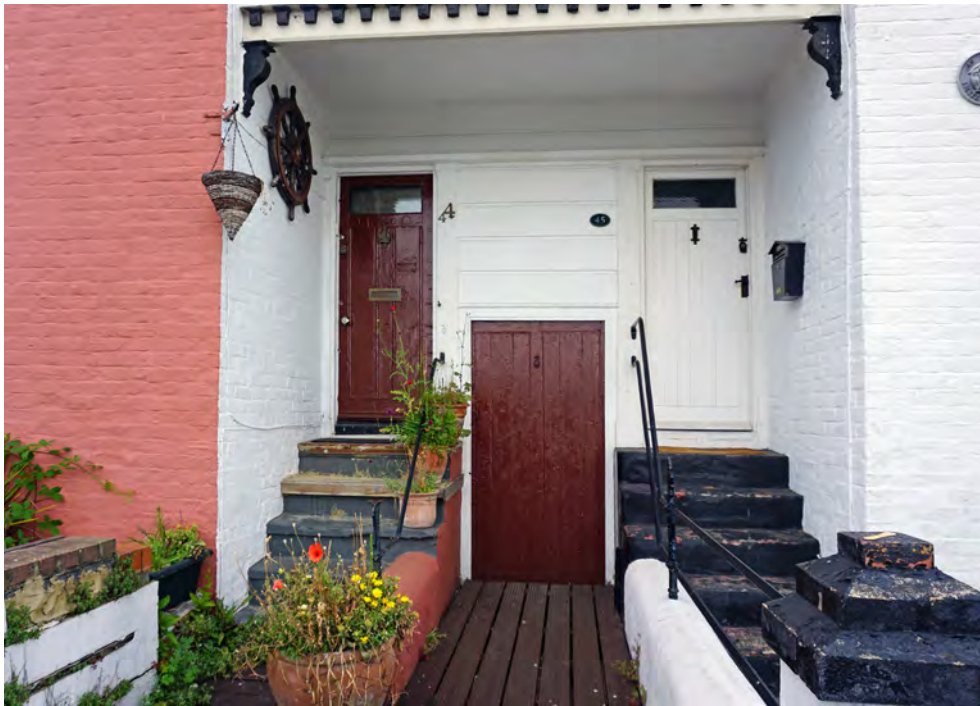
Good survivals of timber doors with glazed panel at the top and original stone steps, albeit painted

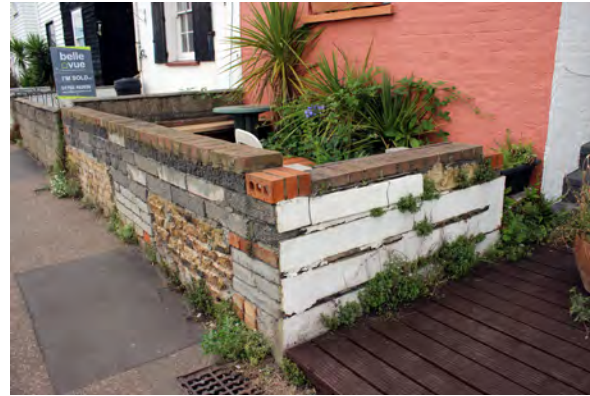
Poor boundary wall treatment

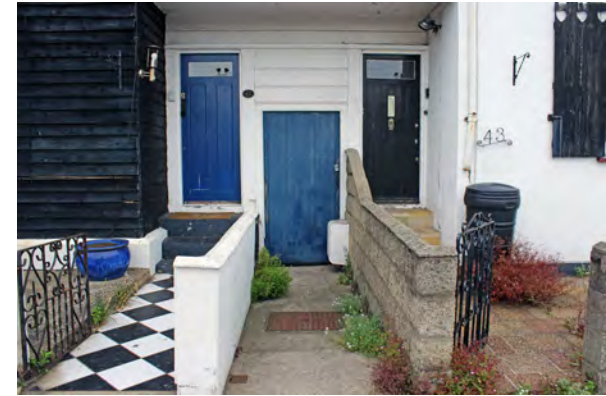
Mix of boundary wall treatments

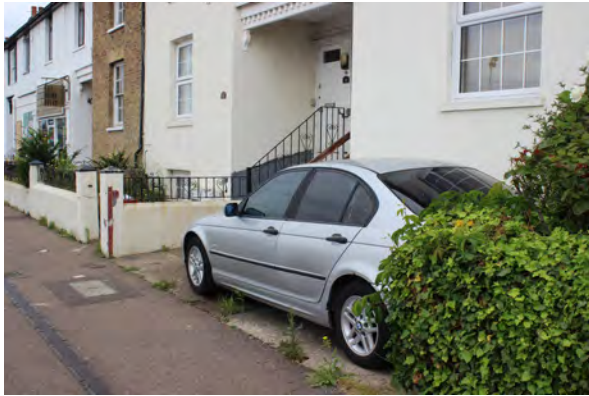
Front garden converted to parking with the loss of boundary treatment

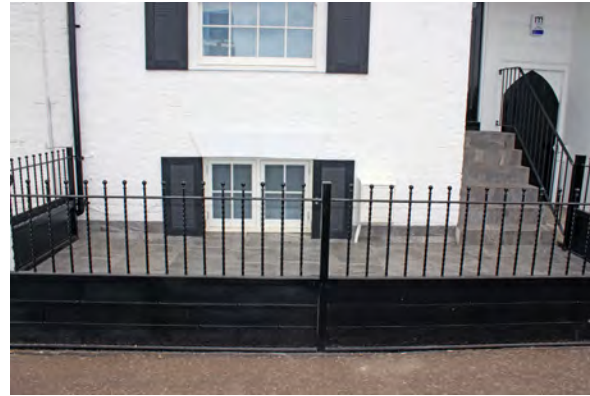
Paved over front garden reducing opportunities for the addition of greenery

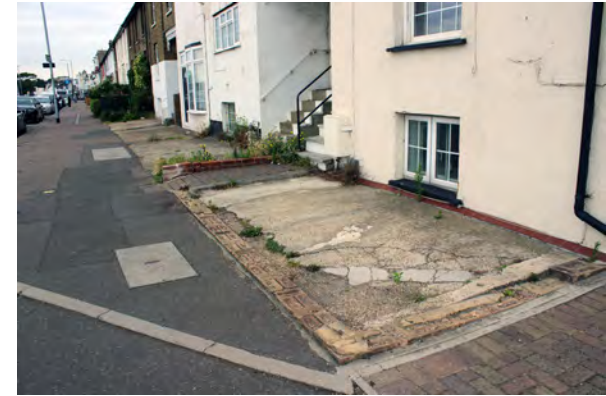
Front gardens converted to parking with the loss of boundary treatment

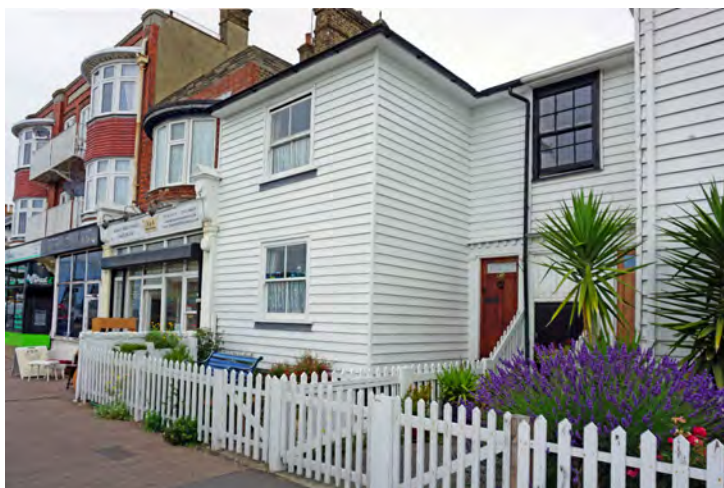
Address	Value	Designation
41 Eastern Esplanade	Positive	N/A

See list description. Mid-19th century. Mirror image to No.40. Two window range. Timber framed and weatherboarded two-storey house, painted white. Set back in centre to doorway with dentil cornice and window above. Timber door with glazed pane at the top, accessed up stone steps. Entrance door is stained and a painted finish would be more appropriate. Double hung timber sash windows, eight panes per sash. Slate roof. Appropriately slim profile rainwater goods, though painted white to blend in the weatherboarding. Cement rendered brick chimney shared with No.42. Cement render is an inappropriate and unattractive material. Front garden enclosed by picket fence with planting that has a positive impact on the building's setting. Rear boundary fence (not brick wall).

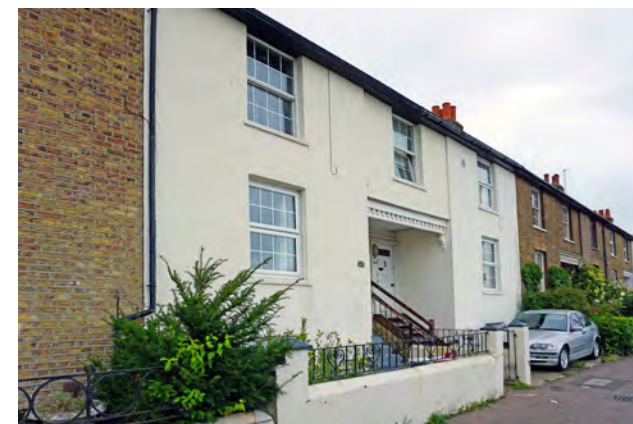
Address	Value	Designation
51A Eastern Esplanade	Positive*	N/A

Mid-19th century house converted into two flats. Two-storeys plus semi-basement. One window range. Originally yellow facing brick now rendered. Rendering of brickwork is inappropriate and would benefit from removal if possible without damaging the bricks, though this is unlikely so repainting in white would also be acceptable. Fire plaque ('Royal') on first floor wall. Doorway recessed on ground storey, under an open porch, with dentil detail cornice and scroll brackets. Timber door with leaded glazed pane at top, in an appropriate design though leading to the glazing in not in keeping, accessed up modern timber steps. Timber steps would benefit from replacement with stone. Timber sash windows replaced by uPVC sliding sash or top hung casements with stuck on 'glazing bars'. Basement window also uPVC. uPVC windows would all benefit from replacement with timber to match the originals. Slate roof with yellow brick chimney shared with No.52. Utility meter boxes to front elevation are unattractive. Boundary wall removed and garden concreted over, which is inappropriate. In use as parking space. This would benefit from reinstatement as a planted front garden with a boundary wall.

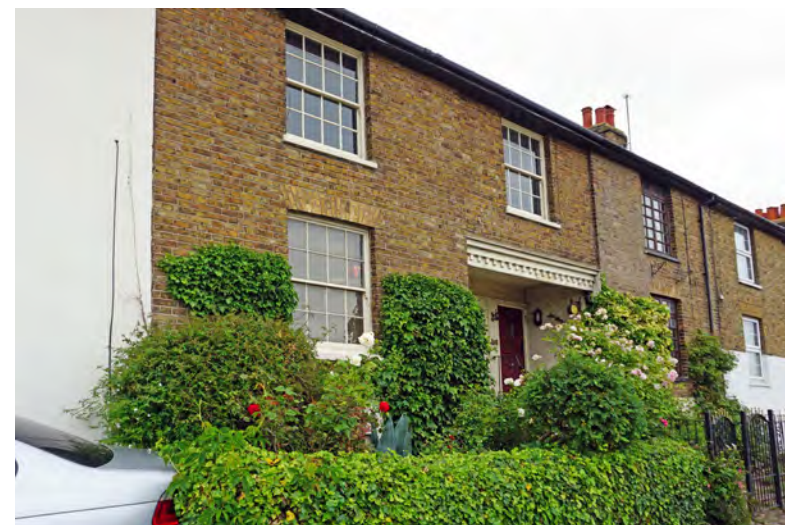
Address	Value	Designation
53 Eastern Esplanade	Positive*	N/A

Mid-19th century house. Two-storeys plus semi-basement. One window range. Yellow facing brick. Doorway recessed on ground storey, under an open porch, with dentil detail cornice and scroll brackets. Timber 'stable' door with central small window pane to top section, not entirely in keeping though better than a uPVC or panelled example, accessed up brick steps, which would benefit from replacement in stone. Sash windows replaced by inappropriate timber casement windows. Slate roof. Yellow brick chimney stack shared with No.54. Metal railings around front garden. Some planting adds character.
