Prittlewell Conservation Area Appraisal

Southend-on-Sea: Prittlewell Conservation Area Appraisal

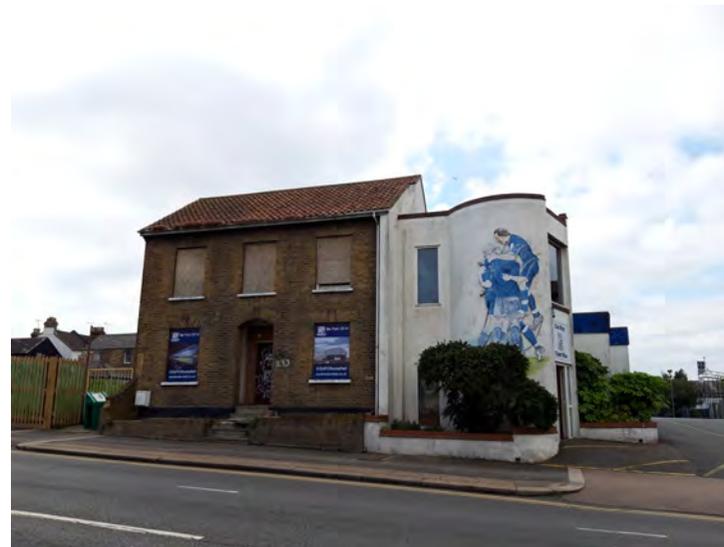
Vacant house on Victoria Avenue

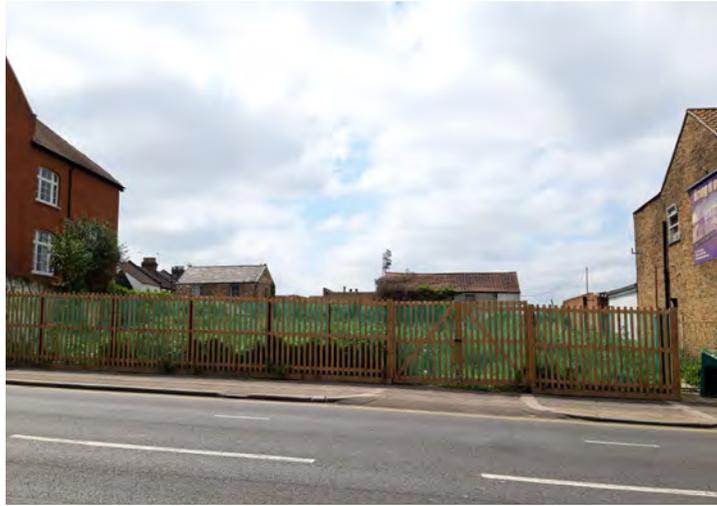
Vacant gap site where new development will need to be treated sympathetically to the characteristics of the Conservation Area

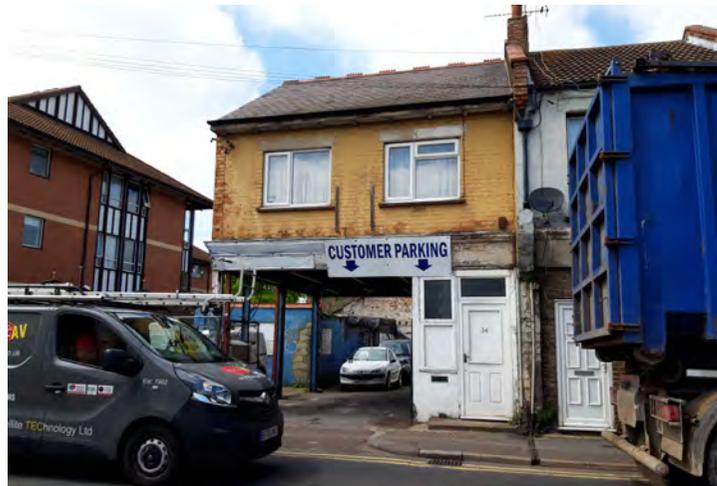
Substantial alterations to this former shop have seriously eroded its historic character

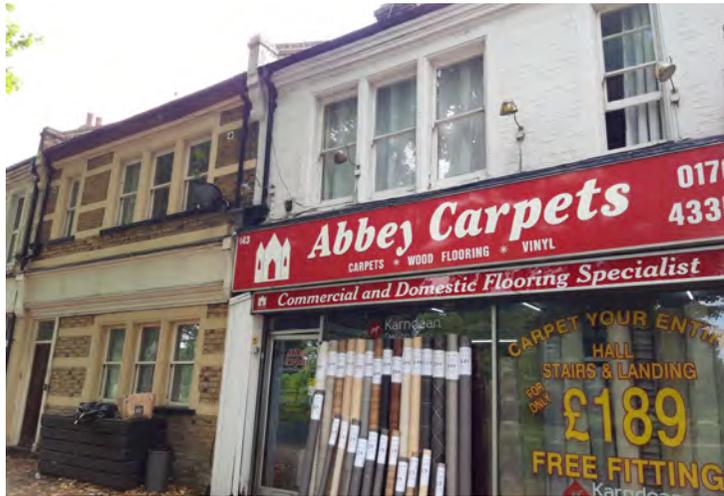
Oversized, garish signage and large area of glazing to a shop front inserted into a terraced house

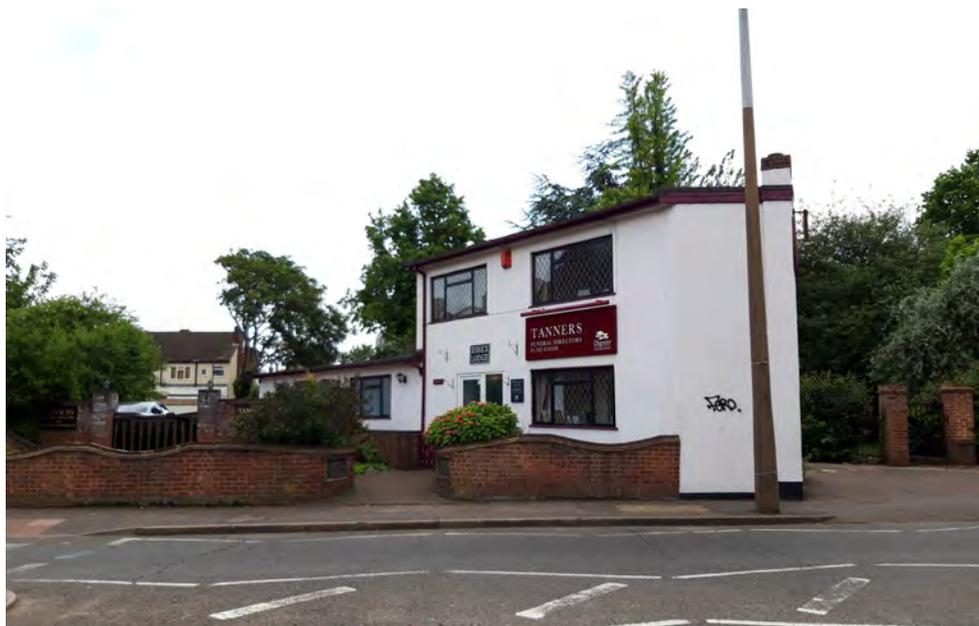
c.1850, original use not known. Now funeral directors. Site aligned diagonally from road, giving access in the 19th century to field at rear. Building flank is on street boundary. Much altered, two-storey, rendered, flat roof, metal framed leaded light windows. Garden to east side provides some good greenery on East Street, vehicular access to yard and garages at rear. Red brick boundary wall with scalloped coping contributes to the Conservation Area. Prominent in street scene.

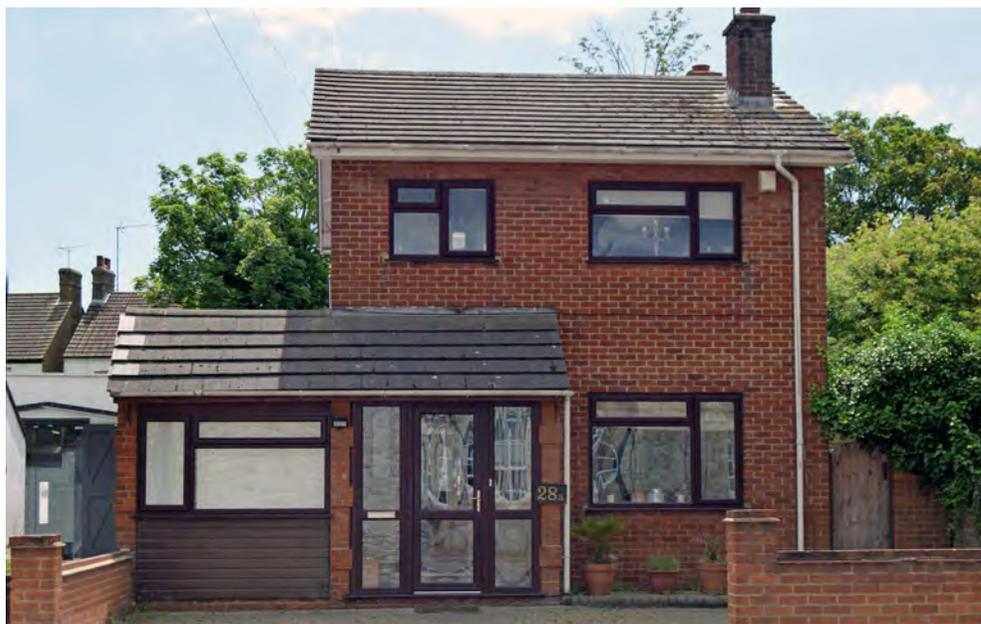
Small modern red brick two-storey house set back from road with a garden and low brick boundary wall. The front garden is predominantly hardstanding. Green landscaping to soften the driveway's appearance would contribute to the character of the Conservation Area.

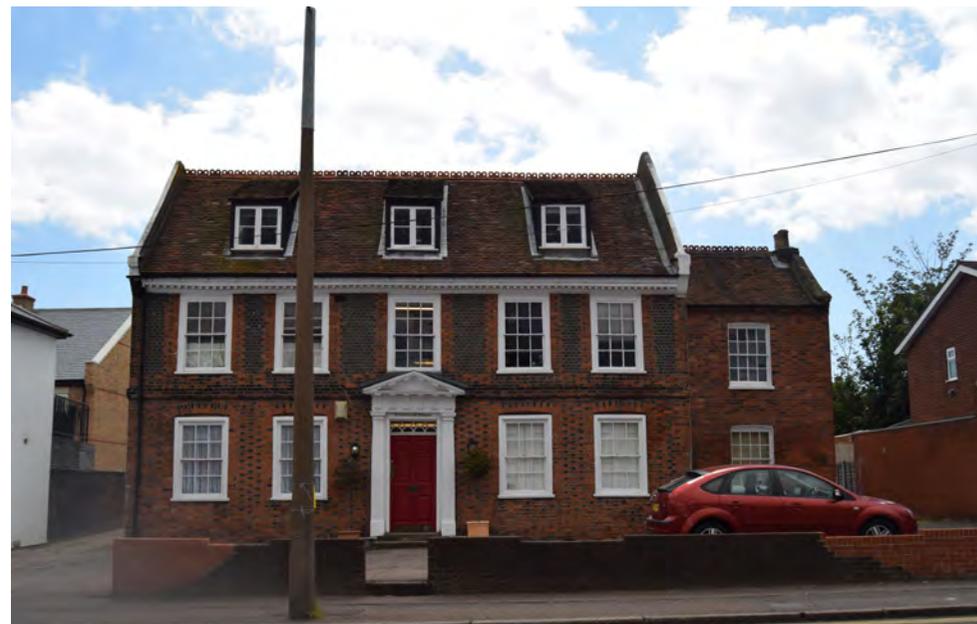
| Address | Value | Designation |
|---|---|---|
| 30 East Street | Positive | Grade II |

See list description for more details. An 18th century red and blue brick house, two-storeys with attic floor, with symmetrical five-bay frontage. Important historically and for townscape. Building set back from road behind low brick wall and tarmac parking area – unsightly. Would benefit from green soft landscaping to enhance the setting of the Listed Building and Conservation Area. The 20th century buildings to the rear are unsympathetic but are not prominent in townscape.

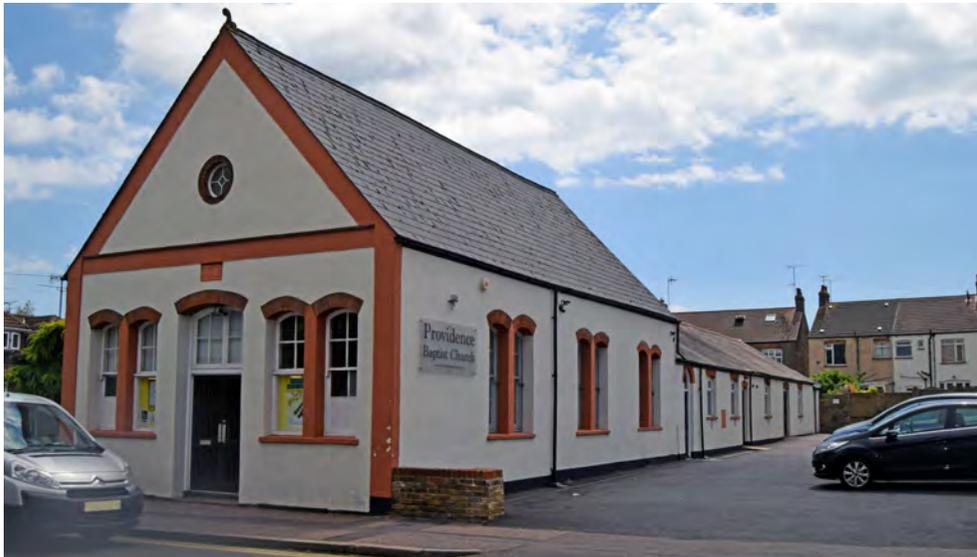
c.1854, single-storey chapel with gable end on street boundary, stock brick now rendered with red brick heads to openings. Timber sliding sash windows, long flank walls prominent. Artificial slates to roof, though natural slate would have been preferable and more sympathetic to the character of the Conservation Area. Car park to side, tarmac surface, with low walls to street frontage – scope for improvement with planting and enhanced use of permeable surface materials suitable to the Conservation Area. Modern door to front not sympathetic to age/style of building. Porthole window on front elevation.

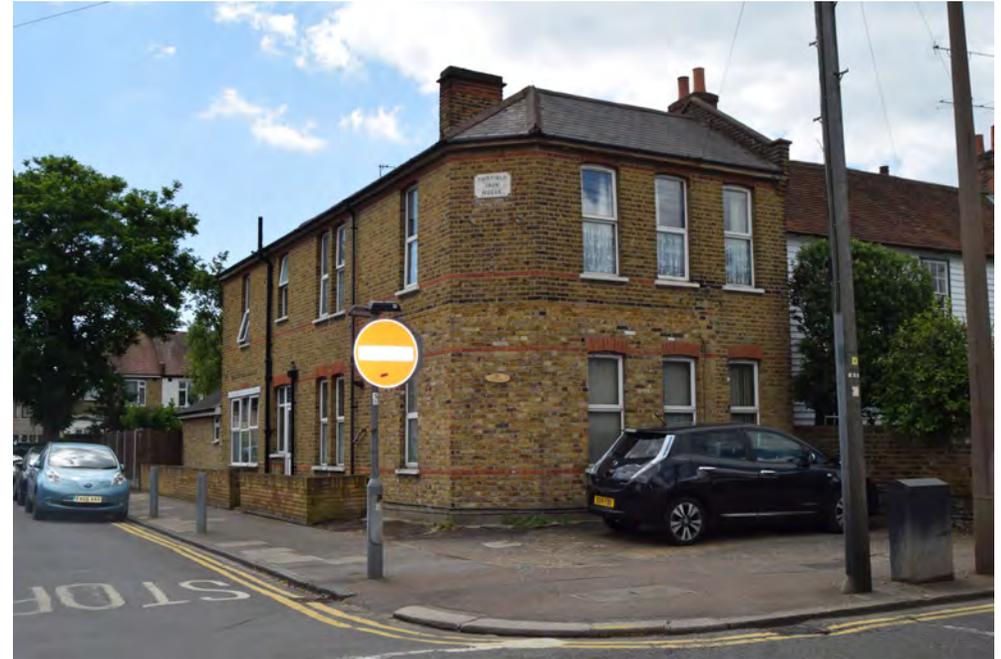
1926 'Tickfield House', slate roof, two-storey stock brick with red brick bands, uPVC windows (top hung) are unsympathetic in materials and form have eroded character. Tarmac forecourt open to East Street, electric car charging point installed, which would benefit from enhancement with soft landscaping and the reinstatement of a boundary enclosure. Date stone inset within front wall. Canted corner where brick differs slightly at ground floor – possibly a former shop front infilled at ground level in previous years. The brickwork is not a particularly good match but does include red brick details in character with the rest of the building.

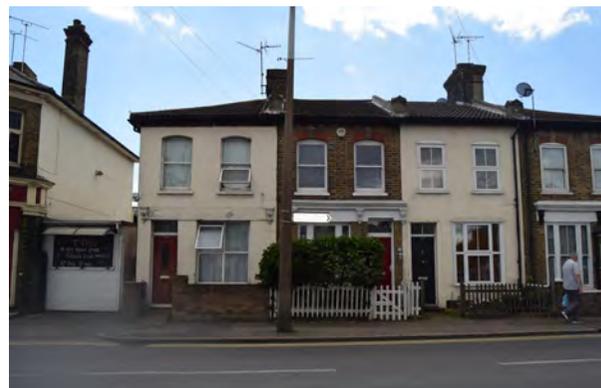
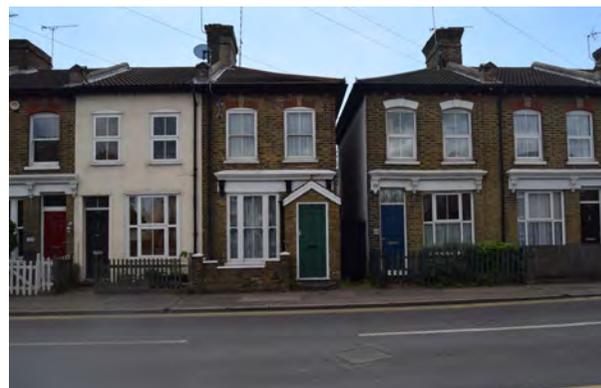
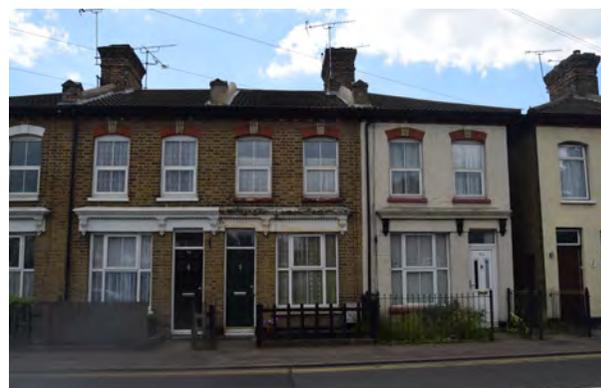
c.1880. Three groups of two-storey terraced houses close to street boundary. Originally, each terrace with mirrored frontage design, hip end slate roofs, stacks at each hip, stock brick with red brick band to eaves and to first floor window arches which have pale yellow brick keys. Originally timber sliding sash windows with central glazing bars, three-section sliding sash window to ground floor. Simple four panel timber door with fanlight. Pre-cast cornice with dentils and three brackets across frontage at first floor level. Unsympathetic alterations – concrete roof tiles (all), windows replaced with uPVC in a variety of opening types (Nos.90, 94, 96, 100 (inc. gd. fl. bow), No.102 (inc. gd. fl. bow), No.106), front doors all later replacements, some with uPVC and some in timber (the latter is preferable), porch with pitched roof added to the front of No.100, rendered front (No.84 (flank with return to front), Nos.90, 102), painted brick (Nos.92, 98 (to red brick arches)), cornice removed (Nos.90, 102, 106) and poor state of repair to Nos.94 and 84. Restoration needed. Varied front boundaries – uniform treatment would be beneficial.

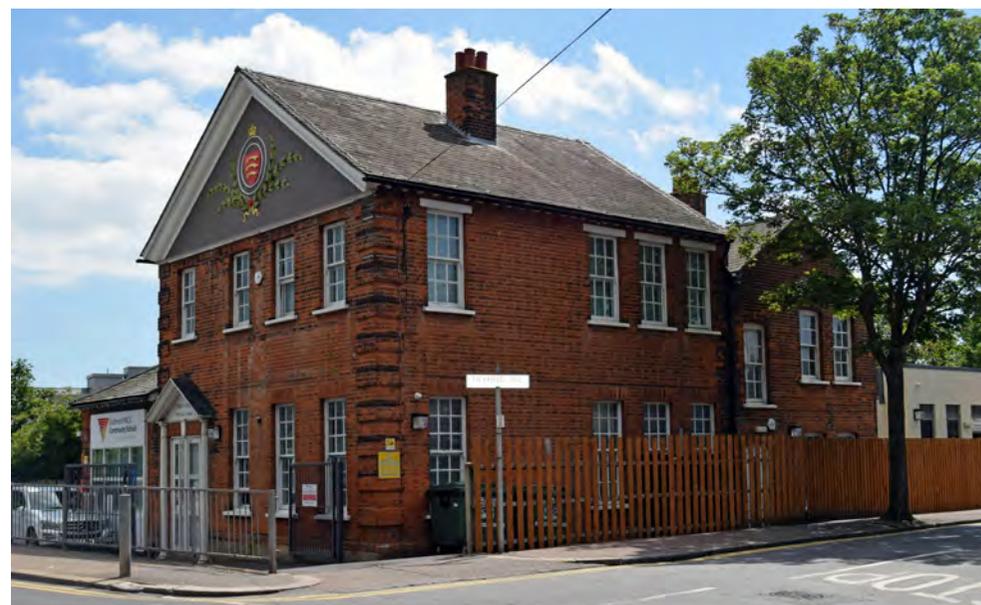
| Address | Value | Designation |
|---|---|---|
| 110 East Street 'Ticket House' | Positive* | N/A |

c.1911, former Territorial Army Drill Hall, now Southend YMCA Community School. Return frontage to Tickfield Ave. Two-storey with single-storey modern rear additions. Slate roofs. Main building – red brick, gable to front with projecting eaves, plaster(?) motif on gable, red brick quoins, altered door to front unsympathetic, modern windows and signage to ground floor front (single storey element of building) also unsympathetic, elsewhere windows timber sliding sash with brick soldier course over. Signage unsympathetic. Modern railings/timber fence – unsympathetic. Tarmac forecourt needs improvement.

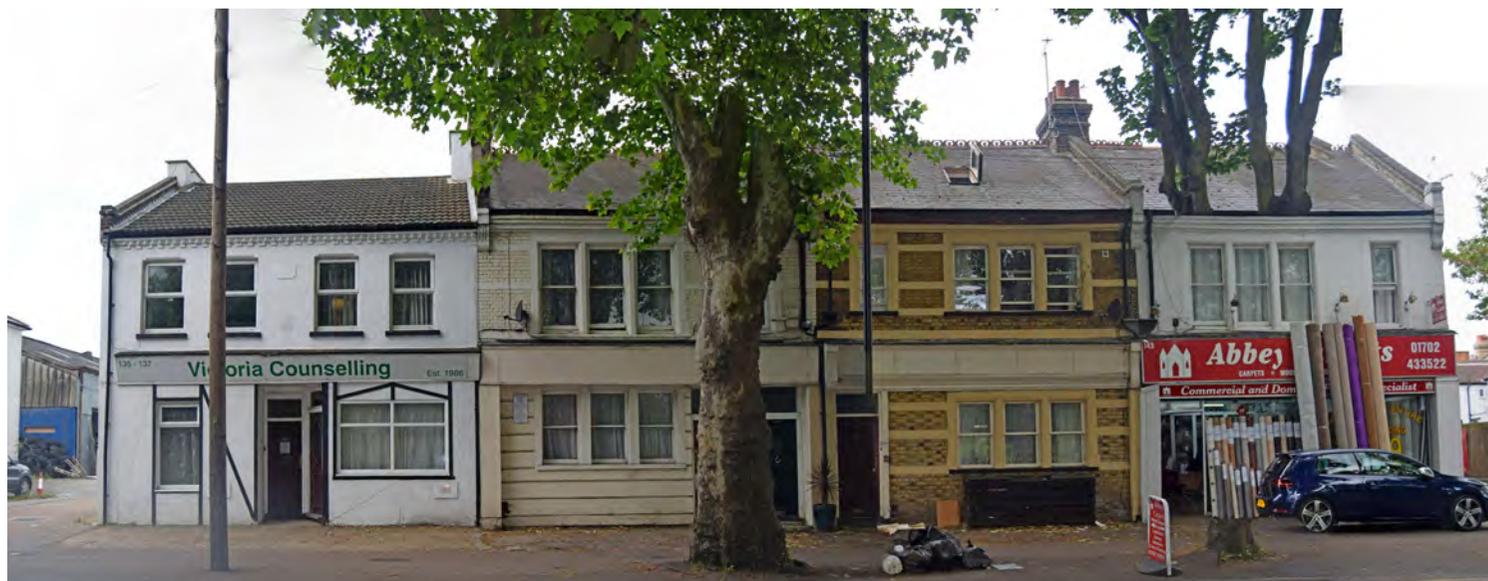
c.1900, originally four terraced houses, converted to shops/offices. 139–143 have slate roofs, red tiled decorative ridge, yellow brick with stone(?) bands and surrounds to openings, brickwork now mainly painted, which is unsympathetic. Where original materials and details survive, these are positive. Timber sliding sash windows to first floor of Nos.149 and 143, metal(?) frames sashes to No.141 in correct form but unsympathetic material. Modern timber sash windows to ground floors of Nos.139 and 141. No.139 has inappropriate stone mouldings/cladding applied over brickwork to ground floor. No.143 painted brick and with a poorly designed modern shopfront. Some fascia brackets remain. Nos.135–137 has different design, now rendered and with inappropriate applied timbers, poor design to ground floor office. In need of restoration.

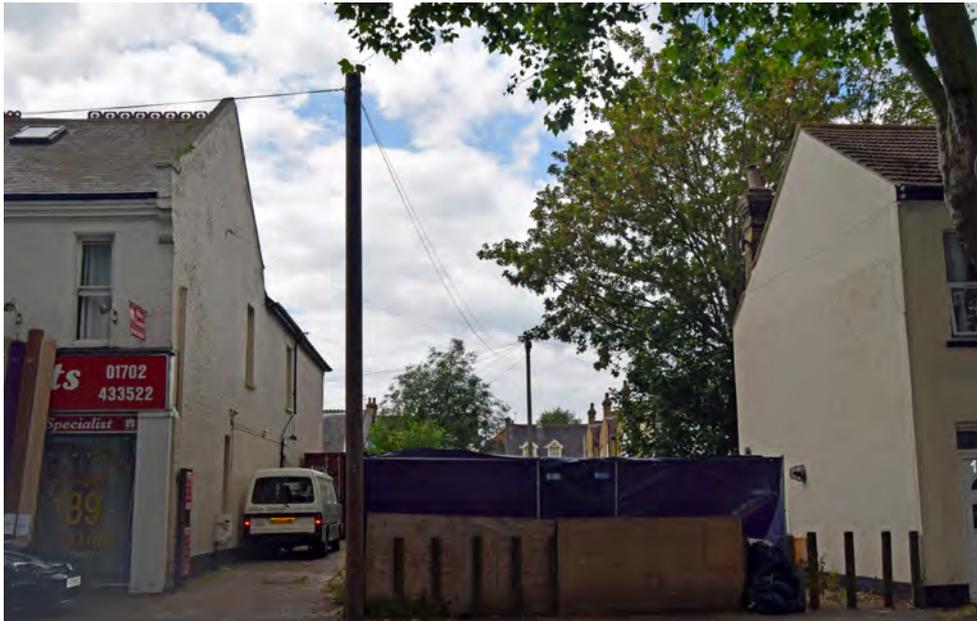
Unused open site, overgrown with vegetation and used as a dumping area. In need of landscaping or sympathetic development.

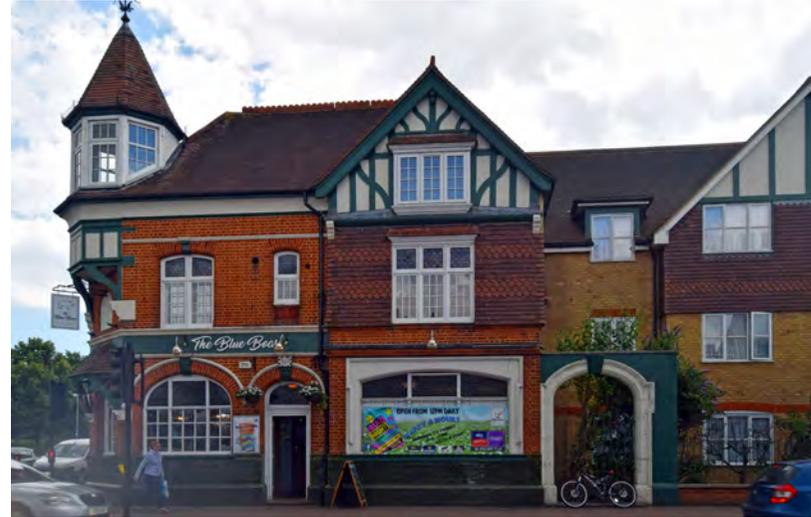
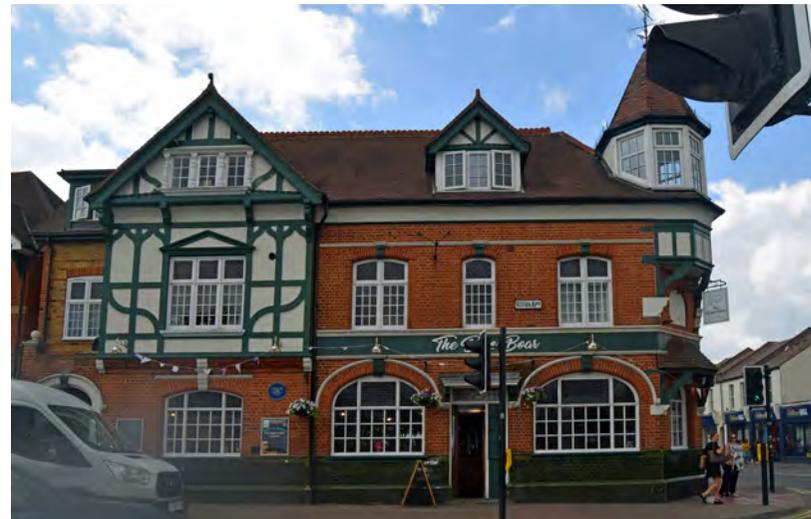
c.1899, Arts & Crafts design – red brick, with glazed tiles to ground floor, plane tiled roof with decorative ridge and corner turret. Ground and first floors – timber casement windows with arched heads and small panes to upper lights. Attic floor – windows replaced with unsympathetic uPVC, though would benefit from replacement of unsympathetic uPVC windows. Its corner position makes it an important townscape feature.

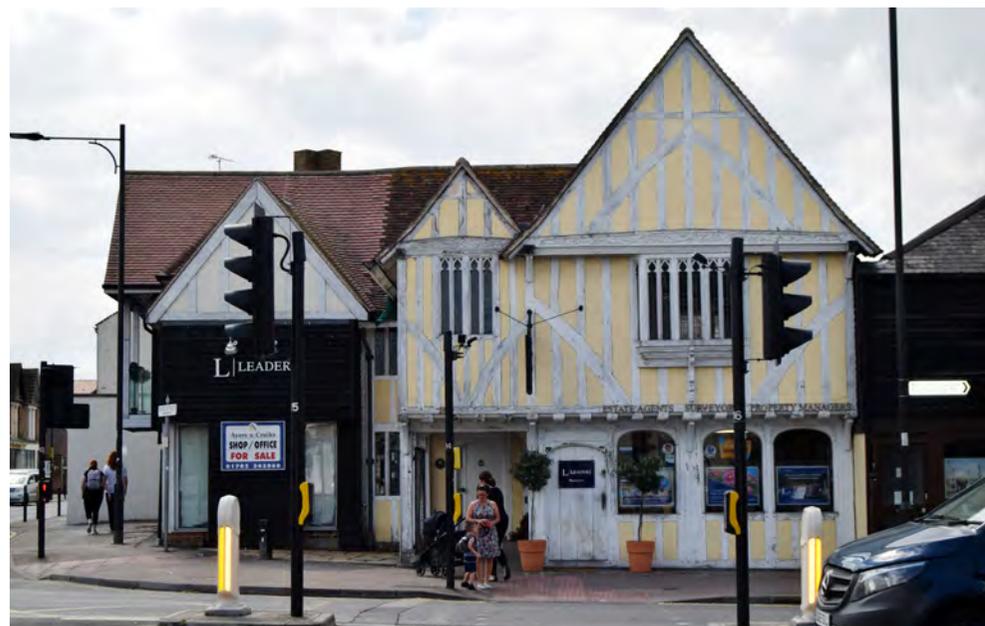
See list description for more details. Mid-15th century hall house. Timber framed. Repaired and restored c.2004, now occupied by estate agent. Crucial to Prittlewell's townscape and character. Attached to south side is two-storey mock-timber framed building, with weather boarded sections and gables. Generally sympathetic but vacant shop to extension at the time of survey (2019). The cluttered street furniture on the junction adjacent provides a poor setting for this important listed building.

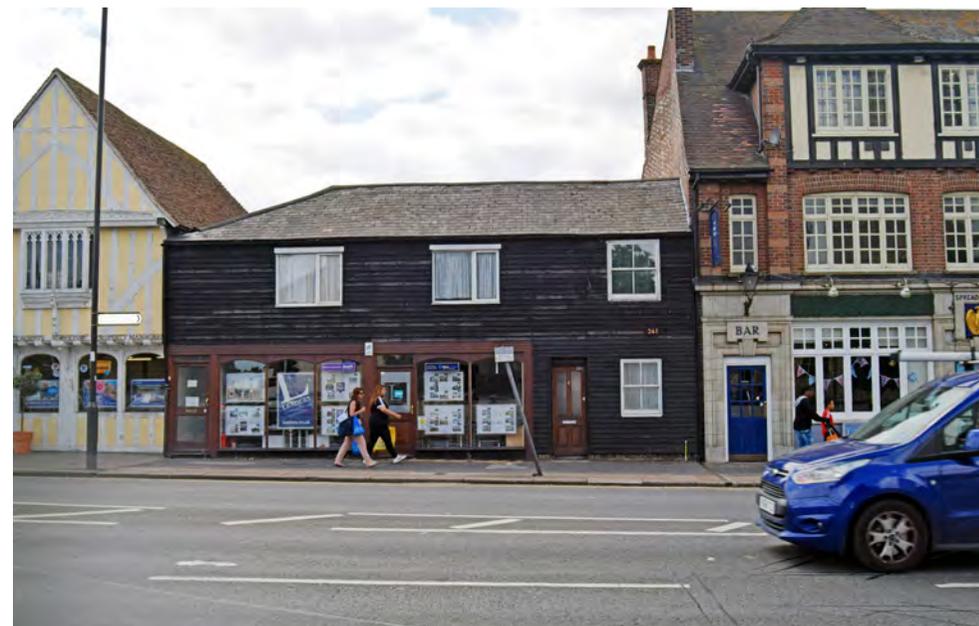
| Address | Value | Designation |
|---|---|---|
| 257–261 Victoria Avenue | Positive* | N/A |

Early to mid-19th century. Originally three cottages (historic photographs show rendered walls), slate roof with hip to south end. Now converted to single office to ground floor and flat over with substantial alterations. Weatherboarding to ground and first floor and casement windows in enlarged openings to first floor are inappropriate. Windows would benefit from replacement with timber sashes. Ground floor has simple shop windows, which are not inappropriate but the brown staining to the timber is not particularly in-keeping and would benefit from painting. Occupied by estate agents.

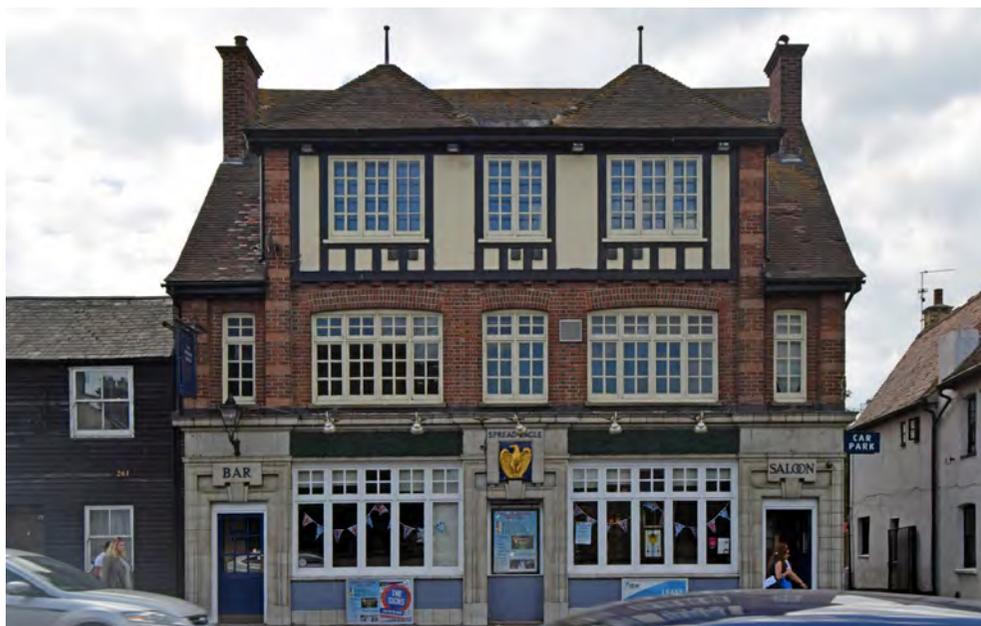
c.1910 (?), replaced previous PH. Substantial three-storey PH, symmetrical frontage with dominant triple dormer. Generally Arts & Crafts style but with Art Deco motifs to ground floor. Steep plain tiled roof, stacks to flanks, finials to hipped dormers, red brick frontage with creasing tiles to brick pilasters, faience to ground floor. Timber casements and fanlights. Side access to rear garden. Busy road is a poor setting for the building.

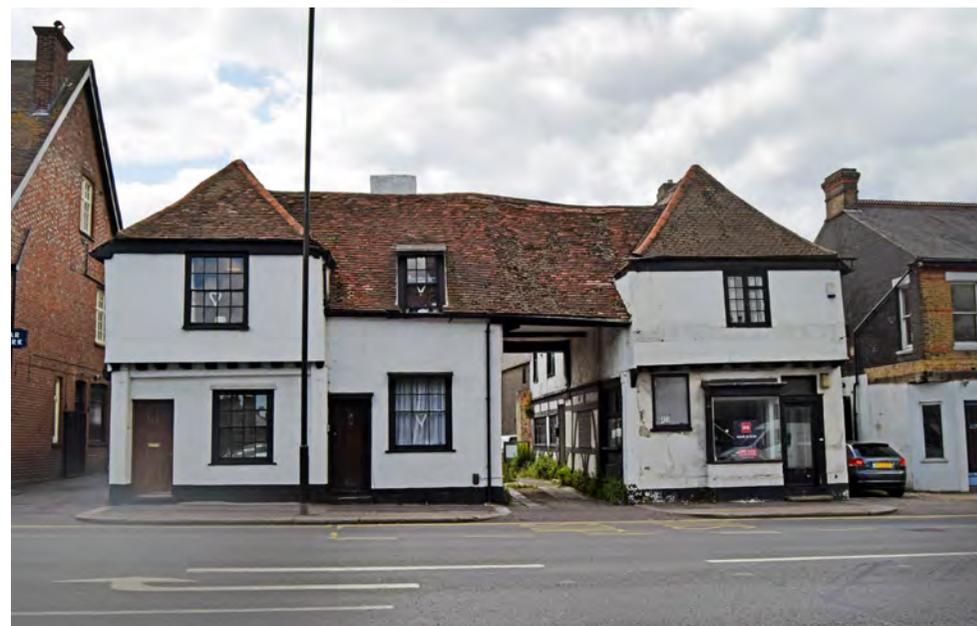
| Address | Value | Designation |
|---|---|---|
| 269–275 Victoria Avenue | Positive* | Grade II |

See list description (Appendix A) for more details. A 16th century timber framed two-storey building. Originally a single hall house with medieval shop. Now subdivided into two residential units and office. Central vehicular access to rear buildings through original hall. Peg tiled roof patched with plane cement tiles. Stacks truncated. Unsympathetic treatment of elevations and soffit to vehicular access. Important in townscape opposite church. No.275 retail unit currently vacant. In need of general repairs and restoration. Busy road is a poor setting for the building.

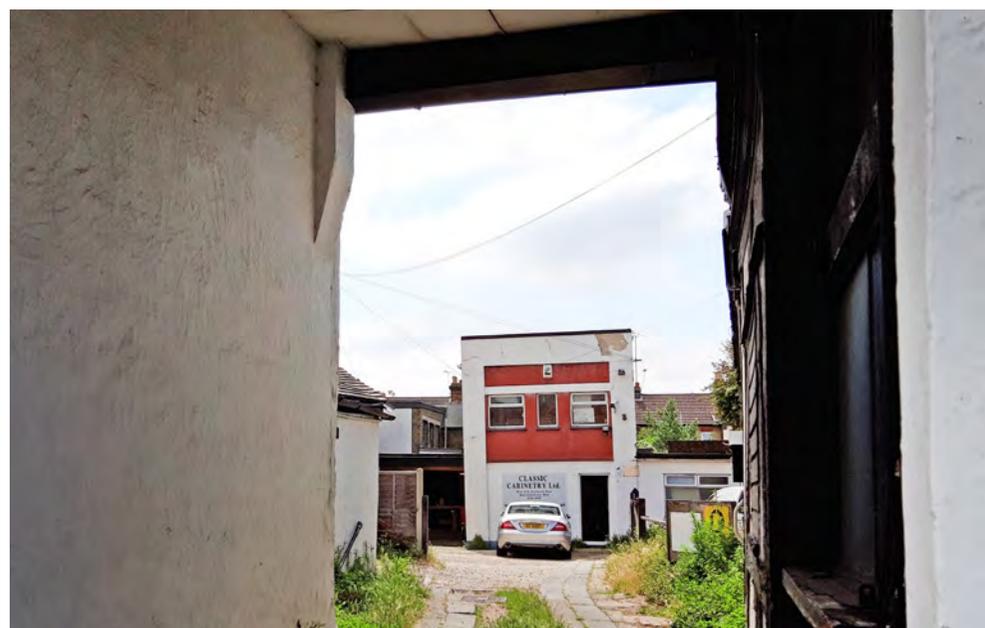
Early 20th century buildings substantially altered and unsympathetic to neighbouring buildings. This backland site has the potential for sensitive regeneration which respects the setting of the Listed Building.

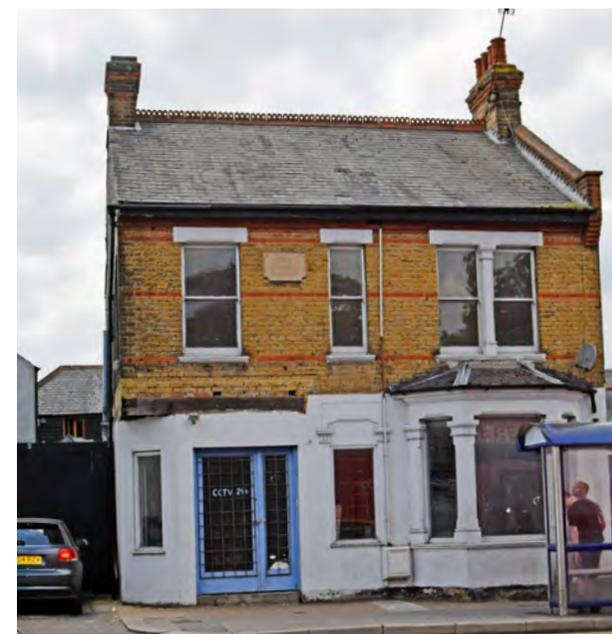
| Address | Value | Designation |
|---|---|---|
| 277–279 Victoria Avenue | Positive* | N/A |

c.1902, originally a house, now with vacant shop to part of ground floor, which has involved an unsympathetic alteration of the façade with the removal of the former bay window which would benefit from reinstatement. Slate roof with decorated red ridge tiles. Stock brick with red brick bands. South flank black paint. Ground floor rendered, door (modern), bay window to ground floor. Timber sliding sash windows (possibly original) to first floor, fixed casements to ground floor windows. Part of the brickwork above the shop entrance in is poor condition. Bus shelter adjacent provides a poor setting for the building.

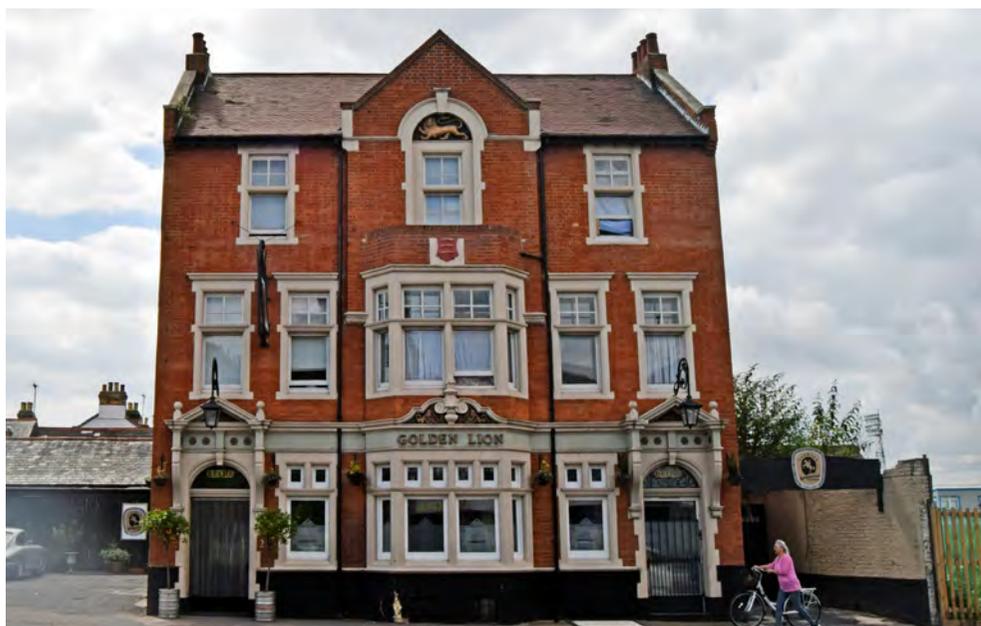
c.1910 (?), three-storey, symmetrical frontage. Typical Edwardian design. Plane tiled roof, truncated stacks, red brick, painted stone surrounds to openings, central two-storey bay with balcony and parapet. Timber sash windows to upper floors, casement windows and fanlights to lower floors. Closes view from St. Mary's Road. Rear area formerly a pub garden, plus residential unit. Car park to side – formed on a demolition site and creates an unsympathetic frontage gap.

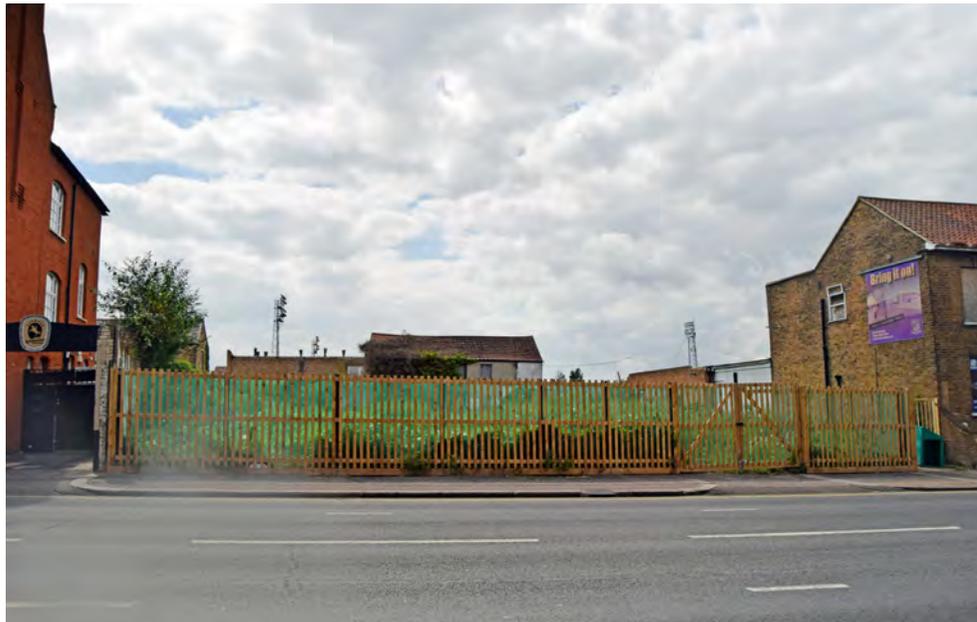
| Address | Value | Designation |
|---|---|---|
| Rear of 287 Victoria Avenue | Positive* | N/A |

Stables to rear c.1890 – two-storey, much altered, vacant and inaccessible but with potential for contributing to area’s character – in need of restoration.

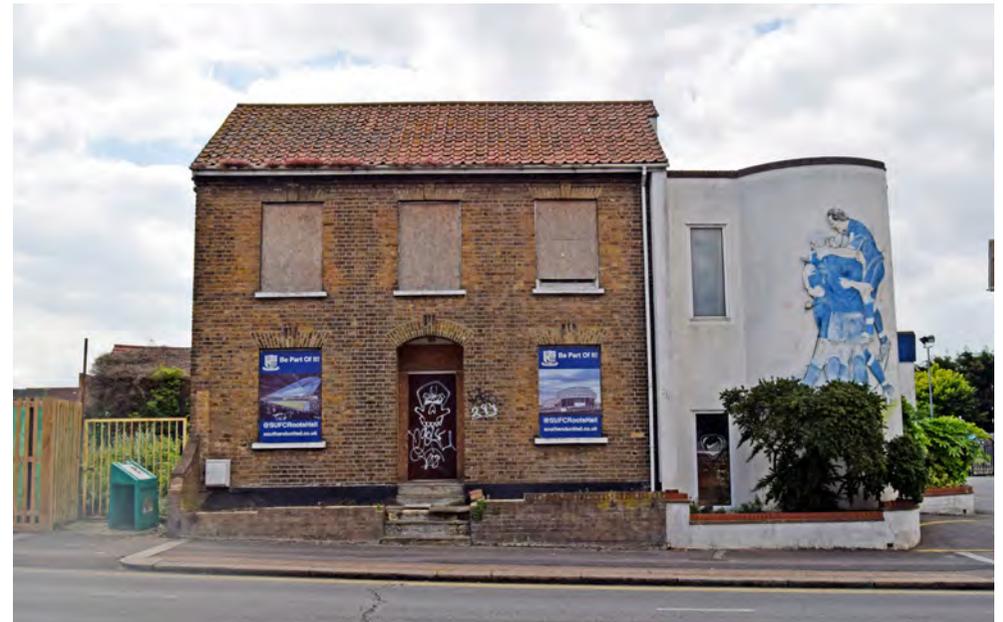
| Address | Value | Designation |
|---|---|---|
| 299 Victoria Avenue | Positive* | N/A |

c.1900, two-storey double fronted house, originally attached to house to north which is now demolished. Property is boarded up and has suffered vandalism. Clay pantile roof, yellow brick, windows not visible due to boarding, recessed entrance. Unsympathetic treatment of front ‘garden’ area and north flank wall. In need of enhancement through a viable new use that restores timber windows and door, reinstates boundary wall and front garden and brings the building back into good condition.

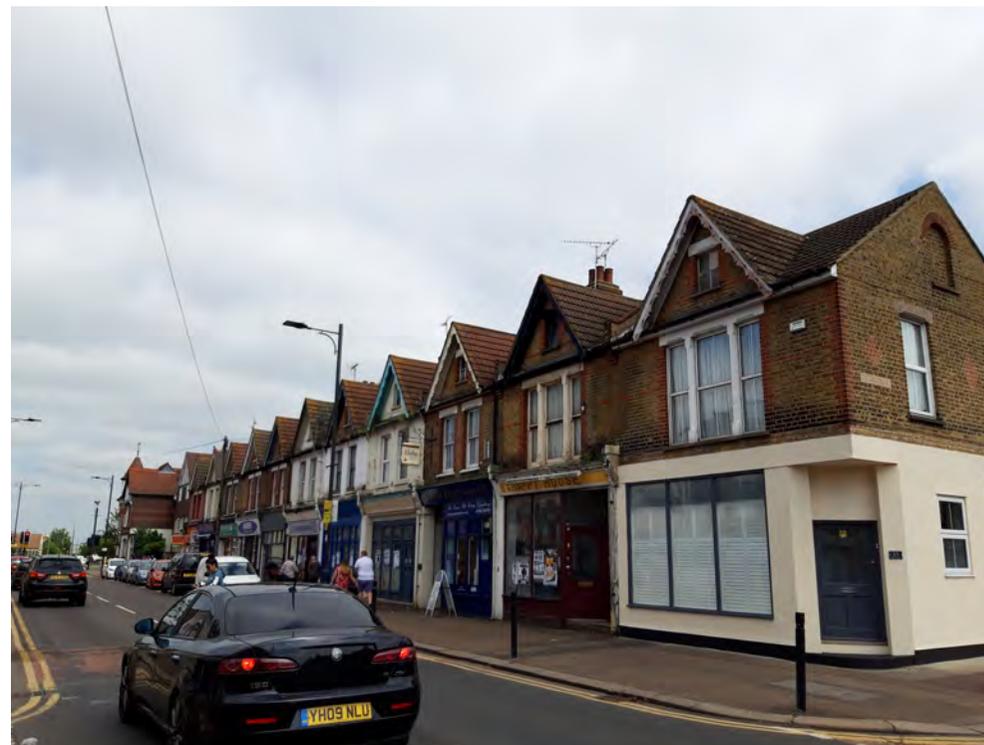
c.1901. A terrace of purpose-built shops and flats over. Originally with slate roofs, stacks to alternate party walls, gables to the front with small casement window, stock brick with red brick detailing and window arches, sliding sash windows to 1st floor and shopfronts with recessed canted entrances, panelled doors and fascias between fascia scrolls. Nos.21 and 23 have slightly different design with triple sash windows to first floor. Some shopfronts are altered and unsympathetic to the original design. Those that retain corbels, modestly sized fascias, timber framed shop windows with stall risers and doors to the side, are positive, though many would benefit from improvement of condition. Other inappropriate alterations: No.3 – painted brick and casement/louvre windows; No.5 – painted brick (though retains original sash windows); Nos.7 and 9 – uPVC windows to first floor; No.13 – painted brick and uPVC windows; No.15 – rendered to first floor and uPVC windows; No.21 – window in dormer replaced; No.23 – uPVC windows (out of proportion on west flank) and unsympathetic conversion of ground floor to residential use, with the loss of the shop front and the infilling of the shop window. Restoration of original features needed. The buildings all require general maintenance and refurbishment and continuity of shop frontages as they detract from the street scene.

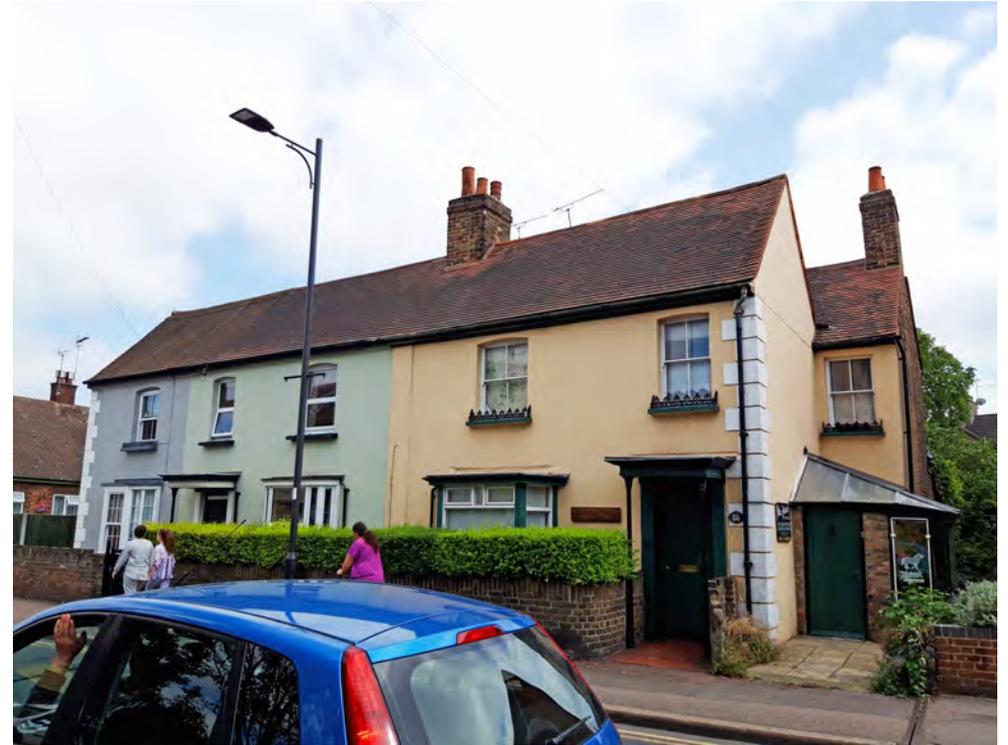
| Address | Value | Designation |
|---|--|---|
| 37–41 West Street | Positive – though would benefit from replacement of uPVC windows with timber | Locally listed building |

Late 18th century. Three cottages, double range with plane tiled roofs. Brick built and rendered with corner quoins, ground floor bay, entrances on front on Nos.39 and 41 with canopies supported on iron columns, No.37 has side entrance. No.37 has uPVC windows, sash style but not slimline to bay. No.39 has uPVC top hung casement windows. No.41 has timber sash windows to first floor, with replacement timber windows to bay. Mix of sliding sash windows – three with central glazing bar, another in Georgian style, the remainder are uPVC. Originally curved glazing to side of bays and small panes (now altered). Mid-20th century boundary wall to street.

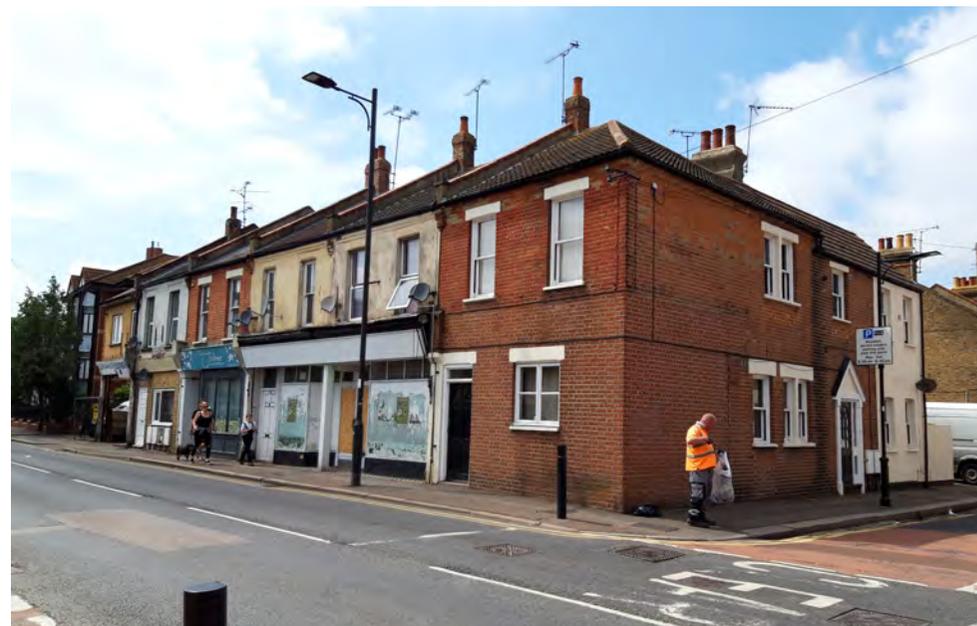
c.1900. Two-storey terrace of shops and flats over. Originally with slate roof, red brick, precast lintels and sliding sash windows to first floor. Much altered: No.24 ground floor converted to flat – windows and door poorly designed – concrete tiled roof; Nos.26–28 concrete tiled roof, rendered, altered windows (No.26 uPVC, No.28 modern timber sashes), continuous fascia across shopfront; No.30 modern timber shopfront sympathetically designed, fascia between brackets; No.32 rendered, concrete tiles, metal windows, shop front bricked in and domestic door and window added, four meter boxes and two satellite dishes; No.34 open ground floor car sales, first floor supported on section of flank wall. uPVC windows in widened openings, painted brick to first floor, modern door and adjacent window, advertisement on flank wall. Most shops are closed and street scene is undesirable (though No.30 has been sympathetically renovated). No.32 has several broken gas meter cupboards across front façade and is generally in a poor state of repair. No.26–28 also in poor state of repair.
