Leigh Cliff Conservation Area Appraisal

Southend-on-Sea: Leigh Cliff Conservation Area Appraisal

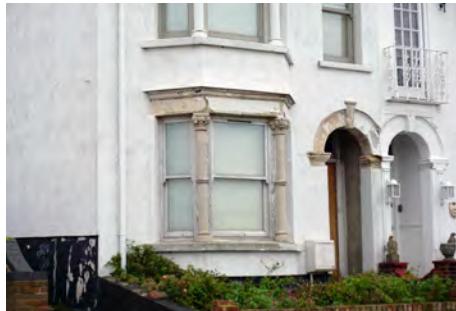
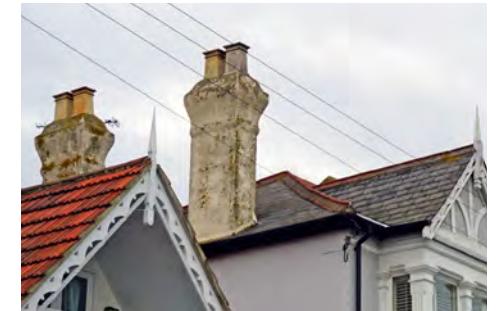
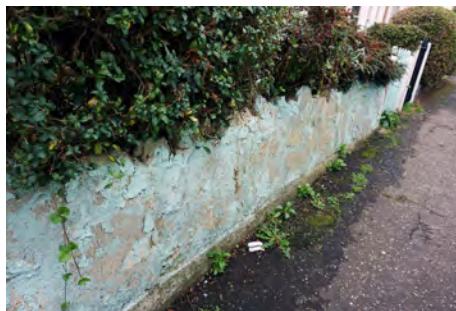
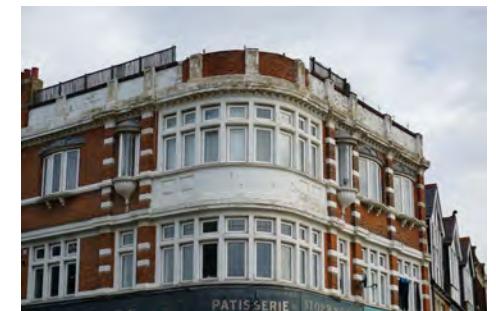
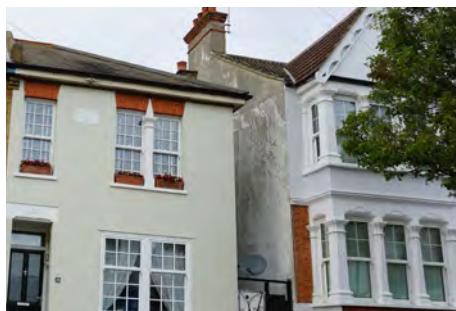
6.3.1 The condition of buildings within the Conservation Area is generally good, with many houses well-presented. However, there are some which are in poor decorative condition, with unsightly peeling paintwork. This issue relates to a few houses within the residential streets on side elevations, decorative features and chimneys, as well as on paintwork to upper floors of shops on Broadway. Some pathways within front gardens are cracked and uneven, and a few boundary walls also have peeling paint.

Examples of Poor Decorative Condition

- 6.3.2 Keeping buildings in good condition will ensure the area is an attractive and desirable place to live and work.
- 6.3.3 Undertake regular maintenance and checks to prevent problems from occurring and to protect original features. This will also ensure that small problems do not become bigger, more costly issues to fix.
- 6.3.4 Follow guidance in section 6.4 to ensure repairs and alterations are carried out in an appropriate manner.

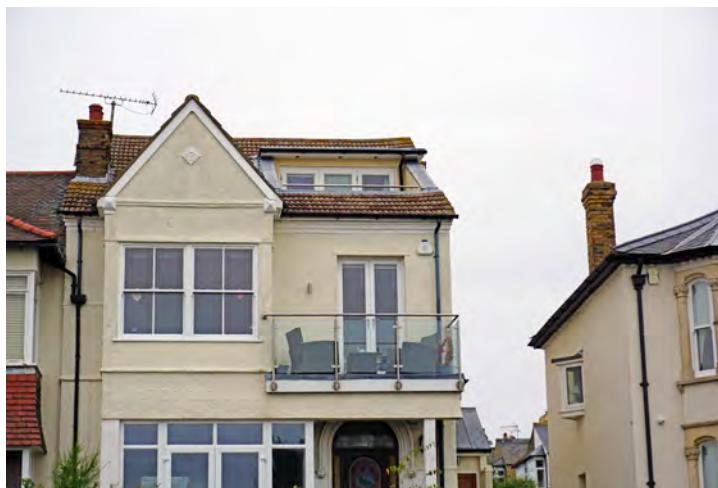
Glazed balustrade to balcony

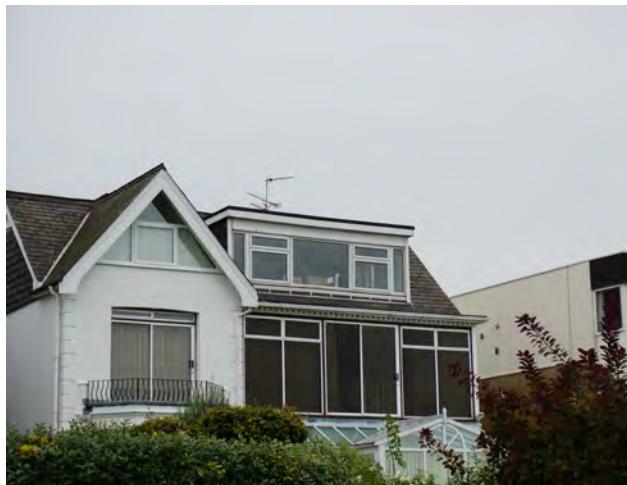
Inserted large dormer and picture windows

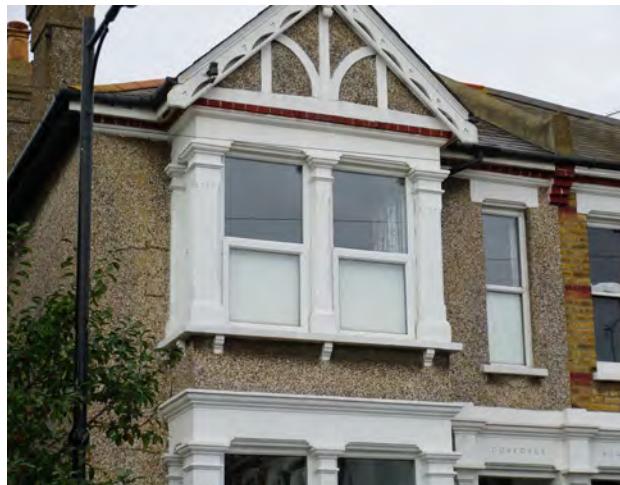
Inappropriate pebbledash render and uPVC windows

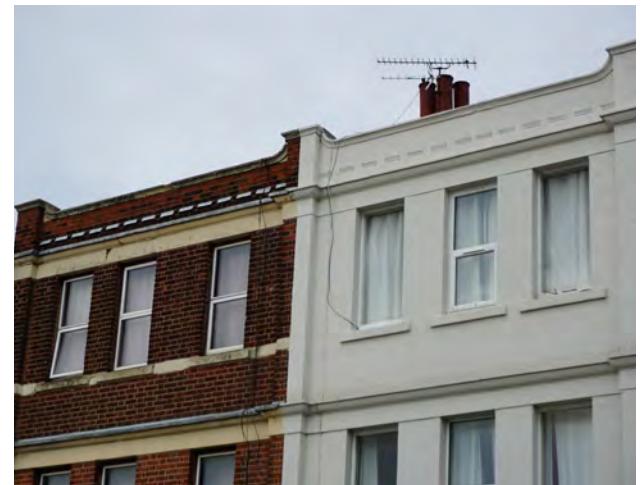
uPVC windows on upper floors of shops

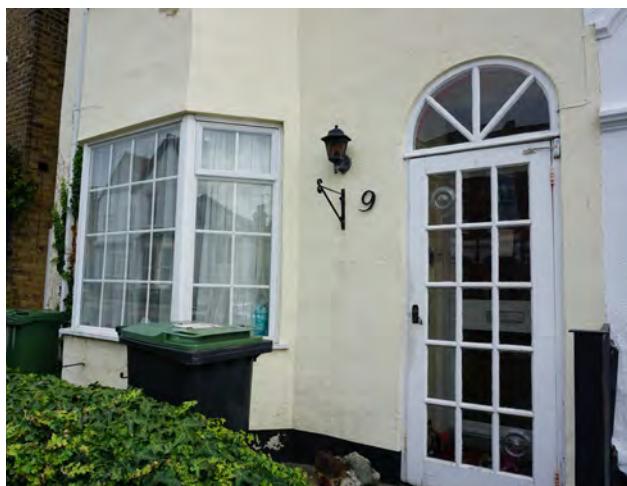
Infilling of porch with door that has an overemphasis on glazing and uPVC windows with top hung casements and the loss of stone mullions to the bay

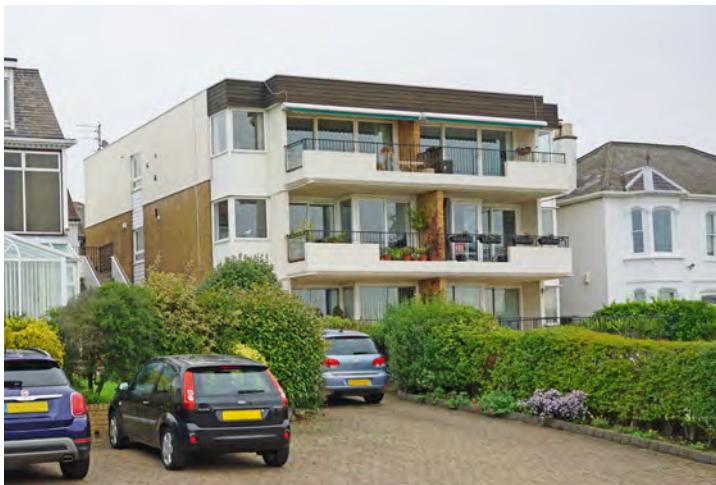
Block of flats on Cliff Parade

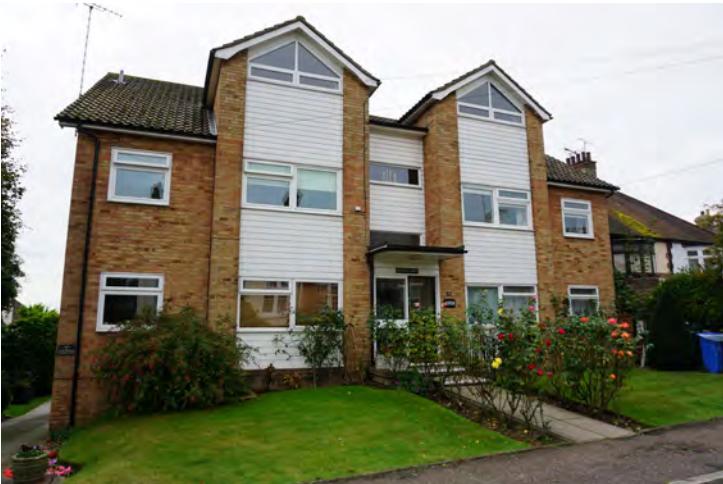
Queens Court on Queens Road

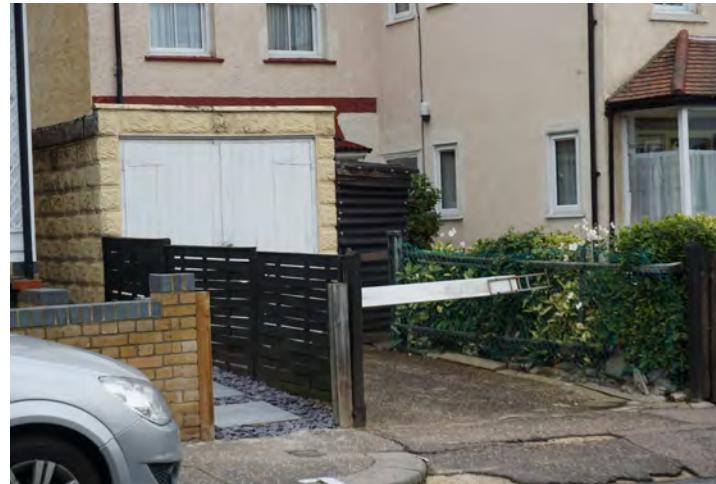
Poor quality garage

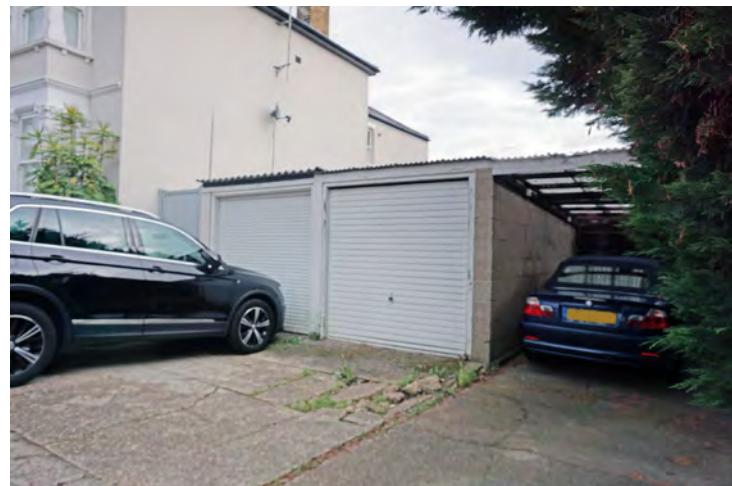
Bland garages

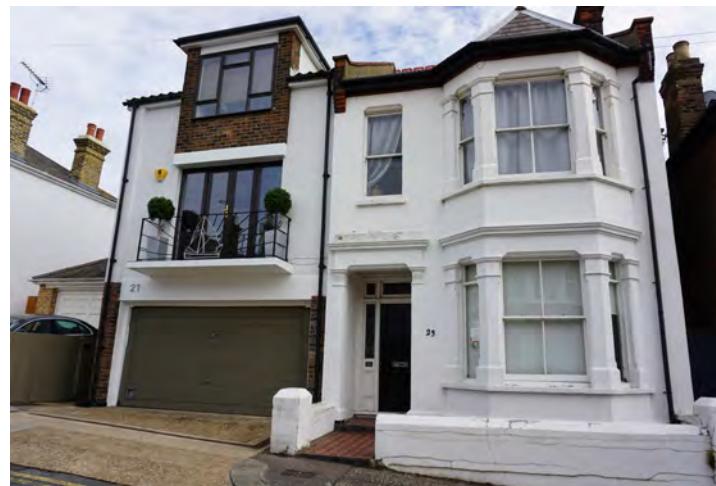
New property to left with ground floor garage

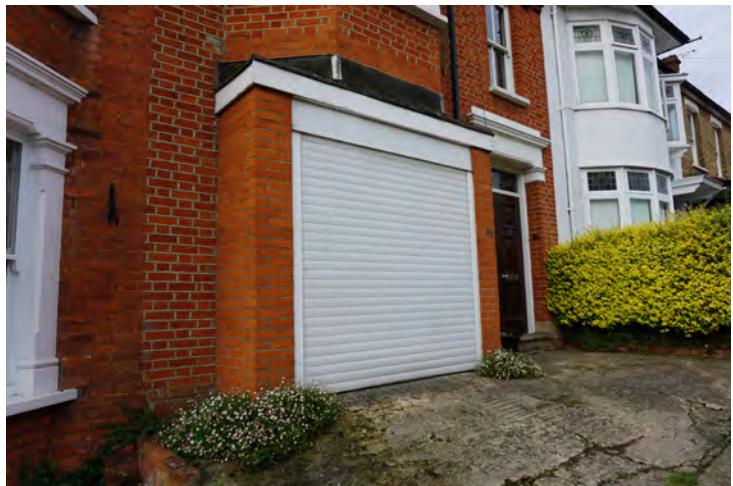
Ground floor garage inserted pre-1983 in the position of an original bay window

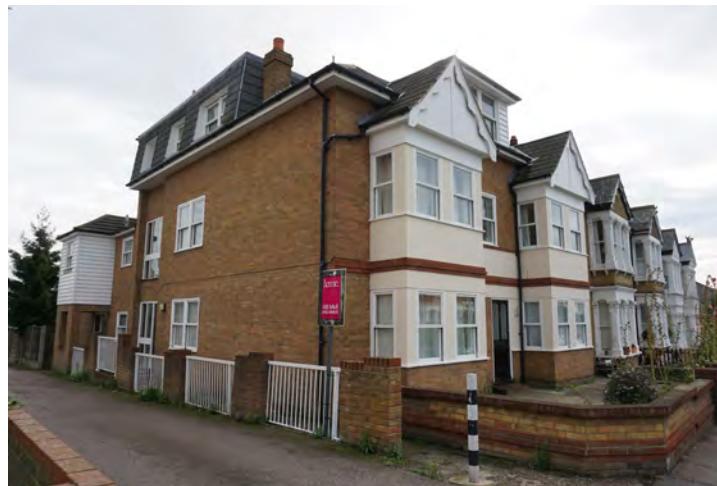
Modern houses which make an attempt at replicating the form of the houses around them, though are inferior in design to the original houses and have boxy mansard roofs to the rear

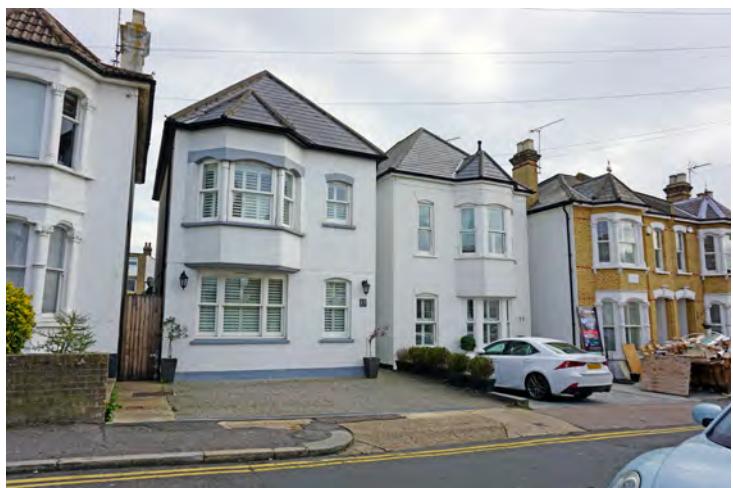
New houses with designs that more successfully integrate into the Conservation Area, though proportions are inferior to the historic houses and parking is poor

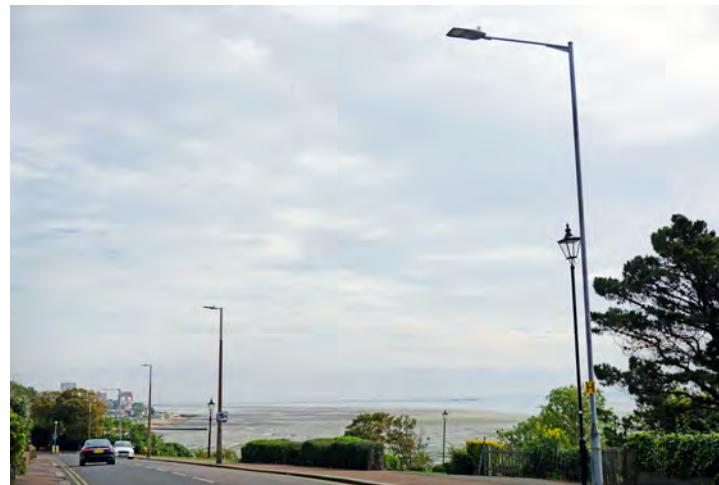
- 6.3.24 Streetlights on Cliff Parade are tall and out of character with the domestic nature of much of the Area, such as those made of concrete. When they become due for renewal in the future, replacements of reduced height and improved design should be installed. Ones of a traditional design on Broadway are examples of successful replacements in a design appropriate to the Conservation Area. At the edge of Cliff Gardens, there is a streetlamp with a cast iron standard on which a Victorian style lantern has been mounted. This is much more successful than using the utilitarian lanterns that have been used elsewhere in the Conservation Area and could be more widely imitated.

Tall modern lampposts in concrete or silver coloured metal, compared with a black lamppost in a traditional style and much shorter height, on Cliff Parade

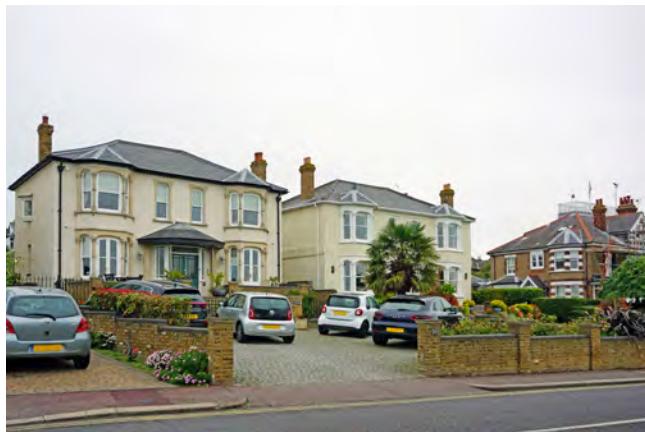
Large hard landscaping area for cars, though the retention of part of the boundary wall and planting is good

- 6.3.38 Retain and maintain the trees, planting and green spaces within the Conservation Area.
- 6.3.39 Front gardens without greenery or landscaping would benefit from their introduction.
- 6.3.40 Review the possibility of further street tree planting within the Conservation Area.
- 6.3.41 Take opportunities to reinstate boundary enclosures to front gardens. Low brick walls topped with railings are generally the most appropriate boundary treatment.
- 6.3.42 Enhance the quality of front gardens by removing insensitive hardstanding.
- 6.3.43 Where off-street parking is permitted in front gardens, boundary treatments should be partly retained and planting should be used to enhance the areas.

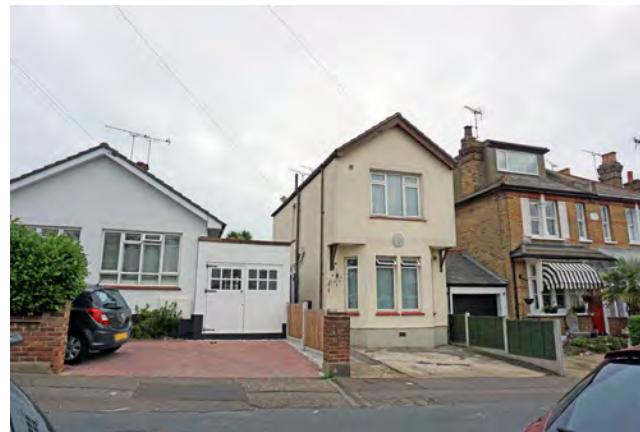
Driveways converted from front gardens, with poor surfacing and lacking planting

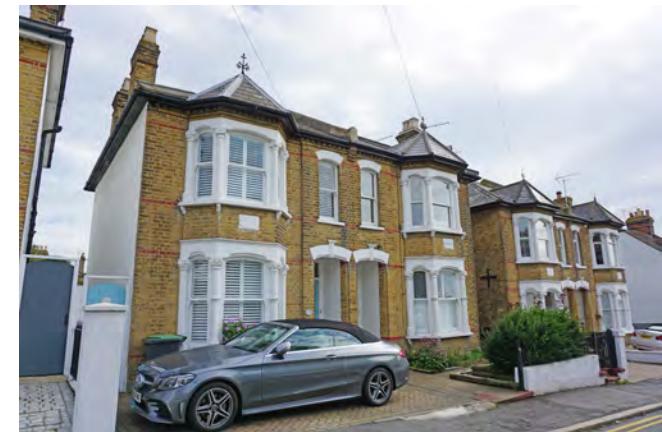
Parking bay to the front of a house

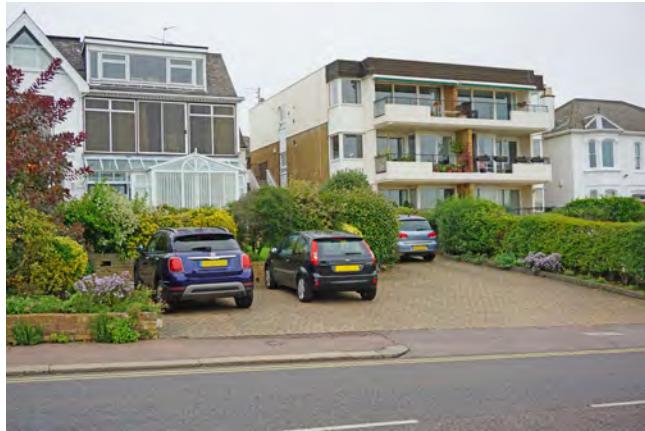
Removal of the boundary wall for large area of hard landscaping disrupts the continuity of the boundary line along the street

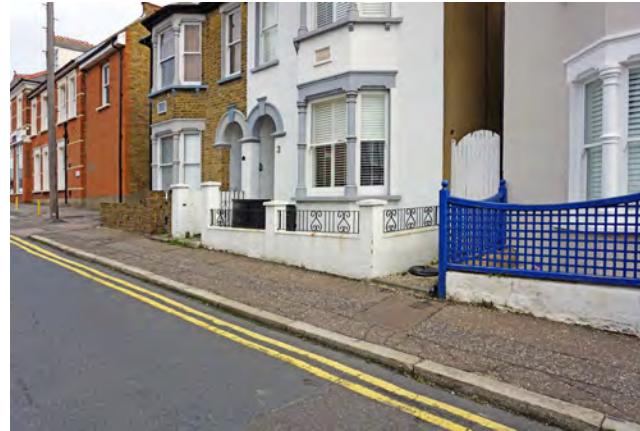
Lack of consistency in boundary treatments

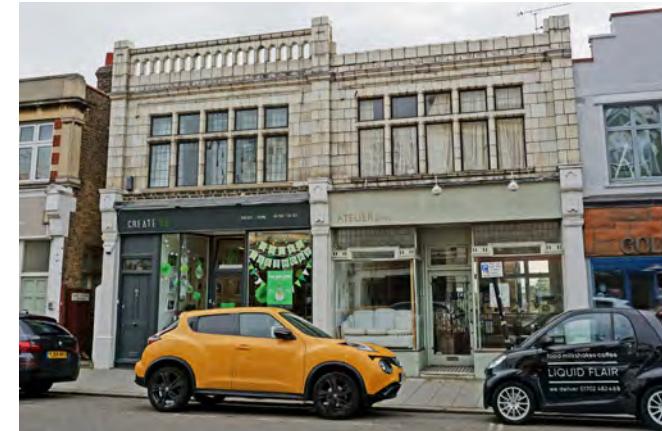
No.96 (right hand shop) Broadway a Locally Listed Building

6.3.45 Nos.86 and 96 Broadway (shown on Map M) were recommended for addition to the Local List during the Appraisal process and are designated as Locally Listed Buildings.

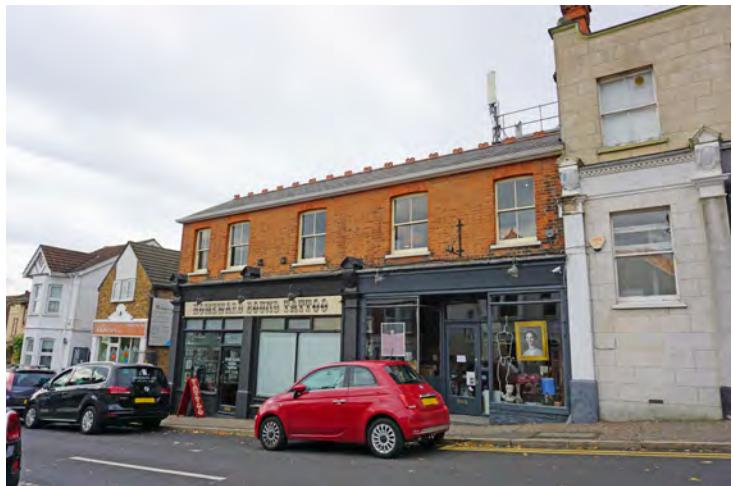
Good shop fronts and well-preserved range to the rear of Stuart House

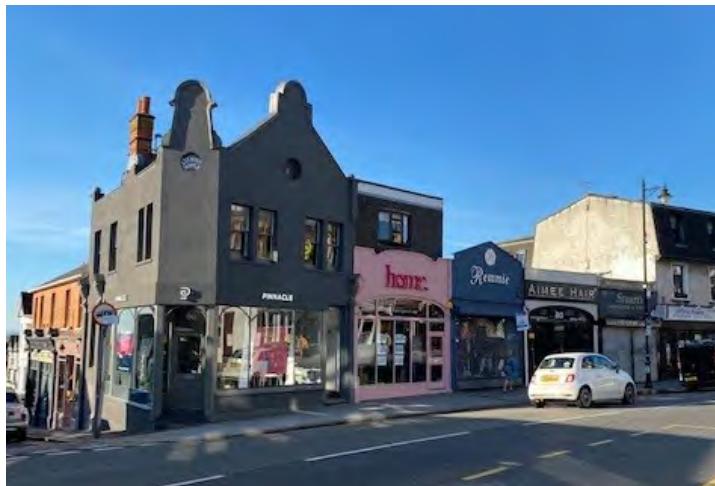
Stuart House at the corner of the row of shops on Broadway, with interesting gables and good shop front

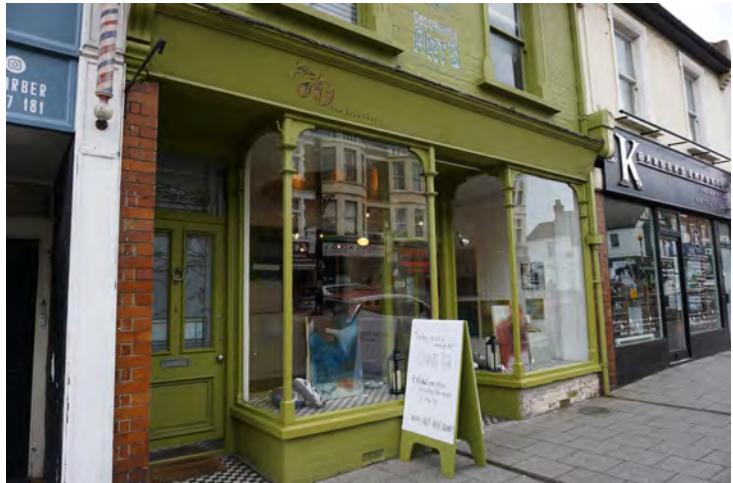
Well-preserved historic shop front within the range of shops on Broadway

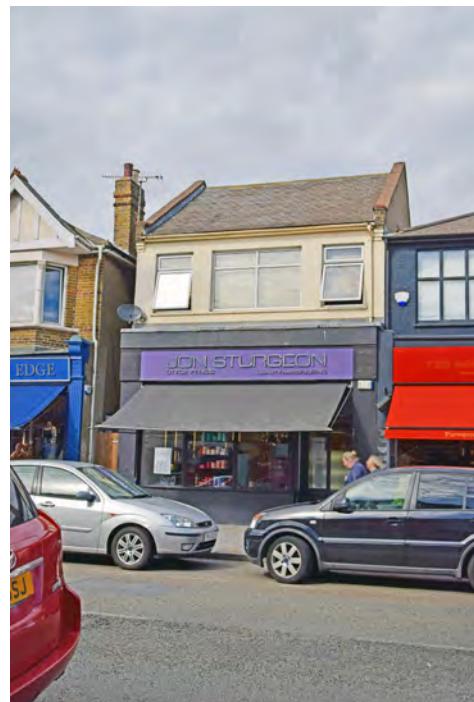
Apparently a later infill building, fletton brick, with a large metal window at first floor divided into small panes. New shop front is modern but in a sympathetic traditional form with awning and appears tidy. Black painted exterior is rather overbearing and stark and perhaps not appropriate for Conservation Area.

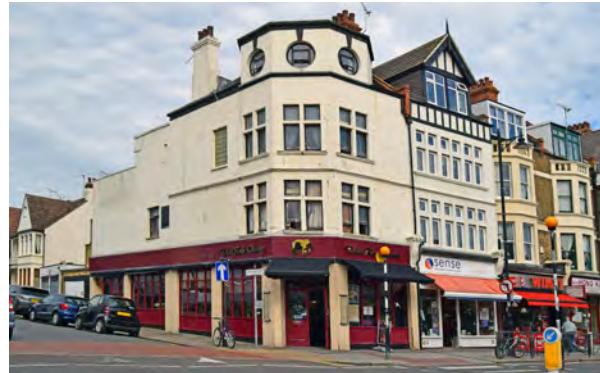
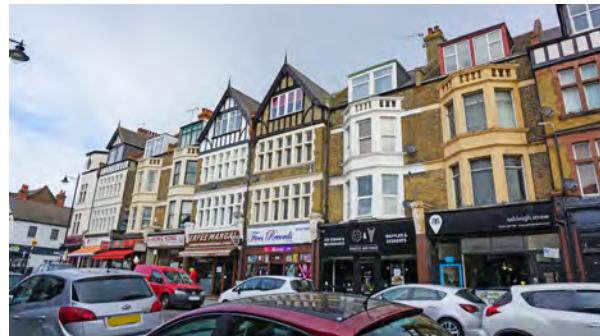
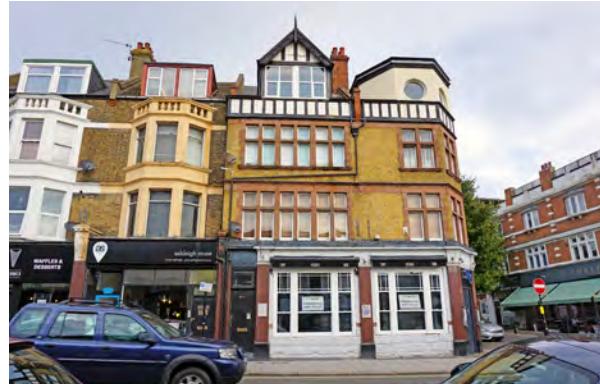
Built as a stylish parade of shops between Leigh Hall Road and Oakleigh Park Drive, the properties are three-and-a-half storey, the date 1905 is visible on one of the hoppers. A symmetrical arrangement, bays with wide six-light windows beneath gables, rather Tudor in style, alternating with more Victorian-looking pairs of canted bays beneath dormer windows which were originally gabled but are now flat-roofed. The corner buildings have polygonal turrets at the roof level which originally had cupolas above which have since been lost. Stock brick with Nos.93 and 95 now painted and gable painted to No.101, stone (possibly sandstone) dressings now painted, slate roofs (the gable of No.97 now in concrete tiles). Timber sashes retained on some upper floor windows but there are some timber and uPVC replacements which are unsympathetic, especially to the dormers and gables. uPVC windows on the upper floors at No.99 are subject to an ongoing enforcement case at the time of writing. uPVC windows would benefit from replacement with timber. Shop fronts variable, Wimpy being particularly garish, though some display traditional elements such as stall risers. The shop front at No.101 was subject to an enforcement case at the time of writing for unauthorised removal of the timber shop front. No.109/111 (currently vacant) at the corner with Oakleigh Park Drive has been rather aggressively cleaned at the first floor. The original shop front is in marble veneer above artificial stonework with vermiculated rustication. However, the

windows have been changed, though not as permitted. There are at least 9 satellite dishes on these buildings.

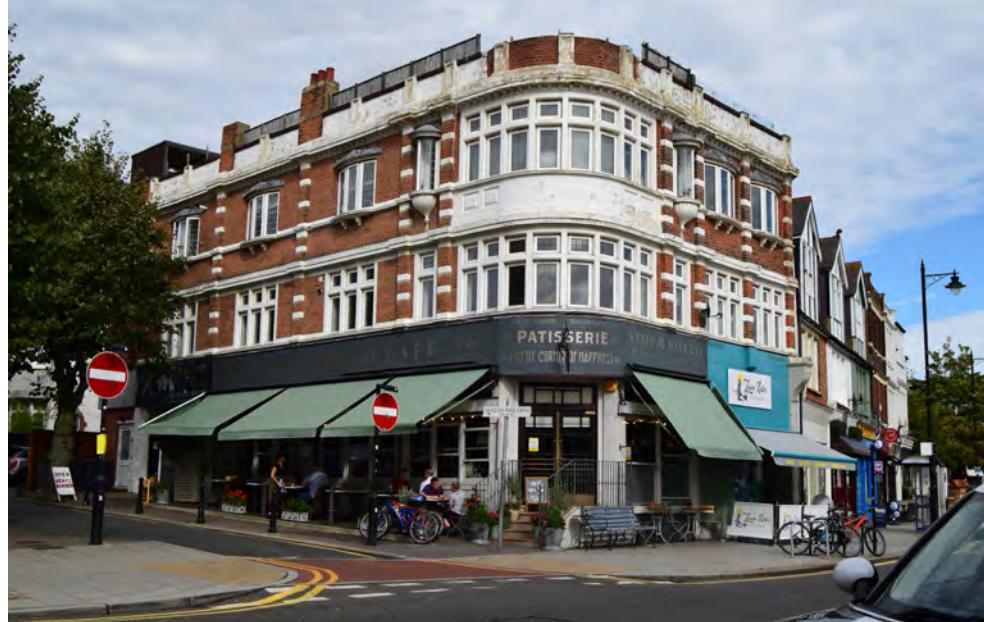
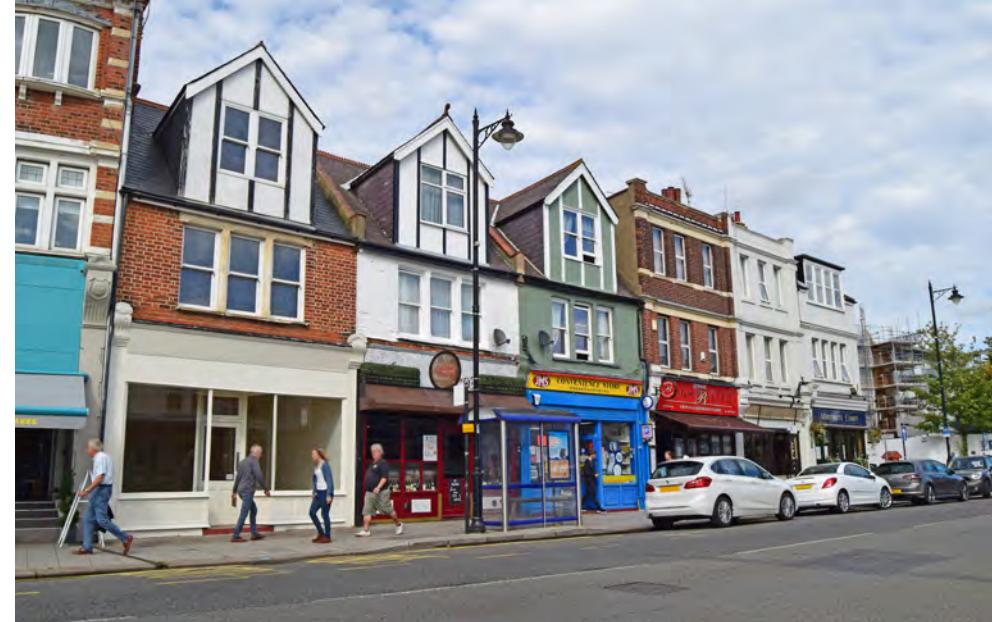
Address	Value to Area's Character	Designation	Address	Value to Area's Character	Designation
113–115 Broadway, 'Stop the World Cafe' and 'Lemon Witch Kitchen'	Positive*	Locally Listed	117–121 Broadway, vacant, 'Cellar Wine Bar', 'Convenience Store'	Positive*	N/A
Description			Description		
Three storey with a parapet roof, civic in character, brick with stone dressings though these have been painted, oriel windows with lead roofs and projecting half round windows, elegant but windows now uPVC. No.113, sympathetic renovation at ground floor level into a patisserie with outside tables and chairs, Art Deco style double door, sash windows over stall risers, awnings and attractive planting. No.115, neat shop front but fascia is overly large. Upper floors in poor decorative condition.			Row of three shops, two and a half storeys, with the half storey being large gabled dormers. Slate roofs, tile hung sides to dormers, half-timbering to gables. Red brick but No.119 has been painted and No.121 is rendered and painted. Some timber sash windows remain but others are uPVC albeit in sash form, though central gable has casements of an inappropriate form. Good timber shop front to No.117. Shop front to No.121 has garish colours and fascia. Roller shutter to No.119 is unattractive. Satellite dishes visually intrusive.

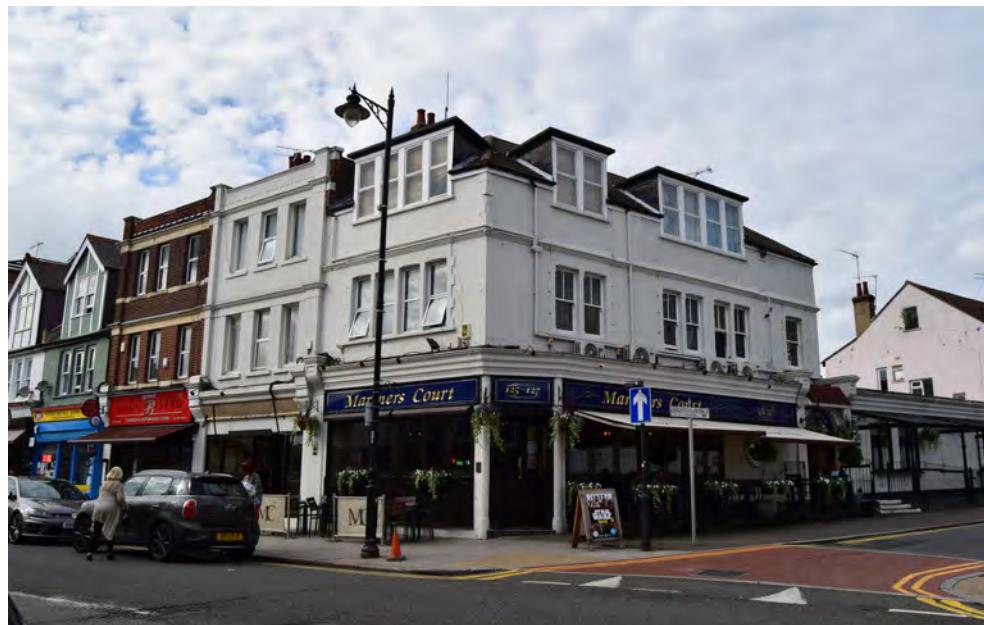
Three storey building. Nos.123 and 125 are a matching pair, with No.127 designed separately. Originally red brick but Nos.125 and 127 are cream painted. Large flat-roofed dormers to No.127, possibly original. All with unsympathetic uPVC windows. Shop fronts and signage appropriate for the Area.

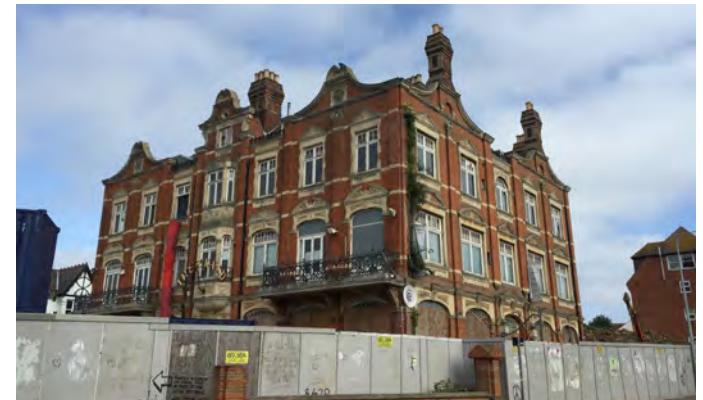
(2018)

In a style befitting its name, this three-storey locally listed building with attics, is an example of late Victorian baroque (dated 1899). Red brick with stone dressings, notably aprons and pediments to the windows, prominent chimneys, fancy gables, and balconies to the front elevation. Large mullion and transom windows with small pane top lights with coloured glass. Reasonably well preserved externally, though the stonework is eroded in some places and cement pointing has caused some of the soft red brickwork to spall.

Empty at time of writing and under redevelopment, so the building was surrounded by scaffolding and a high construction site fence.

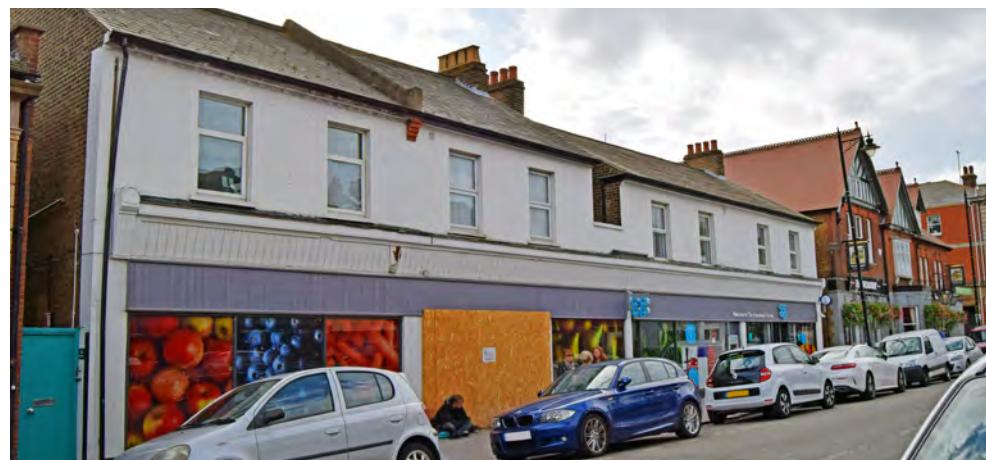
Originally two residential terraces, now all one retail unit, the ‘Co-op’. Stock brick, rendered and lined out to the front. Slate roofs with stock brick chimeneys. uPVC windows. The window of the shop front is divided with piers along the former property lines which helps to give it some historic context. The fascia runs the full length of the shop and would benefit from also having divisions at former property lines. Deeper stall risers would also be more historically appropriate. The profile of the old fascia survives but it is now infilled with matchboarding.

Beneath it are inserted fascias, mostly filled with printed window stickers of fruit and vegetables or garish posters. One window boarded at the time of survey.

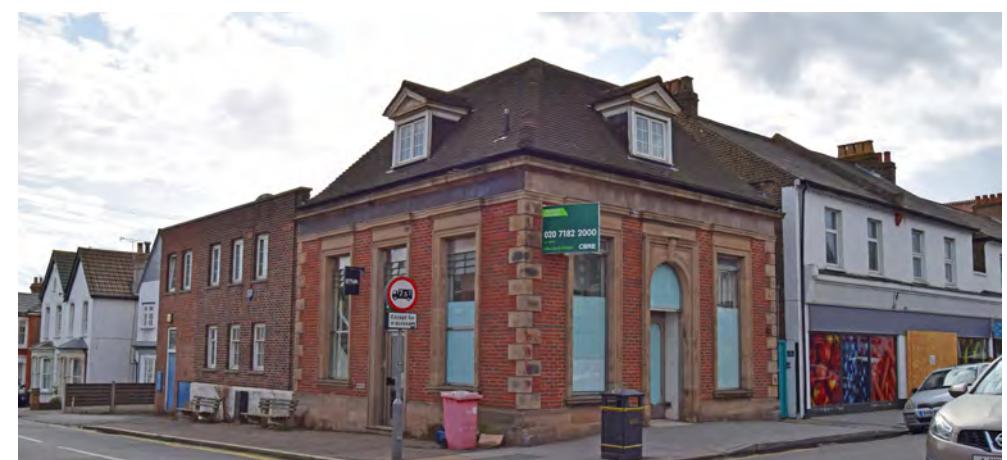
This is a distinctive, one-and-a-half storey building purpose built as a bank. Approximately square on plan, hand made bricks, stone window surrounds and doorcase, rusticated quoining. The original glazing has been lost and replaced with featureless sheets of plate glass. Ugly rear flat roofed two-storey extension probably of the 1950s down Seaview Road, brown brick badly repointed, windows at first floor now uPVC.

Vacant at time of survey.

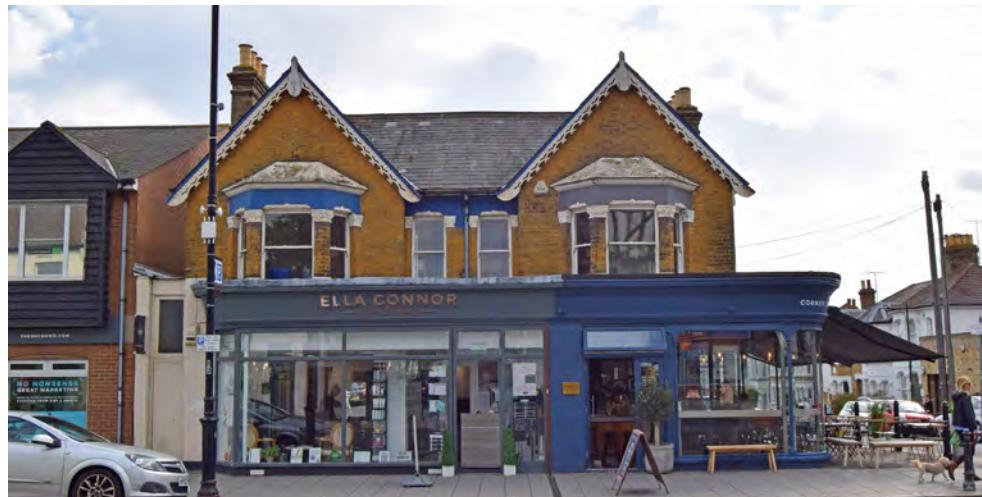
Shop fronts imposed on the ground floor. No.44 has a very fine old shop front with curved glass and cast iron columns which extends down Victoria Road, though there is an ugly flat roof extension at the south end at first floor level, with uPVC windows. Shop front to No.46 is also sympathetic.

First floor level in need of maintenance and redecoration.

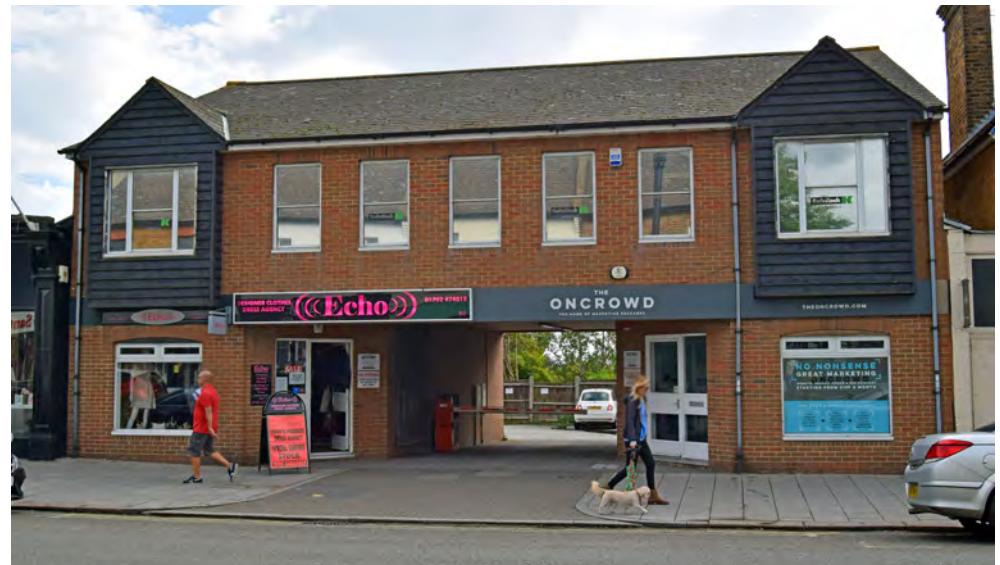
Late 20th-century redevelopment (?1980s), with two retail units beneath weatherboarded and jettied gables either side of an arch over a vehicle passageway. Although the intention was good, it does not match the Victorian character of the street. The brick is too brown, the arch too wide, giving views of the car park beyond, and the gables too low and weak.

Mirrored glass in first floor windows is odd choice and not appropriate for the area.

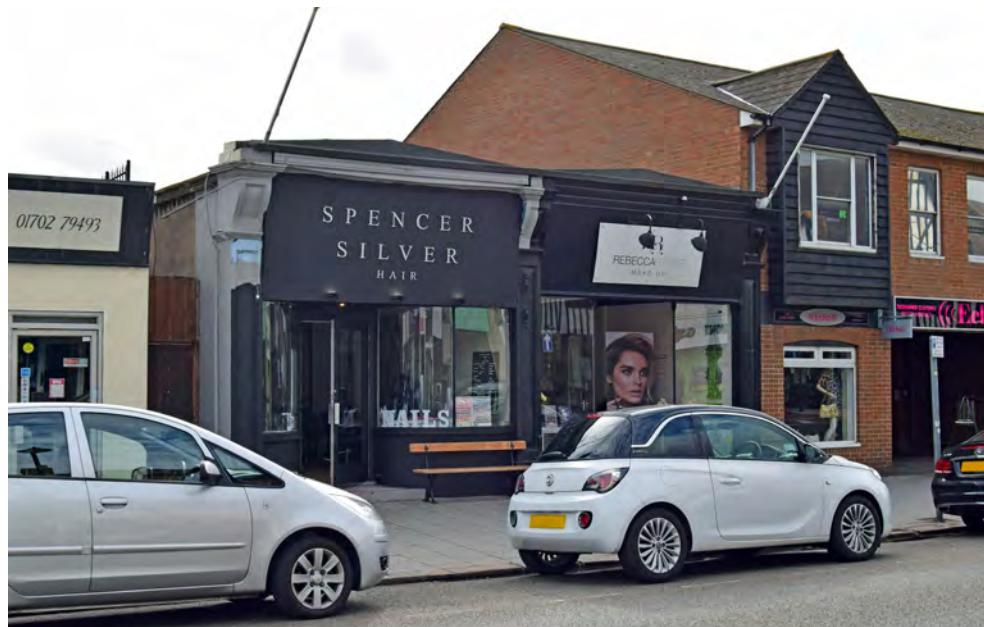
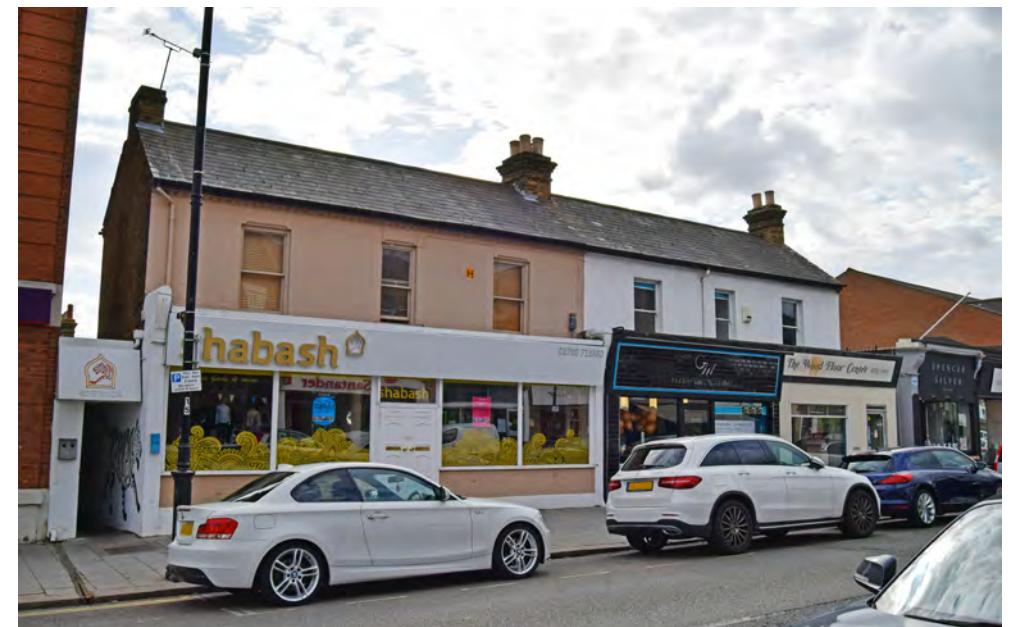
Address	Value to Area's Character	Designation	Address	Value to Area's Character	Designation
52–52a Broadway ‘Rebecca Ryther Make-Up’, ‘Spencer Silver Hair’	Positive	N/A	54–56 Broadway	Positive*	N/A
Description			Description		
Two single storey shops, probably built as shops. Fascias large but these seem to be original proportions and shop fronts well kept and smart, with corbels surviving and good curved glass to No.52a.			Built as a terrace of houses, stock brick but painted at first floor on the frontage, slate roofs, timber sashes at the first floor, shop fronts imposed on the ground floor. Shop fronts reasonably sympathetic, except No.54 which has odd proportions.

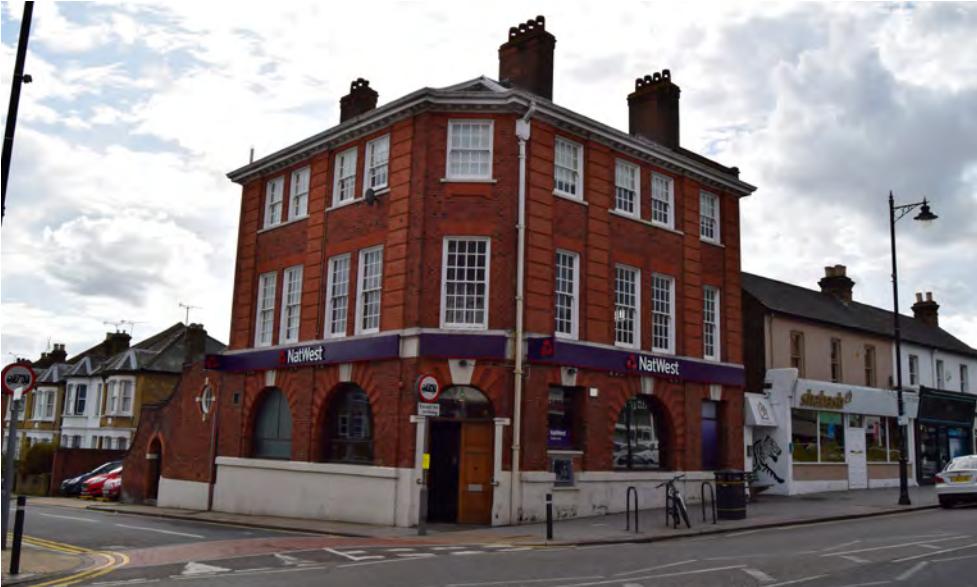
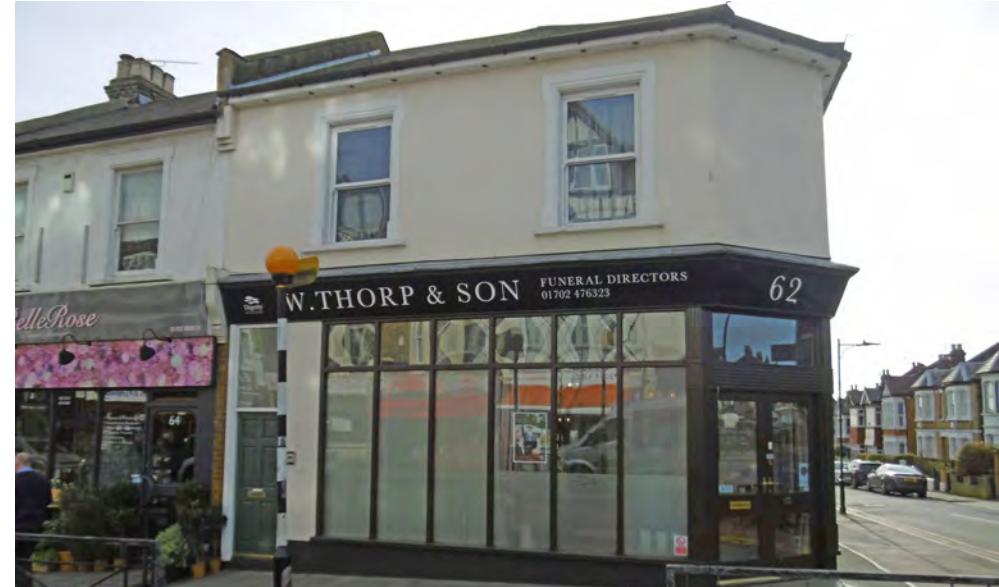
Address	Value to Area's Character	Designation	Address	Value to Area's Character	Designation
58 Broadway 'NatWest'	Positive	Locally Listed	62 Broadway 'W. Thorp & Son: Funeral Directors & Monumental Masons'	Positive	N/A
Description			Description		
A handsome three-storey building in a prominent corner position. Handmade red bricks, gauged brickwork used for rusticated voussoirs and quoins, stone plinth, keystones and string courses. Slate roof with very big brick chimneys.			Corner building in terrace. Two storeys with hipped slate roof. First floor painted render, ground floor a replacement timber shop front but in a relatively traditional style with double door on the chamfered corner of the building.		
Large round headed windows at ground floor, Georgian style sashes above. Unsympathetic flat-roofed and windowless modern extensions to rear.			Two storey range extending down Avenue Road. Timber sash windows set in moulded architraves, which is a common design across Nos.62-76.

Would benefit from repainting of ground floor rendering to plinth.

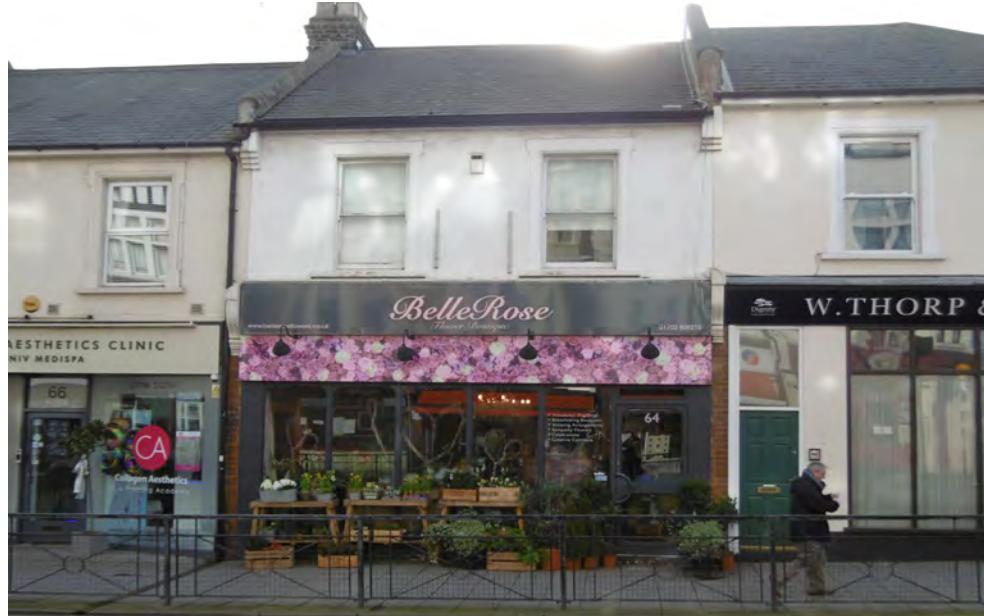
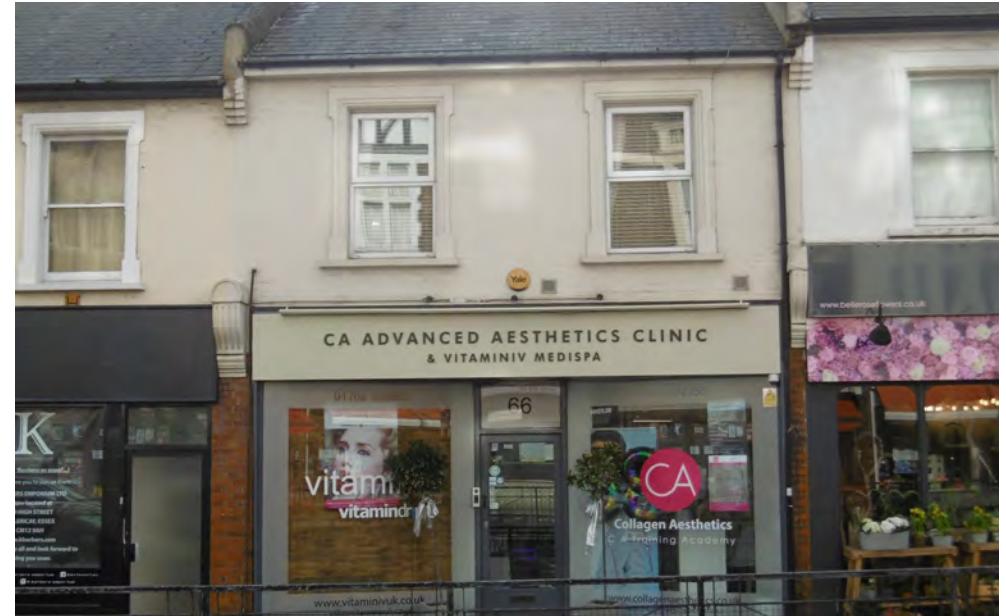
Address	Value to Area's Character	Designation	Address	Value to Area's Character	Designation
64 Broadway 'Belle Rose'	Positive	N/A	66 Broadway 'CA Advanced Aesthetics Clinic'	Positive*	N/A
Description			Description		
Two storey shop in terrace. Slate roof. Painted render to first floor which is in need of repainting. Timber sash windows in moulded architraves, which are a common design across Nos.62-76. Shop front has good timber framed window with stall riser and recessed door to the side. Moulded corbels either side of the fascia, though truncated to insert slightly wider fascia board. Fascia double height and too large, also in plastic material which is inappropriate.			Two storey shop in terrace. Slate roof. Painted brickwork to first floor. Inappropriate uPVC windows which would benefit from reinstatement with timber sashes. Windows set in moulded architraves, which are a common design across Nos.62-76. Moulded corbels either end of the fascia, which is modern and neat but slightly too large. The shop front is a modern insertion in aluminium with canted windows and lacks stall risers which is not particularly in keeping.

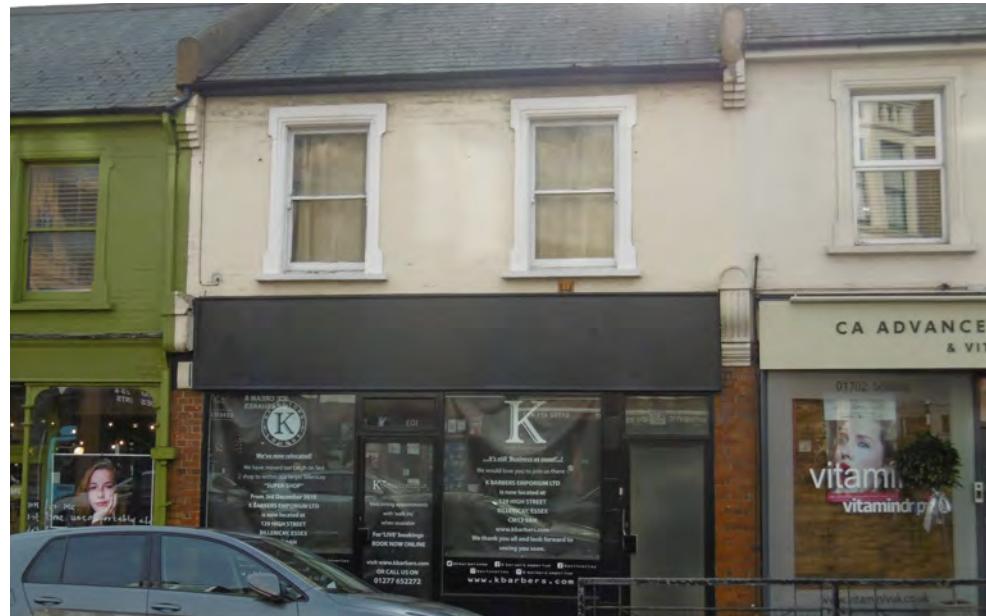
Two storey shop in terrace. Slate roof. Painted brickwork to first floor. Timber sash windows set in moulded architraves, which are a common design across Nos.62-76. Moulded corbels either end of the fascia, which is a modern replacement and overly large. The later aluminium shop front is not particularly in keeping.

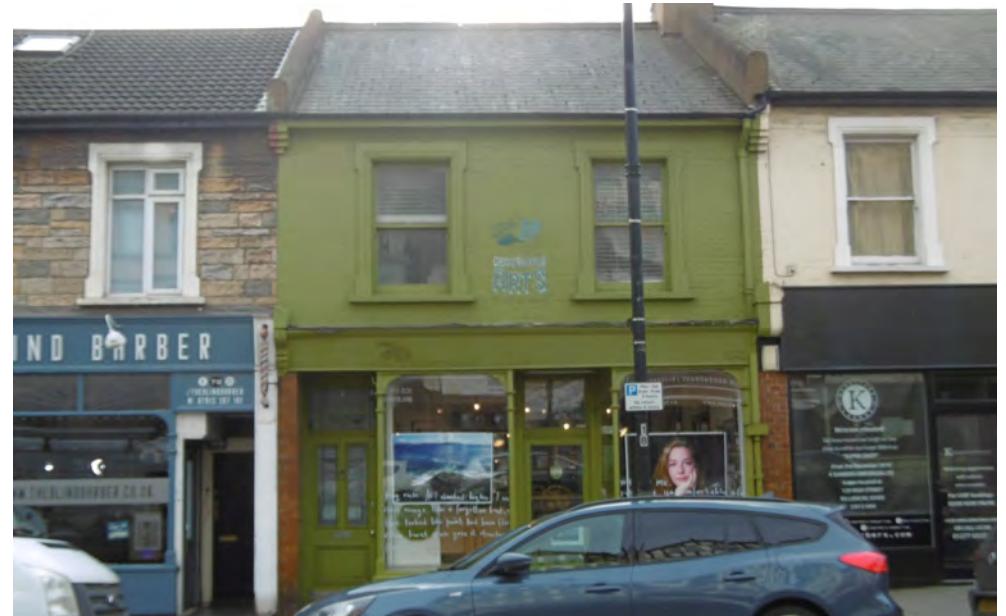
Two storey shop in terrace. Slate roof. Painted brickwork to first floor in green which is rather overbearing. Timber sash windows set in moulded architraves, which are a common design across Nos.62-76. Moulded corbels either end of the original fascia. The original shop front survives and is attractive. It incorporates recessed central shop door with recessed side door to the accommodation above, both with fanlights over, brick stall riser, timber framed windows with column details to the mullions
