Leigh Cliff Conservation Area Appraisal

Southend-on-Sea: Leigh Cliff Conservation Area Appraisal

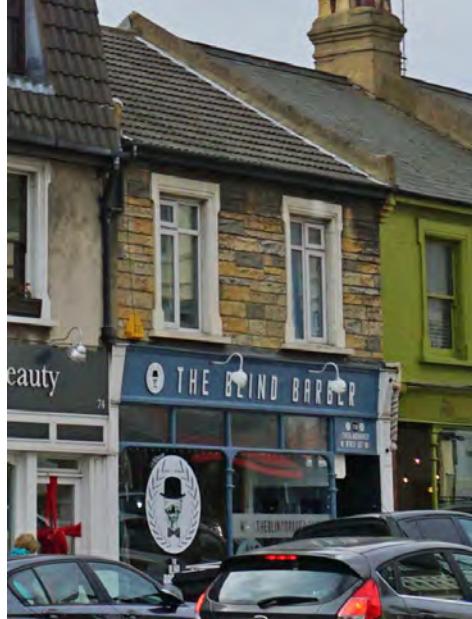
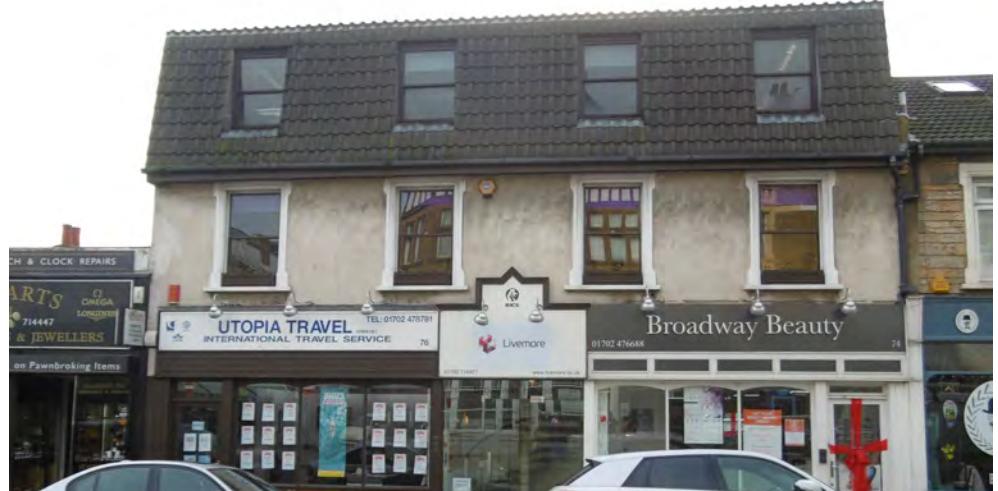
Address	Value to Area's Character	Designation	Address	Value to Area's Character	Designation
72 Broadway 'The Blind Barber'	Positive*	N/A	74/76 Broadway 'Broadway Beauty', 'Livemore', 'Utopia Travel'	Negative	N/A
Description			Description		
Two storey shop in terrace. Inappropriate concrete tile roof which would benefit from reinstatement with slate. Fake stone cladding to first floor is very unsympathetic. uPVC casement windows are also inappropriate and would benefit from replacement with timber sashes. Windows set in moulded architraves, which are a common design across Nos.62-76. The ground floor, however, has a good quality surviving historic shop front with timber fascia between pilasters (the original moulded corbels have been removed but the pilasters are an appropriate replacement), sunburst design leaded fanlights, timber framed windows with column detail mullions, stall riser, recessed side door.			Formerly two shops which were of the same design as Nos.62-72 but have been substantially remodelled. First floor with sash windows (dark stained timber?) has some resemblance to the original, with the original moulded architraves to the windows surviving. However, the walls have been rendered with a textured render and the window frames are later replacements. A large mansard roof with concrete tiles and four inset windows is very unattractive and disproportional. The ground floor has been replaced to incorporate two shop fronts either side with a central entrance to an office. The shop fronts have brick stall risers and timber frames to the windows but have overly large fascias and cluttered signage. The centre entrance has a large fascia and fully glazed door which is not in keeping.

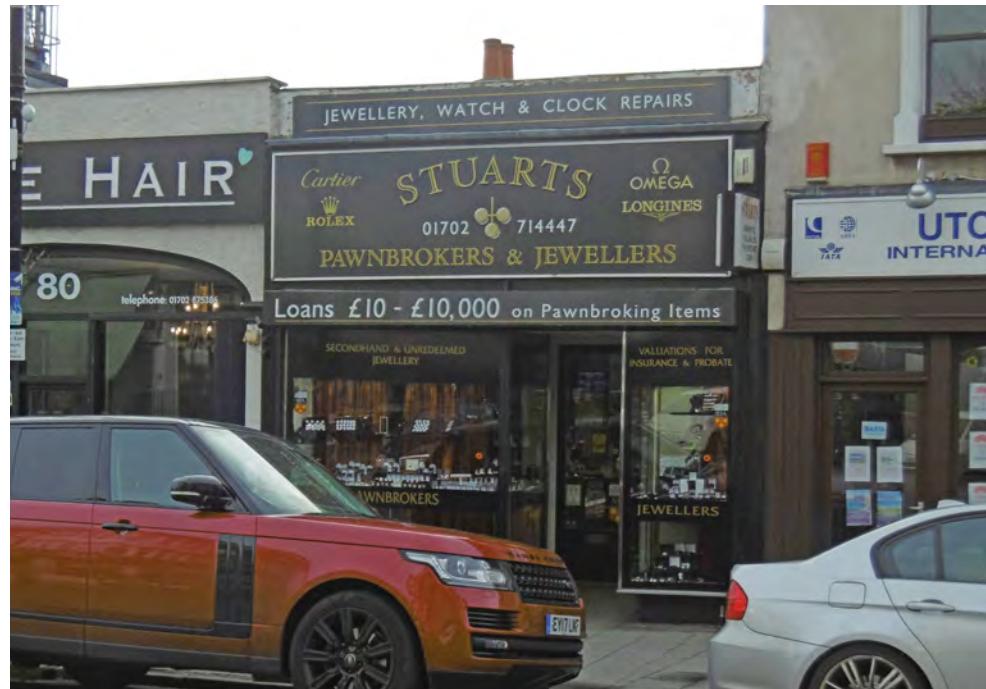
Address	Value to Area's Character	Designation
78 Broadway 'Stewarts Pawnbrokers and Jewellers'	Positive*	N/A

Single storey shop. Overly large fascia and cluttered signage dominates. The shop front is aluminium but at least features short stall risers and a recessed entrance door. Reduction of signage would improve the appearance.

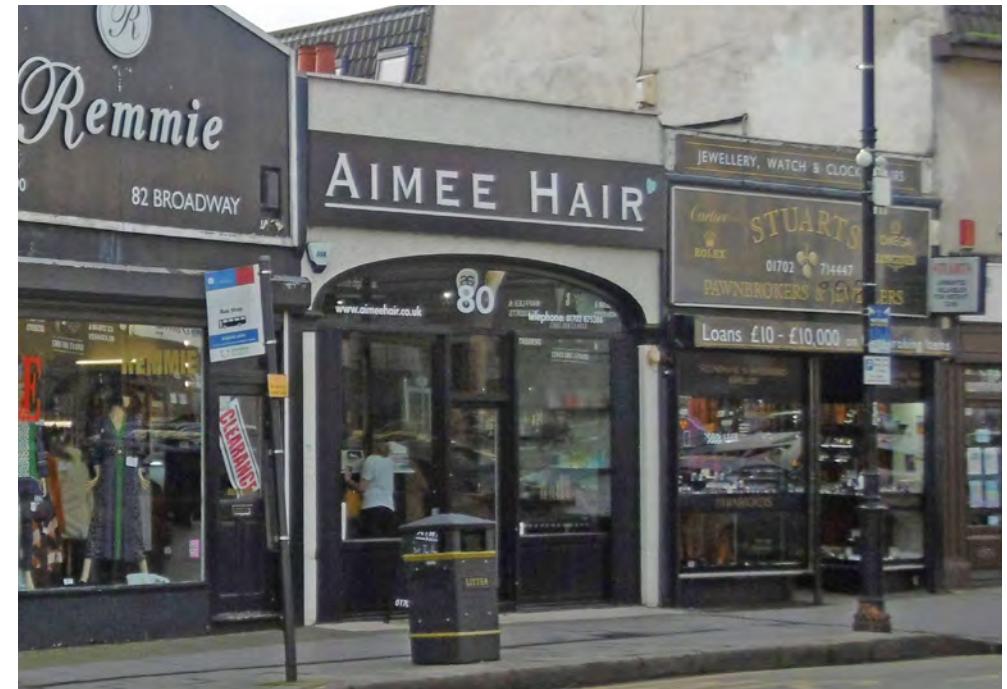
Address	Value to Area's Character	Designation
80 Broadway 'Aimee Hair'	Positive*	N/A

Single storey shop. Fascia of reasonable proportions but in a plastic material not in keeping. Shop front is a good design in timber, with arched glazed fanlight and central door, with stall risers to the windows.

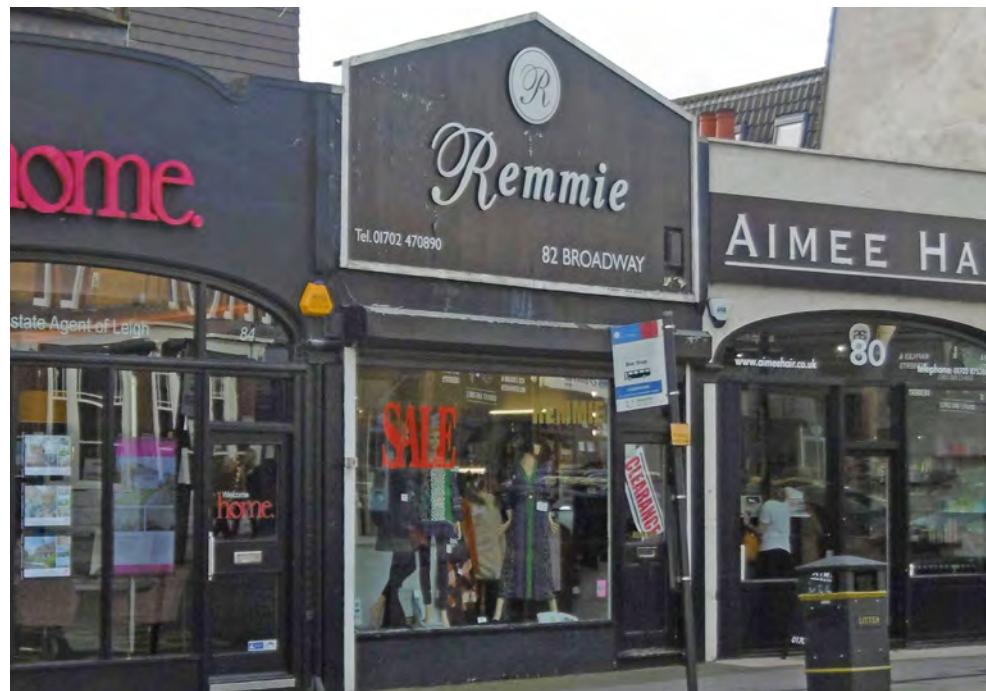
Address	Value to Area's Character	Designation
82 Broadway 'Remmie'	Negative	N/A

Single storey shop. The fascia is very large and overbearing. The shop front is a later replacement and bland.

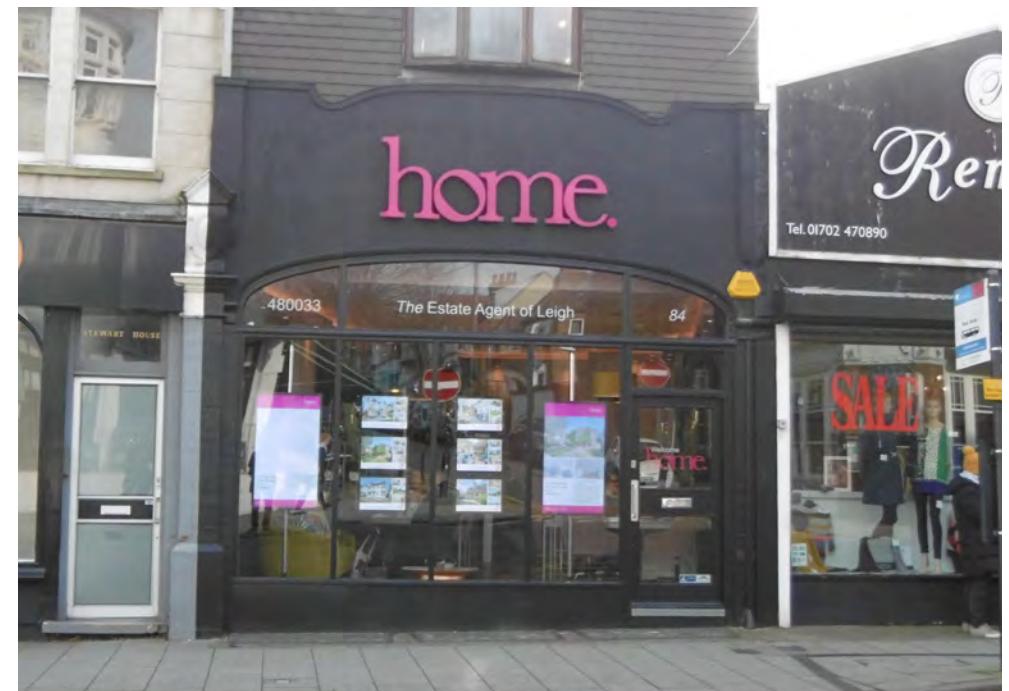
Address	Value to Area's Character	Designation
84 Broadway 'Home'	Upper Floor: Negative, Ground Floor: Positive	N/A

Two storey shop, the upper floor being a late-20th century addition. It is boxy and bland, with hung tiles that are not in keeping and an inappropriate uPVC window. The ground floor has a good shop front though, with timber framed glazing broken up with mullions, with stall riser below and arched fanlight above. Large fascia above but this appears to be historic, with curved detail to the top.

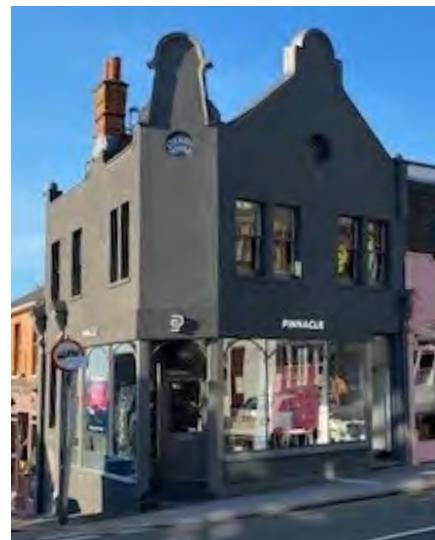
Two storey corner building with chamfered corner. Circular plaque identifying it as 'Stewart House'. Upper floor to Broadway and to corner chamfer have distinctive decorative gables that are prominent in the streetscape. There is also a tall red brick chimney on the east elevation. The upper floors are clad in faience tiles, though these have been painted black recently. Timber sash windows in pairs. Ground floor shop front has corner door, which is modern but timber with glazed upper panels so is appropriate. The windows are set above a stall riser and feature slender timber mullions with attractive arched glazing bars. Modern fascia added recently. A replacement aluminium door at the west end of the north elevation is inappropriate. On the east elevation there is a single bay

flanked by pilasters and decorative corbels and cornice above. This may have been the location of a door that has been filled in with a timber sash windows and tiles similar to those on the upper floors.

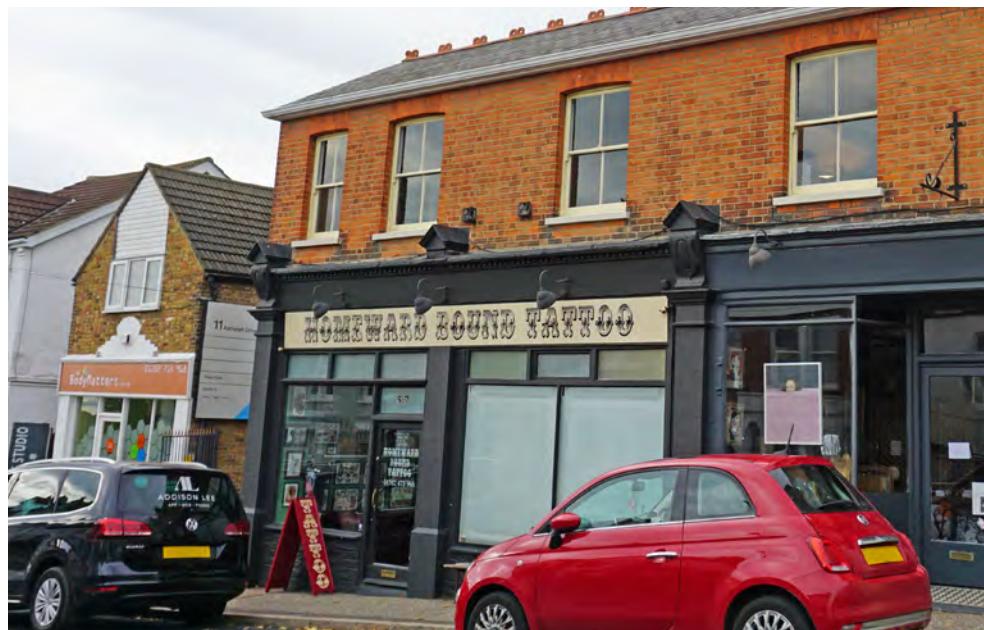
Two storey shop which is part of the same building as the neighbouring No.3. Red brick upper floor with timber sash windows. Slate roof with decorative clay ridge tiles. Good quality surviving shop front with original fascia and dentilled cornice flanked by decorative corbels set on pilasters. Timber framed shop windows set above stall risers. Timber glazed front door likely a later replacement but not inappropriate.

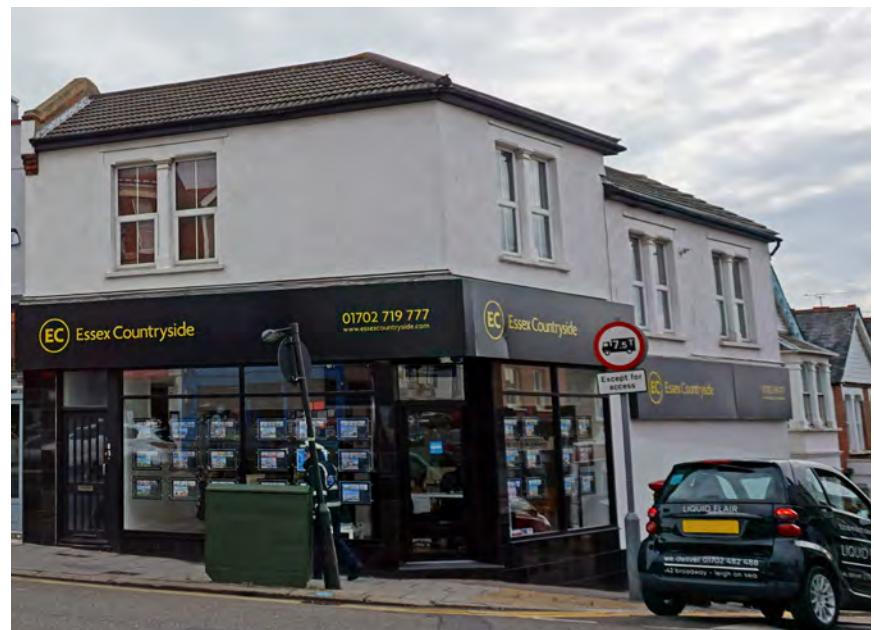
Two storey corner shop. Replacement concrete tile roof, rendered and painted first floor, mullioned windows with central pilaster but uPVC windows. Modern shopfront with rather bland fascia.

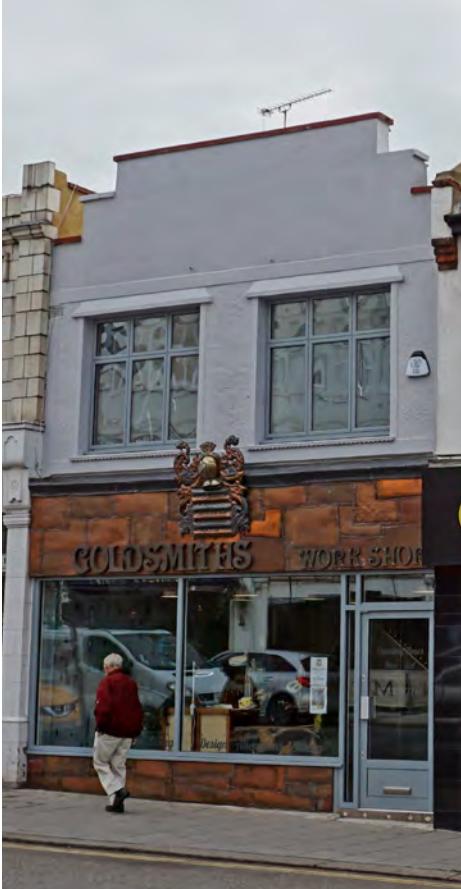
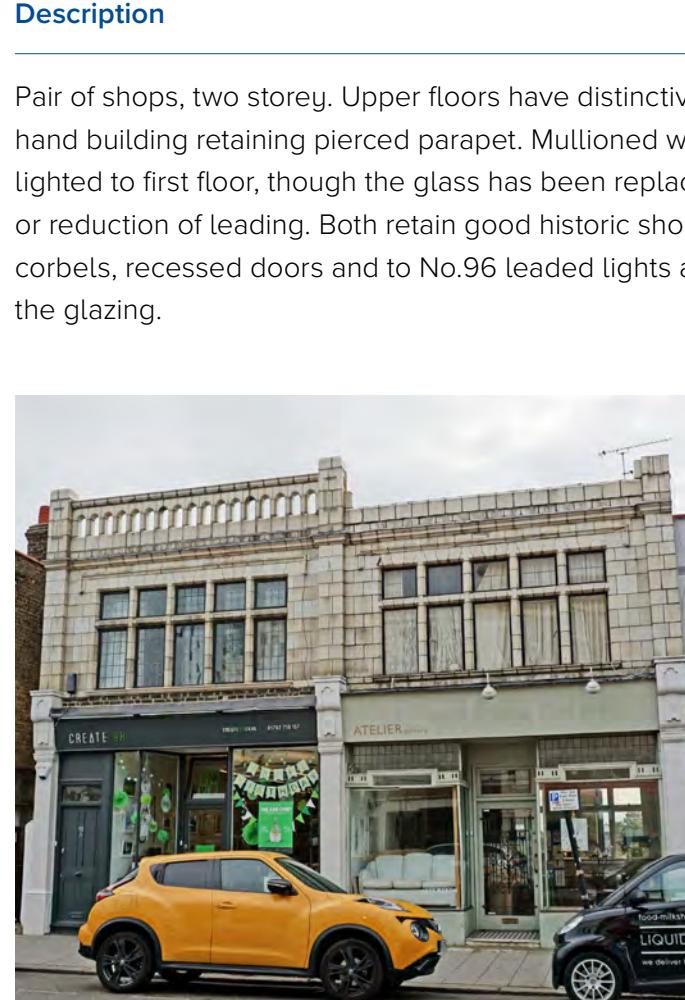
Address	Value to Area's Character	Designation	Address	Value to Area's Character	Designation
94 Broadway 'Goldsmiths'	Positive	N/A	96-98 Broadway 'Atelier Gallery', 'Create 98'	Positive	No.96 Locally Listed Building
Description			Description		
Two-storey building with stepped gable to parapet giving a touch of Art Deco style. Painted render to upper floor. uPVC casement windows though in an appropriate form. Shop front with metal plates to fascia and stall riser, though not unsympathetic.			Pair of shops, two storey. Upper floors have distinctive ceramic tiles with left hand building retaining pierced parapet. Mullioned windows with leaded lighted to first floor, though the glass has been replaced to No.96 with loss or reduction of leading. Both retain good historic shop fronts with carved corbels, recessed doors and to No.96 leaded lights above a cornice set into the glazing.

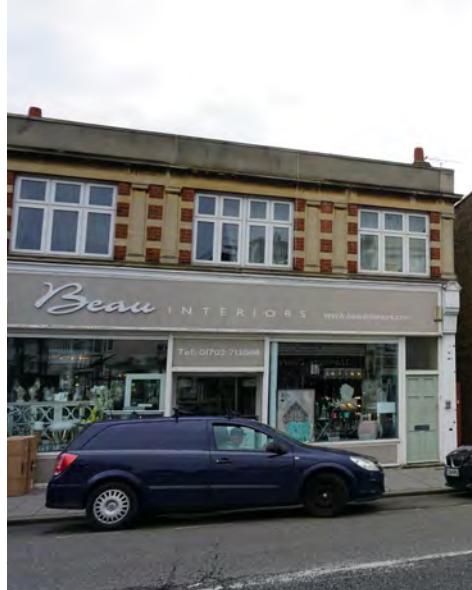
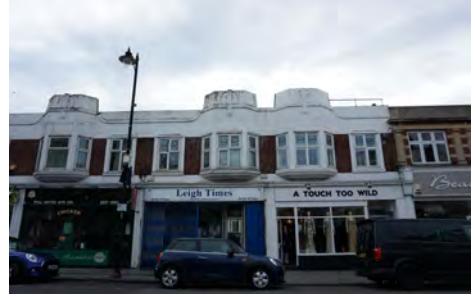
Address	Value to Area's Character	Designation	Address	Value to Area's Character	Designation
100-102 Broadway ‘Beau Interiors’	Positive*	N/A	104-110 Broadway	Positive*	N/A
Description			Description		
Two-storey shop, with red brick upper floor with stone dressings and rendered parapet. Unsympathetic uPVC windows. Good shop front.			Two-storey row of shops with a touch of Art Deco style. Upper floors are red brick with rendered dressings and parapet. Parapet features distinctive raised sections over oriel windows and contain a carved motif. Unsympathetic uPVC windows except for No.110 which has original timber casements with stained glass. Shop fronts are all rather bland modern replacements and metal grille shutter to No.104 is unappealing.

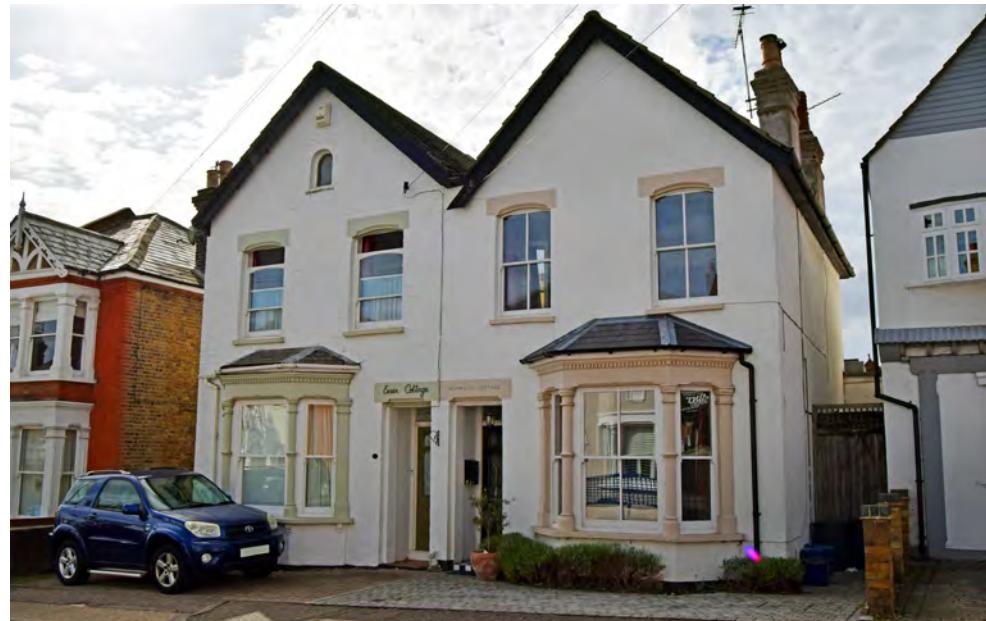
A somewhat unusual pair with big steeply pitched gables to the street, canted bays at ground floor only. Both are now painted white, with painted stonework in muted shades round windows and doors. Timber sashes to all windows. Concrete tiles to No.12. Boundary wall lost and large areas of hard landscaping with little planting to soften the appearance.

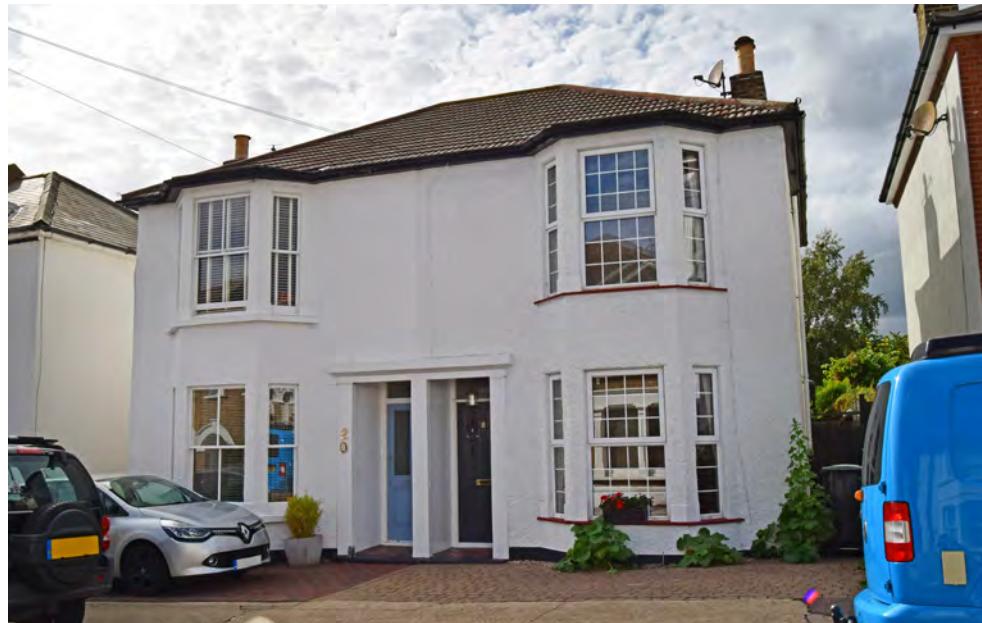
Address	Value to Area's Character	Designation
18–20 Seaview Road	Positive*	Article 4

Two houses, the whole pebbledashed and white painted. Canted bays rising full height. Reroofed in unsympathetic concrete tiles. The detailing of the window surrounds has been lost, as have the hipped roofs over the bays. No.18 has uPVC windows, the more inappropriate because notionally divided into small pane glazing. No.20 retains timber sashes. Recessed porches with timber doors containing glazed upper panes and fanlights above. The garden block paved and used for parking.

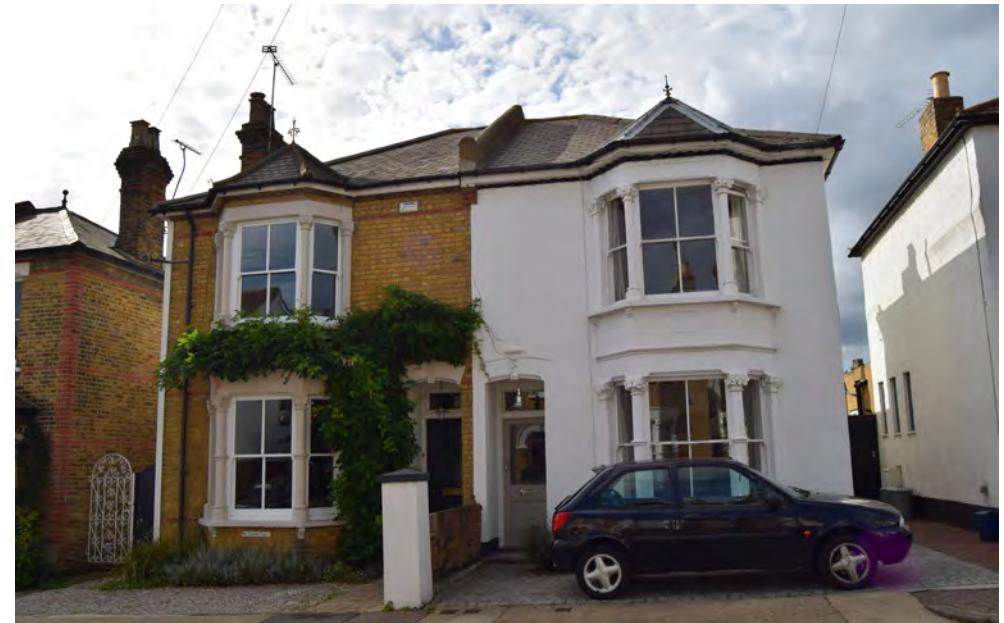
Address	Value to Area's Character	Designation
22–24 Seaview Road	Positive	Article 4

Two-storey pair of houses. Full height canted bays, window mullions with foliate capitals. No.22 white painted, No.24 still with its stock brickwork intact. No.22 has lost its chimney. Slate roofs with iron finials to hipped roofs over bays. Recessed porches with timber doors containing glazed upper panes and fanlights above. Both have paved gardens used for parking with boundary wall lost. Planting and loose gravel surface to No.24 improves the overall appearance.

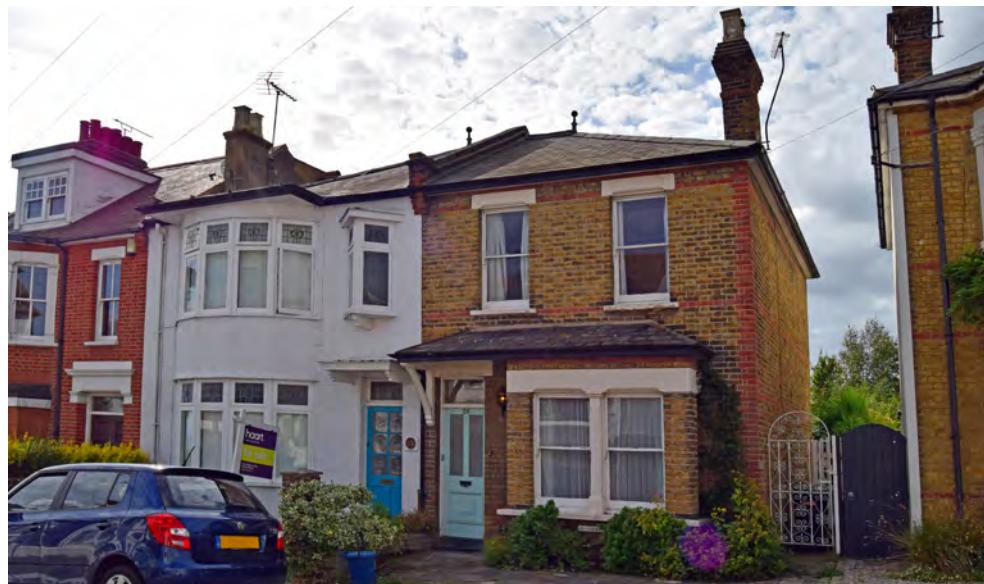
A rather different pair, originally (to judge from No.26) stock brick with red brick details with a ground-floor rectangular bay beneath a lean-to roof, timber sash windows and timber door with glazed upper panels and fanlight. But No.28 has been completely remodelled or rebuilt in the 1930s, rendered and painted, with a full height bow-fronted bay and windows with top lights with stained glass, and a V-shaped window above the front door. Unusually it retains its distinctive boundary wall made of brick wasters. Boundary wall to No.26 has been lost but planting helps relieve the paved parking area.

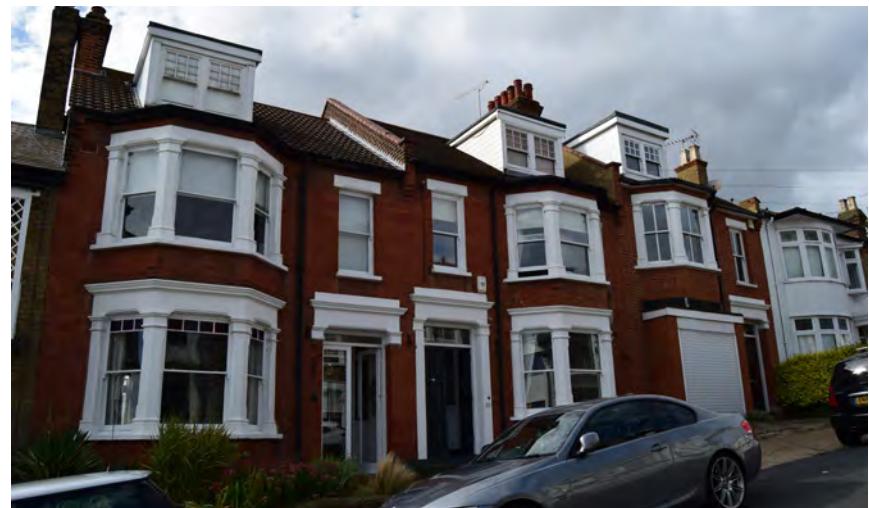
A row of three with red brick façades which present a striking contrast with the white-painted stonework round the windows and doors. Big canted bays beneath flat roofs. The main roofs are steeply pitched with machine made tiles (now concrete on No.34), and have prominent, original flat-roofed dormer windows to make the attic space liveable. Nos.32 and 34 have had the entrance lobbies in-filled with doors. Only No.32 still has its original front door with stained glass panels. No.30 has had the ground-floor bay replaced with a garage, which is very intrusive. Only No.34 still has a front garden and also retains a polychrome tiled path, the others being parking bays with hard landscaping. All have lost the boundary wall.

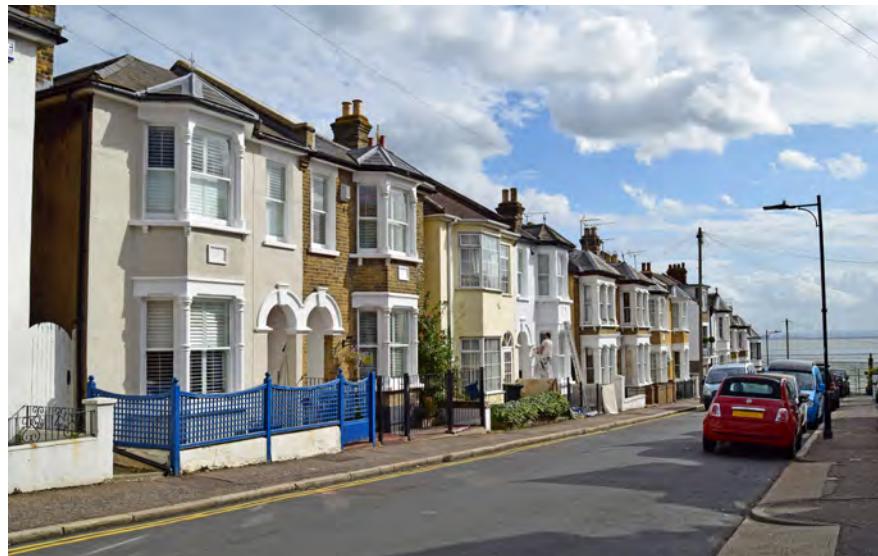
Address	Value to Area's Character	Designation
East Side 1–11 Seaview Road	Nos.1, 3, 7, 11: Positive Nos.5, 9: Positive*	Article 4

Three similar semi-detached pairs, two-storey, canted bays with mullions with moulded capitals, and round-arched doorways with keystones, recessed porches with timber doors with glazed upper panels and fanlights. Only Nos.1 and 7 have not been rendered and painted. Variety of boundary treatments with the blue trellis fence at No.5 particularly not in character with the street. No.9 has uPVC windows the worse for having a small pane effect; the entrance lobby has been closed off and the roof has been replaced with concrete tiles, with the loss of the hipped roof over the bay. Otherwise the houses retain timber sash windows and slate roofs.

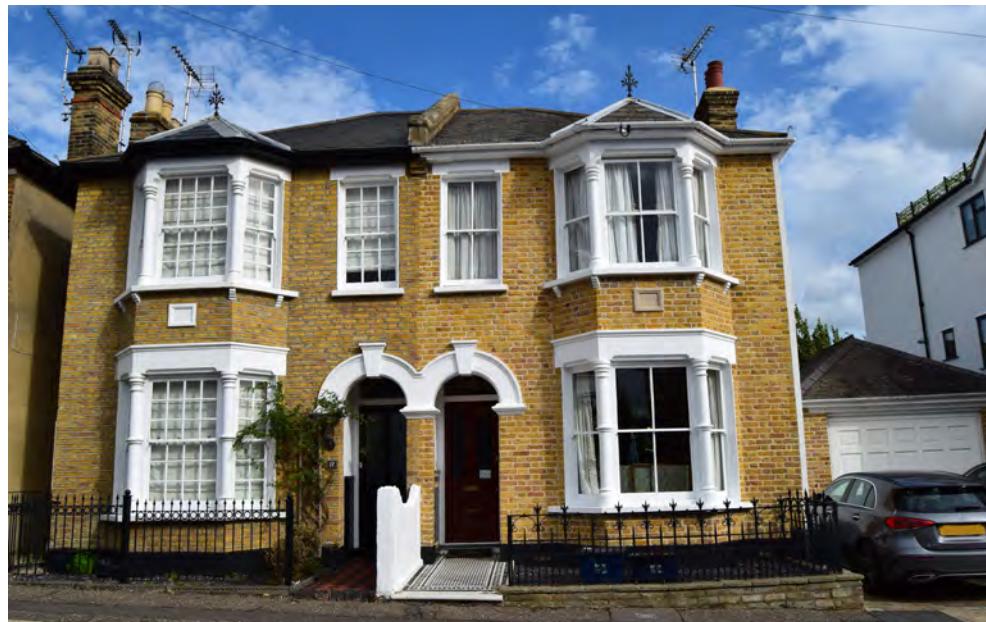
A pair to a similar pattern as Nos.1–11 though bays are canted. Their stock brickwork is intact. No.17 has replacement windows with small panes which is not in keeping, though sash form in general is, and a red and black tile front path. No.19 has new iron railings in a traditional style and a mosaic tile front path. Recessed porches with timber doors with glazed upper panels and fanlights.

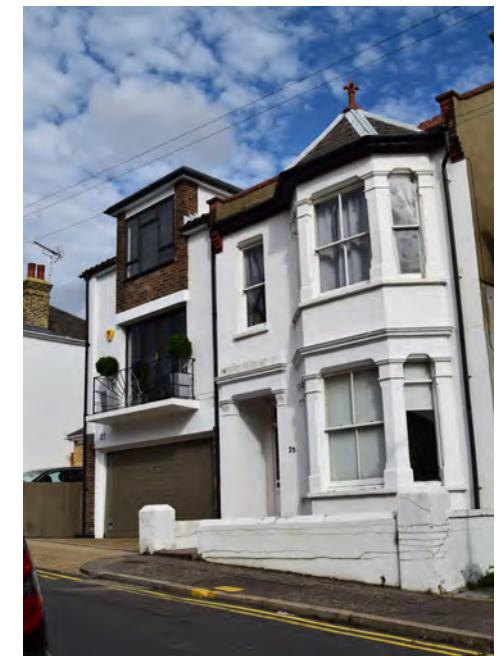
No.23 has a canted bay beneath a hipped roof, brick but now rendered white painted. Timber sash windows, recessed porch with timber door with glazed upper panels and side and fanlights. Its pair to the north was never built and the gap next to it has only recently been developed with the construction of No.21. Although traditional materials have been used, the building is too tall and boxy, having a large dormer window, and the integral full width garage at the ground floor does not fit with the street scene. Design and build, however, are good quality and it is well maintained.

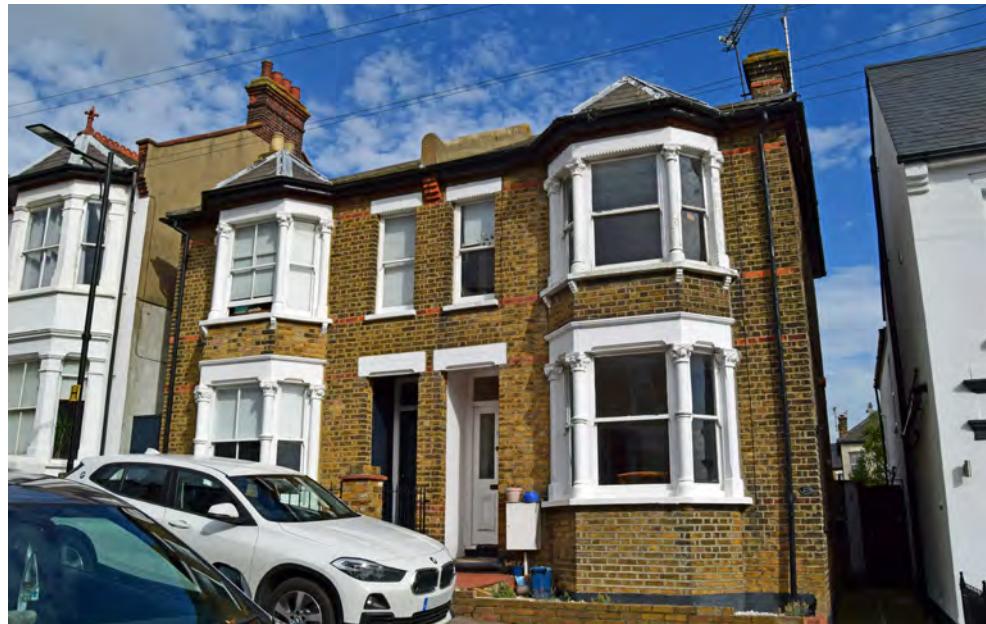
Address	Value to Area's Character	Designation
25–27 Seaview Road	Positive	Article 4

Two-storey pair of houses. Slate roof with hipped roofs over two storey canted bays, well preserved stock brickwork and little altered. Recessed porches with timber doors with glazed upper panes and fanlights. Tiled pathways. No.27 has lost its boundary wall. Similar to Nos.22–24 on the other side of the road.

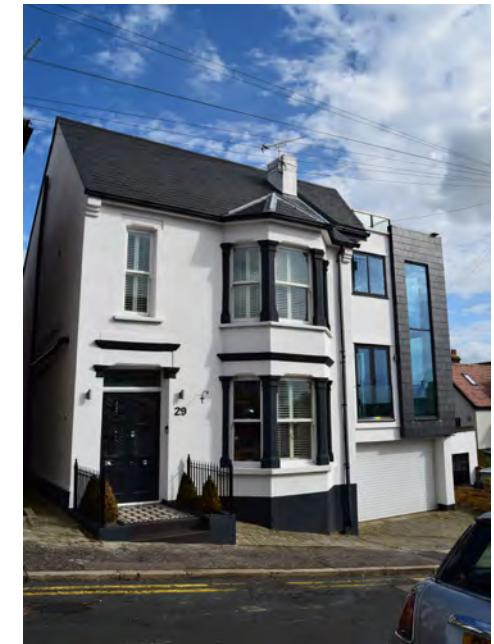
Address	Value to Area's Character	Designation
29–29a Seaview Road	No.29: Positive No.29a: Neutral	Article 4

No.29 was built as a detached house. Two-storey with a canted bay, recently renovated with 1970s/80s extension for No.29a, refurbished in the 21st century. While the extension uses good quality materials, its massing is not in keeping with the character of the Conservation Area, especially in views looking north up Seaview Road. No.29 is white rendered with black door with good quality stained glass. Sash windows with columns to the mullions. Path up to garden has attractive black and white tiles. Sash replacement windows in original building, metal framed in the modern extension.

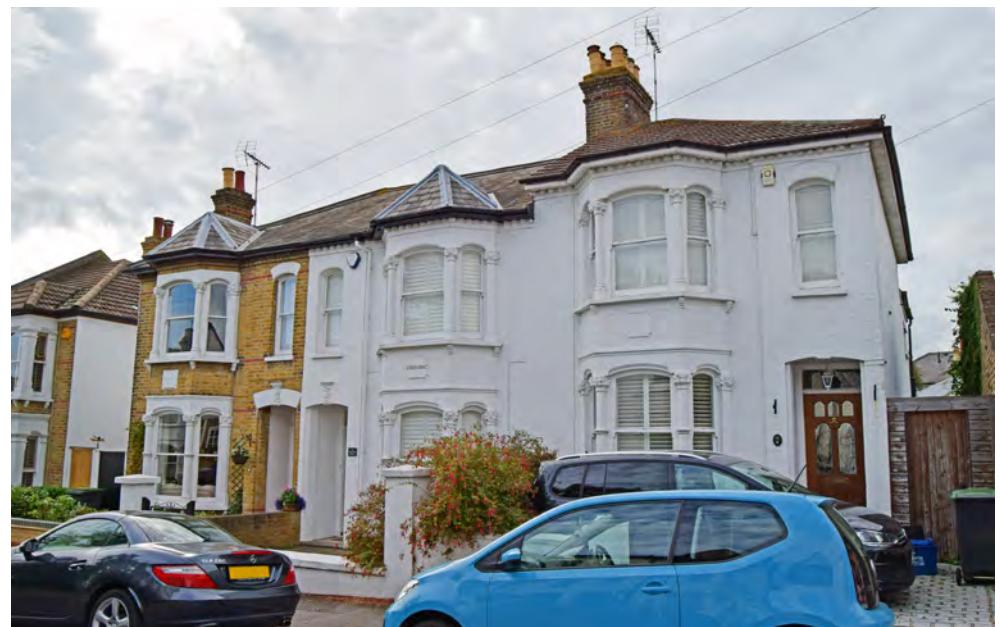
Terrace of three houses, two-storey, slate roofs, stock brick with red brick detailing, canted bay widows with foliate capitals to mullions, sash windows, recessed porches, timber doors with stained glass upper panels and fanlight. Nos.4 and 6 white painted, No.4 with concrete tiles and has lost the hipped roof over the bay. Parking area to No.4, though boundary wall part retained.

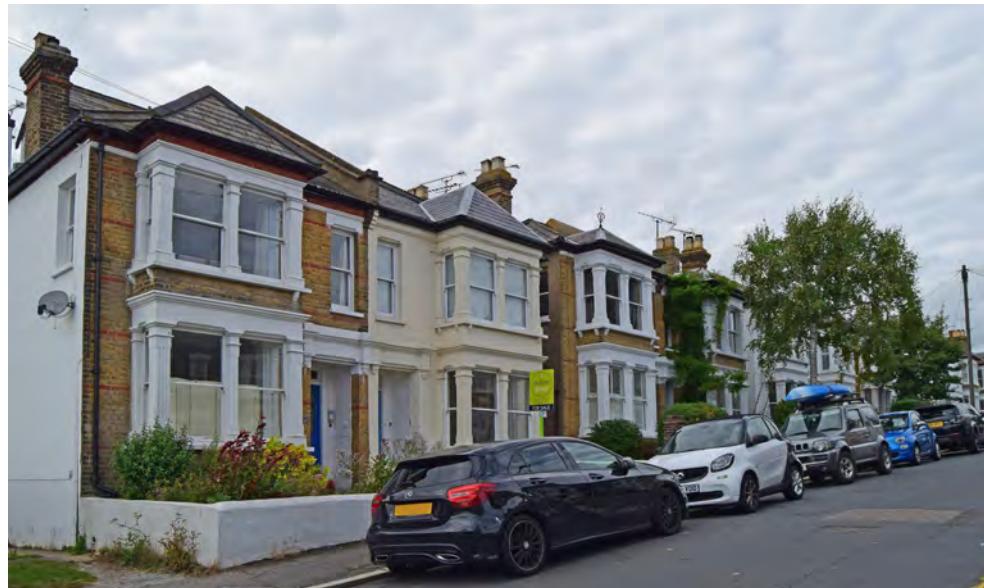
Address	Value to Area's Character	Designation	Address	Value to Area's Character	Designation
10–32 Victoria Road	Positive	Article 4	3 Victoria Road	Positive*	N/A

Identical pairs of semi-detached villas, mostly in good condition. Stock brick with red brick detailing. Full-height rectangular bay windows, timber sashes, slate roofs, recessed porches, timber doors with stained glass upper panels and fanlights. No.10 has concrete tiles, Nos.18 and 20 no longer have their original front doors. No.22 has uPVC windows at the first floor. No.16 has had the sash windows replaced with plain sheets of glass at the first floor. Either white rendered or exposed brick, well maintained and tidy. Most retain front gardens and boundary walls, though at least one converted to parking.

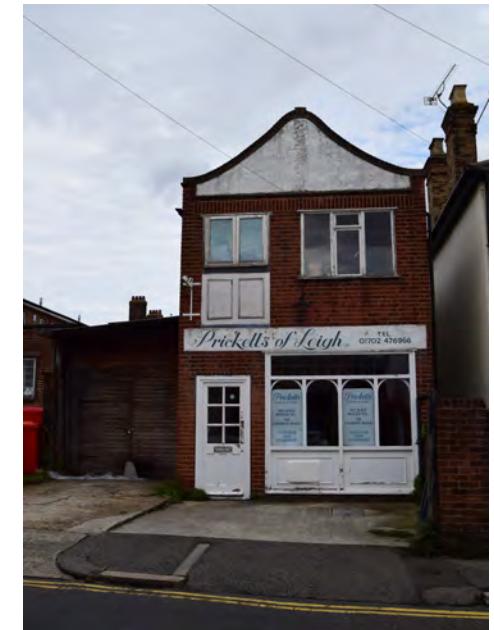
Formerly a shop and workshop, an early 20th-century stock brick building refronted between the wars. The shop front has arched detailing to the frame, at the first floor there are metal windows. There is parking in front of it. The building respects the residential character of the road and fits into it satisfactorily. Could be improved greatly with some maintenance, replacement of first floor windows and sympathetic repainting of exterior.

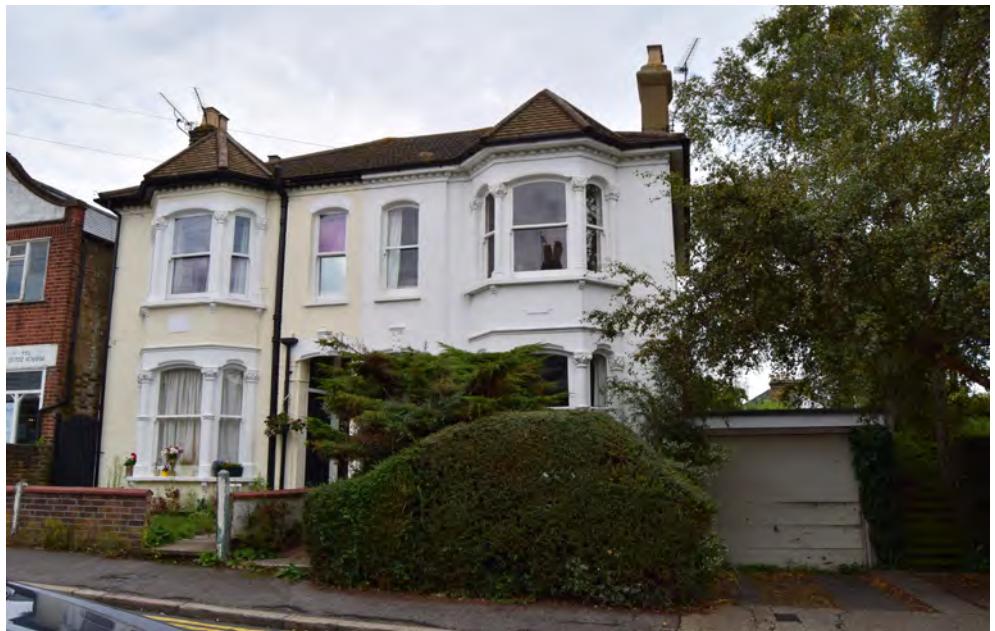
Address	Value to Area's Character	Designation
5–7 Victoria Road	No.7: Positive No.5: Positive*	Article 4

Pair of two storey houses, originally brick but now painted, concrete tile roofs, canted bay windows with foliate capitals to mullions, timber sash windows, recessed porches. No.5 has replacement door which is mostly glazed, plus an additional door inserted within the porch, while No.7 retains timber paneled door with glazed upper panels and fanlight. Nos.5 and 5a converted into well maintained flats, though would benefit from a slightly better maintained front garden.

No.7 has a well planted front garden including a silver birch tree which make a positive contribution to the streetscene.

A double garage, beneath a wide gable and built of keyed fletton brick, represents infill of the gardens between Nos.7 and 13. It dates probably from the 1950s.

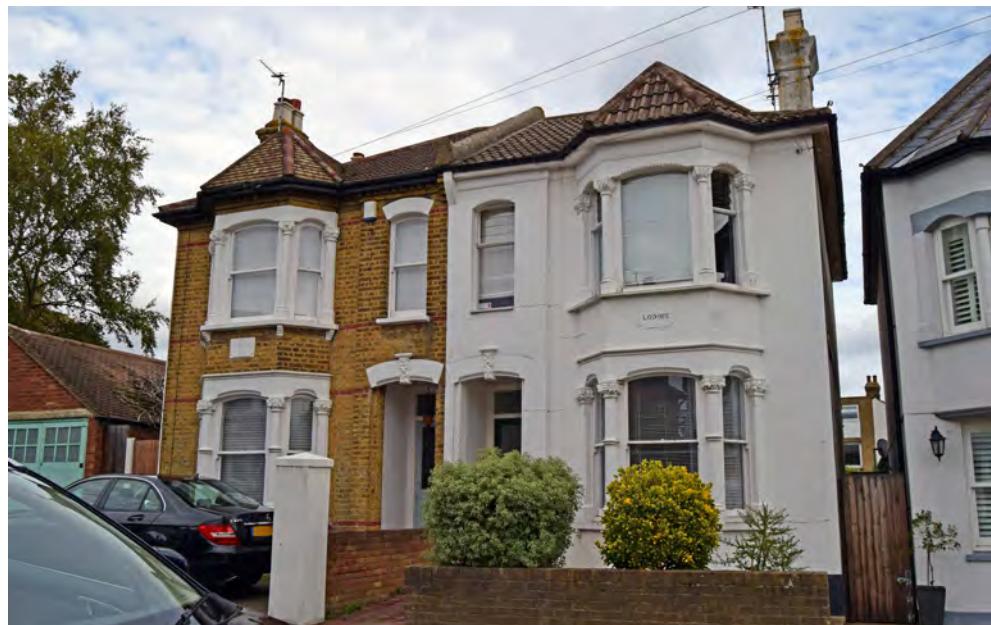
A semi-detached pair 'Grasmere' and 'Lodore'. Two-storey with canted bay windows. Yellow stock brick with red string coursing, No.15 rendered and painted white. Sash windows, except for central window to first floor bay to No.15 which is a single large sheet of glass. Recessed porches, No.1 with original timber door with stained glass upper panels and fanlight. Door to No.15 is a later replacement. The garden of No.13 has been given over to block paving. No.15 has a black and red tiled path. Both tidy and attractive.

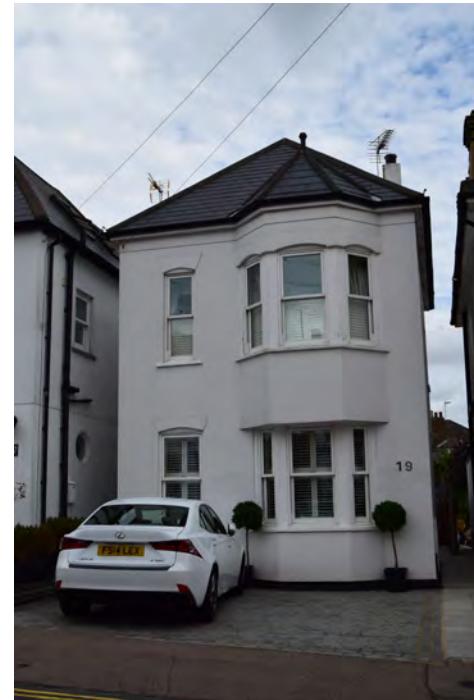
New house built on the site of two previous modern mid-century garages. Has been built to make reference to the surrounding Victorian properties, but is of smaller proportions. The ground floor bay has been made smaller to accommodate parking, the building lacks detailing and the proportions are odd.

Frontage is block paved to allow for car parking which looks stark.

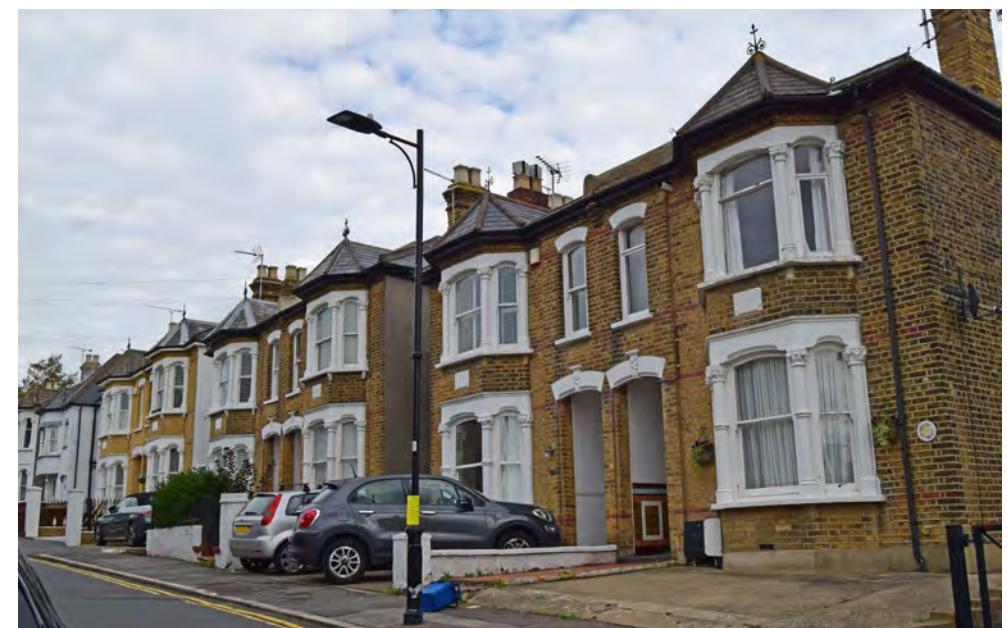
Address	Value to Area's Character	Designation
21–31 Victoria Road	Positive	Article 4

Three matching semi-detached pairs. Two-storey, slate roofs, stock brick with red brick detailing, canted bay windows with foliate capitals to mullions, sash windows, recessed porches, timber doors with stained glass upper panels and fanlights. Nos.21, 23, 25 and 31 have lost their gardens to car parking. No.21 has a sympathetic replacement front door. No.31 has timber casement windows at the first floor.

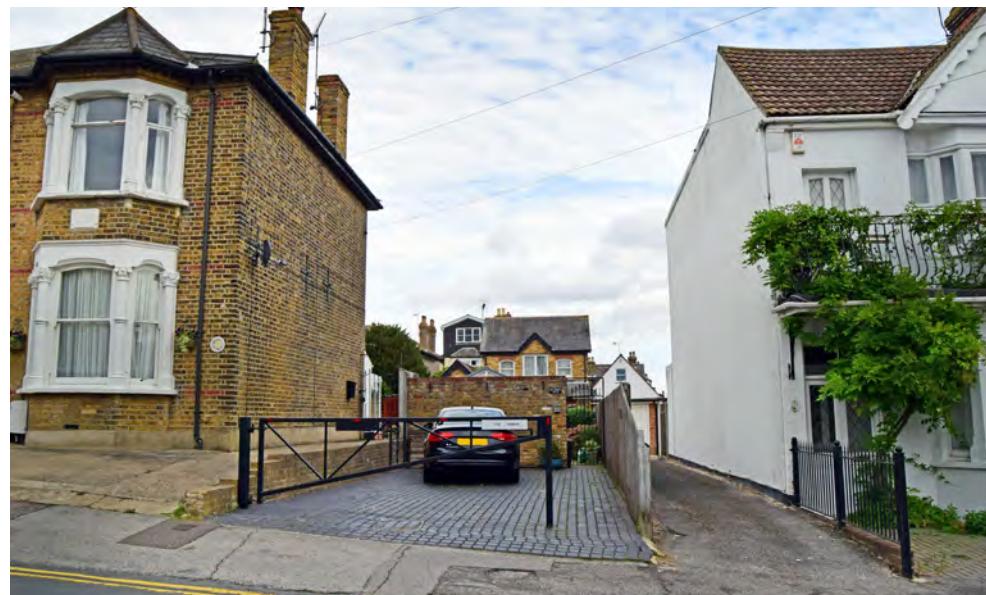
Address	Value to Area's Character	Designation
The Stables	Positive	Article 4

Originally the stables of No.31 Victoria Road were sited here. The current building is a complete rebuild to the same shape as the original stables. It is set so far back that little of the house can be seen from the street. Instead, there is a large parking bay which terminates in a blank brick wall. The utilitarian gate is inappropriate for the Area. This area would benefit from some soft landscaping and the gate replaced or removed.

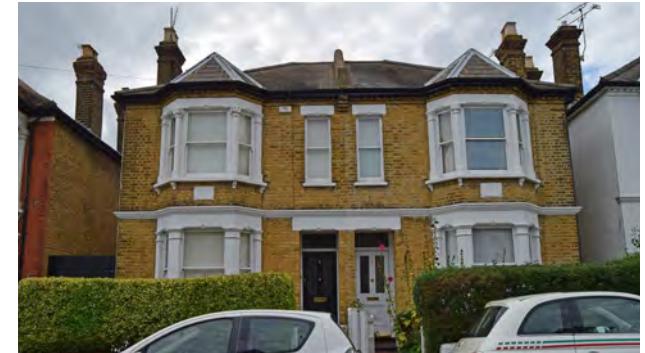
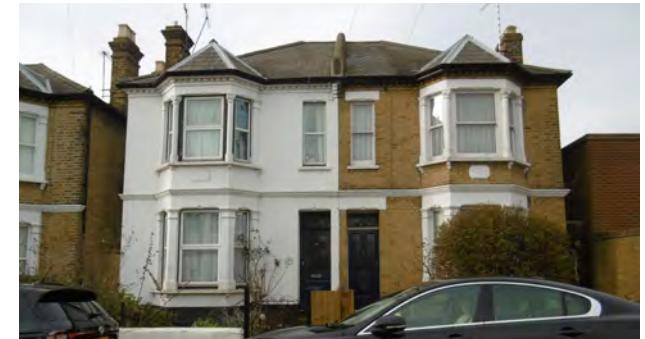
The oldest houses in the road. Two-storey, slate roofs, canted bay windows, timber sashes, recessed porches, timber doors with stained glass upper panels and fanlights. Yellow brick. All have retained their front gardens and Nos.6 and 8 retain original timber gates. No.4 is rendered and has unsympathetic uPVC windows.

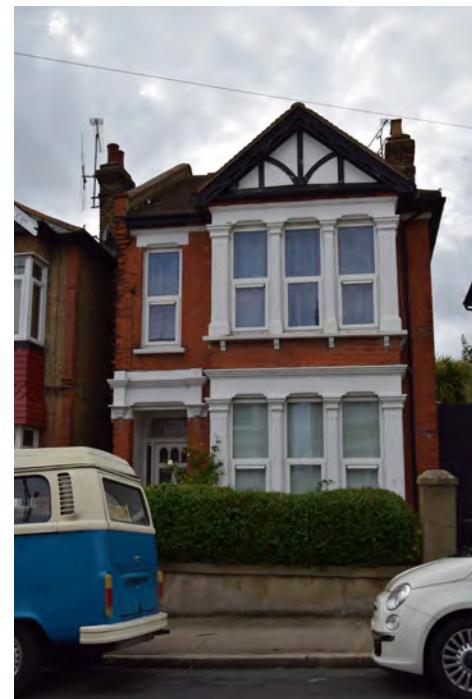
Exceptionally, a detached house, but keyed brickwork at the corner indicates that a second house to create a pair was planned but not built. Red brick façade, stock sides, rectangular bay beneath gable with timber framing. Recessed porch with timber door with stained glass panes and fanlight over. Windows now in uPVC. Machine made tiles. Retains boundary wall and original timber gates, as well as polychrome tiled path.

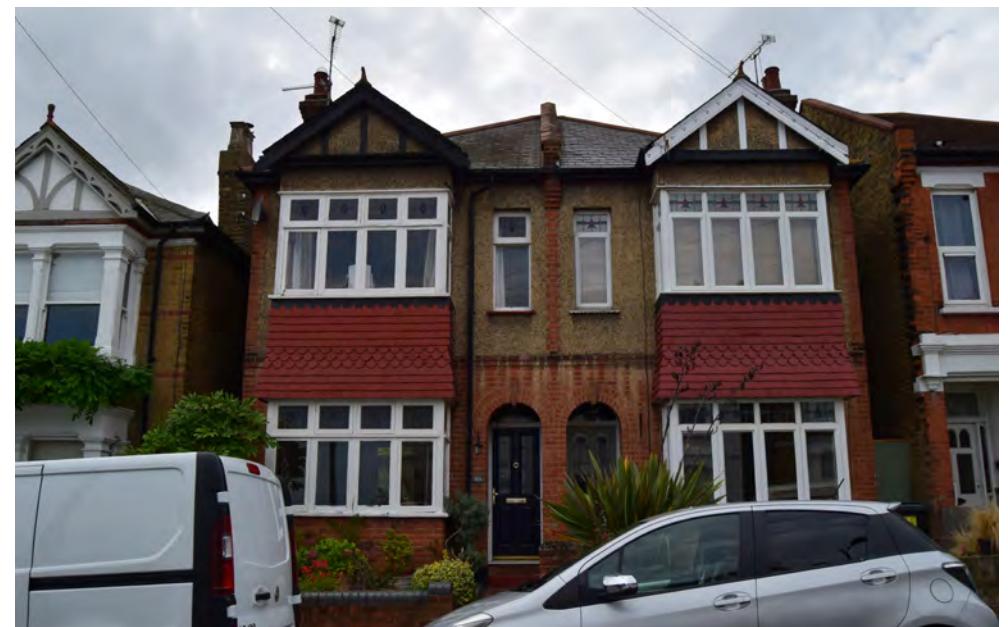
A pair of infill houses, not on the 3rd edition map, and hence presumably late 1920s. Façades in red brick at ground floor, pebbledash above, stock brick to sides and rear. Rectangular bays with tile hanging, casement windows with top lights with small panes with stained glass. No.12 has uPVC windows but of a design which mirrors the original. Recessed porch with timber door with stained glass panes and fanlight over. Tiled pathway to No.12a.
