Leigh Cliff Conservation Area Appraisal

Southend-on-Sea: Leigh Cliff Conservation Area Appraisal

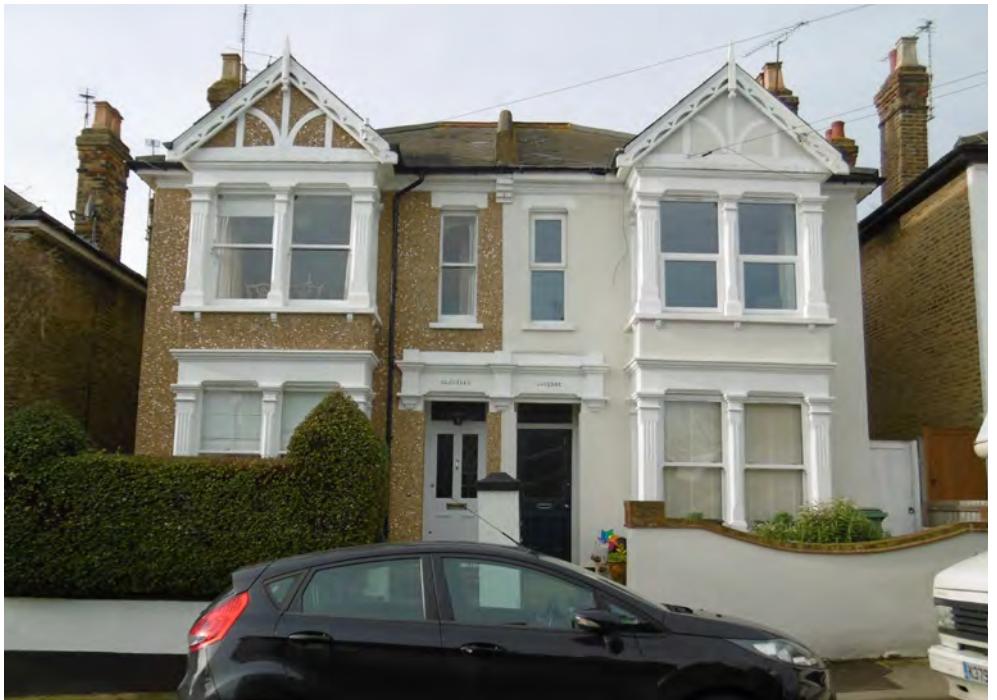
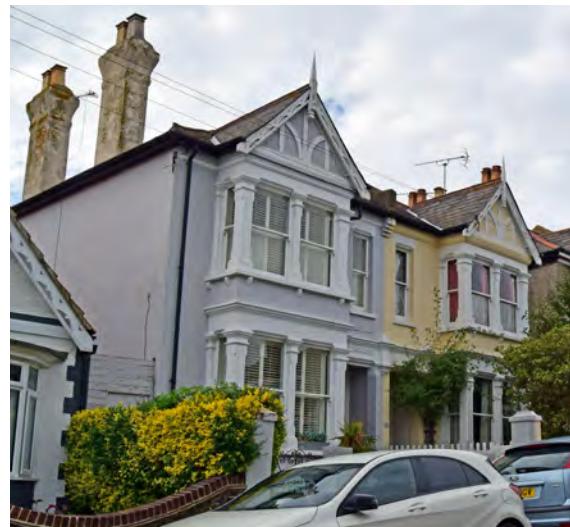
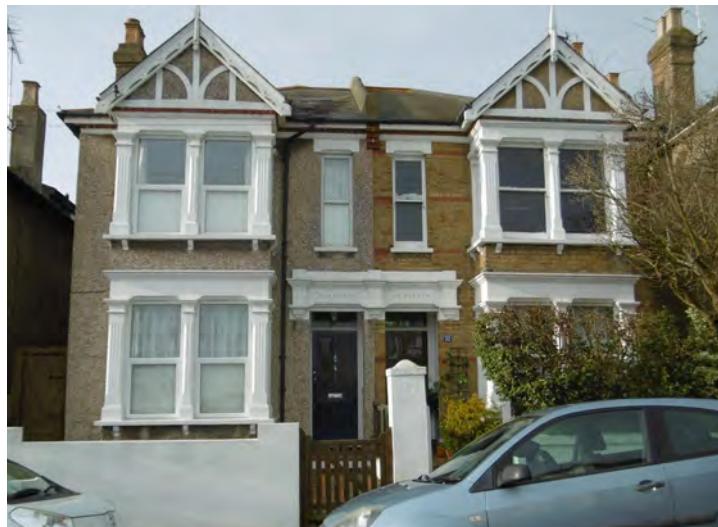
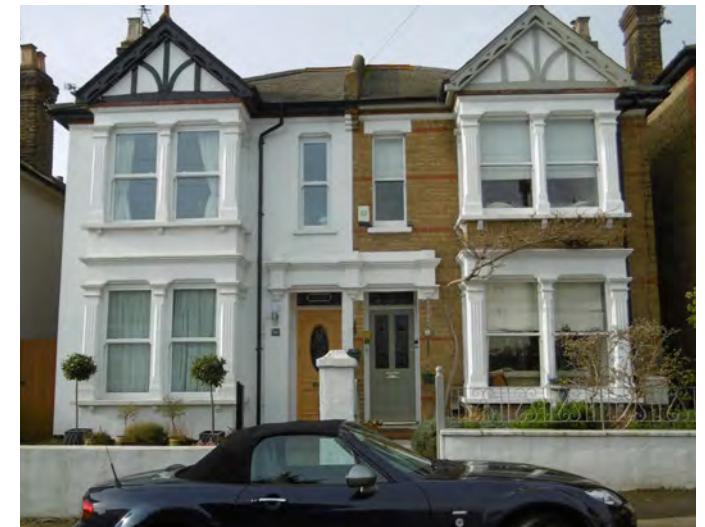
Address	Value to Area's Character	Designation
14–28 Avenue Road	Positive	Article 4

Four pairs of houses. Two-storey, slate roofs, rectangular bay windows under half-timbered gables with decorative barge boards, timber sashes, recessed porches, timber doors with stained glass upper panels and fanlights. Nos.16, 18, 26 and 28 are rendered and white painted. Nos.20 and 24 have been pebbledashed. No.18 has uPVC windows at the first floor; No.24 has uPVC windows and a replacement door which is mainly glazed, both unsympathetic. All retain front gardens and a few have tiled paths.

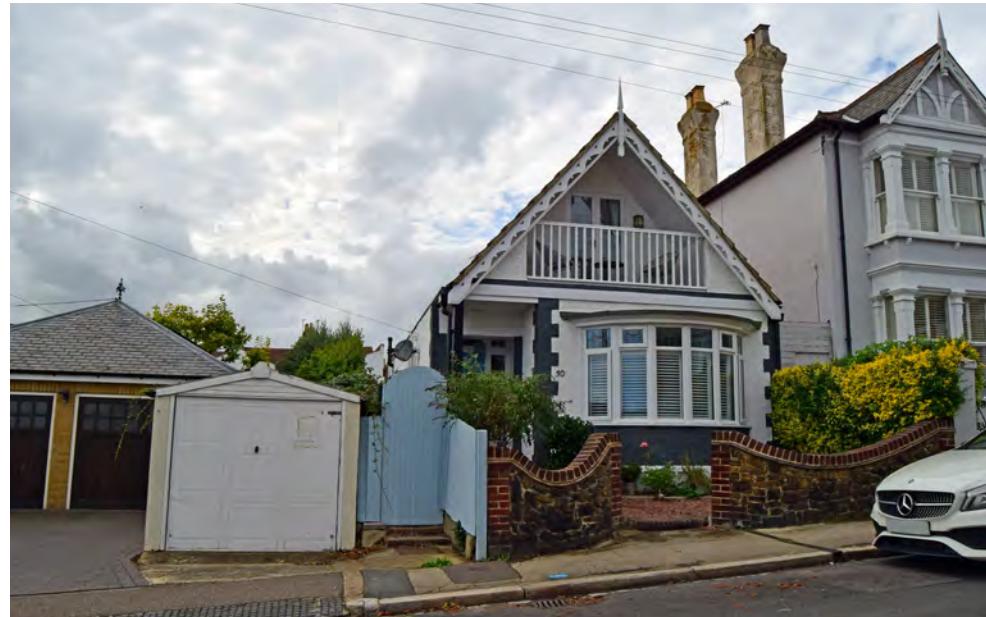
Address	Value to Area's Character	Designation
30 Avenue Road	Positive*	Article 4

An unusual and attractive bungalow, dating from the 1920s or 1930s, with a bow window to the ground floor above which there is a balcony within the gable which has decorative bargeboards. Rooflights have been inserted in the south roof pitch. Prefabricated garage on south side. uPVC windows have been added. Burr brick and red brick boundary wall is attractive.

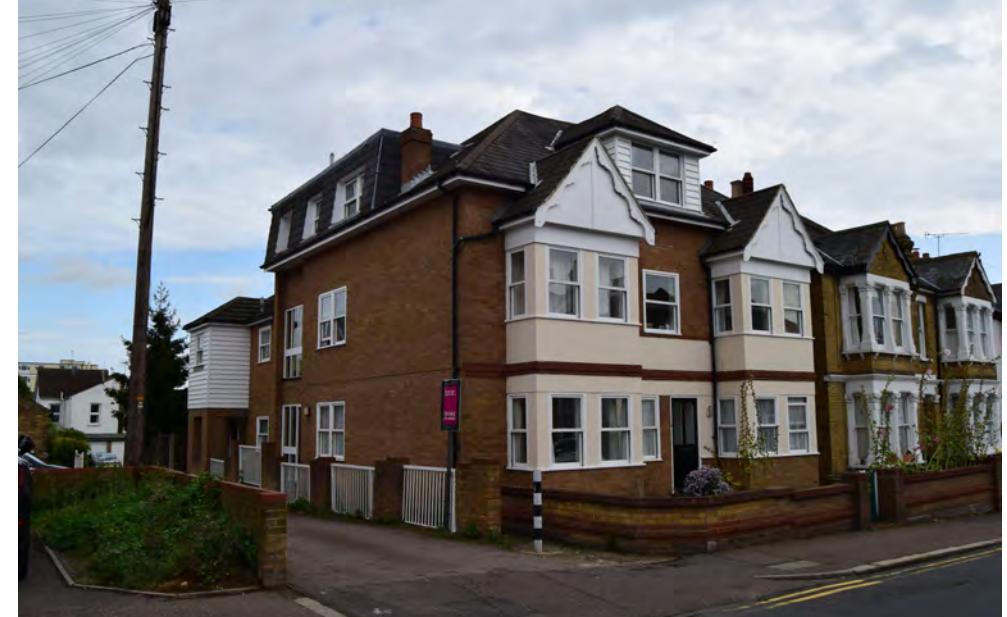
Address	Value to Area's Character	Designation
1–3 Avenue Road	Negative	N/A

A block of late 20th-century flats, taking some references from the Victorian terraces, though not very successfully. The materials and detailing let it down, as do a prominent dormer window on the front elevation, and a very large flat roofed one on the north elevation.

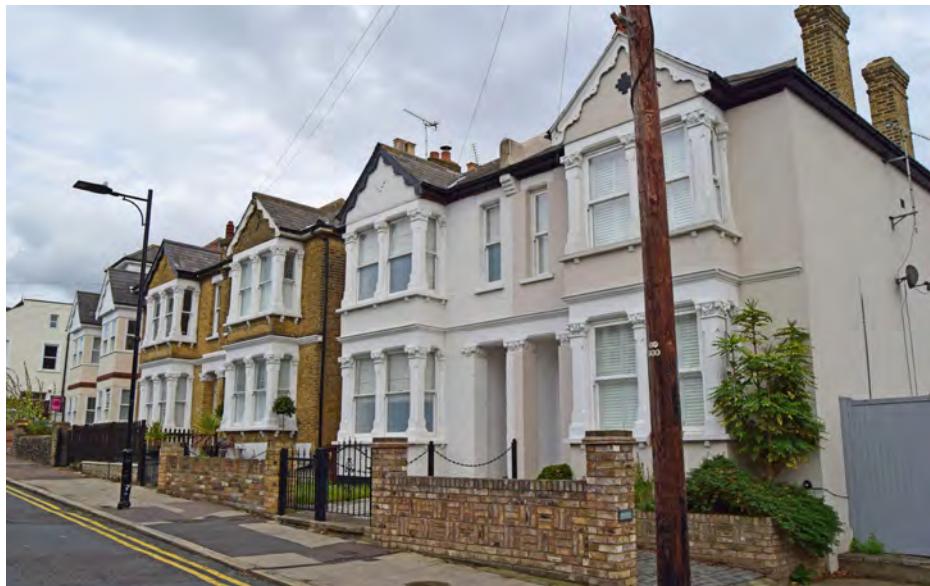
Address	Value to Area's Character	Designation
5-11 Avenue Road	Positive	Article 4

Two semi-detached pairs. Two storey, slate roofs, rectangular bay windows under gables with decorative barge boards and brick motif, timber sashes, recessed porches, timber doors with stained glass upper panels and fanlights.

Nos.9 and 11 have been pebble-dashed and painted. The pebbledash is not in keeping. Front gardens retained, though a variety of boundary treatments. Tile pathways to Nos.7, 9 and 11.

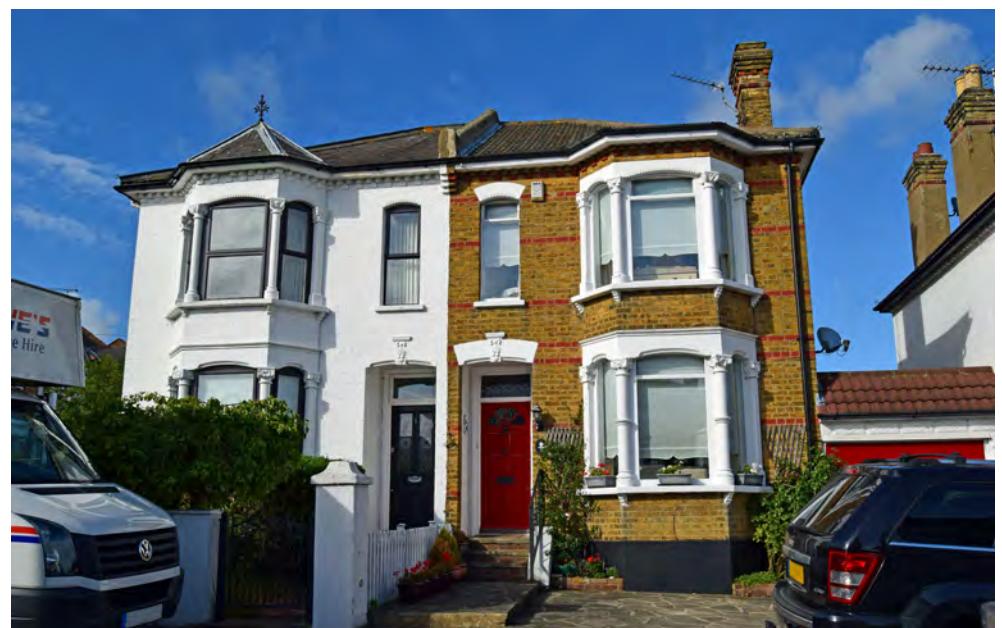
Semi-detached pair with canted bays. Originally both stock brick with red brick banding but No.1 is painted white. No.3 now has a flat roof, not a hipped one, over the bay, with concrete tiles, a front garden paved over, and satellite dish on its flank wall. Both have unsympathetic replacement windows. Recessed porches both with replacement doors but reasonably sympathetic designs, with fanlights over.

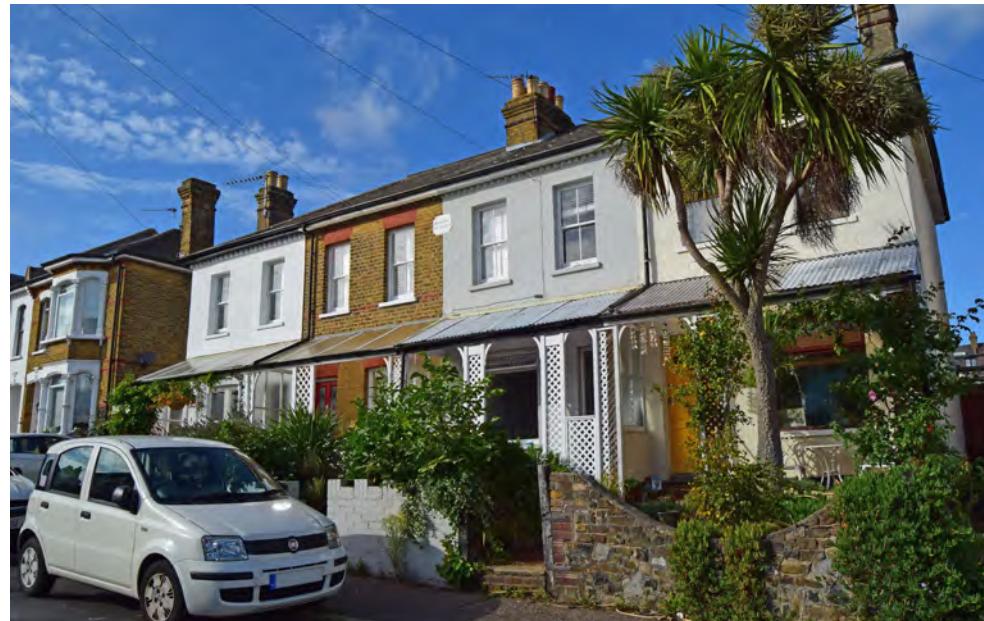
Address	Value to Area's Character	Designation
5–11 Queens Road	Positive	Article 4

Derwent Cottages, a flat fronted terrace with a continuous glazed lean-to verandah. Originally stock brick with red brick details but only No.7 not painted or rendered. All have replacement front doors but these are sympathetic, in timber with glazed upper panels. Timber sash windows except for ground floor of No.9 and all on No.11. Hipped slate roof. All retain front gardens, with a variety of boundary treatments.

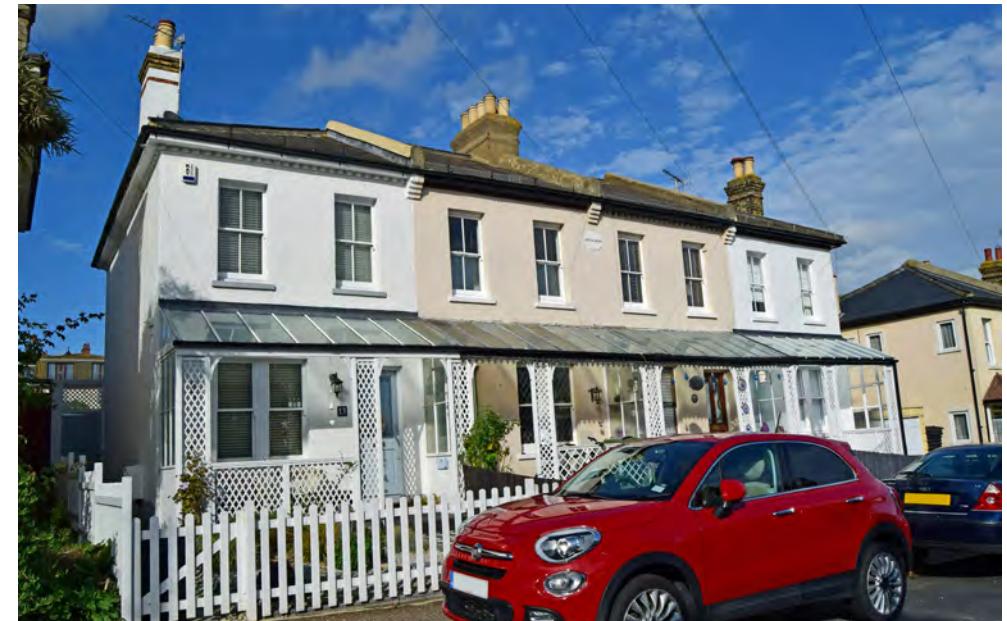
Address	Value to Area's Character	Designation
13–19 Queens Road	Positive	Article 4

Greta Bank. Similar to Derwent Cottages, the façades all rendered and painted, also with a continuous verandah, but the fenestration is better preserved and they all have traditional if not original front doors. Hipped slate roof. All retain front gardens, with a variety of boundary treatments.

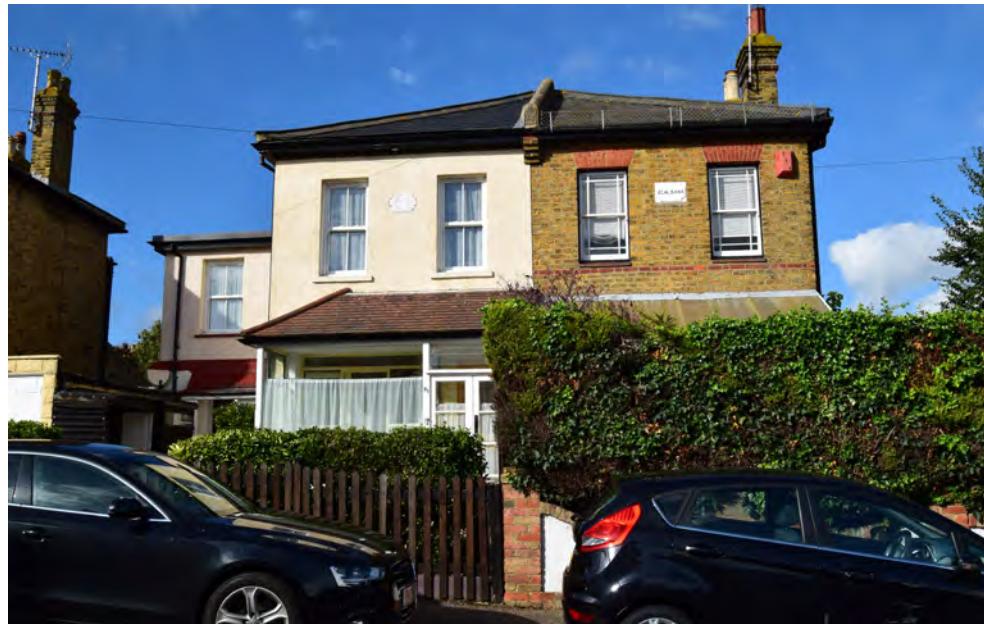
A semi-detached pair. Two-storey, stock brick with red brick details, though No.21 now rendered and painted. Hipped slate roof. No.21 has replacement windows though some are sash form, a glazed front extension and a flat-roofed extension to the side, which have all eroded its character. No.23 has attractive windows with marginal glazing and a glazed ground floor extension but to a more sympathetic design than No.21.

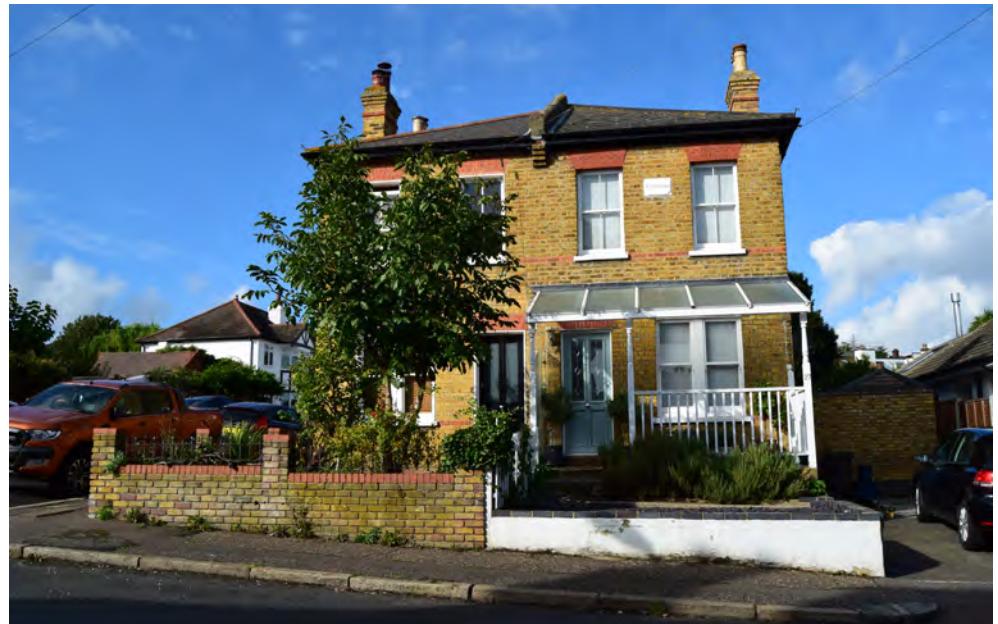
Flat fronted semi-detached pair of houses, stock brick with red brick details, gauged brick arches with tuck pointing. Hipped slate roofs with brick chimneys. No.27 now has a sympathetic verandah added to its front elevation. Timber doors with glazed upper panes, replacements but in-keeping.

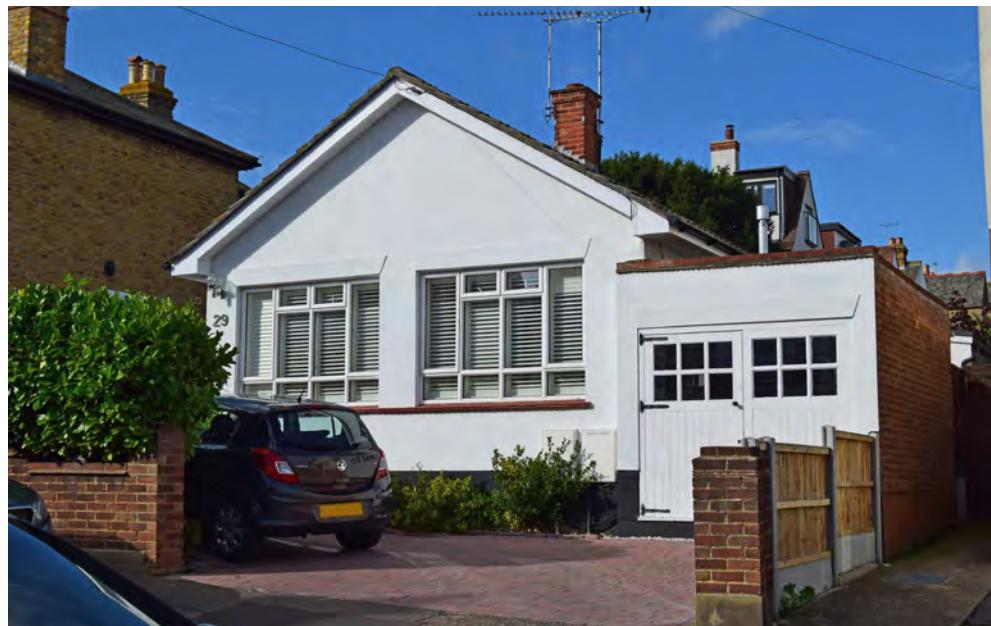
A bungalow, strangely out of place though well presented, rendered white, uPVC windows. Pleasant front garden, and well presented garage.

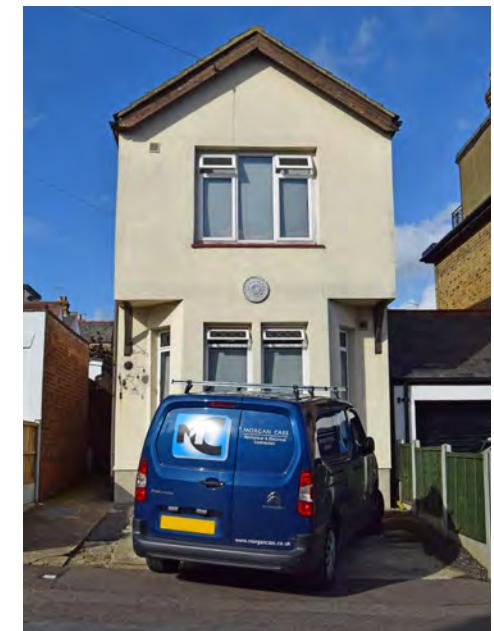
Early 20th-century house now rendered and remodelled and unrecognisable as such, with uPVC windows and tarmac front garden.

Property would benefit from landscaping or planting to soften appearance.

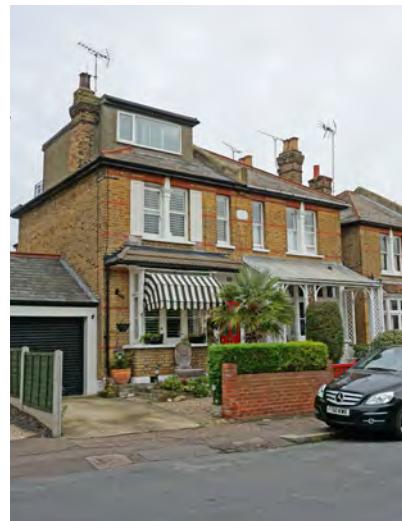
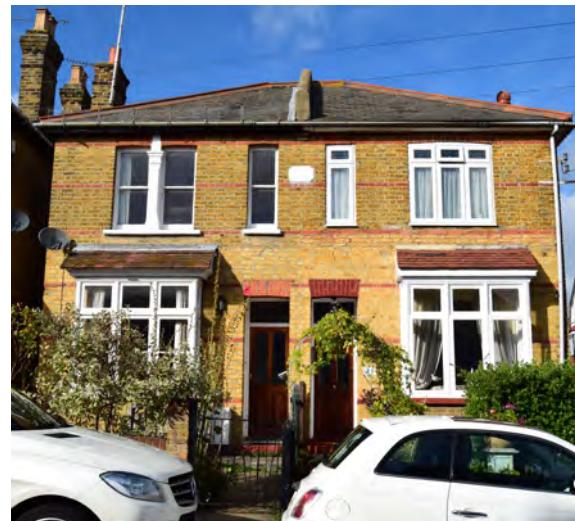
Two similar semi-detached pairs, two-storey, stock brick with red brick detailing, each with a single storey bay under a lean-to tiled roof. No.37 with an attractive verandah with curved lead roof. No.35 bay window roof extended across the façade with concrete tile roof. Recessed porches with timber doors with glazed upper panes and fanlights, some replacements but in-keeping. They still have exposed stock brickwork and slate roofs, but No.35 has an over-large dormer window and No.41 uPVC at the first floor.

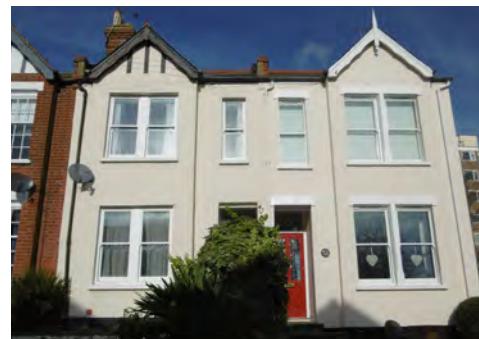
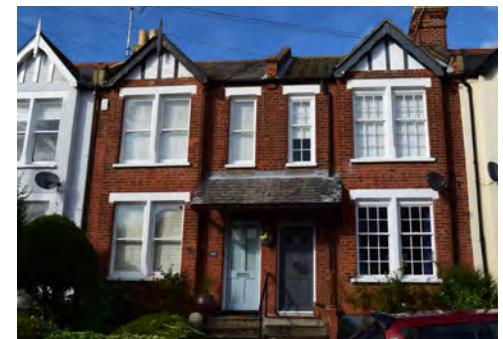
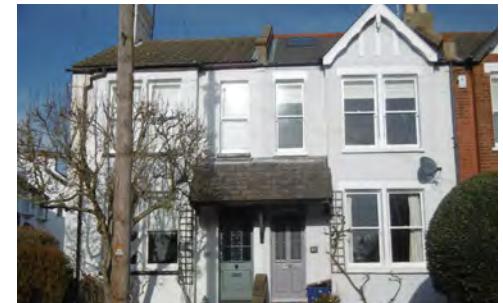
A terrace of six houses arranged as three semi-detached pairs, with slightly projecting bays beneath low half-timbered gables, and lean-to porches with slate roofs. Timber doors with glazed upper panes and fanlights, some replacements but in-keeping. Originally red brick but Nos.45–47, and Nos.53–55, are rendered. Generally well preserved, but No.45 has lost its gable, Nos.45 and 51 have concrete tiles, and the porch has been removed from Nos.53–55.

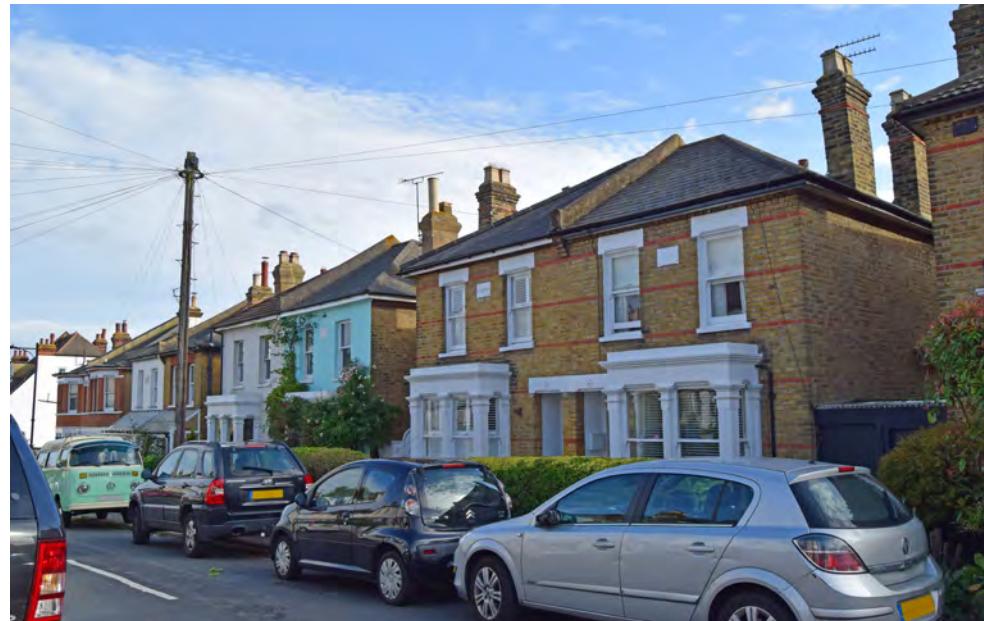
Three similar semi-detached pairs, originally stock brick with red brick detailing, and flat-roofed rectangular bays with white-painted stone mullions and surrounds. Timber sash windows. Recessed porches with timber doors with glazed upper panes and fanlights, some replacements but in-keeping. Generally well preserved. Nos.4 and 12 have concrete tiles instead of slate. Nos.10 and 12 have been painted. A more appropriate colour would have been better suited for No.10.

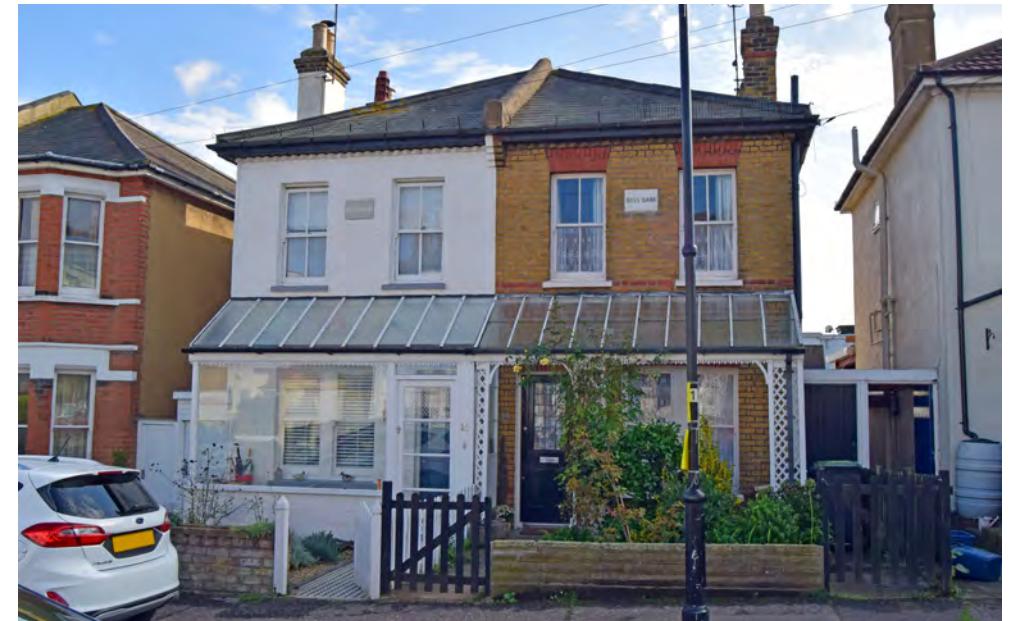
Address	Value to Area's Character	Designation
14–16 Queens Road	Positive	Article 4

Semi-detached flat-fronted pair, to which a verandah has been added. Infilling of verandah to No.16 is not entirely in-keeping. Stock brick with red brick detailing, though No.16 is painted white. Hipped slate roof. Timber doors with glazed upper panels.

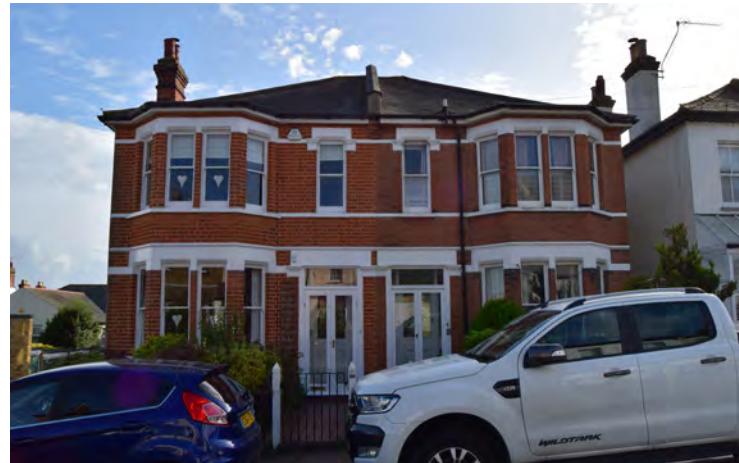
Address	Value to Area's Character	Designation
18–20 Queens Road	Positive Garages: Negative	Article 4

Handsome well preserved semi-detached pair with red brick façade, and full height canted bays beneath flat roofs. Main roof is hipped slate. Timber sash windows. Timber doors with glazed upper panels and fanlights, set in recessed porches, though these have been in-filled with glazed double doors. No.20 has a tiled footpath to the front door. Post and chain boundary to front gardens.

A row of four flat-roofed garages, occupying an infill site, originally the garden of a house on Cliff Parade. Stock brick, metal doors, fronting a large garage court. Their prominent frontage position, and the concrete surfacing around them, is unfortunate.

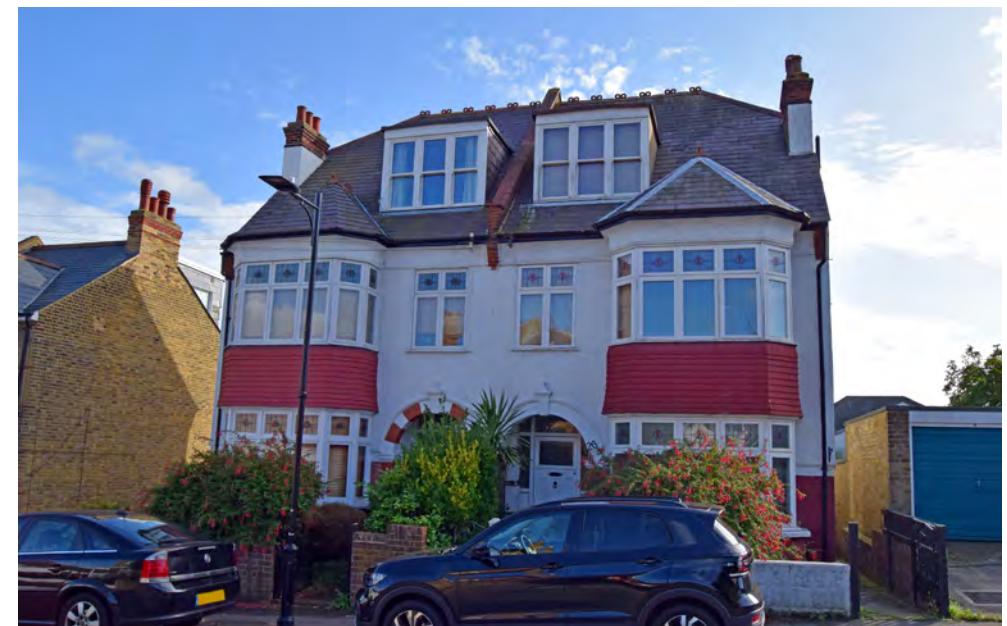
Later in date, a pair of 1920s semi-detached houses, two-and-a-half storey with a deep plan, which makes them taller than the rest of the road. Ground floor red brick, upper floor rough cast render white painted. Polygonal bays with tile hanging under hipped slate roofs, large original dormer windows. Casement windows with stained glass in the top lights.

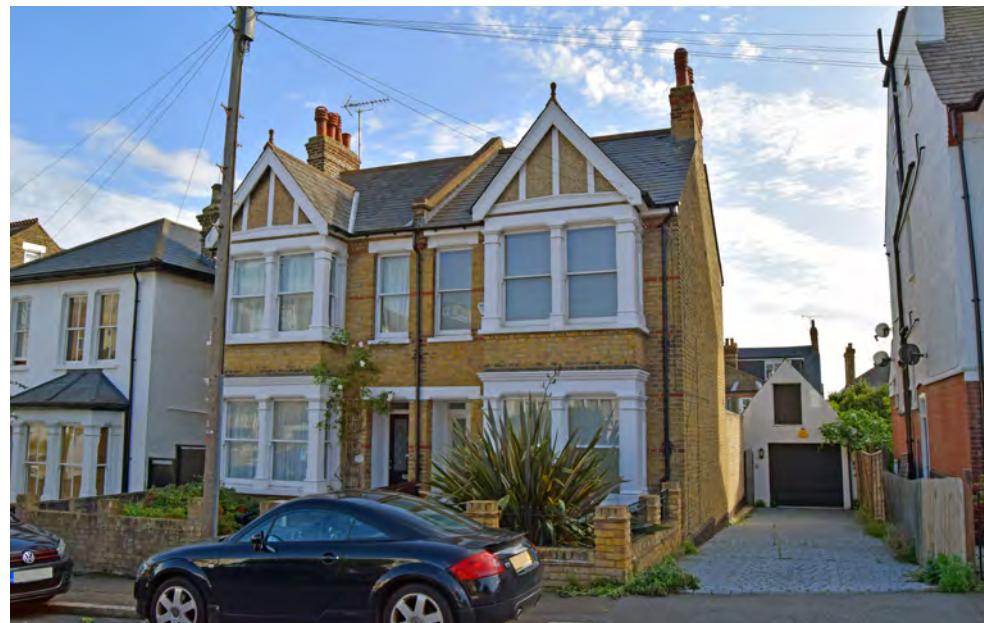
Address	Value to Area's Character	Designation
30–32 Queens Road	Positive	Article 4

Semi-detached pair, two storeys, stock brick with red brick details, rectangular bays under gables with half-timbered decoration. Slate roofs. Sash windows. Recessed porch with timber doors with glazed upper panels and fanlights.

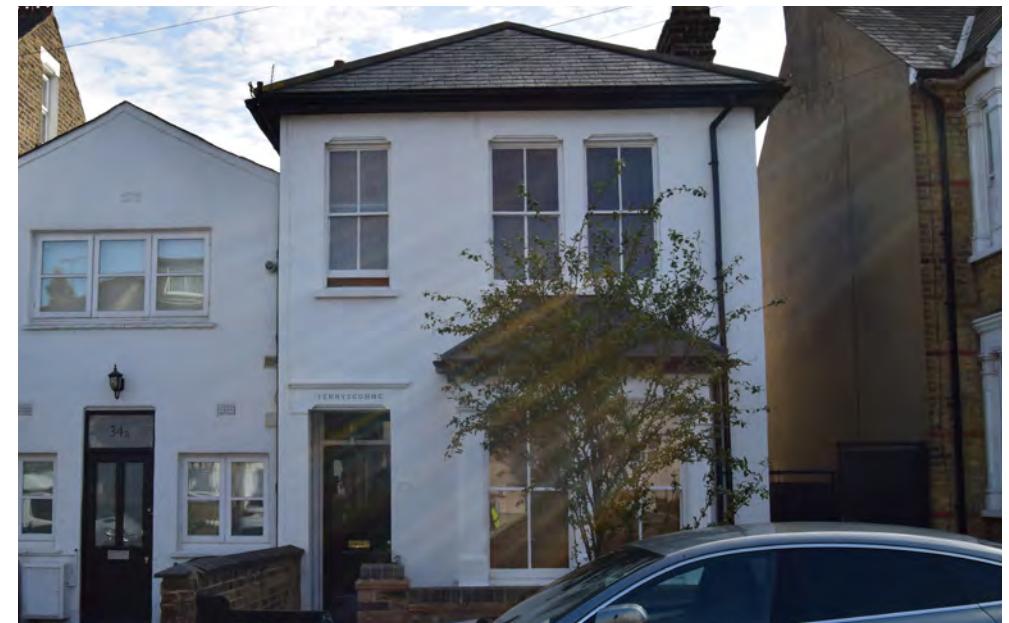
Address	Value to Area's Character	Designation
34 Queens Road	Positive	Article 4

Two-storey house, ground-floor rectangular bay, white rendered, slate roof, sash windows, recessed porch with timber door with glazed upper panels and fanlight.

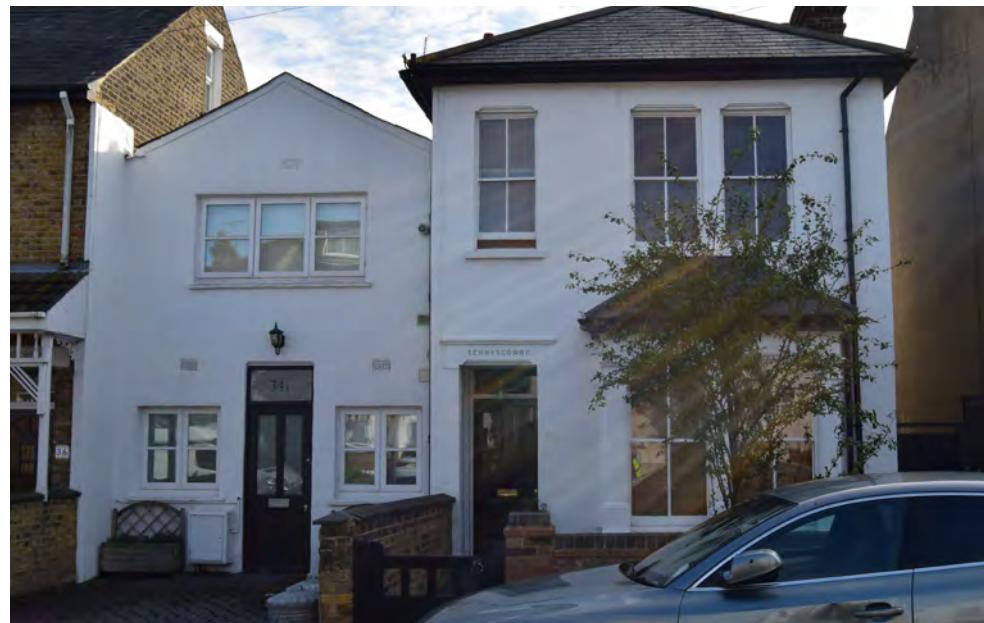
Address	Value to Area's Character	Designation
34a Queens Road	Neutral	Article 4

Not originally a house, possibly a workshop, low gable to the street, white rendered, uPVC windows, and a paved front garden. Planting at front would soften appearance. Would benefit from taller window proportions.

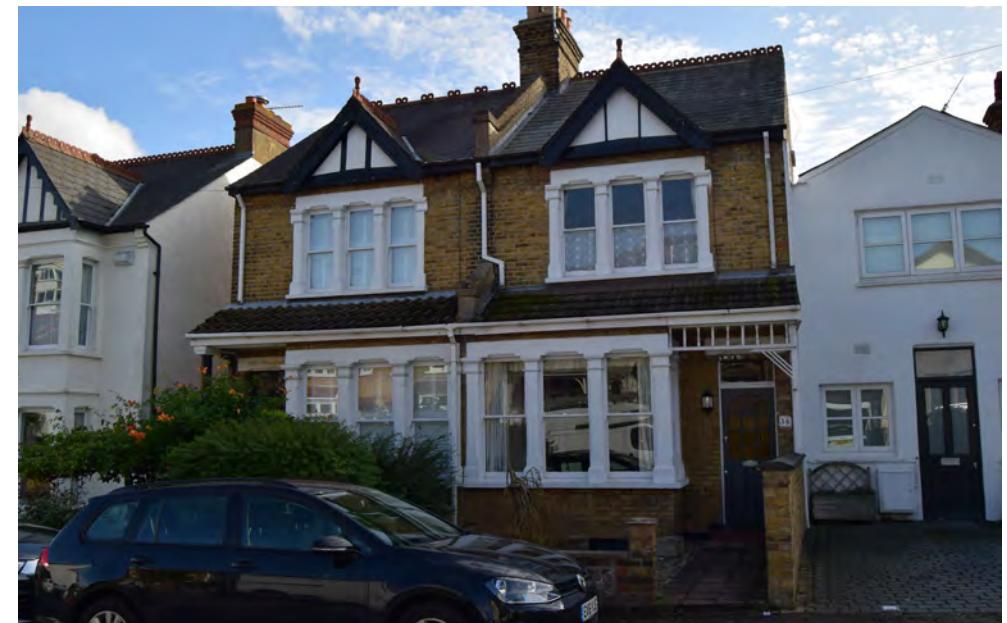
Address	Value to Area's Character	Designation
36–38 Queens Road	Positive	Article 4

Two storey pair of houses, stock brick, single storey rectangular bays under a lean-to roof with concrete tiles which continues to form a porch for the front doors. Door to No.36 is timber with glazing to the upper half, a replacement but in-keeping. Door to No.38 is timber with stained glass and stained glass fanlight. Timber sash windows. Gables to first-floor windows. Crested ridge tiles.

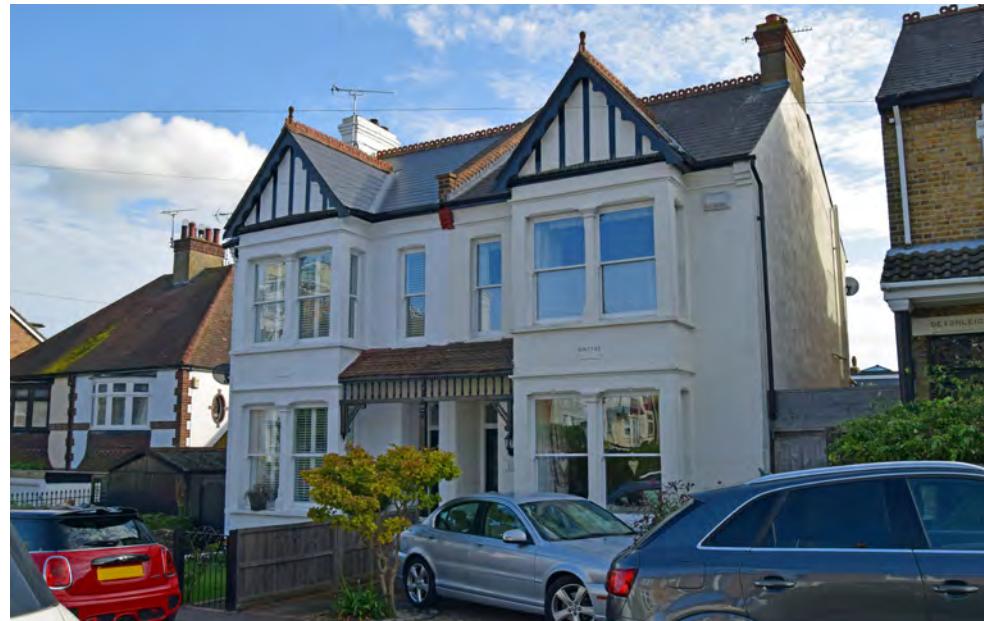
Address	Value to Area's Character	Designation
40–42 Queens Road	Positive	Article 4

Semi-detached pair, painted rough-cast render, rectangular bays beneath half-timbered gables. Crested roof tiles to slate roof. Sash windows. Red tile roof to porches, recessed doors, timber with glazed upper panels and fanlight. The garden of No.40 has been block paved. No.42 has a boundary wall of vitrified brick.

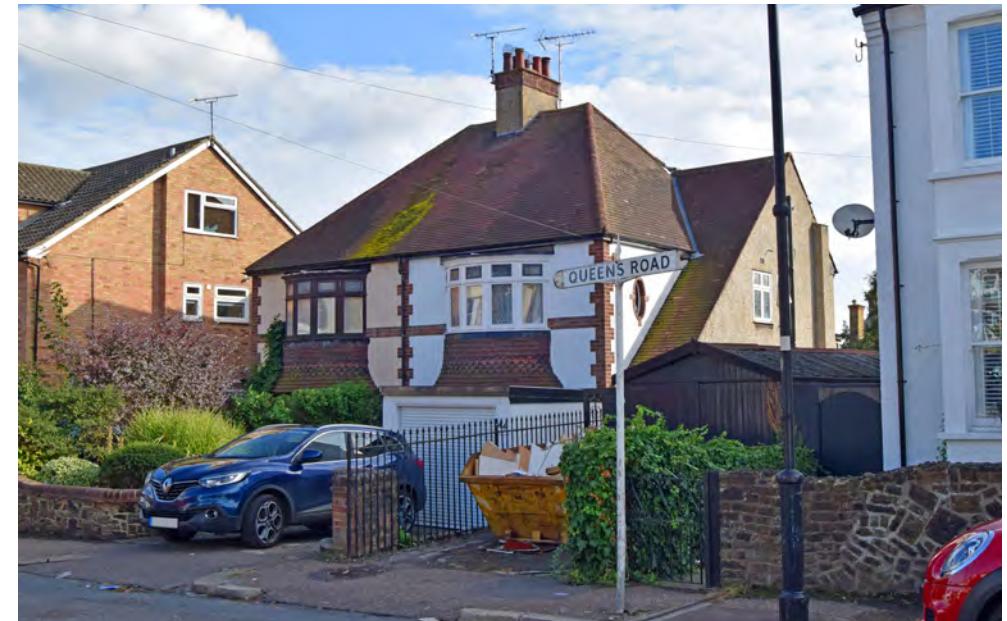
Address	Value to Area's Character	Designation
44–46 Queens Road	Positive*/ Positive	Article 4

Semi-detached pair dating from the 1920s/1930s, each with a curved two-storey bay with tile hanging. Rendered walls with exposed red brick details. Red tile roof. Timber casement windows with stained glass top panels. Different from the rest of the street in style, and also in being set further back from the frontage, the gardens now being used for parking. Integrated garage at the front of No.44 is unattractive

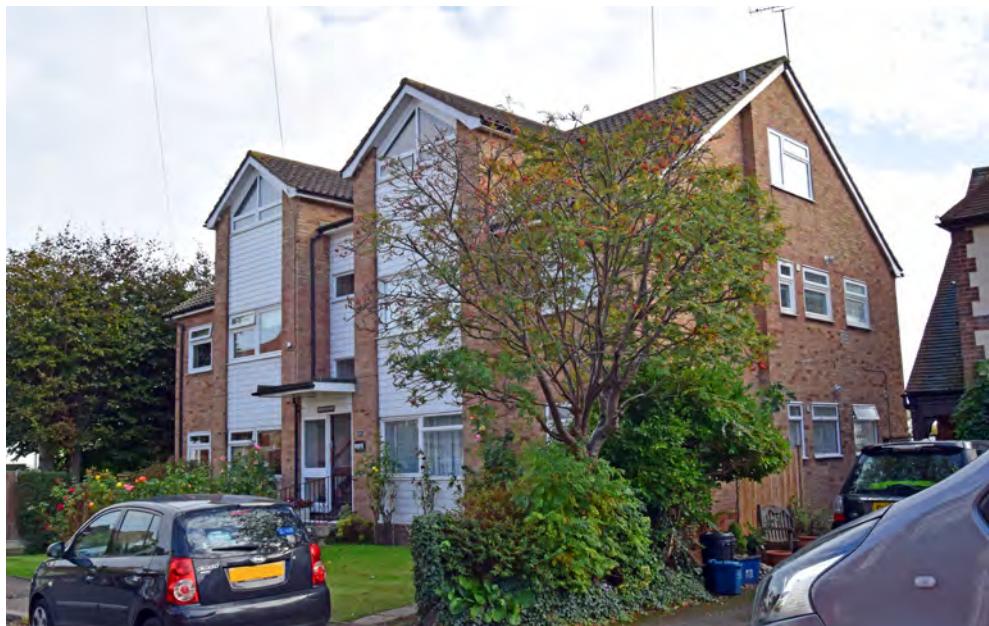
Address	Value to Area's Character	Designation
Queens Court	Negative	Article 4

Flats with two three-storey bays, fletton brick and white weatherboard to the projecting bays which have glazing in the top of the gables. Does not match the rest of the street in scale, materials or design.

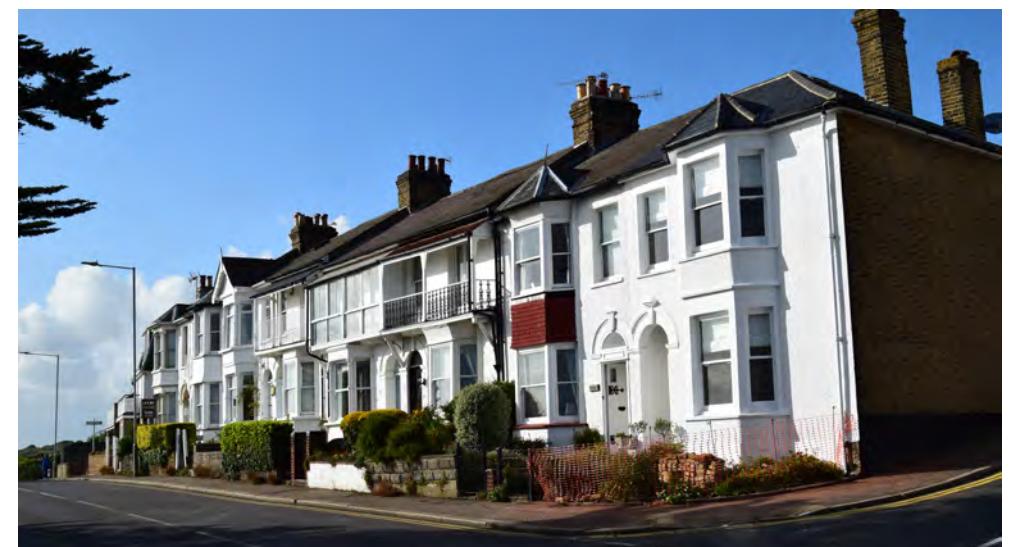
Address	Value to Area's Character	Designation
5–12 Cliff Parade	Positive*	Article 4
Description		
Terrace of houses, originally built to the same pattern, with full height canted bays under hipped roofs, and round arched doors with keystones. Originally brick but now all rendered and painted. Slate roofs. The bays are now often altered. Nos.8–10 have had balconies with cast iron balustrades constructed across first floor level with the bay removed. The first floor balcony to No.9 has been inappropriately in-filled. The sashes are mostly intact, but No.7 has replacement uPVC windows. No.5 has had the single window on the first floor unsympathetically converted to a door with small balcony. Nos.7–11 have had the front lobbies enclosed by outer doors. Hung tiles added to bay of No.11. No.5 is in poor state of repair and requires maintenance and repainting.

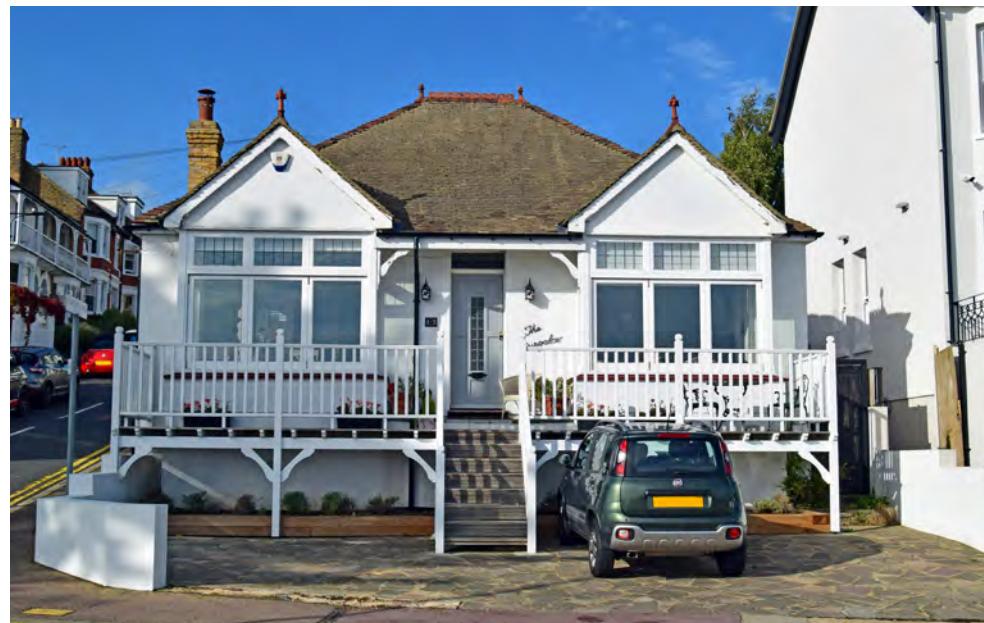
Address	Value to Area's Character	Designation
13 Cliff Parade	Positive	Article 4

The Bungalow, a double-fronted bungalow with two gables facing the road, built in the 1920s. The slate roof has crested ridge tiles and finials, and the brickwork has been painted white with white timber window frames. The front garden is used for parking and the large area of hardstanding would benefit from landscaping to soften the frontage. The balcony is a modern timber replacement that is in keeping, though not as elaborate as the original balcony.

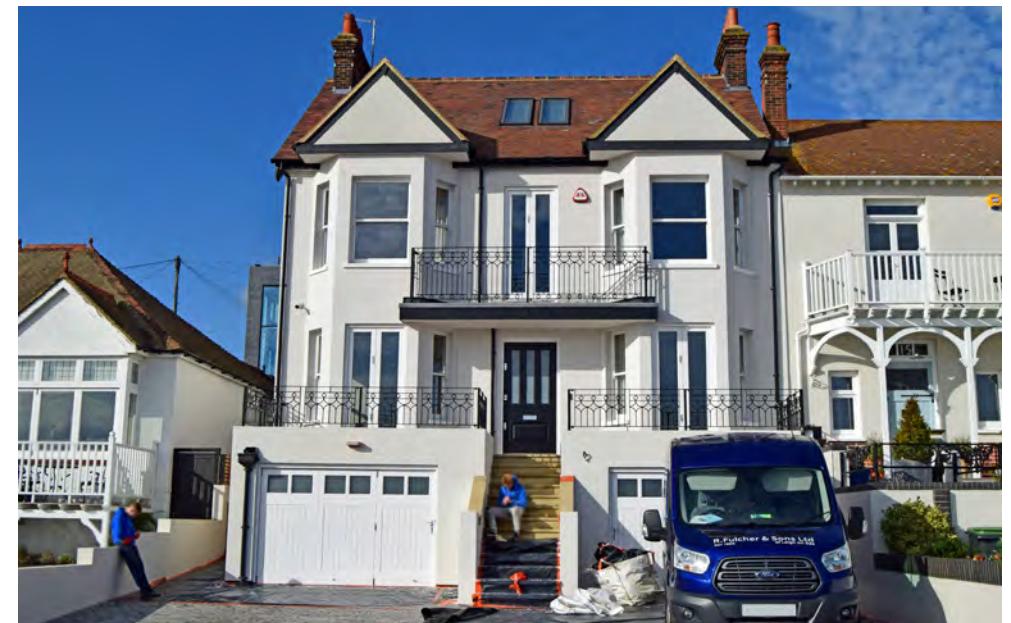
Address	Value to Area's Character	Designation
14 Cliff Parade	Positive*	Article 4

Large double-fronted house with full height canted bays beneath gables, red tile roof with discreet roof lights, new replacement windows. Garages in the basement either side of the steps to the front door are not in keeping. This flight of steps is an original feature and shown on the 2nd edition OS map. Modern metal railings to balcony and above garages. Balcony is a later addition, with the original sash window extended down to form a door. Would benefit from planting to soften hard landscaped frontage. Boundary wall lost.

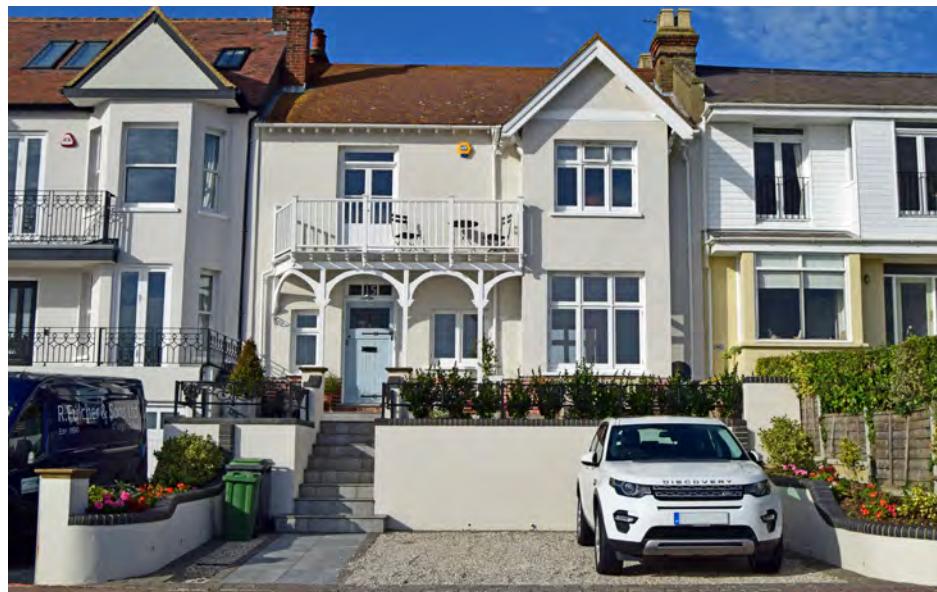
Address	Value to Area's Character	Designation
15 Cliff Parade	Positive	Article 4

Nicely restored house in an Arts and Crafts style, with a cross-wing gable, and timber casement windows with opening top lights. Painted render. Red tile roof. Pretty timber balcony above front door. A modern terrace with good cast iron railings has been built up round the steps to the front door, leaving the rest of the garden area used for parking. This has been carefully designed, with paving in sandstone and tegula or similar, and engineering brick copings to the enclosing walls. However, loss of enclosing boundary wall is regrettable.

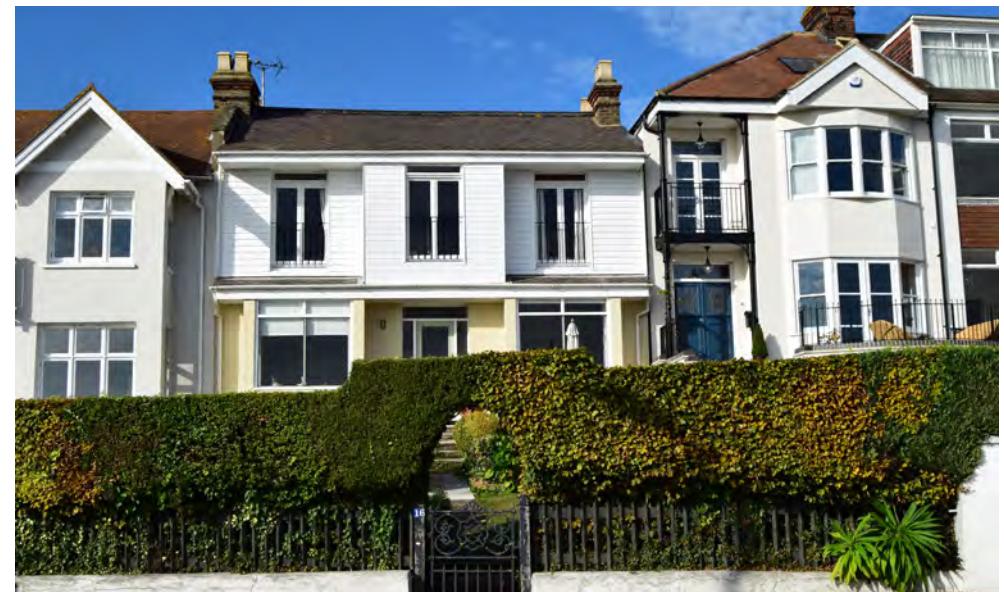
Address	Value to Area's Character	Designation
16 Cliff Parade	Positive*	Article 4

A late Victorian house, looks modern due to extensive remodeling which has reduced its character. Historic photographs show gables with decorative barge boards above the first floor windows, a pebble dash finish with mock timber framing, and timber posts to the porch. Slate roof and stock brick chimney, with French windows and white shiplap boarding at the first floor. Picture windows to ground floor and modern glazed door. Attractive hedged front garden.

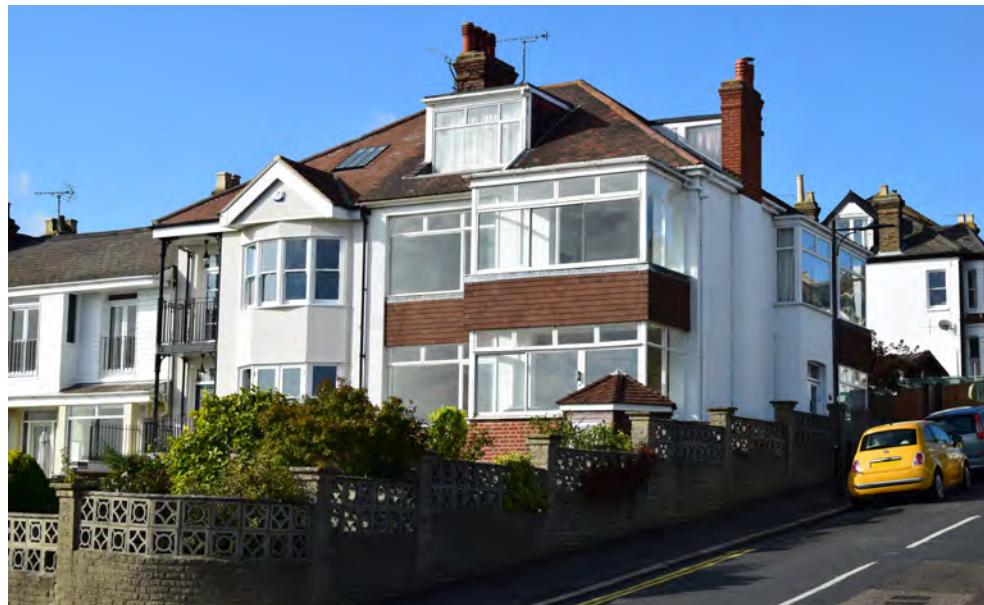
Infill development of the 1920s and 1930s, on the site of a former church and the Victoria Hall. Probably built as a large pair of semi-detached houses. No.16a is closer to the original appearance, with a bow-fronted bay, now with replacement sash windows, and black painted attractive metal verandah at ground and first floor levels, timber double door with stained glass panels. No.16b has been completely remodelled with the construction of a huge bay with picture windows, glazed in balcony and an over-large dormer window. It retains little of its original character.
