Leigh Cliff Conservation Area Appraisal

Southend-on-Sea: Leigh Cliff Conservation Area Appraisal

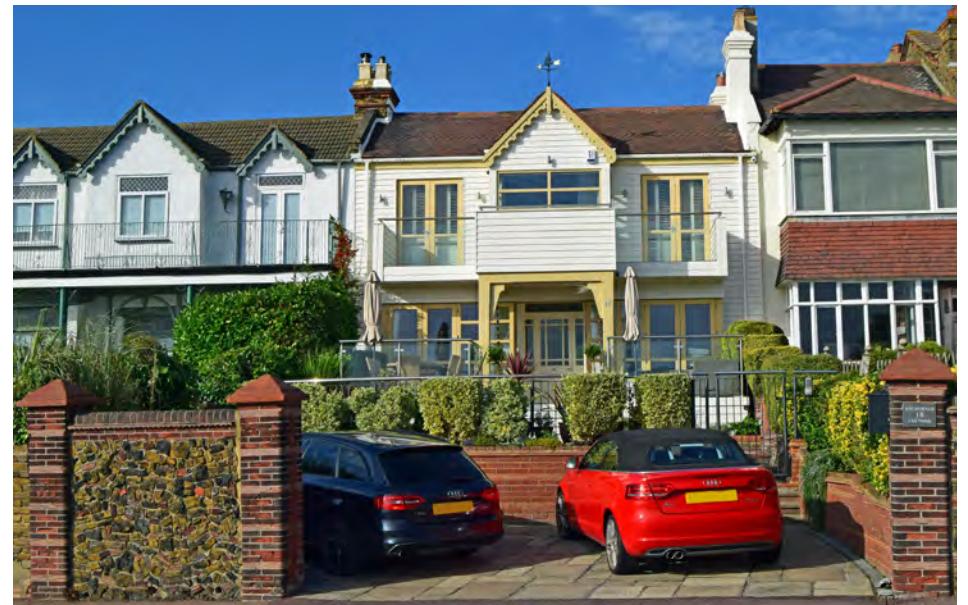
A pair of late Victorian houses, with small gables facing the street and balconies, now much altered. No.17 is white rendered and has concrete tiles. The windows are casements with top lights. No.18 has red tile roof and has been clad in cream-painted weatherboard, which has eroded the character of the house. Pleasant terrace to the front. Planting in both softens appearance onto street. Boundary wall part retained to No.18 helps to mitigate the insertion of a driveway.

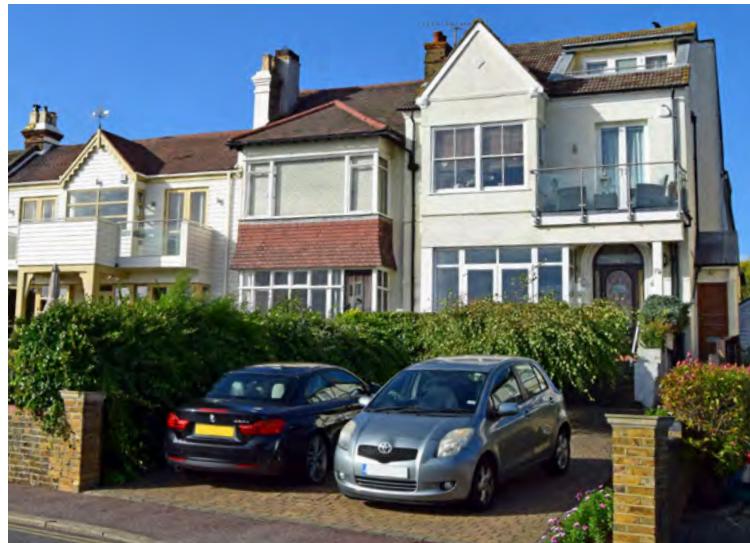
No.19 is an infill house of the 1920s or 1930s set in the gap between 18 and 19a. Its front elevation is occupied by a large rectangular bay beneath a hipped roof, with unsympathetic picture windows at the first floor. Timber door. No.19b comprises a late Victorian house, white rendered with reinstated sash windows. Glazed balcony to first floor is not in-keeping and an inset balcony to the roof, although not characteristic of the street, replaces a previously over-scaled box dormer and is therefore an improvement. Timber door with attractive stained glass. Garden to front of No.19a has been used for parking, could be improved with landscaping or planting.

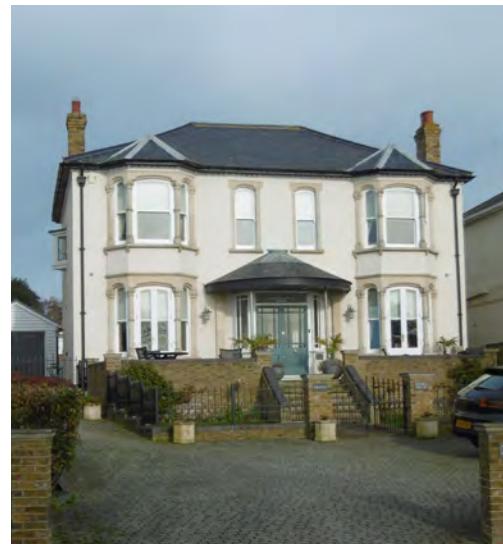
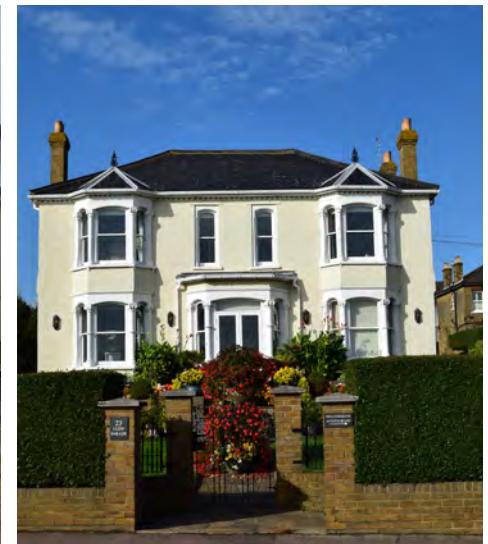
Originally two semi-detached pairs, now adapted as single houses. Full height canted bays under hipped roofs, mullions with foliate capitals, dog's tooth ornament over windows, similar to the houses on the east side of Victoria Road. Timber sash windows. Hipped slate roofs. The conversion has involved substitution of a single for the pair of front doors. Both have been carefully restored and well maintained. No.23 has well landscaped front gardens, though No.20 has used part of theirs for parking.

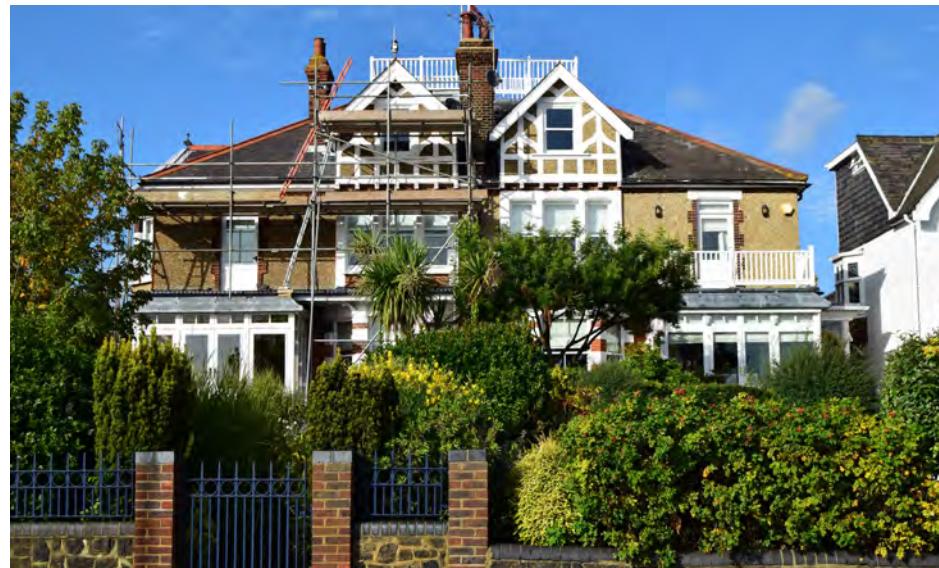
Address	Value to Area's Character	Designation
24-25 Cliff Parade	Positive	Article 4

A large semi-detached pair on an infill site, probably first decade of the 20th century, with Arts and Crafts influence, such as red brick at ground floor, pebbledash at first floor, and timber framing in the gables. Both are very well presented; first floor balcony with timber balustrade extends across the full frontage over a wooden conservatory, and there is a belvedere. No.25 is undergoing renovation (near completion). Very large and well landscaped gardens, an asset to both properties. Good stone and red brick boundary wall topped with railings.

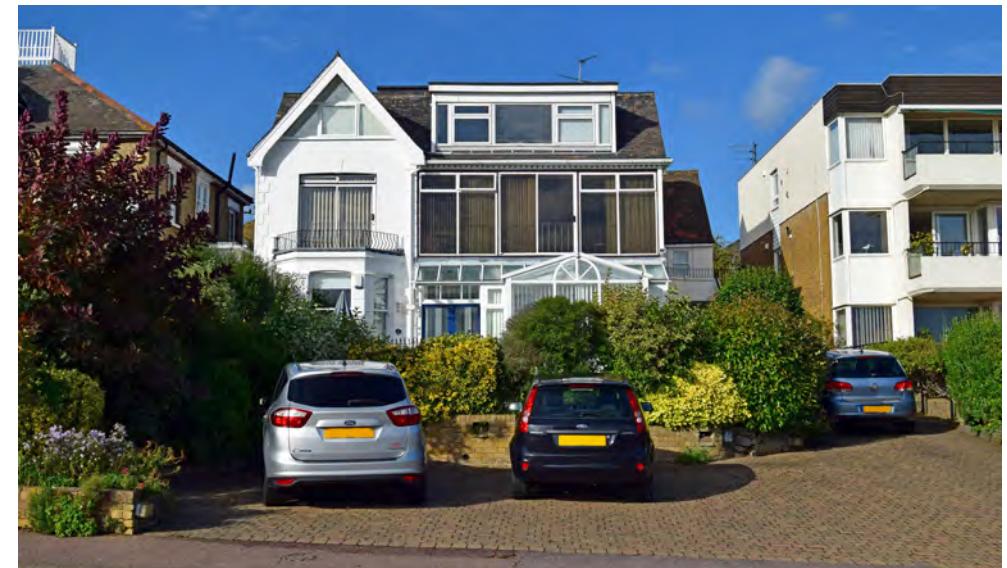
Address	Value to Area's Character	Designation
26 Cliff Parade	Positive*	Article 4

A late Victorian house, with inappropriate renovations, raised in height to the rear under a flat roof, large flat-roofed dormer, fully glazed balcony, picture windows, conservatory at ground floor front, and use of uPVC. Large parking area with the loss of front boundary wall. Historic photos show timber windows, a stone balustrade above the ground floor bay window, an open balcony with timber railings to the first floor and a timber framed ground floor conservatory. Some of the original character could be reinstated, though it would require substantial remodelling.

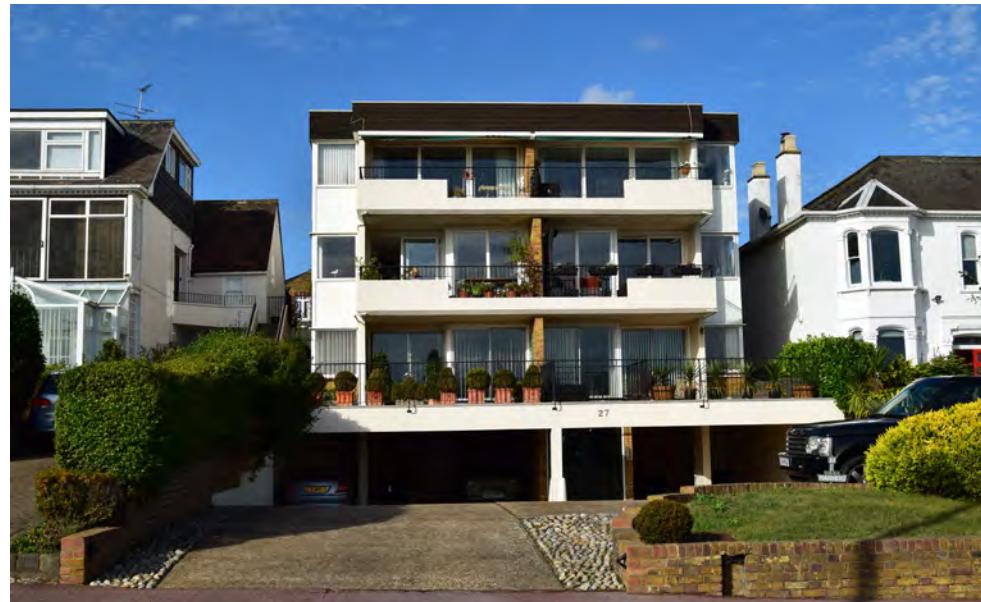
Address	Value to Area's Character	Designation
27 Cliff Parade	Neutral	Article 4

Large three-storey flat-roofed block of flats replacing an earlier hotel, brick and white painted render, front elevation occupied by balconies, parking in garden area despite basement garaging. Well maintained, but out of character in terms of scale and massing.

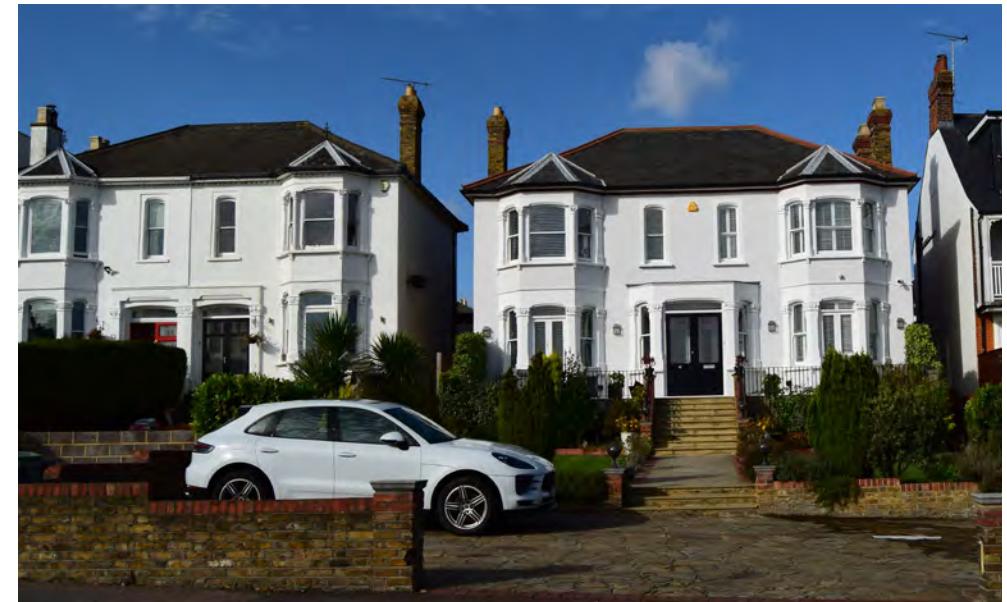
Address	Value to Area's Character	Designation
28-31 Cliff Parade	Positive	Article 4

Two pairs of similar late Victorian semi-detached houses (though eastern pair has now been converted into one property), canted bays beneath hipped slate roofs, rendered and painted, but generally well preserved apart from sash windows to front of bay on No.28 being replaced with large panes of glass. Timber sashes elsewhere. French windows in the ground-floor bays of Nos.29-31. All use front garden area for parking with loss of most of the boundary walls.

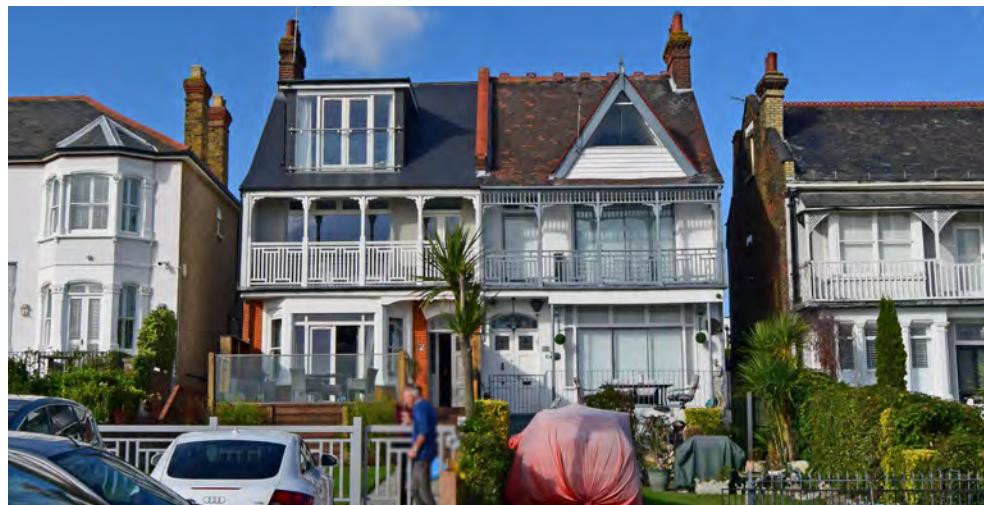
A semi-detached pair, early 20th century, their later date evident from the steeply pitched roof, No.32 has slate, while No.33 is red tile. Both have had their first floor windows replaced. The dormer window to No.32 has a glazed Juliet balcony which is out-of-keeping. Both have attractive timber balcony at first floor level, No.32 a successful replacement, No.33 the original. No.33 also has replacement windows at the ground floor but not unsympathetic. Glazed gable to No.33 is unusual addition, but not unattractive alteration, to make use of attic space. Timber doors with glazed upper panels, double in the case of No.33. Front boundary walls lost for driveways to both properties. Glazed balustrade to patio area on No.32 is not in keeping.

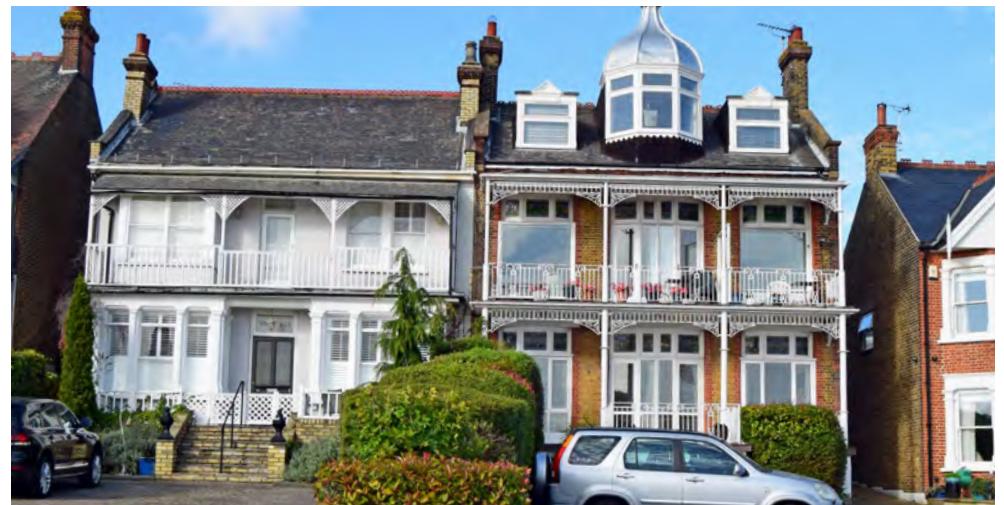
A pair of large double fronted houses, early 20th century. Steep pitched roofs, in slate, originally brick but No.34 now painted. Their main features are full width balconies, different in style, in the case of No.35 extending to the ground floor as a verandah. Sash windows to No.34. No.35 has replacement windows which extend the full height of each floor, though in timber and with stained glass top panes. There is a cupola to the roof, a distinctive feature in the street scene, with two dormer windows added to the sides which would benefit from improvement of proportions and detailing. Timber door with glazed upper panels to No.32, while door to No.33 is part of the central ground floor window. The extensive parking at both houses is regrettable.

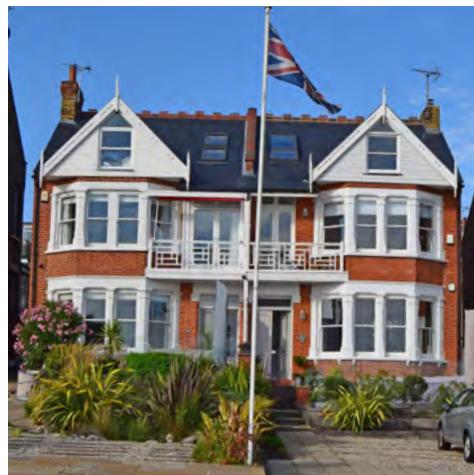
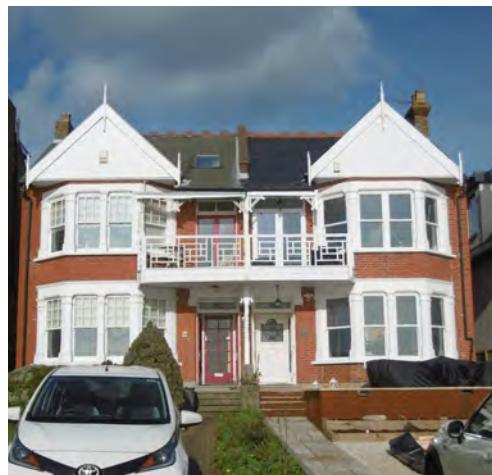
Address	Value to Area's Character	Designation
36-39 Cliff Parade	Positive	Article 4

Two similar semi-detached pairs, steep roofs covered with slate with crested tile ridges, canted bays beneath timber-clad gables, linked above the entrance doors by attractive white painted wooden balconies. Red brick. Sash windows, with those to Nos.37-39 with smaller panes to upper sash. Timber front doors with stained glass panels and fanlights, in recessed porches, though most have timber double doors enclosing the porch, though in a sympathetic design. Well preserved and maintained. Loss of enclosing boundary wall and extensive parking area regrettable.
