# Milton Conservation Area Appraisal

# Southend-on-Sea: Milton Conservation Area Appraisal

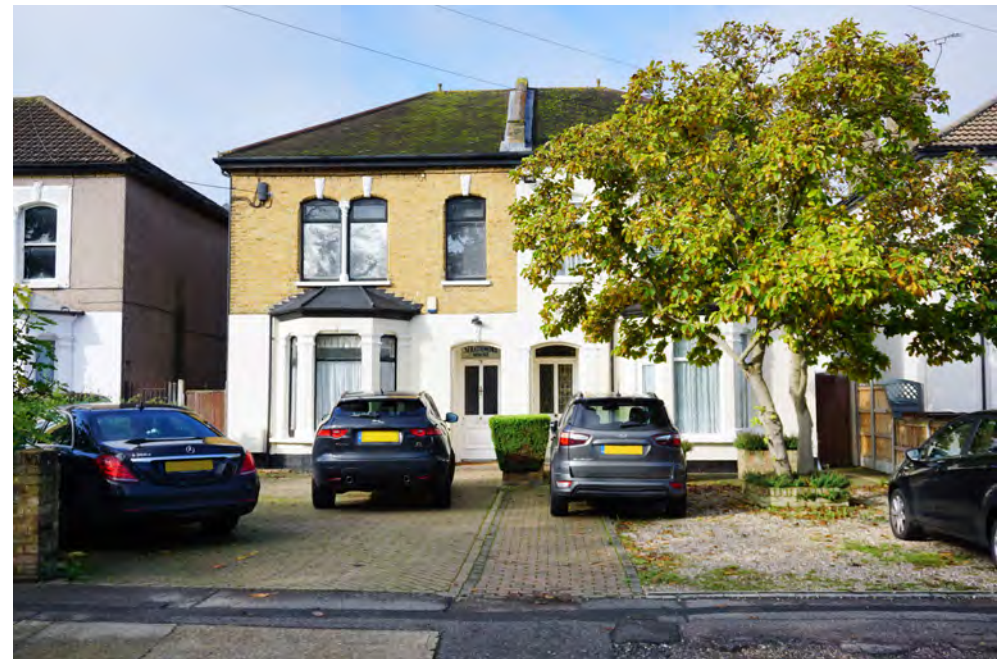
Flat conversion along Avenue Road with multiple car driveway.

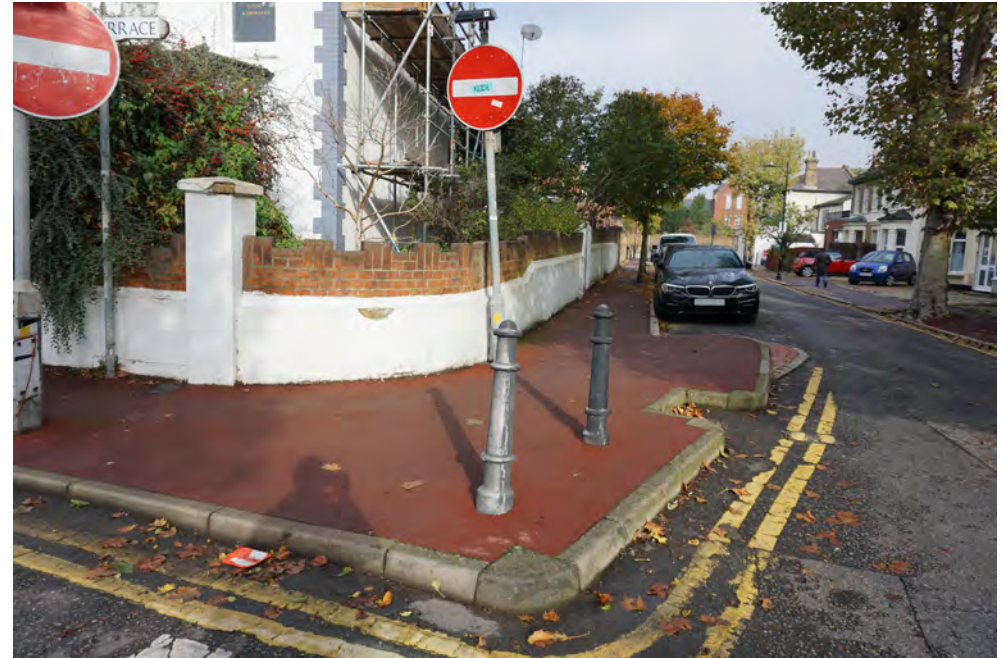
- 5.4.2 Traffic calming measures installed a number of years ago within the Milton Conservation Area are still in evidence along the roads. They were installed with the intention of reducing the use of many of the side roads as cut throughs and to reduce traffic speed, especially around the school. Whilst the objectives of the scheme may have been achieved, the visual impact on the Conservation Area is unsympathetic. While some elements are of better quality than usual, such as the red tarmac pavements and red brick speed bumps, the additional signage and other street furniture, such as bollards, have added to the visual clutter and the build outs have altered the historic street alignment. While the need for some form of traffic calming in this area is recognised, a scheme more sensitive to the historic environment would make a significant improvement to the character of the Conservation Area.

Good quality red tarmac pavement but multiple signs and bollards, along with wide yellow lines

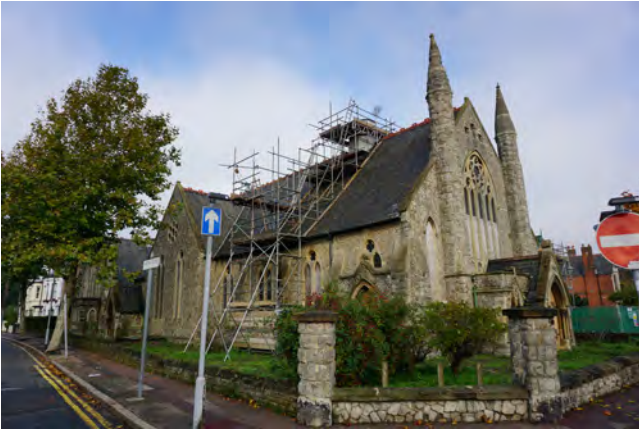
Park Road Methodist Church, currently vacant

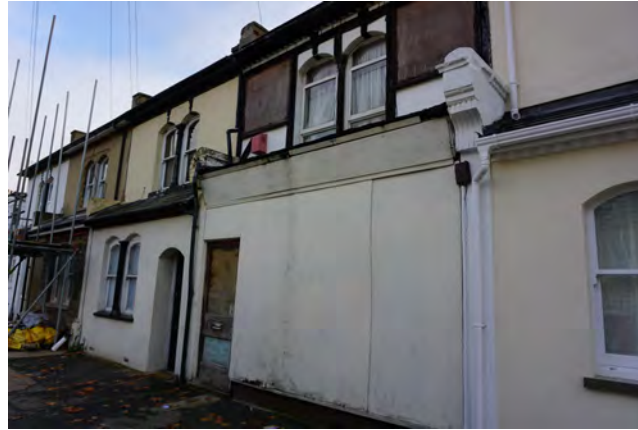
Poor decorative condition of buildings on Park Road

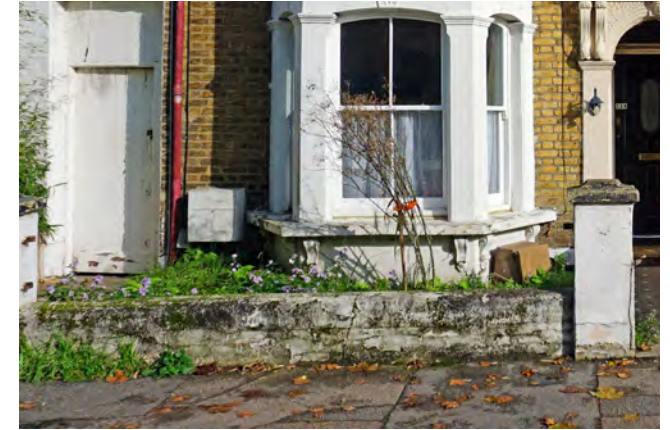
Boundary wall in poor decorative condition

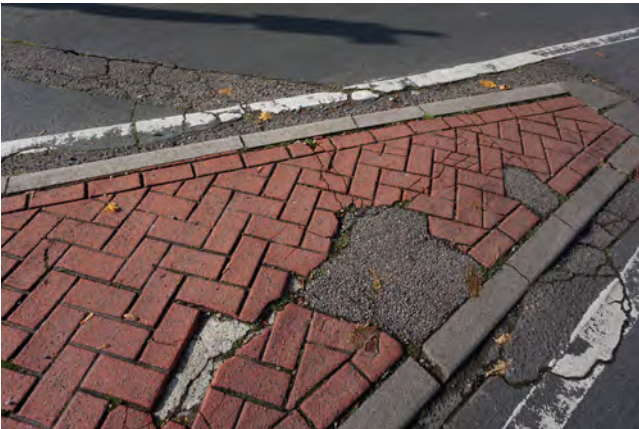
Brick effect paving, which is damaged and patched in tarmac

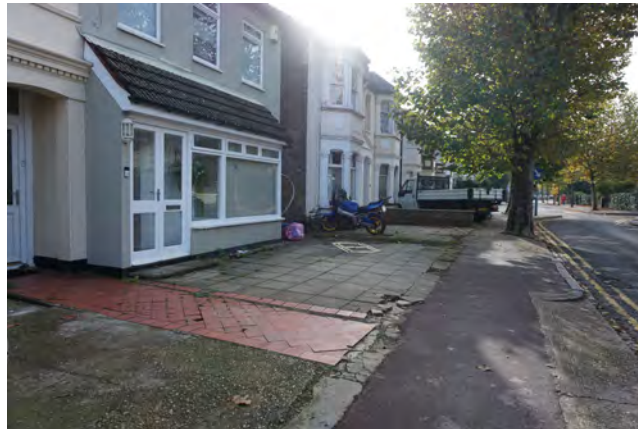
- 6.3.2 The condition of the surfacing of some streets and private driveways is poor in some instances, through a lack of appropriate maintenance and/or renewal. On pavements there are frequent incidences of the surfacing being damaged by tree root growth.

Damaged surfaces to private driveways

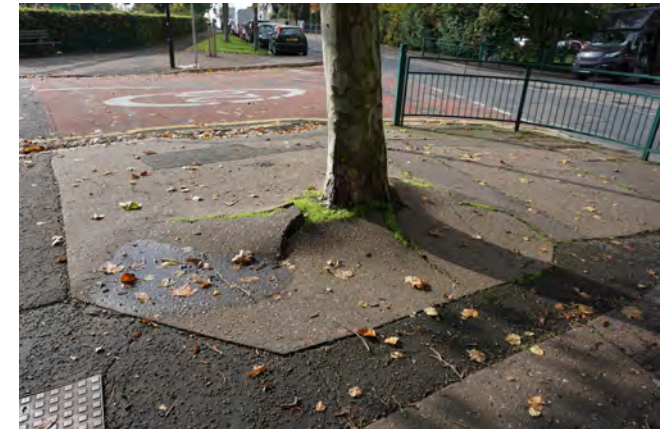
Damaged pavement surfaces through tree root growth

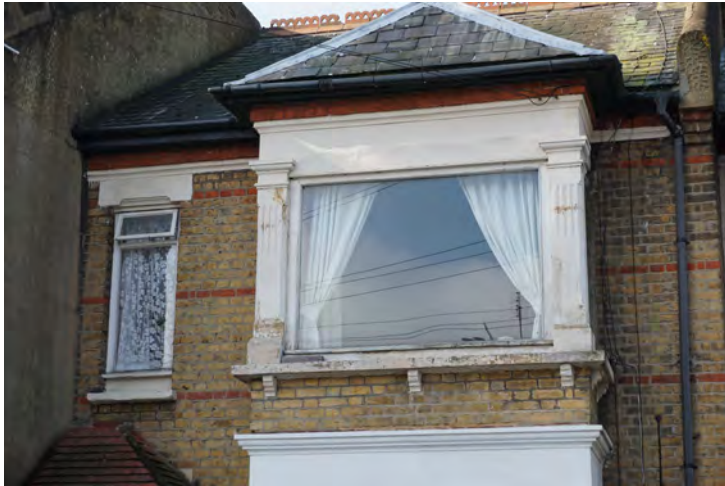
Inappropriate picture window and casement window replacing sash windows

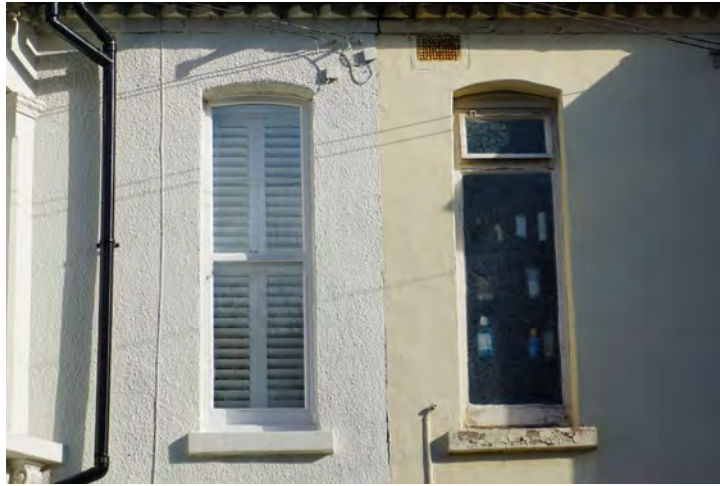
Inappropriate casement window on the right, compared with a traditional sash on the left

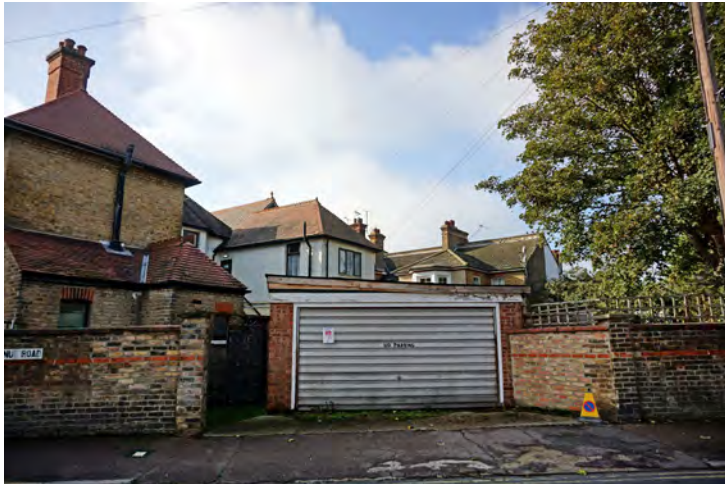
Utilitarian garage

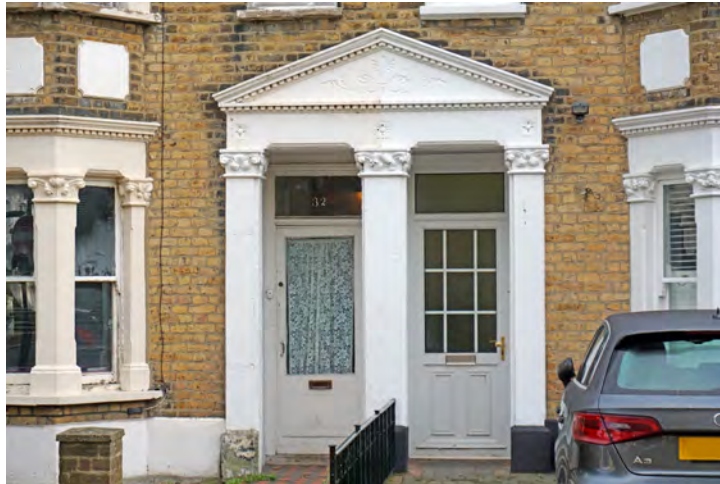
Replacement front doors which do not have the same character as the original timber ones with stained glass

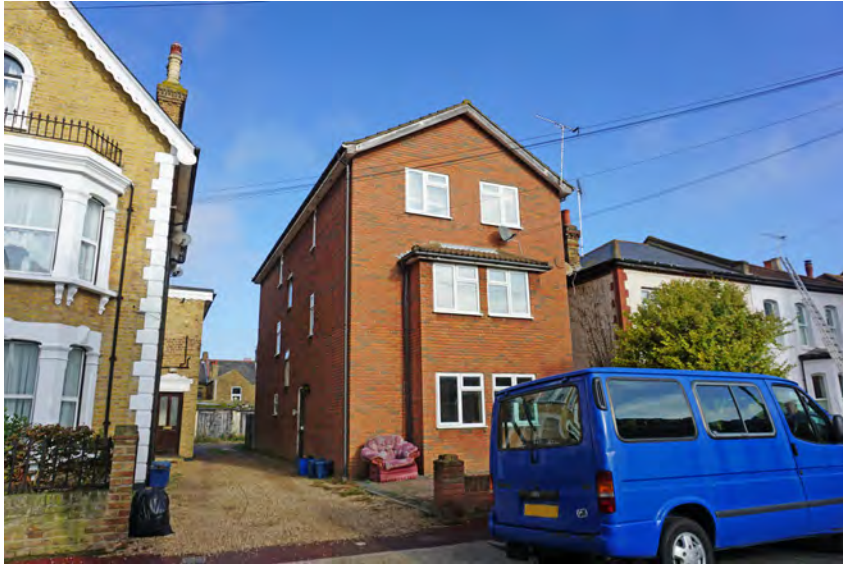
Bland modern building on Park Terrace which is an inappropriate design for the Conservation Area

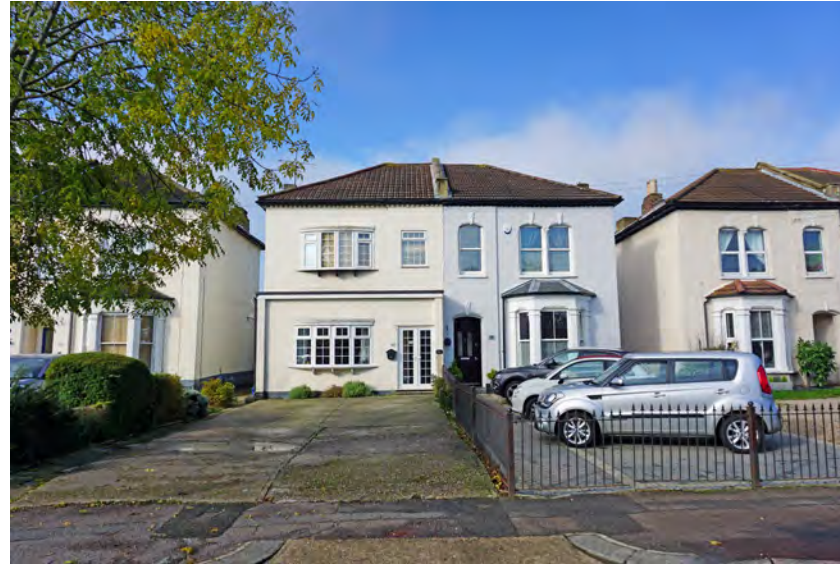
Inappropriate boxy modern extension to the ground floor and bow window to first floor which replace the original bay and sash windows. There are opportunities to enhance this building through the reversal of inappropriate changes

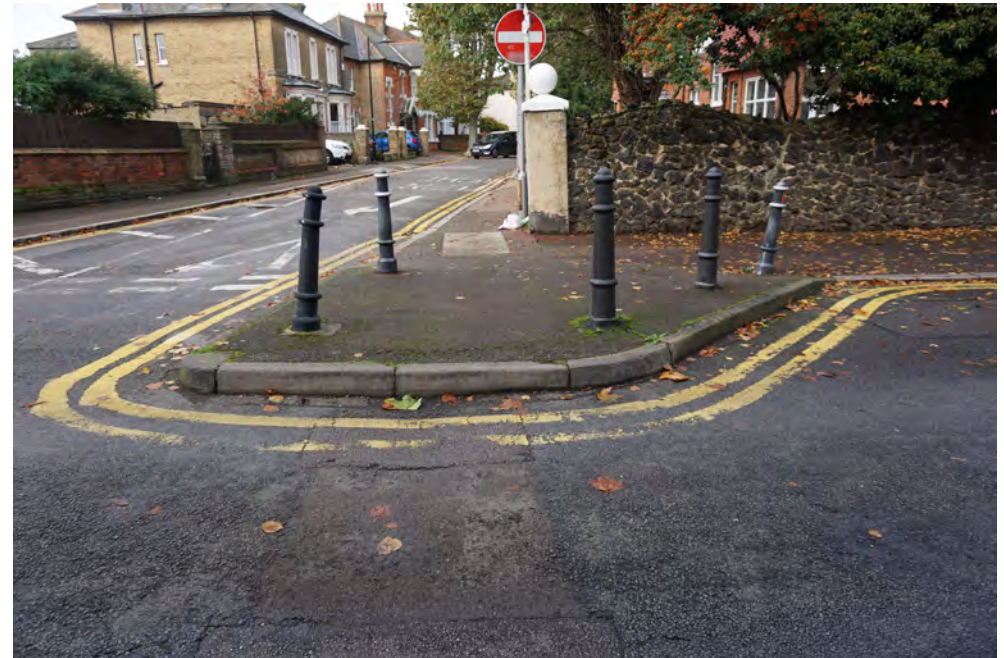
**Multiple bollards and road markings at a junction**

- 6.3.40 Road markings should be the minimum necessary for safety. When repainting of road markings is required, use narrower 50mm lines in primrose, suitable for use in conservation areas.

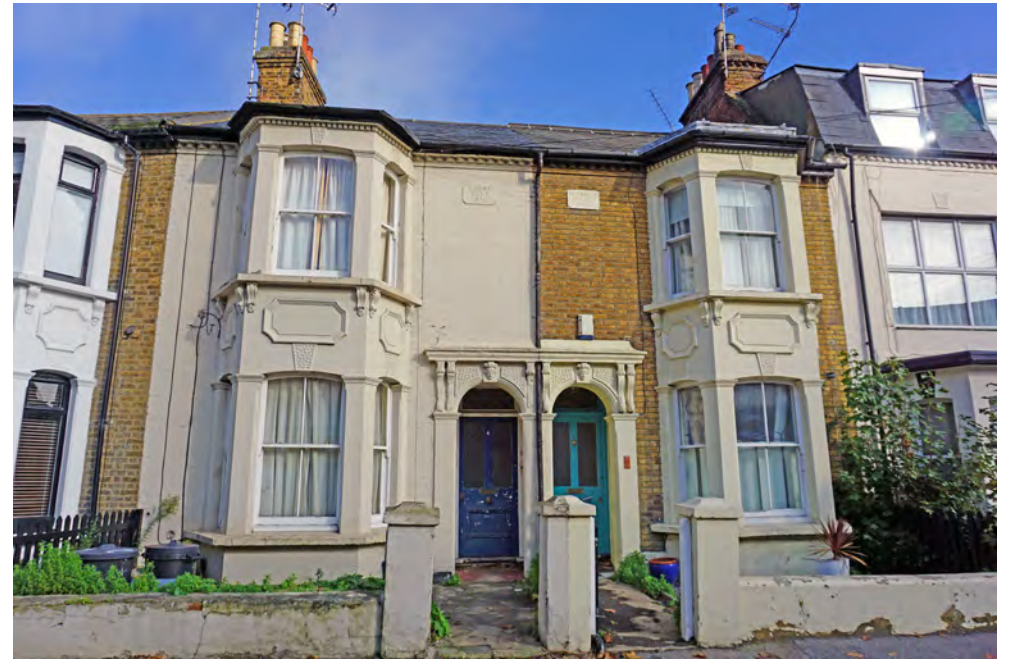
Dated 1874. Divided into flats. Intact except for painted brickwork. Original low boundary wall retained but painted and with railings lost. Property would benefit from maintenance, particularly the garden, garden wall and front door.

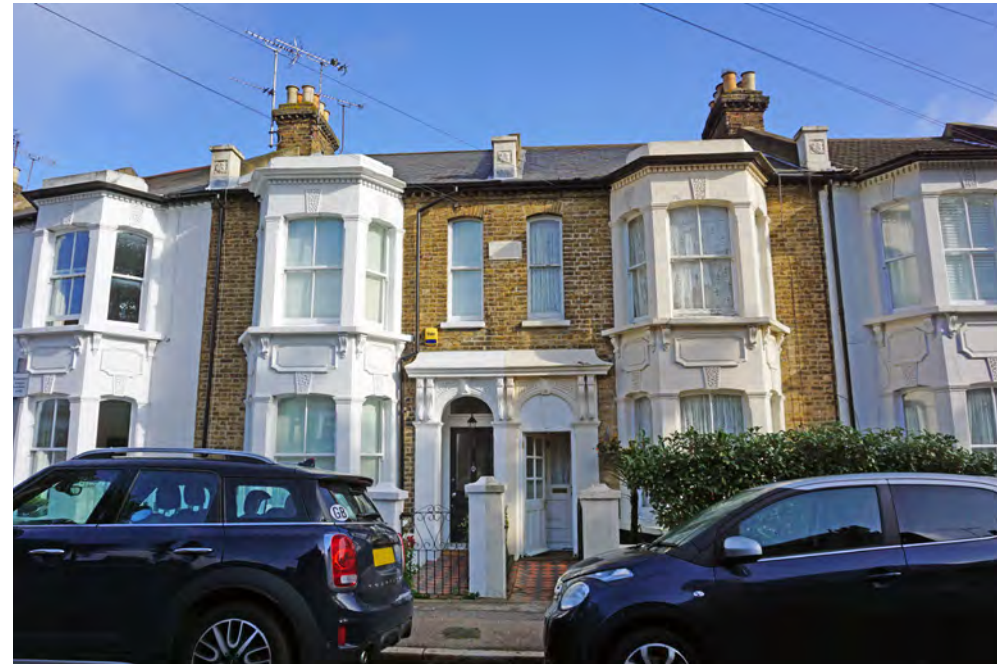
Divided into flats. Original yellow stock brickwork remains. Original windows replaced with uPVC casements at first floor. Original boundary wall remains and has been topped with decorative metal balustrade. Modern timber door with small glazed panel not entirely in keeping. Attractive tiled path.

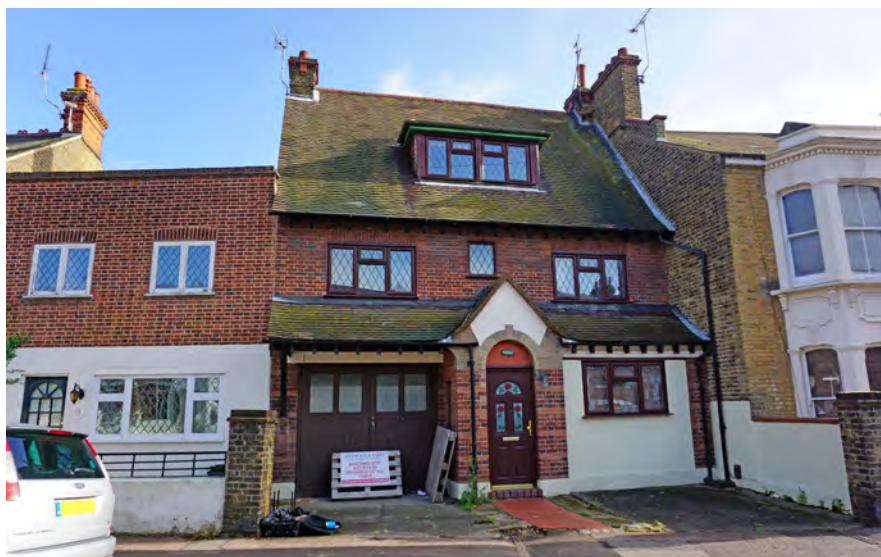
Address	Value	Designation
38 Avenue Road	Positive* – Windows and area of hardstanding could be improved	Article 4

Later infill development built 1929. Red brick with clay tile gabled roof with steeper pitch to adjacent terrace. Two storeys with accommodation in the roofspace and front dormer. Brown uPVC leded light casement windows and mock-stained glass door. Timber bracketing detail under eaves and under pitched roof feature to ground floor. Enclosed gabled porch is the main feature. Integral garage and unattractive concrete hardstanding covering entire frontage have a detrimental impact and would benefit from use of surface materials sympathetic to the character of the Conservation Area, reinstatement of the boundary wall and some soft landscaping.

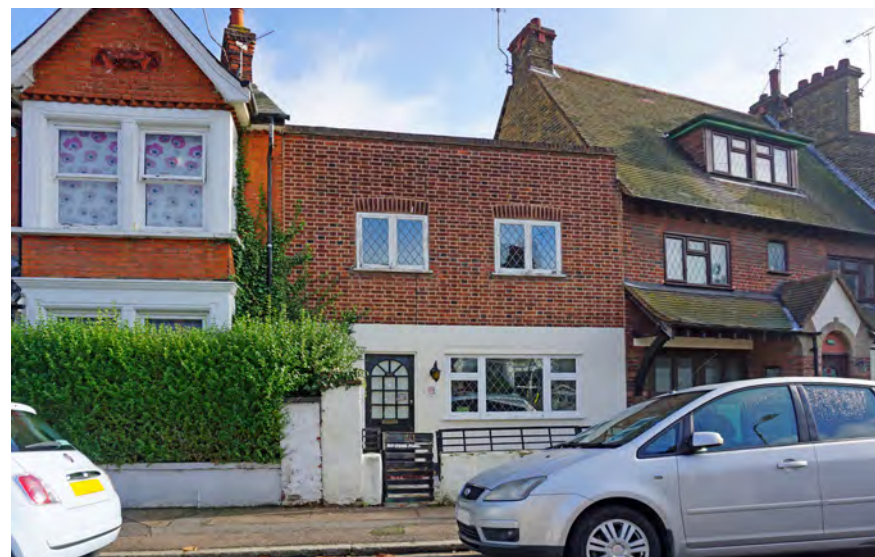
Address	Value	Designation
40 Avenue Road	Neutral – with some improvement could be a charming addition to street	Article 4

Later infill development c.1930s. Originally built as a store and garage and later converted to a separate dwelling in the 1980s. Two storeys with parapet roof. Red brick to first floor with render below. uPVC leded light casement windows. Modern timber and glazed door. Low boundary wall topped with metal railings enclosing front garden.

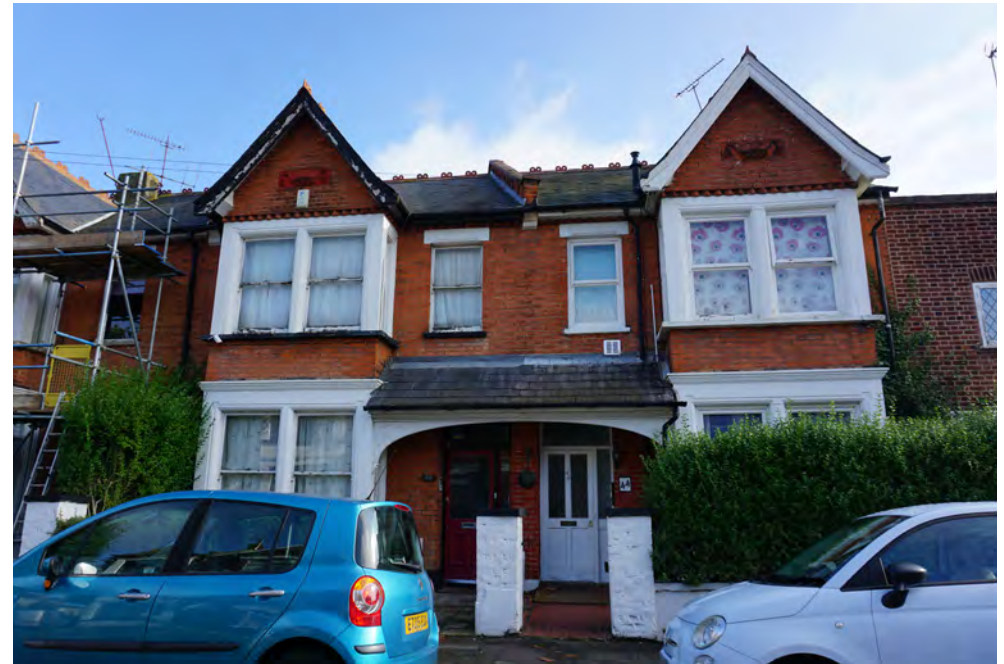
Property intact including brickwork, slate roof, timber sashes and front wall. Window frames in need of maintenance/repainting.

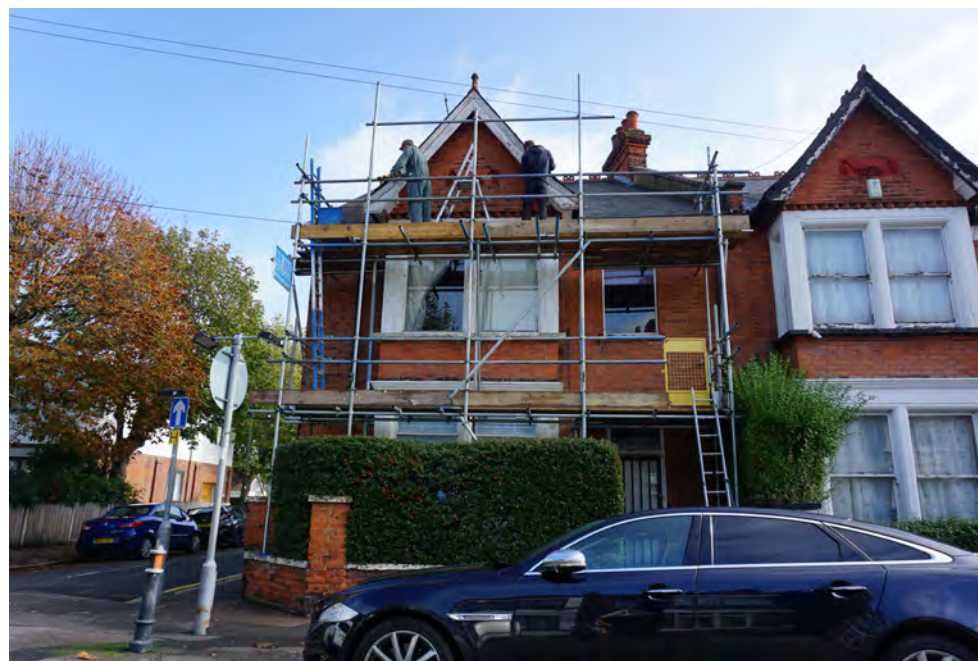
Address	Value	Designation
48 and 48a Avenue Road	Positive* – would benefit from sash window reinstatement and more traditional style door to No.48a.	Article 4

Corner property divided into flats. No.48a faces Avenue Road and No.48 faces Park Terrace. Original sashes to front and side replaced with timber top hung casements. Original front door faces Park Terrace (directly onto street) and has an attractive scrolled pediment and original timber paneled double doors. An additional modern front door has been inserted onto the Avenue Road elevation where there may have been a window originally. Door is largely glazed which is out of character.

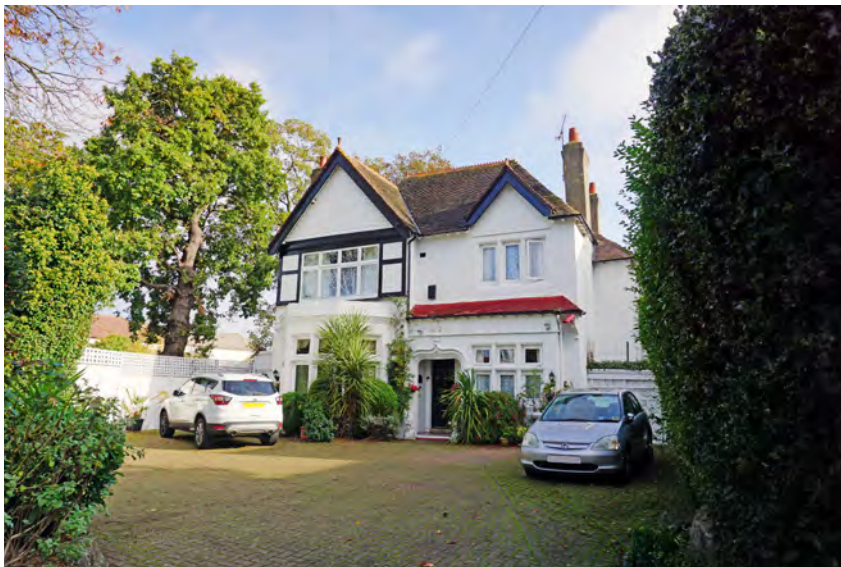
Address	Value	Designation
52 Avenue Road	Positive – would benefit from reinstatement of half-timber detail to gable	Article 4

Built in 1891. Brickwork has been rendered. Modern boarding to main gable. Front garden paved for parking but some planting has been maintained on the frontage which provides some enclosure.

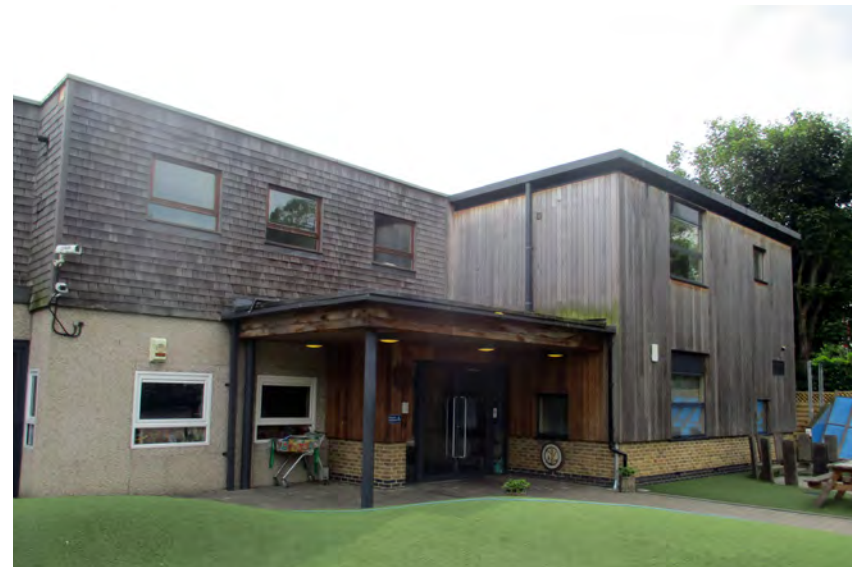
Photo  
2017

Address	Value	Designation
Barons Court Infant School Avenue Road	Main building: Neutral Southern extension: Positive	Article 4

Built in 1968 and much extended and remodelled. Two storeys with flat roof. The most recent addition completed only a few years ago and includes cedar cladding to front elevation and modern extension to south side facing Park Crescent. Recent works have improved the character of the building as a whole.

Set well back from the road with parking area and playground to front. Mature trees here make a positive contribution to the streetscene. Tall modern green boundary fencing is detrimental to the character of the Conservation Area.

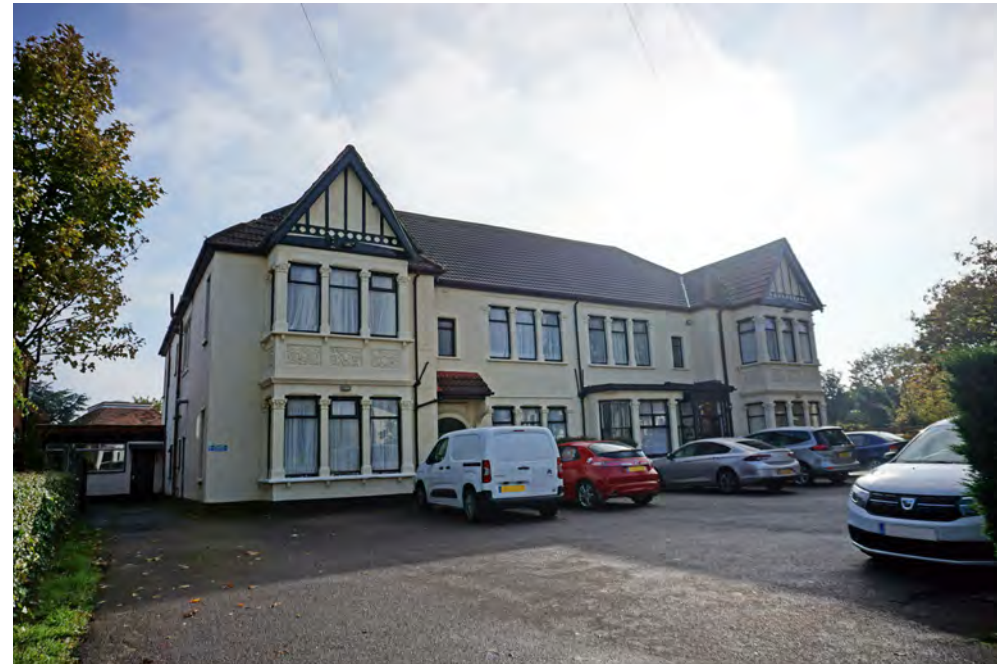
Two storeys with full gabled bays with decorative timber boarding at either end of the building. Almost all windows to the front have decorative foliage detailing to columns. Sash windows replaced with timber top hung casement windows. Modern porch added to entrance at the southern end. Northern entrance infilled with window. Modern concrete tiles to roof.

Set well back from the road and forecourt used as a car park, which is expansive, though the boundary hedge to front provides some enclosure to the street. The forecourt would benefit from landscaping and use of materials sympathetic to the character of the Conservation Area.

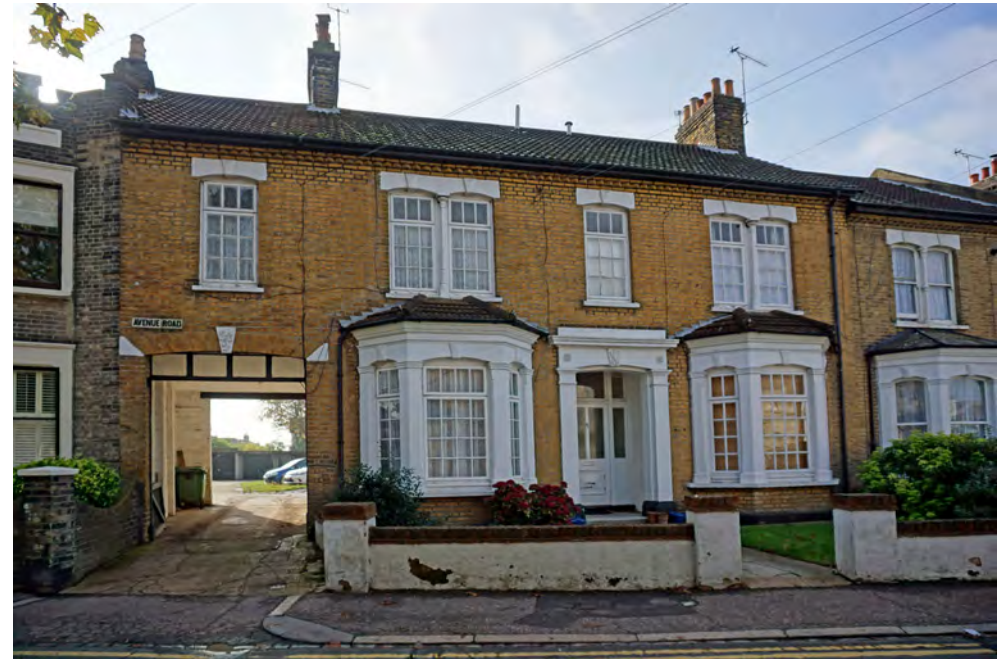
Address	Value	Designation
7 and 9 Avenue Road	<p>No.7: Positive – though roof would benefit from replacement with slate</p> <p>No.9: Positive* – frontage and door could be improved</p>	Article 4

Divided into flats. Property intact except that slate has been replaced with concrete tile. Low front boundary wall and planted front garden make a positive contribution to the street. Concrete tile roof which would benefit from replacement with slate.

Timber sash windows retained. Brickwork has been rendered. Slate replaced with concrete tile. uPVC door. Boundary wall has been removed and frontage has been paved which is detrimental to the street. Concrete tile roof which would benefit from replacement with slate.

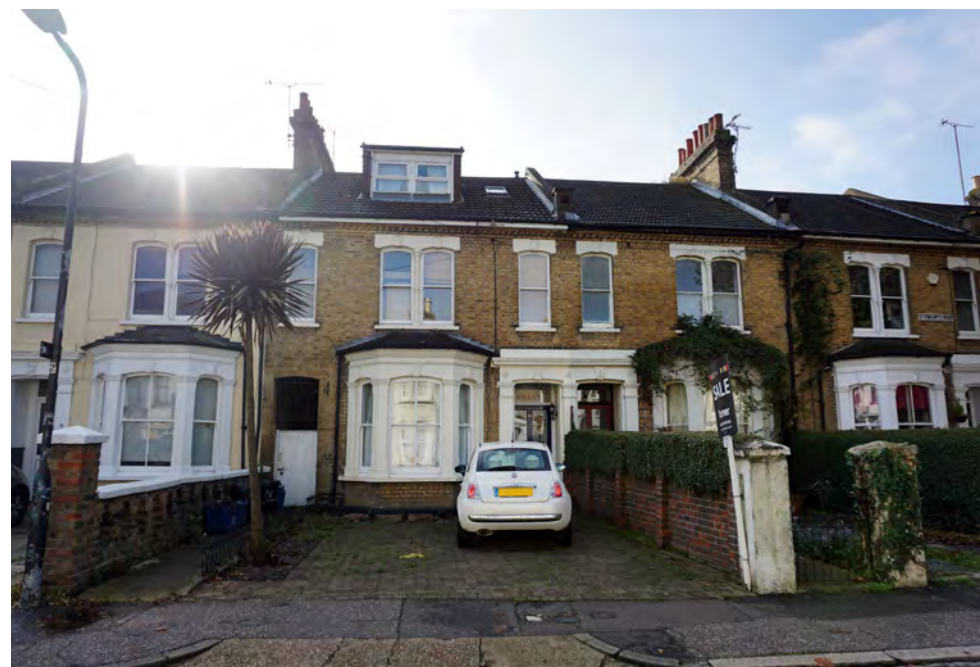
Converted to flats. Property intact except sash windows replaced with timber top hung casements. Open porch with decorative surround, door likely a replacement in a traditional style. Front garden area tarmaced which is detrimental to the historic character. Front boundary wall missing although side boundary walls with tall piers remain dividing the frontage from the neighbours.

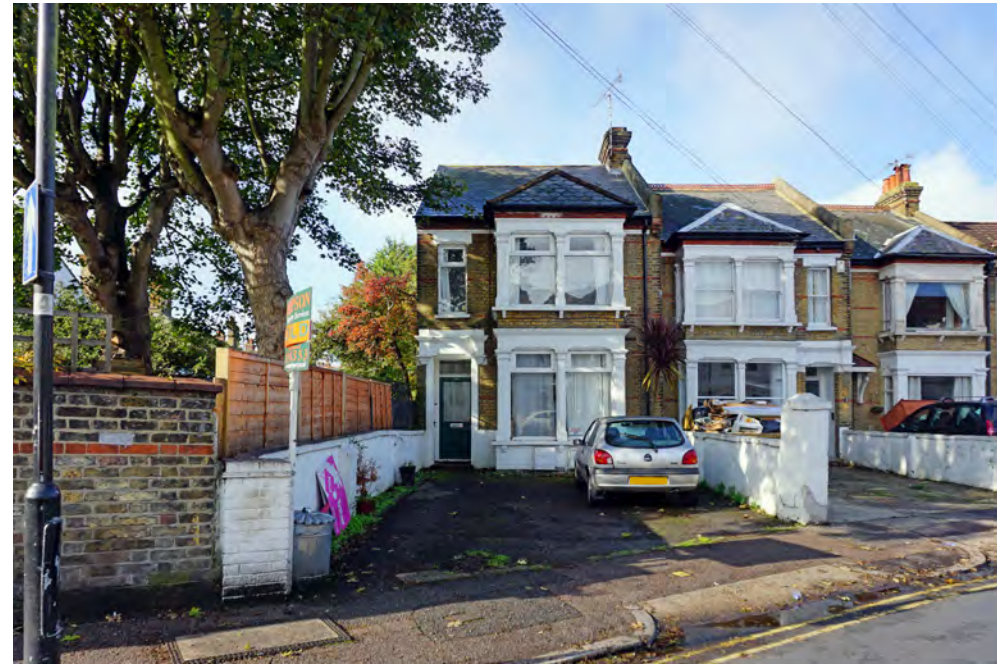
Address	Value	Designation
15 Avenue Road	Positive – though would benefit from reinstatement of boundary and soft landscaping to front garden.	Article 4

Converted to flats? Property intact. Open porch with decorative surround and good front door, possibly original. Front garden area concreted which is detrimental to the historic character. Front boundary wall missing although front side boundary wall with tall piers remains dividing the frontage from the neighbour.

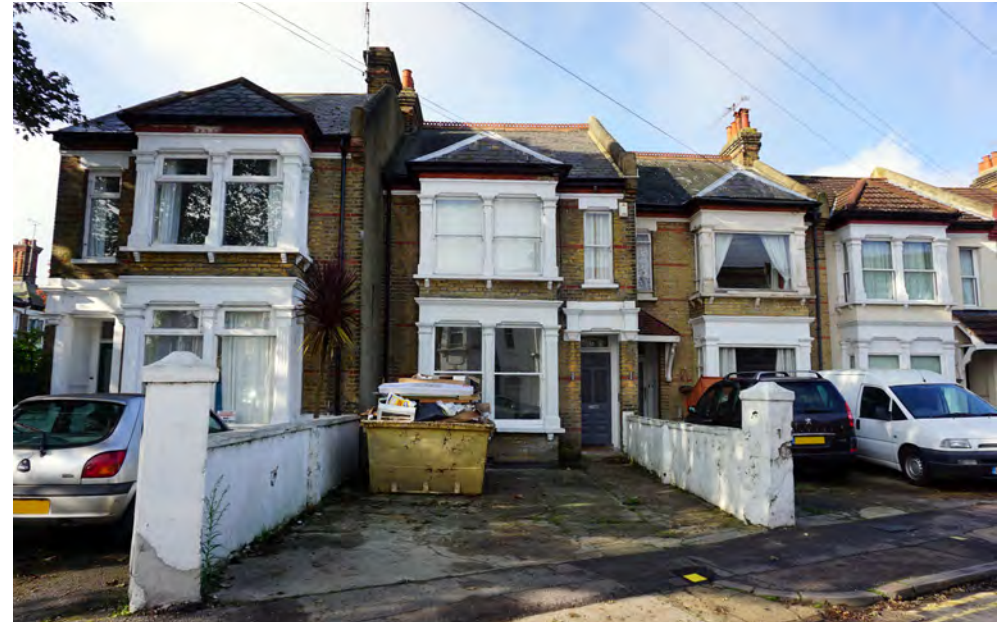
Converted to flats. Property intact except sash windows replaced with timber picture windows, with central mullion removed, or top hung casements. Hipped porch. Front garden area concreted which is detrimental to the historic character. Front boundary wall missing although front side boundary wall with tall piers remains dividing the frontage from the neighbour.

Converted to flats. Timber sash windows replaced with uPVC sashes, brickwork rendered and slate replaced with concrete tile. Unsympathetic mono pitch porch. Front garden appears to be grasscreted but this has failed so has limited softening impact. Front boundary wall missing although front side boundary wall with tall piers remains dividing the frontage from the neighbour.

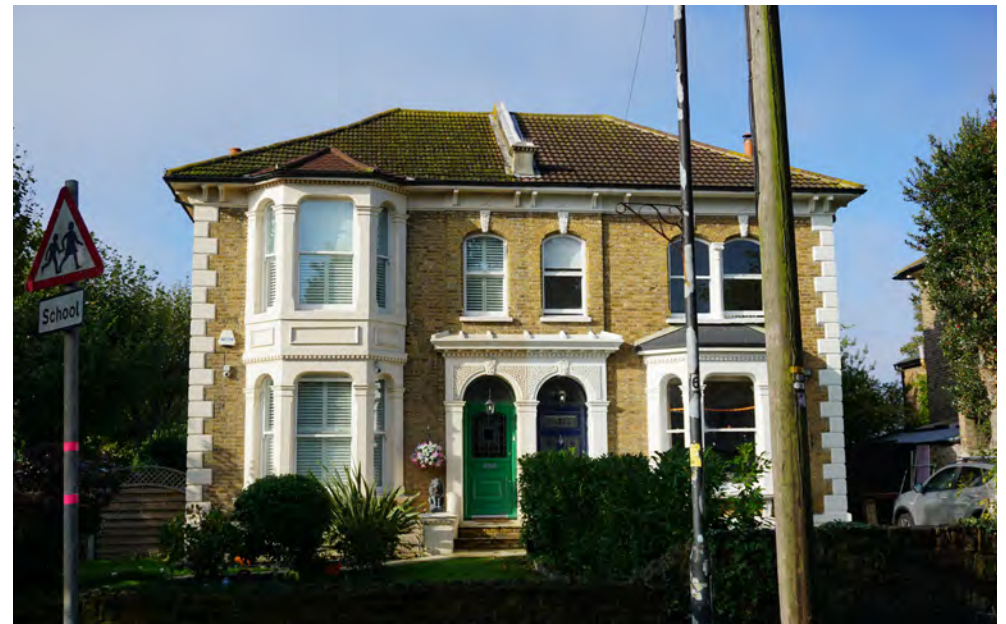
Address	Value	Designation
39-41 Avenue Road	Positive	Article 4

Properties intact except for part of the porch roof missing at No.41. Good section of burr brick boundary wall remaining. Block paved parking areas but surrounded by significant landscaping which makes a positive contribution to the street.

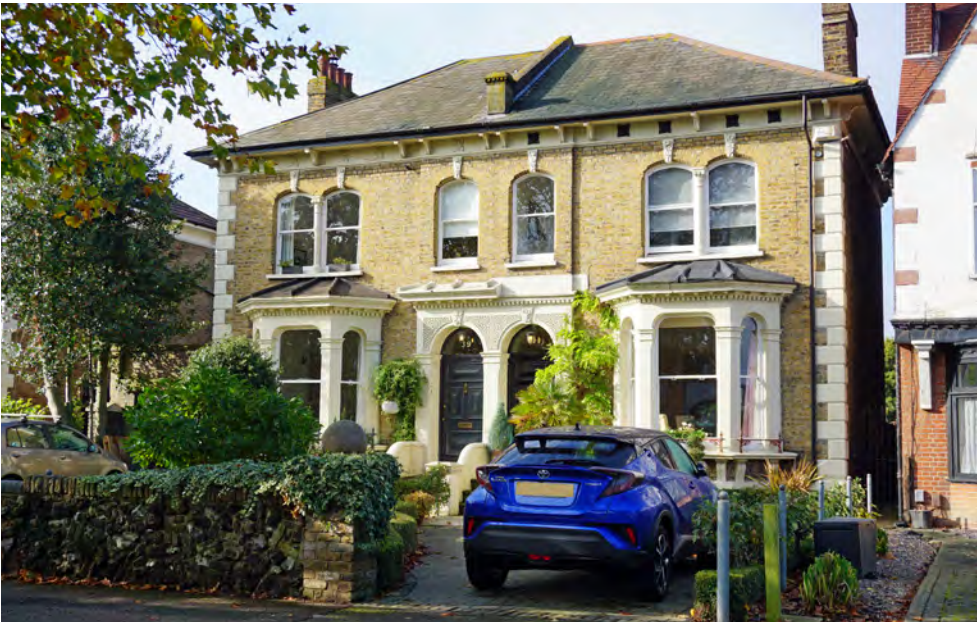
Address	Value	Designation
43- 45 Avenue Road	Positive	Article 4

Small section of boundary wall to front, appears to be burr brick painted white. Frontages mostly block paved but with significant planting.

No.43 is divided into flats.

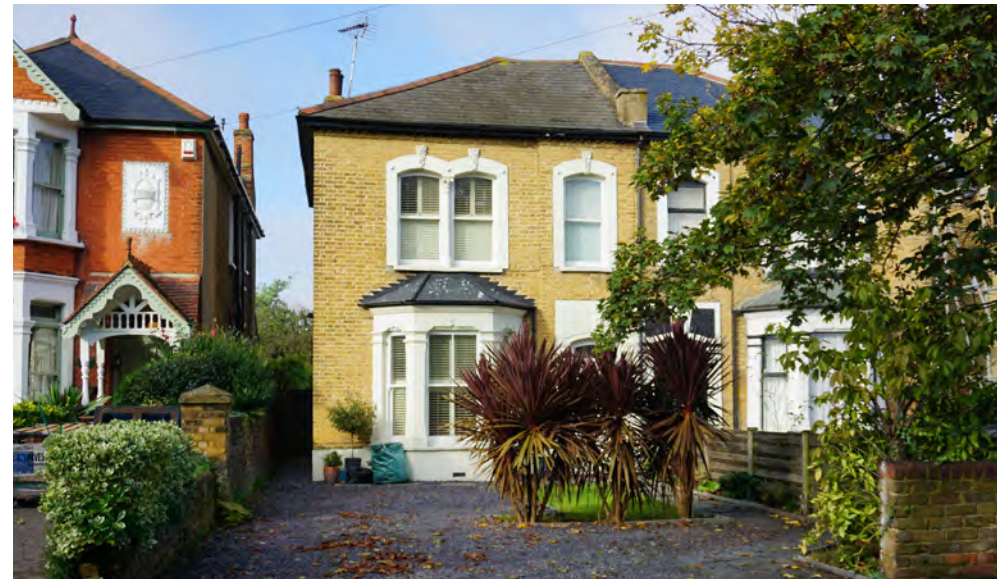
Address	Value	Designation
51 Avenue Road	Positive* – would benefit from reinstatement of sash windows and removal of door infilling porch	Article 4

Original sash windows replaced with timber top hung casements. Original open porch enclosed by modern door which is detrimental to its character. Small section of boundary wall to front provides important enclosure and tree in forecourt important to the streetscene. Front garden hard surfaced and would benefit from higher quality materials and planting.

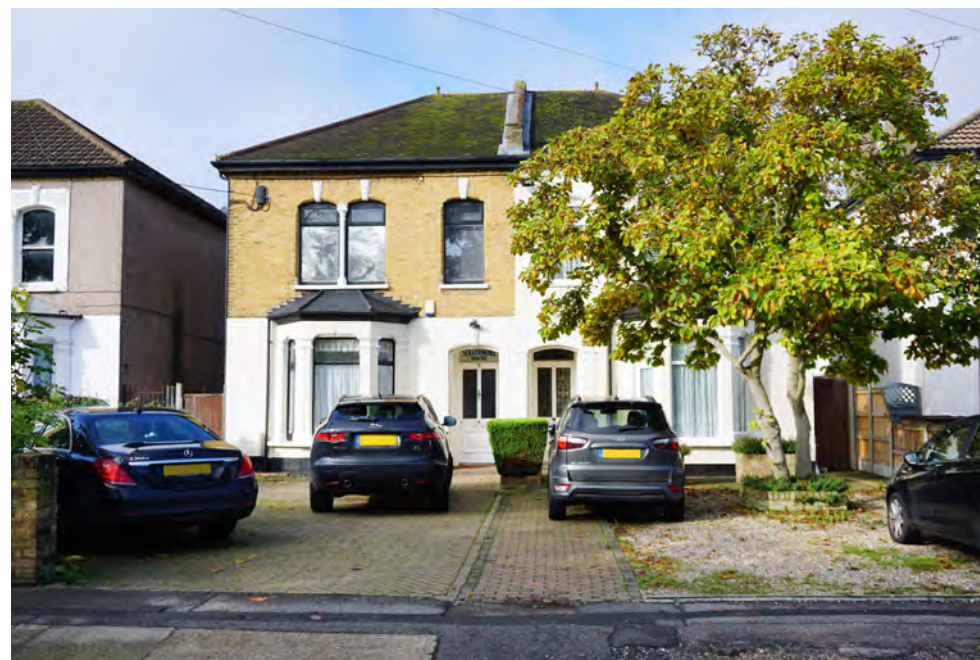
Address	Value	Designation
61 Avenue Road	Positive* – would benefit from reinstatement of sashes and slates	Article 4

Divided into flats. Brickwork has been rendered. Slates replaced with concrete tiles. Original windows have been replaced with timber top hung casements. Good door, possibly original. Part of the frontage is enclosed with a low boundary wall. There is space for two cars but this is softened by planting.

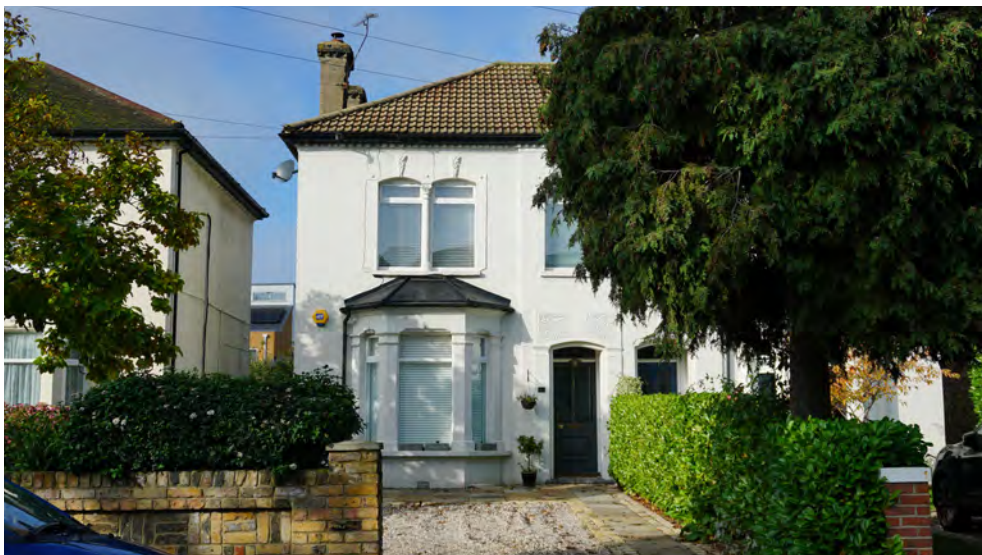
Address	Value	Designation
63 Avenue Road	Positive Though would benefit from reinstatement of slates	Article 4

Brickwork has been rendered. Slates replaced with concrete tiles. Original timber sashes remain at first floor but have been replaced at ground floor by timber picture windows with top fanlights. Part of the front boundary is enclosed by a red brick wall with low piers (with coping stones) which helps to enclose the street. There is parking for one car but most of the forecourt is planted and this helps to soften the building and makes a valuable contribution to the streetscene. Attractive tiled path.

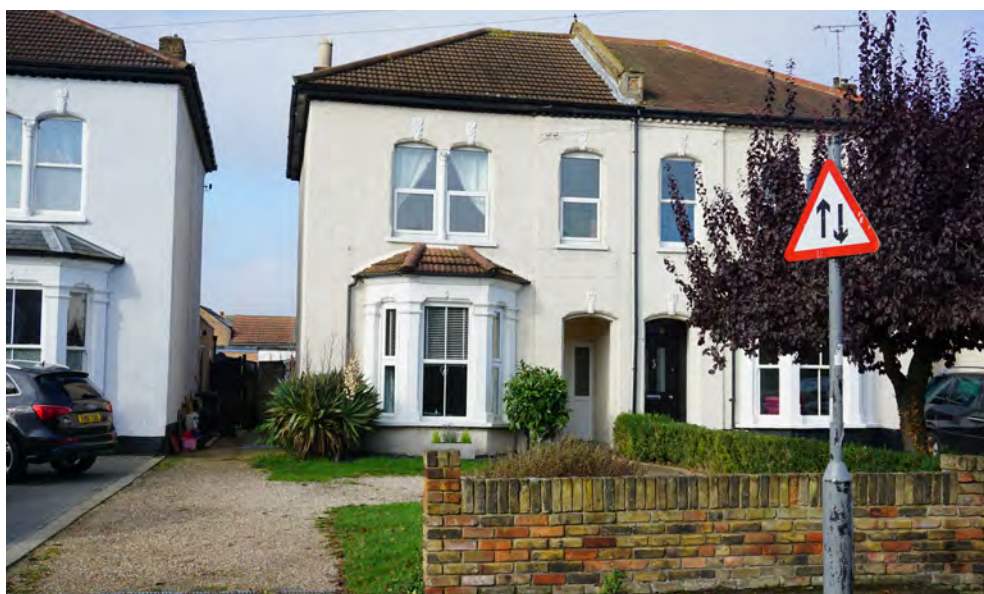
Address	Value	Designation
75 Avenue Road	Positive* - would benefit from replacement of uPVC with timber sashes	Article 4

Brickwork has been rendered. Original timber sashes lost to inappropriate uPVC. Slates replaced with clay tile. Low brick wall to front which provides enclosure to the street and planting on the forecourt also welcome. Good example to how to accommodate parking on frontage.

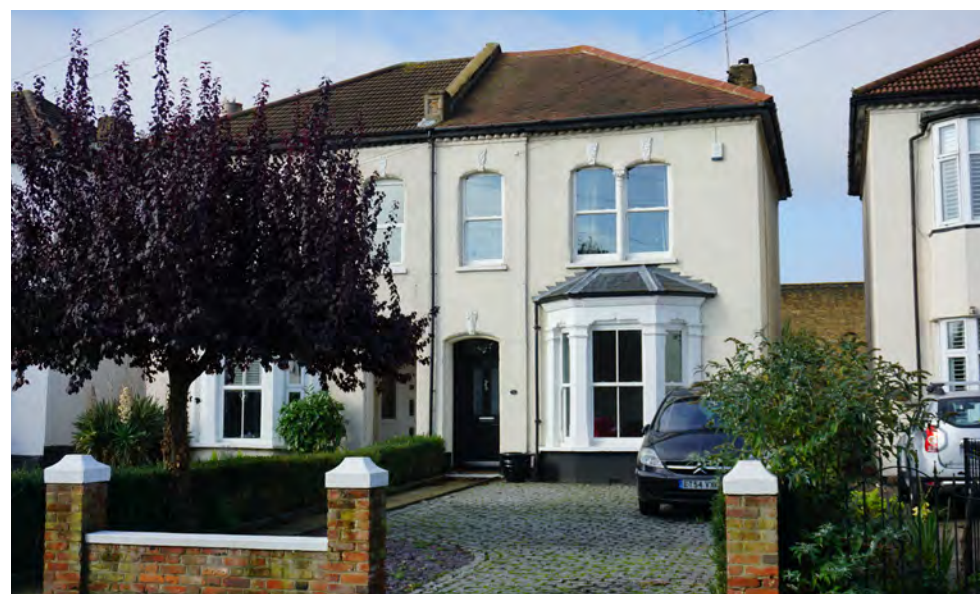
Address	Value	Designation
77 and 79 Avenue Road	<p>No.77: Positive* – would benefit from reinstatement of sash windows</p> <p>No.79: Positive* – would benefit from reinstatement of sash windows</p>	Article 4

Forms a pair with No.79 and was originally the same design but a double height bay window has been subsequently added which disrupts the uniformity. Brickwork has been rendered. Slates replaced with concrete tile. uPVC casement windows Front boundary wall has been removed although part of it has been replaced with modern metal railings which provide some definition to the street. Frontage is block paved with some planting.

Brickwork intact but slate has been replaced with concrete tile and sashes replaced with aluminium top hung casement windows. Low red brick wall to frontage provides good enclosure to the street. Frontage is mostly block paved with small areas for planting.

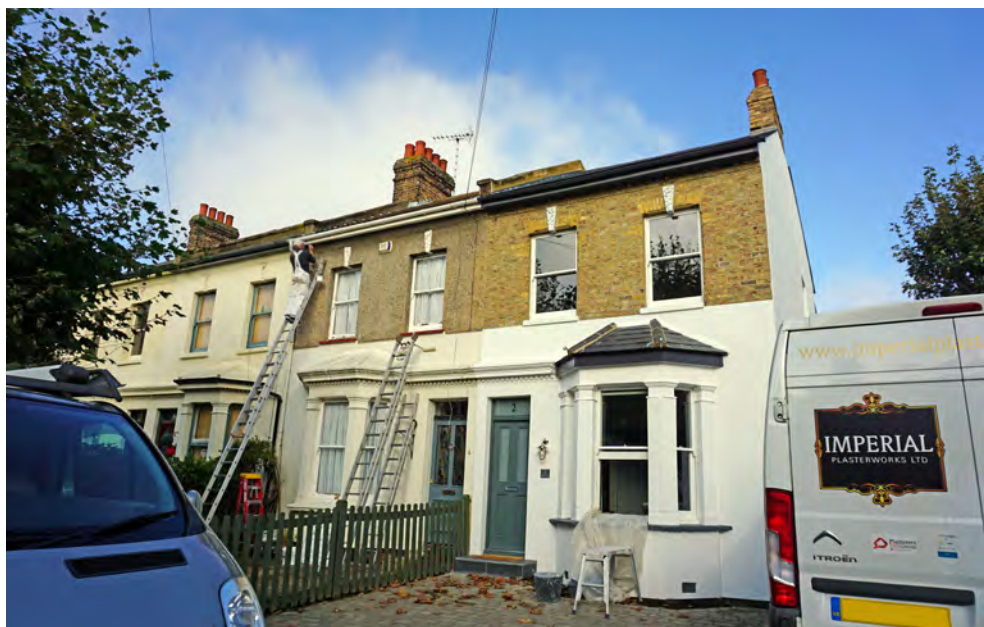
Address	Value	Designation
4 Avenue Terrace	Positive* – would benefit from reinstatement of slates and improvement of pebbledash	Article 4

Original slate roof tiles replaced with concrete tile. Pebble dash cladding added at first floor, ground floor rendered and painted. Planning permission for the conversion of the garden to a driveway was given several years ago. White painted timber sliding sashes remain and make a positive contribution. Good door with stained glass upper panels and fanlight.

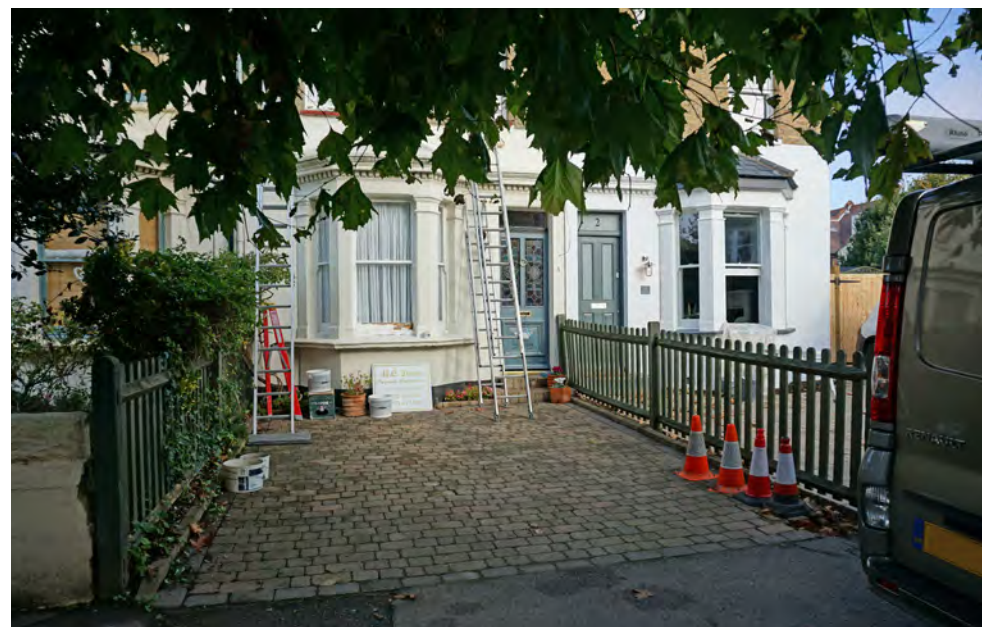
Address	Value	Designation
6 and 8 Avenue Terrace	No.6: Positive No.8: Positive	Article 4

Property intact except for brickwork being rendered. Original features such as slate roof with ridge tiles, timber sliding sash windows remain. Dark staining of the door is not necessarily in keeping. Front boundary wall (painted) and landscaped front garden.

Also fairly intact except for brickwork being rendered (roughcast at first floor, smooth at ground). Original features such as slate roof with ridge tiles, timber sliding sash windows remain. Later door but in keeping. Front boundary wall (painted) and landscaped front garden.
