# Milton Conservation Area Appraisal

# Southend-on-Sea: Milton Conservation Area Appraisal

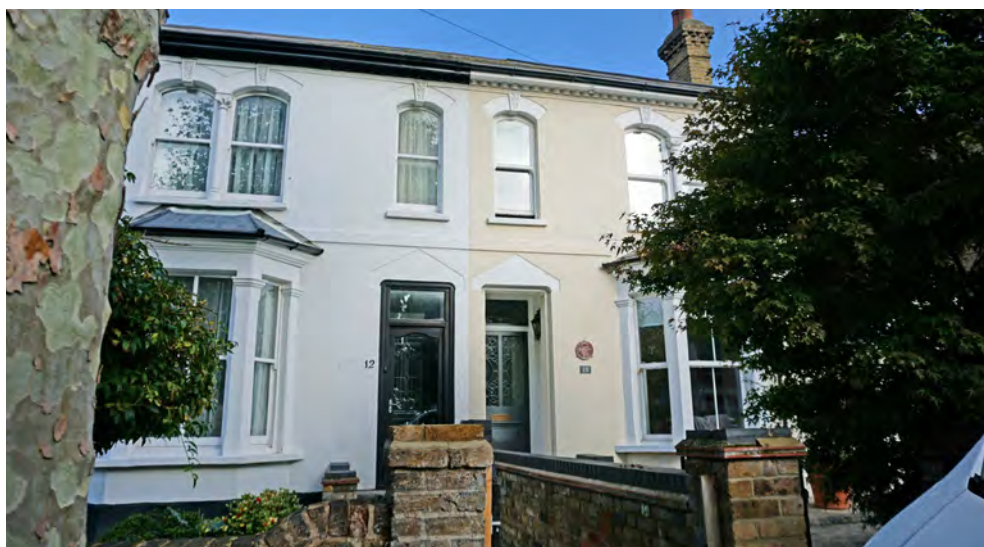
Fairly intact except for brickwork being rendered. Original features such as slate roof and timber sliding sash windows remain. Attractive wooden front door but open porch has been enclosed. Original front boundary wall has been retained and makes a positive contribution to the street. Landscaped front garden with good quality paved driveway to side.

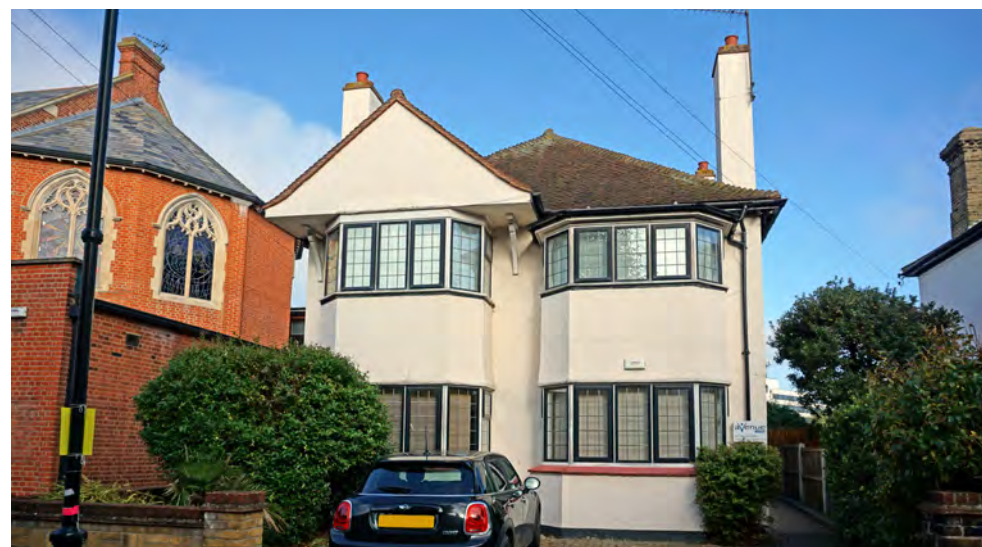
Address	Value	Designation
14 Avenue Terrace	Positive – though frontage could be improved with more planting and uPVC windows would benefit from replacement with timber	Article 4

A two storey detached dwelling with Arts and Crafts influence to its architecture, and built later than the neighbouring properties. White render with red tiled hipped roof. Characterised by two very tall chimneys on either side and unusually, two prominent two storey bays, one with a feature gable, both with black painted uPVC windows with leaded lights. Regrettably most of the front garden has been lost to hardstanding although the material seems to be of a reasonable quality and part of the boundary is enclosed by a yellow stock brick wall enclosing a small area of planting. This property is divided into flats.

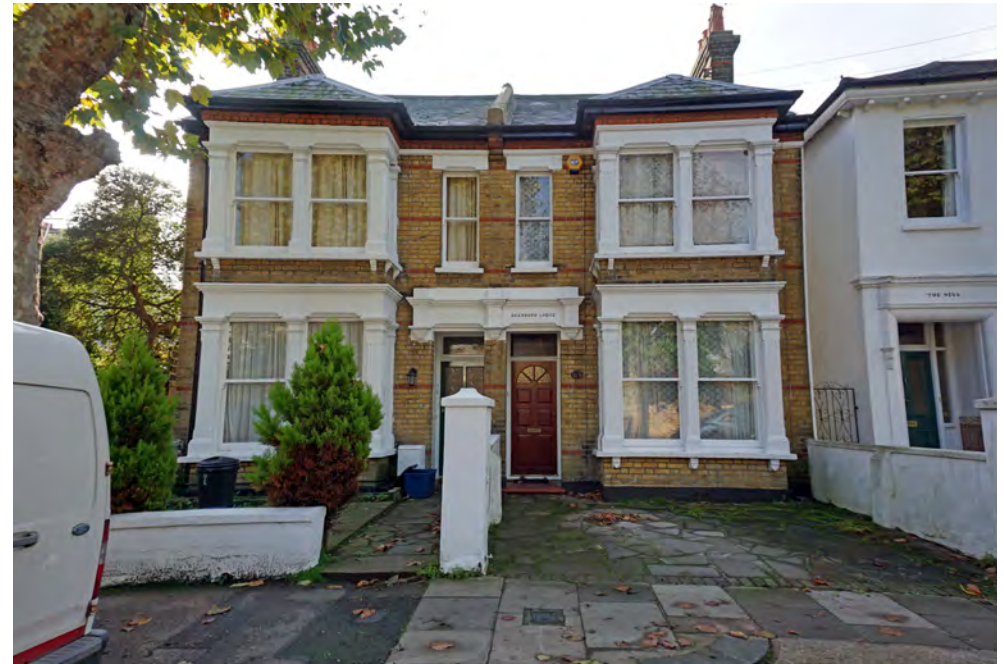
### *No.3 Description:*

Many architectural features retained including slate and brickwork and sash windows. Replica timber front door but with Georgian style fan light detail which is not quite appropriate for this age of property. Regrettably the front boundary wall has been lost to an area of hardstanding that does little to lift the appearance of the property. This would benefit from some landscaping together with the reinstatement of a boundary wall.

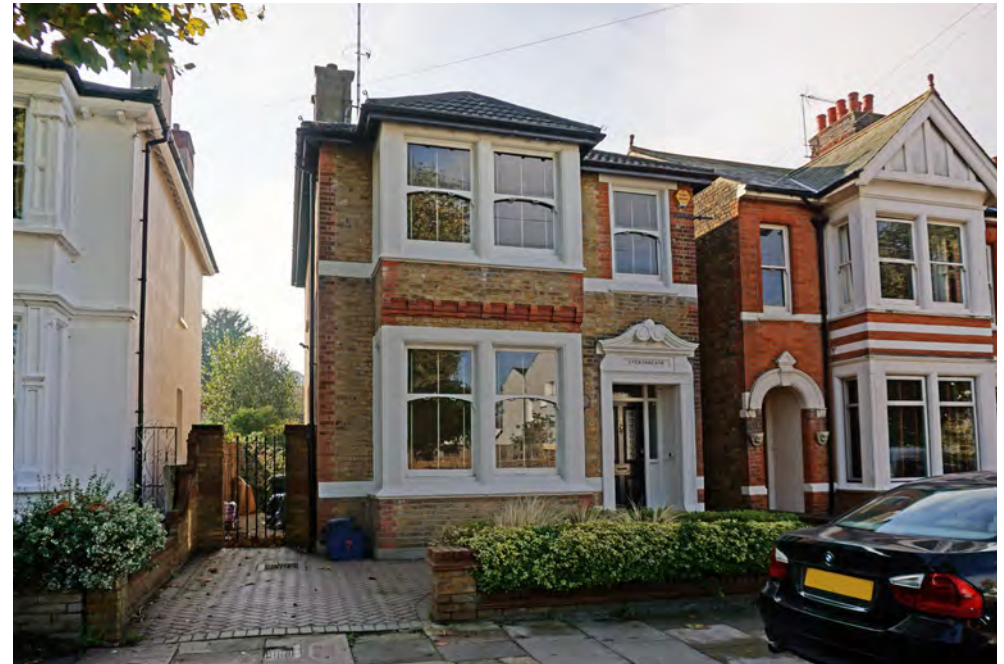
Address	Value	Designation
7 Avenue Terrace, 'Stebonheath'	Positive – though would benefit from replacement of concrete tile with slates	Article 4

An attractive detached Victorian dwelling built in 1894. Two storey yellow stock brick with hipped roof (originally slate but now replaced with concrete tile). Double height bay with simple surrounds and decorative red brick bracketing detailing. Red bricks also used to give 'quoins' effect to the corners of the building and around the first floor window. Distinctive original timber sash windows with curved lower transom to upper sash. Attractive scrolled stucco mounding to open porch. Timber front door with glazed upper panes and fan/sidelights.

Most of the front garden has been lost to hardstanding although an area of boundary wall/planter has been retained which provides space for some planting, softening for the building and some enclosure to the street.

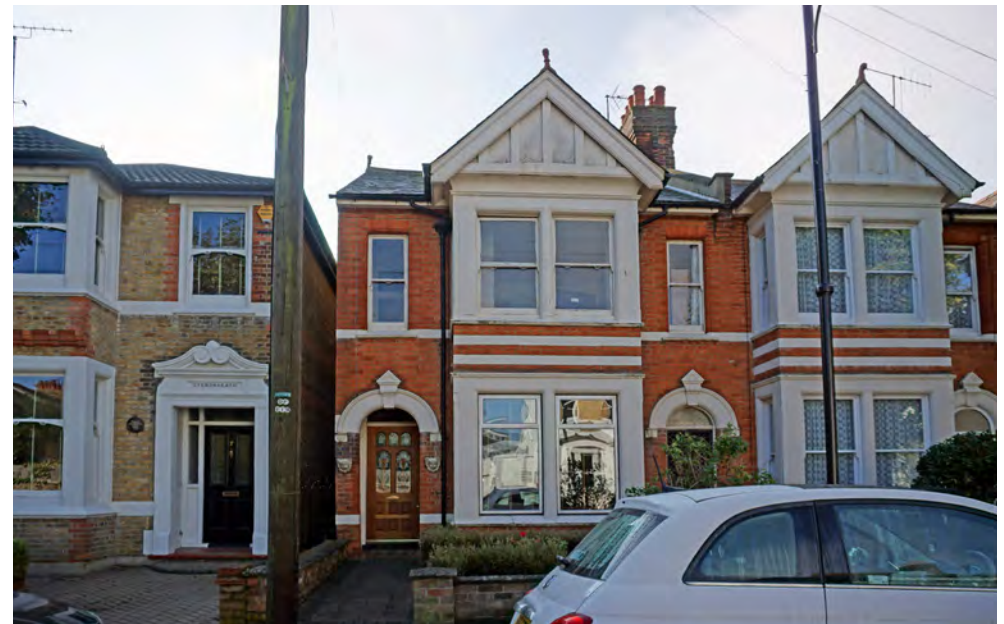
Relatively intact except that the ground floor windows have been lost to uPVC. Replica timber front door with modern stained glass. Stained wood, not entirely in keeping. Low wall to boundary provides enclosure to the street and landscaping in the garden makes a positive contribution to local character.

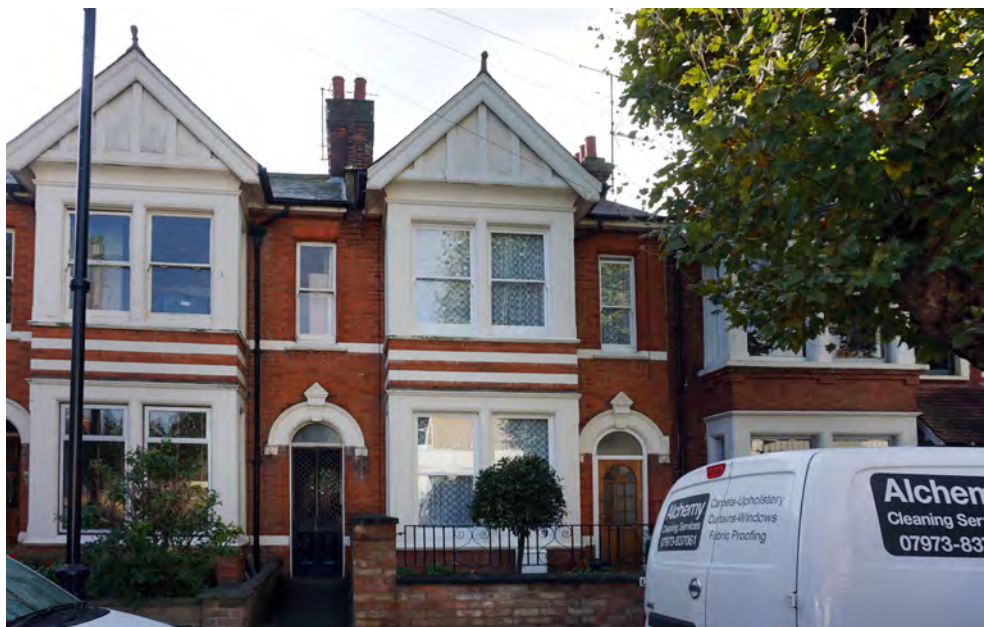
Address	Value	Designation
11 Avenue Terrace	Positive	Article 4

Property intact except for the enclosure of the open porch with a modern traditional style timber front door, though stained wood is not entirely in keeping. A relatively tall brick wall with concrete copings and black metal railings to front provides good enclosure to the street. Small area of planting to frontage but this could be enhanced.

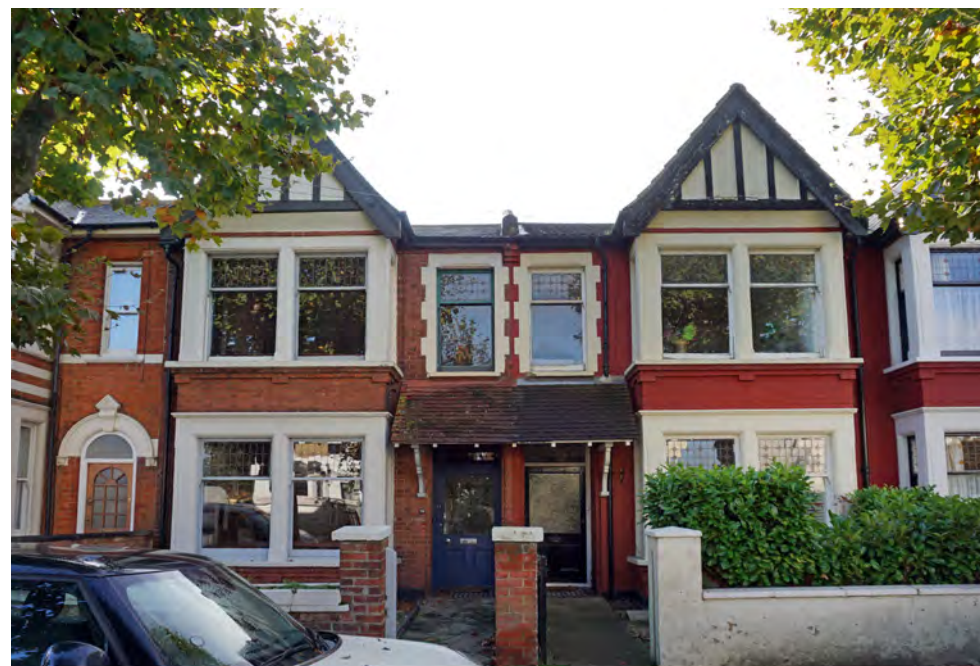
Address	Value	Designation
13 and 15 Avenue Terrace	<b>No.13:</b> Positive <b>No.15:</b> Positive – though removal of paint and replacement of concrete tiles with slate would be beneficial	Article 4

Property intact, including heavy timber front door with stained glass upper pane and fanlight. Decorative tiles to porch floor. Boundary wall retained although showing signs of sinking in the centre and would benefit from repair. Painted timber gate. Some planting to front garden and to top of wall.

Divided into flats. Brickwork painted red and slates replaced with concrete tiles. Sashes remain although are showing signs of wear and tear and would benefit from sensitive repair and repainting. Attractive timber front door and decorative tiles to porch floor. Boundary wall retained to frontage although has been rendered. Timber gate. Mature planting to front garden makes a positive contribution to the street.

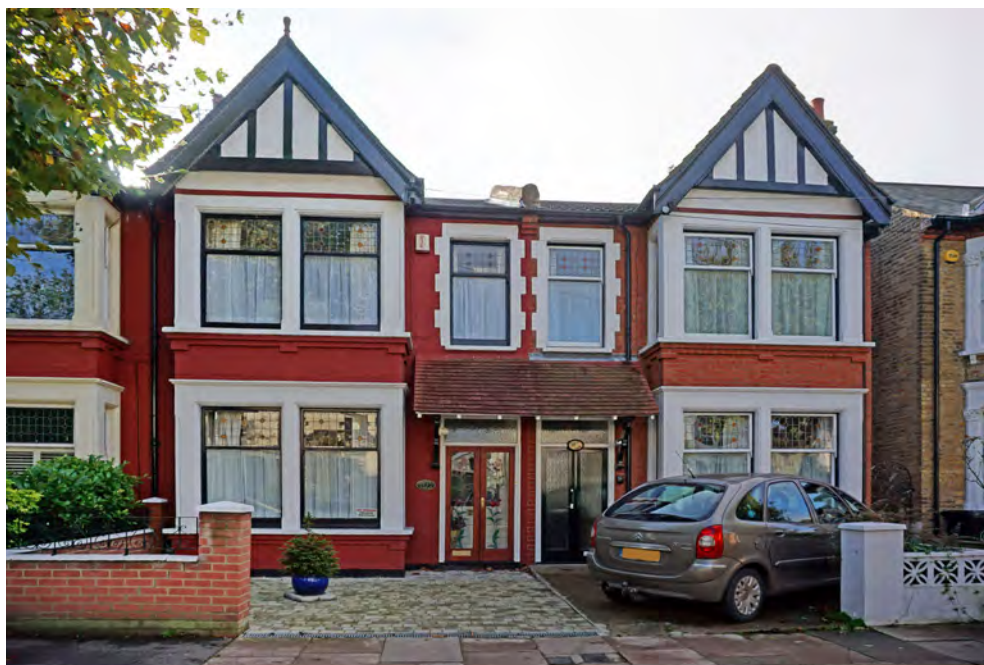
Address	Value	Designation	Description
17 and 19 Avenue Terrace	<p>No.17: Positive*- would benefit from removal of paintwork and removal of door infilling porch</p> <p>No.19: Positive – would benefit from removal of door infilling porch and replacement of concrete tiles with slate</p>	Article 4	<p>(Also see page 159 for architectural description)</p> <p><b>No.17 Description:</b> Brickwork unsympathetically painted red. Original sashes and slate roof remains but unfortunately the porch has been enclosed by modern stained glass French doors which are conspicuous in the streetscene.</p> <p>Section of red brick wall with copings and metal railing covers half the length of the front boundary and provides some enclosure to the street but regrettably the front garden area has been lost to unattractive hardstanding. This would benefit from some landscaping and a higher quality surface material to soften its appearance.</p> <p><b>No.19 Description:</b> Slate replaced with concrete tiles. Open porch enclosed with timber French doors. Timber sashes retained. Boundary wall has been topped with modern decorative blocks and only spans half the frontage but does still provide some enclosure to the street.</p> <p>Regrettably the front garden area has been lost to unattractive concrete hardstanding, although a small area for planting has been retained behind the wall. This would benefit from a higher quality and a more permeable surface material.</p>

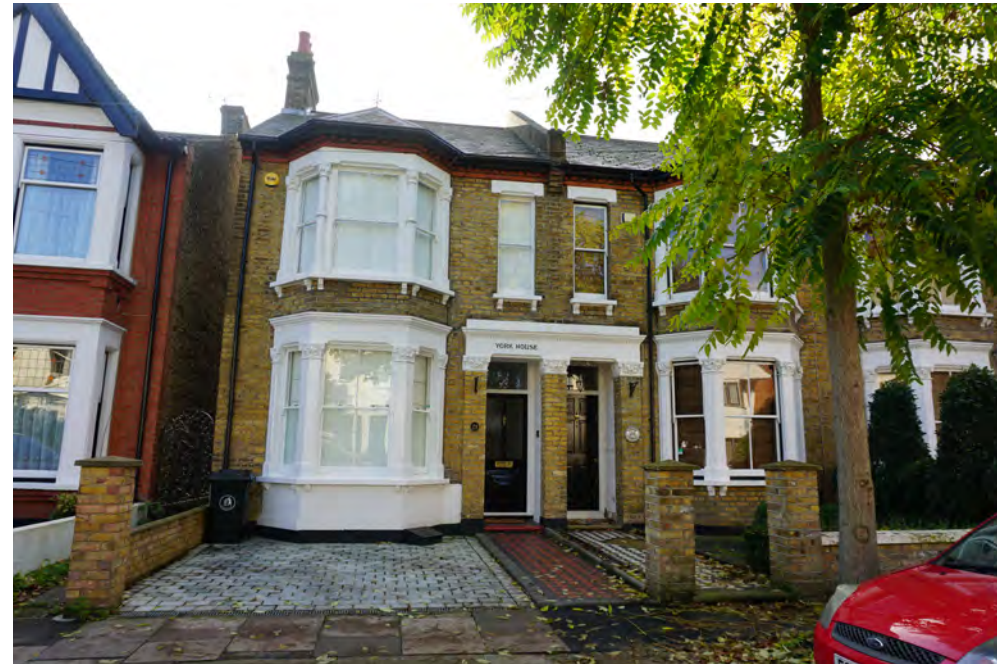
## *No.23 Description:*

Property intact including brickwork, slate and sash windows. Timber front door. Some of the moulded details have been painted black. Decorative tile path and boundary wall retained both of which make a positive contribution to the street. Planting to front garden is also attractive.

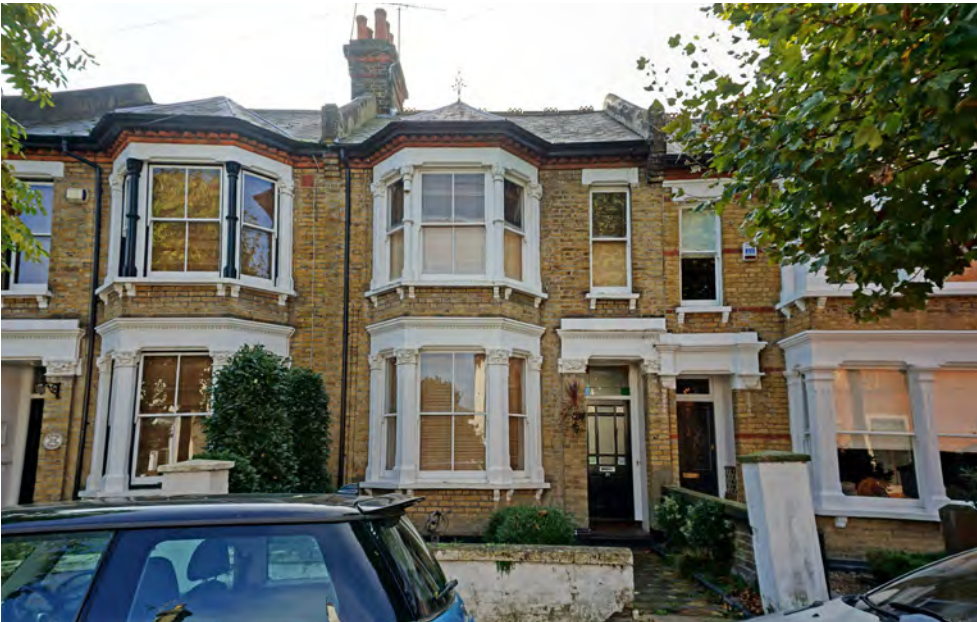
Address	Value	Designation
25 Avenue Terrace	Positive	Article 4

Divided into flats. Property intact including brickwork, slate and sash windows. Only this property has a decorative finial and ridge tiles to the roof. Timber front door with glazed upper panels. Decorative tile path and boundary wall retained both of which make a positive contribution to the street although wall in need of repainting. Planting to front garden is also attractive.

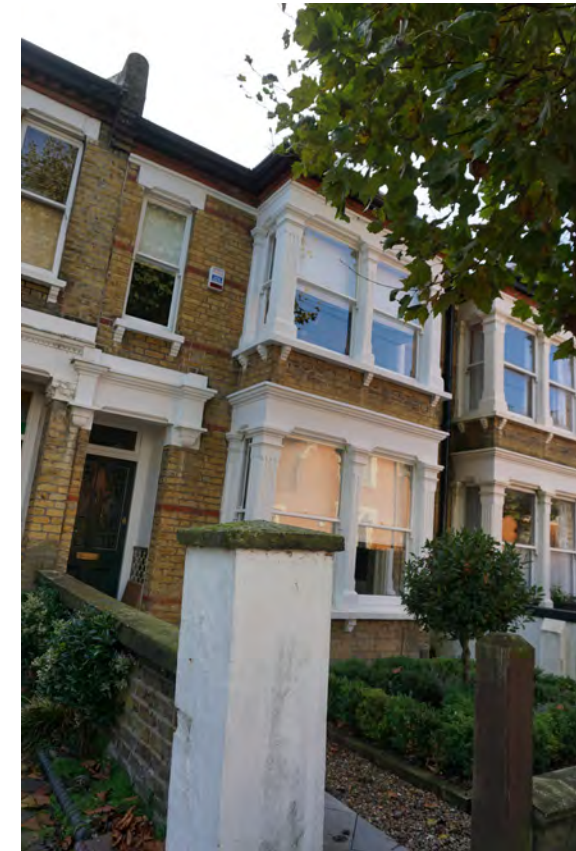
Property intact including brickwork, slates and timber sash windows. Attractive tiles inside sides of open porch at lower level which is not very common in this area. Low brick boundary wall and attractive planted front garden.

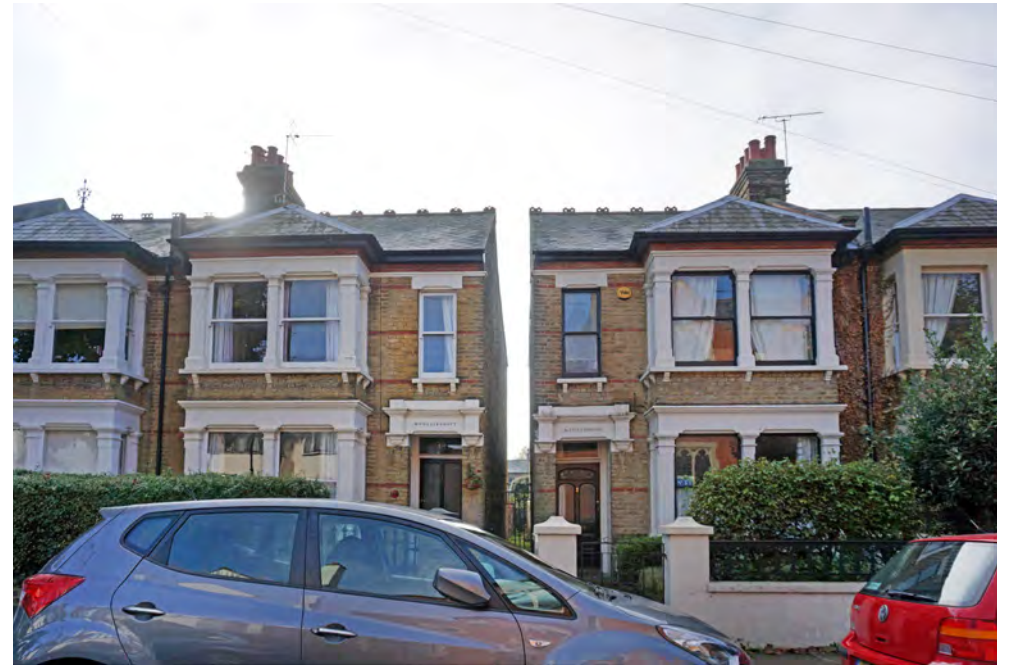
### *No.31 Description:*

Property intact including brickwork, slates and timber sash windows, which are painted black. Good timber door. The front wall has been rendered and is topped with decorative black metal railings which provide good enclosure to the front boundary. Attractive planting in garden also makes a positive contribution.

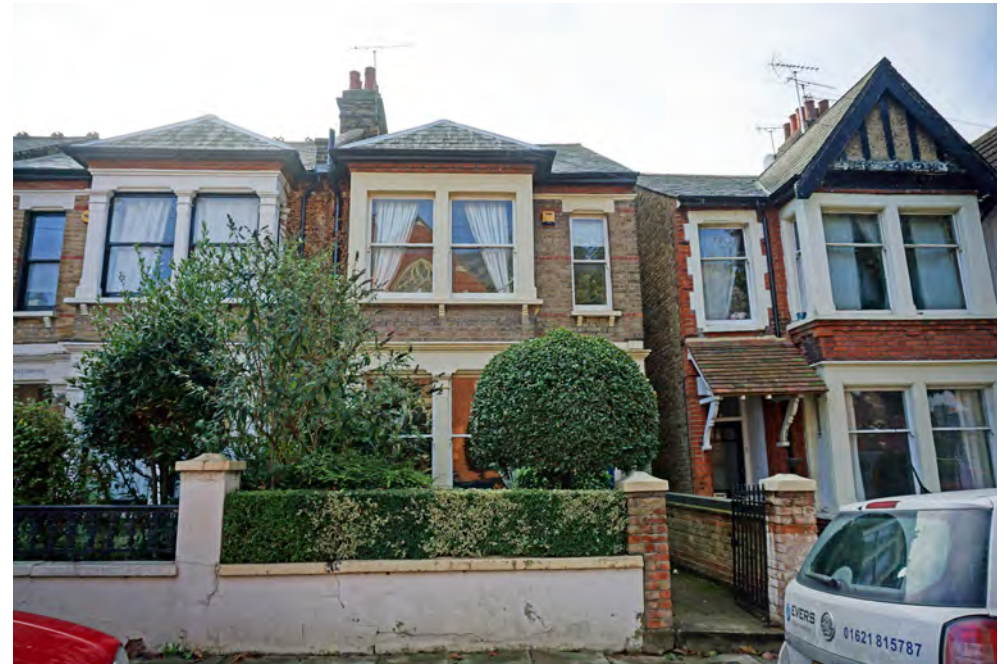
Address	Value	Designation
33 Avenue Terrace, 'St Catherine's'	Positive	Article 4

Property intact including brickwork, slates and timber sash windows. Timber door. Boundary wall has been rendered with brick piers, metal gate and coping stones and hedge behind. This provides good enclosure to the street but would benefit from maintenance. Attractive ornamental tree in front garden.

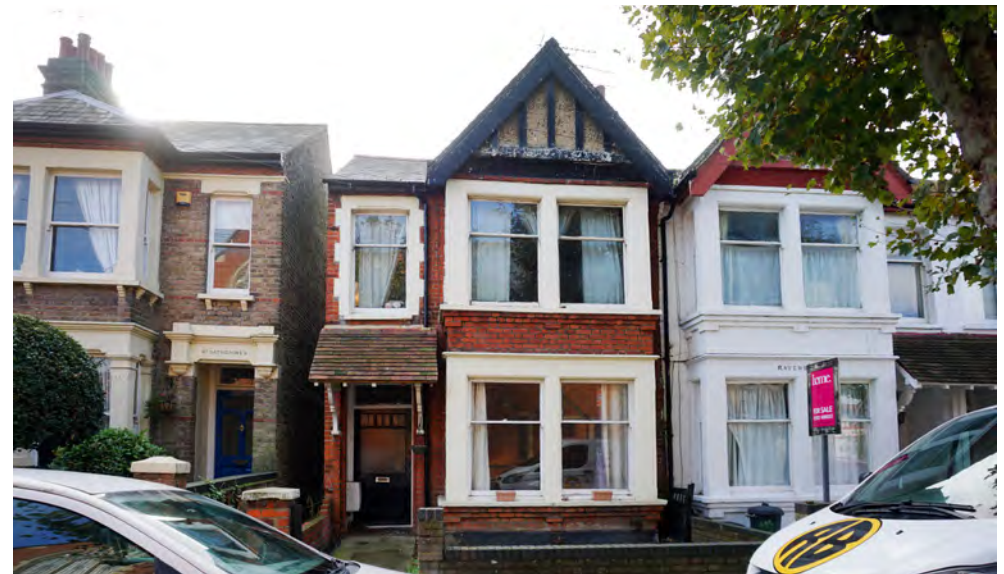
Divided into flats. Property intact including brickwork, slates and timber sash windows. Good timber door. A low brick boundary wall provides good enclosure to the street but regrettably the front garden area has been covered with a poor-quality area of hard surfacing. Upgrading this to a better quality permeable material and the introduction of landscaping would make a significant difference.

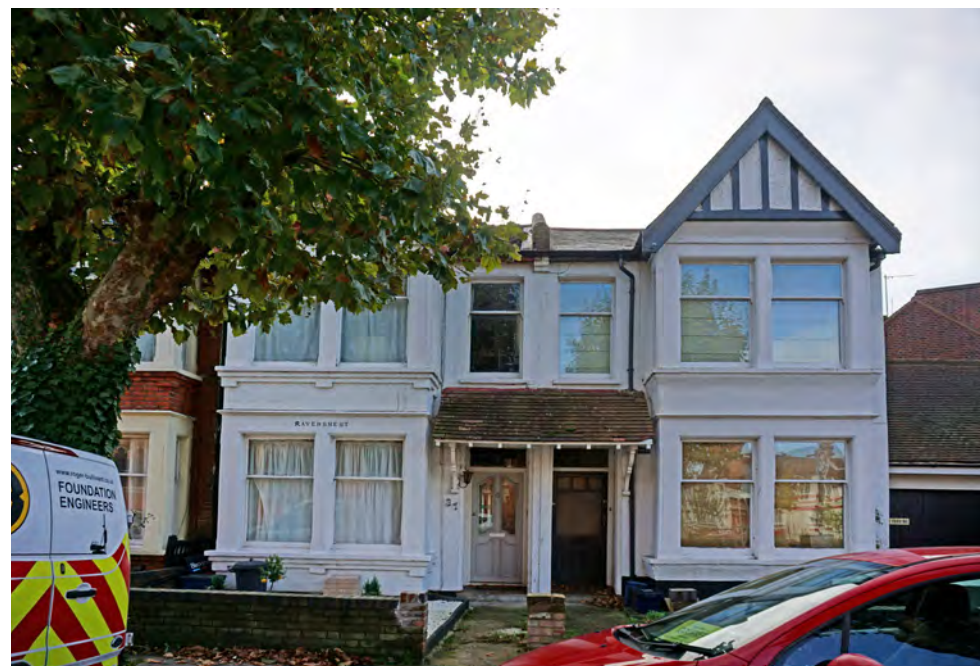
Address	Value	Designation
37 Avenue Terrace, 'Ravensnest'	No.37: Positive – though concrete tiles could be replaced with slate and front garden could be improved	Article 4
39 Avenue Terrace	No.39: Positive – though front garden could be improved

Brickwork painted and slate roof replaced with concrete tiles. Timber sash windows remain. Good timber door. A low brick boundary wall provides good enclosure to the street but regrettably the front garden area has been covered with a poor-quality area of hard surfacing. Upgrading this to a better quality permeable material and the introduction of landscaping would make a significant difference. Visible meter box on front elevation.

Divided into flats. Brickwork rendered but otherwise intact. Good timber door. A low brick boundary wall provides good enclosure to the street but regrettably the front garden area has been covered with a poor-quality area of hard surfacing. Upgrading this to a better quality permeable material and the introduction of landscaping would make a significant difference. Visible meter boxes on front elevation.

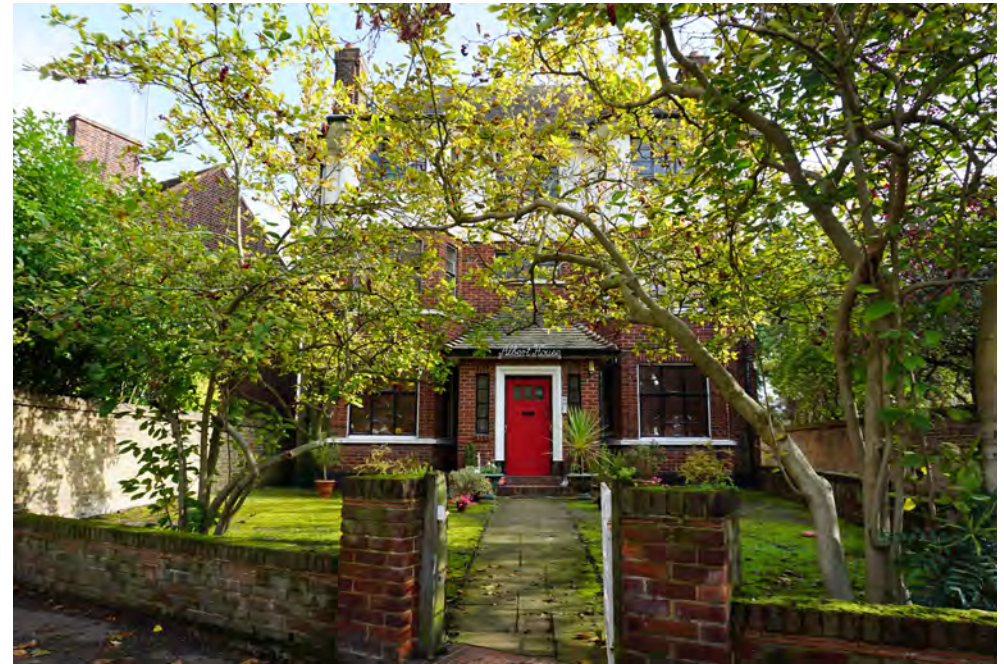
A three storey Arts and Crafts style purpose-built block of apartments c.1947. Dark red brick on lower two floors with white render above. Clay tiled hipped roof and prominent chimneys. It is of symmetrical design with two full height canted bays either side of the large hipped entrance porch. Original metal framed windows have been retained and are a key part of the building's character. Heavy timber door with three glazed panes in the upper portion.

Off street parking is provided to the rear via an access route to the side of the property. While the property is surrounded by a low brick boundary wall, there is a large area of hard surface to the front which would benefit from resurfacing and the inclusion of landscaping to soften its appearance though some effort has been made with planting which is attractive.

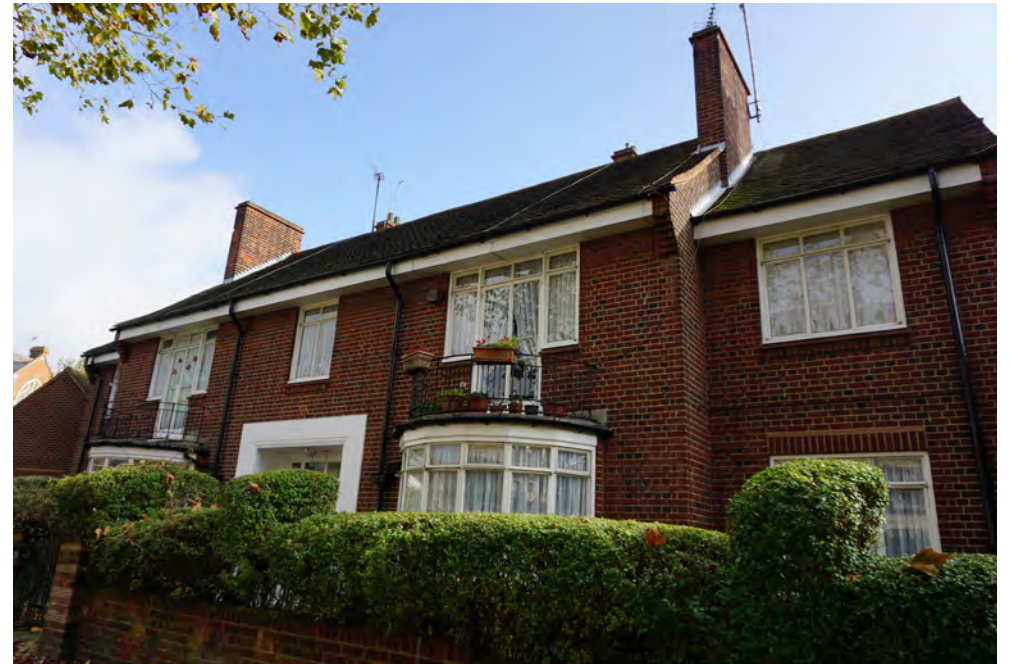
Address	Value	Designation
Glendaurel Court	Positive	N/A

A two-storey apartment block of a similar era to Albert House but of a different design. Red brick with gabled tile roof and white metal framed windows. Distinctive curved bays to the ground floor with metal balconies above and heavy surround to porch.

There is a well-maintained brick boundary wall with hedge and metal gates which surrounds the site.

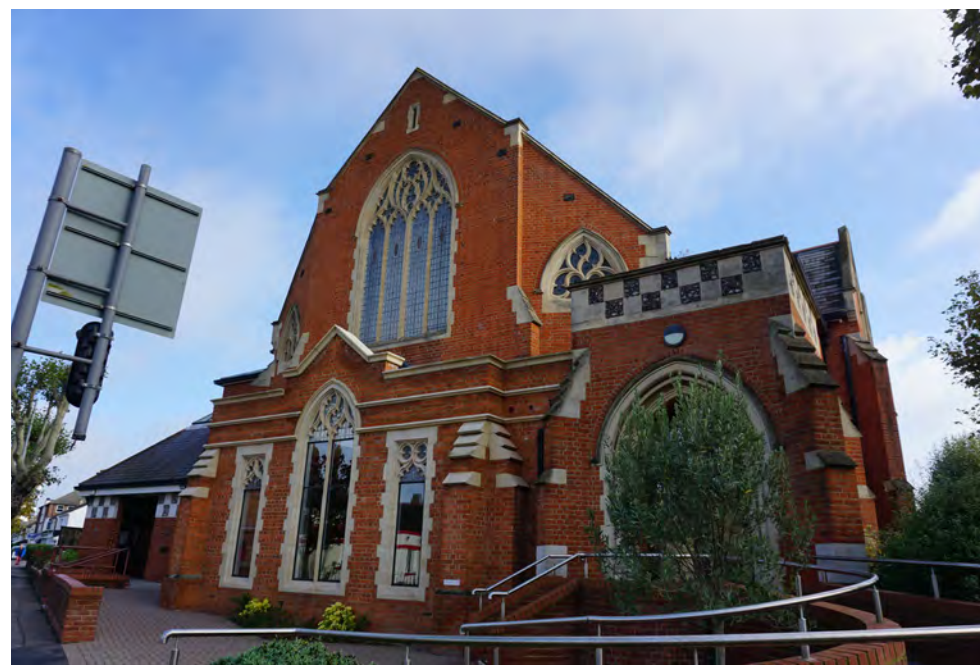
Address	Value	Designation
Avenue Road Baptist Church	Positive	Article 4, Locally Listed Building

An attractive and imposing church situated on the corner of Milton Road and Avenue Terrace. It is a good quality red brick church with Bath stone dressings, attractive windows with reticulated tracery and distinctive flint and stone checkerboard detailing to the parapet. It makes an important contribution to the local streetscene, marking the entrance into the residential streets of the Milton Conservation Area. The church benefits from a low brick boundary wall and well-maintained landscaped beds which enhance its appearance. Originally built in 1900, the church was restored in 1949 following bomb damage on 10th December 1945.

There is a late-20th century single storey extension on the north and west sides of the church which borrows flint chequerwork from the old building. The brick match and delicate window design has also helped to integrate this with the main church building.

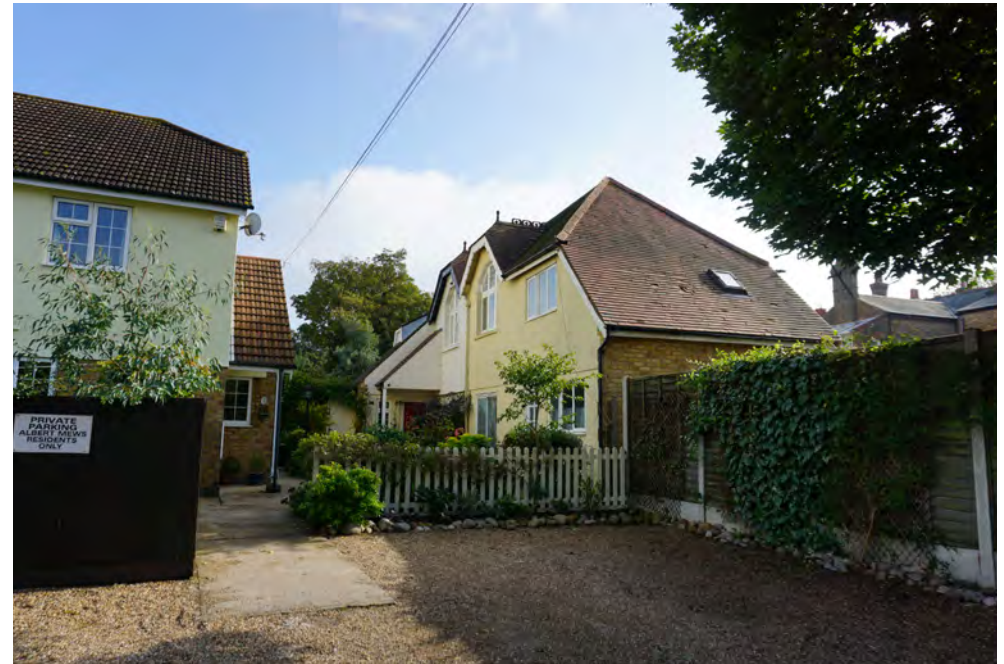
Address	Value	Designation
1-2 Albert Mews	Positive	N/A

Former coach house which appears on the OS map of 1897. It was converted to garages in 1924 and then subsequently converted into two houses in 1985.

Two storeys with prominent clay tiled hipped roof dropping to ground floor level at the sides. Attractive half hipped double gable feature to centre with shaped timber barge boards and decorative terracotta ridge tiles and finial. Large first floor feature windows designed to fit the shape of the gables have been retained on both properties. The building has been rendered and clad with modern boarding and a number of windows have been altered. A front extension has also been built at No.2 using similar materials.

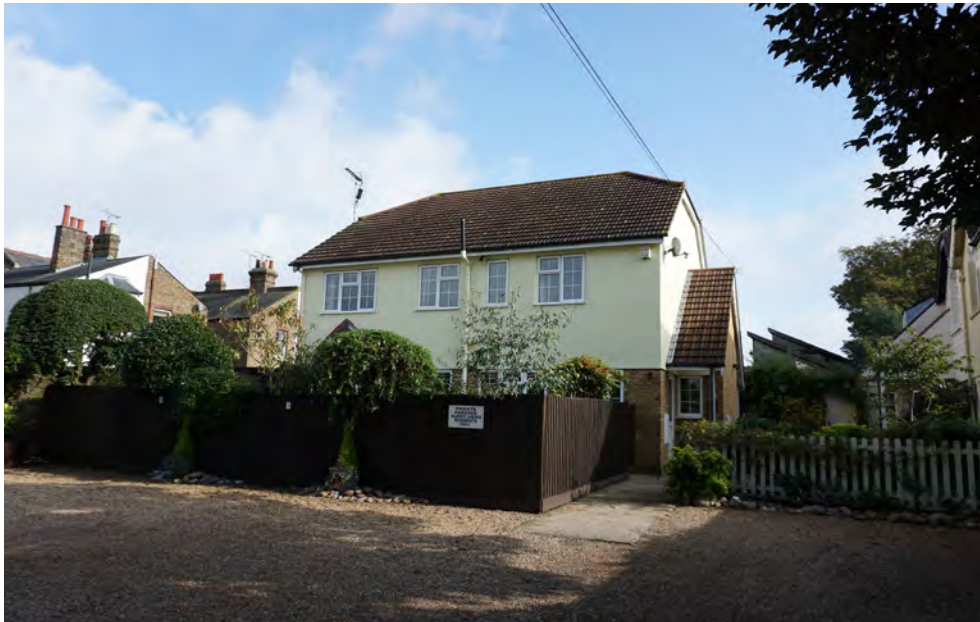
Address	Value	Designation
3-4 Albert Mews	Neutral	N/A

Modern pair of two storey semi-detached houses of a basic design. Half hipped roof with concrete tiles, with uPVC casement windows. Buff brick to ground floor and cream render above.

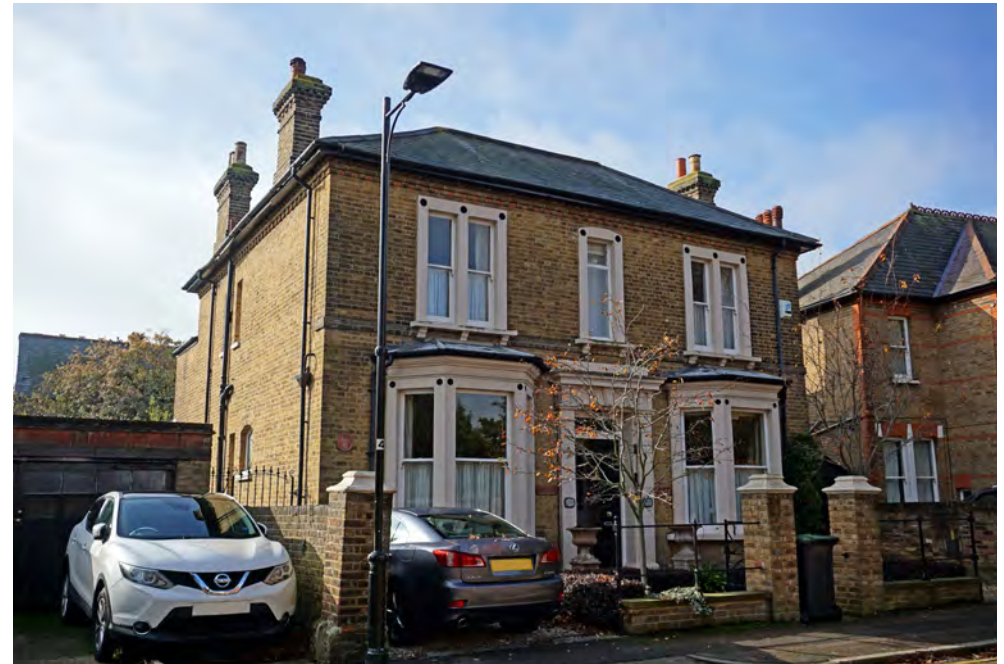
Decorative brick banding below eaves and at first floor sill level. Attractive but simple porch in between the two bays. Black painted timber double doors enclosing porch.

The front boundary is enclosed with a low brick wall with attractive traditional metal railings, capped piers and pedestrian gate and this makes a positive contribution to the street. Attractive tiled path leading to the front door. Two off-street parking spaces have been sensitively achieved each side of the property and sympathetic surface material (gravel) used.

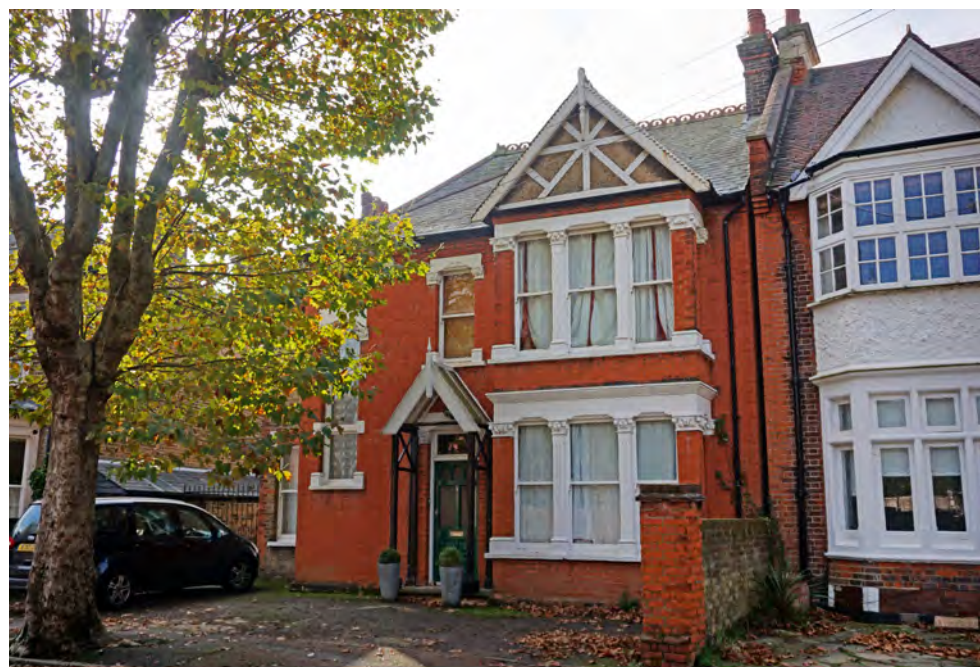
Address	Value	Designation
7 Park Crescent	Positive – though frontage could be improved	Article 4

The property also has a well-proportioned yellow stock brick extension to the east side which is well detailed but not matching to the main part of the house and this is likely to have been a slightly later addition.

The front boundary has been lost and a large area of hardstanding created to the front of the property. This has a negative impact on its appearance and would benefit from reinstatement together with good quality permeable surface materials and the provision of landscaping to soften this area.

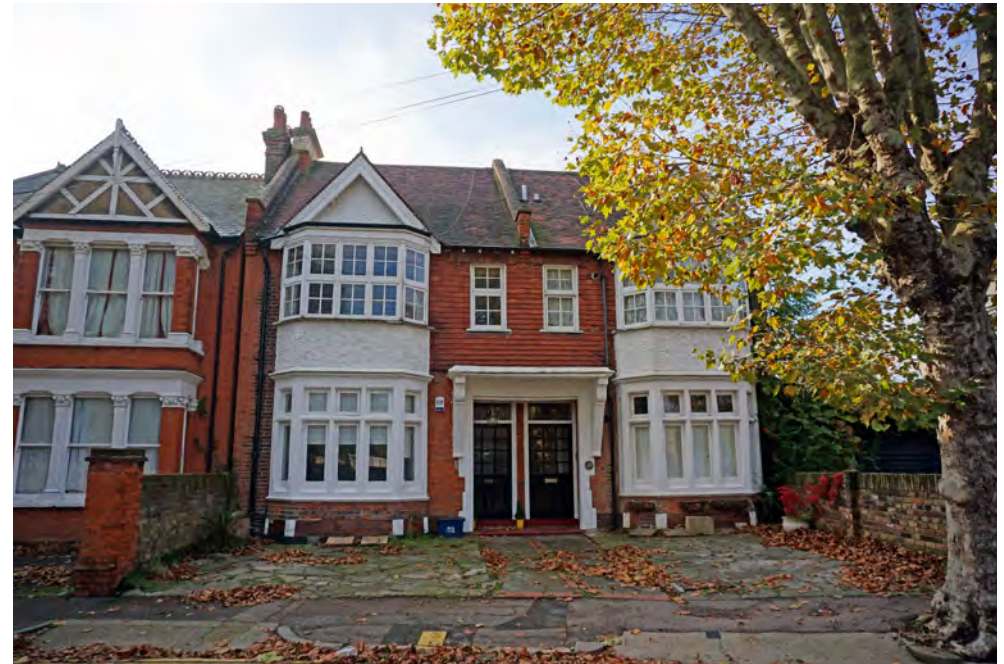
Address	Value	Designation
9 -11 Park Crescent	Positive – though frontages could be improved	Article 4

Front boundary walls have been lost and the front garden areas paved over to provide off-street car parking. The character of the property and its impact on the Conservation Area would be enhanced by the provision of a front boundary wall and landscaping.

Both these properties have been divided into flats

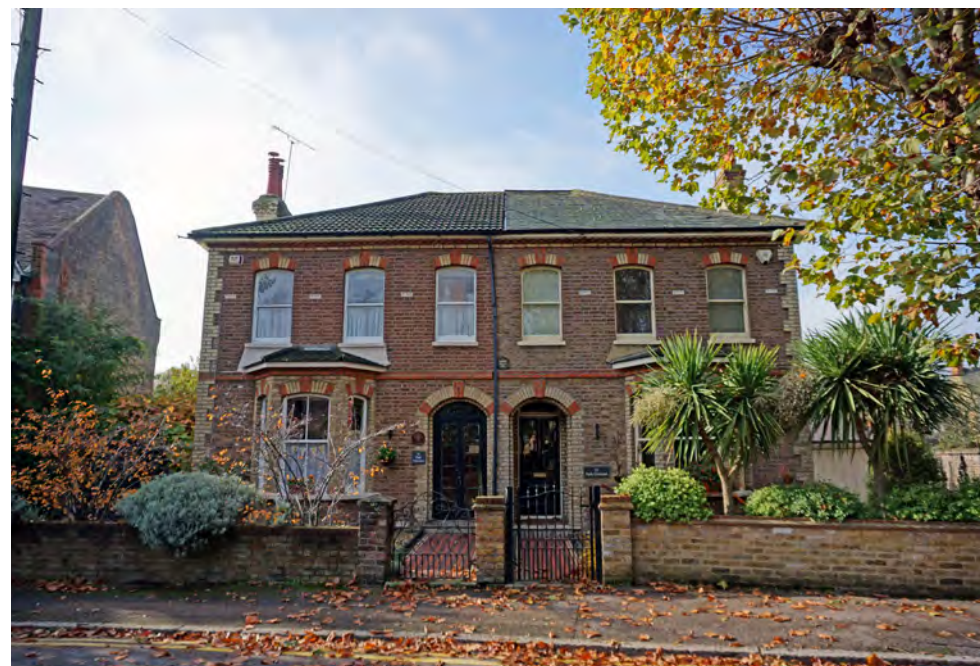
Address	Value	Designation
13 -15 Park Crescent, Albert Villas	Positive	Article 4

The façade is characterized by decorative red and buff brickwork on the bay, porch and window surrounds and is very distinctive. An unusual feature is the equal spacing of three sash windows to the first floor rather than the asymmetric grouping usually found above the bays and entrance.

Both properties are well preserved except for the loss of slate the roof and the enclosure of the open porch to No.13. Door to No.15 is timber with stained glass upper panels and fanlight.

The front gardens of both properties are well planted and enclosed by brick walls. The decorative tile paths have been retained.

A detached garage and driveway has been subsequently built to each side which allows for parking to be sensitively integrated into the streetscene.

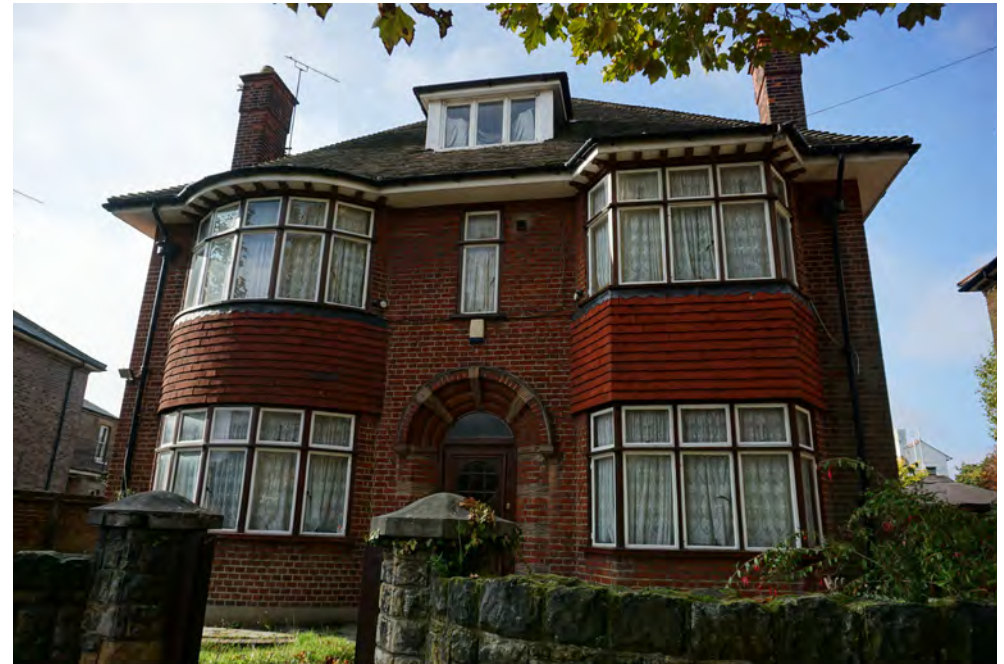
Address	Value	Designation
17 Park Crescent	Positive – though boundary wall should be repaired and frontage could be improved	Article 4

The western section of the curved stone front boundary wall has been retained, the eastern section appears to have been demolished and left in a poor state of repair with a number of loose stones. This may be related to the driveway which sits to the side of the property. The wall would benefit from reinstatement here, up to the driveway, and a pillar reinstated.

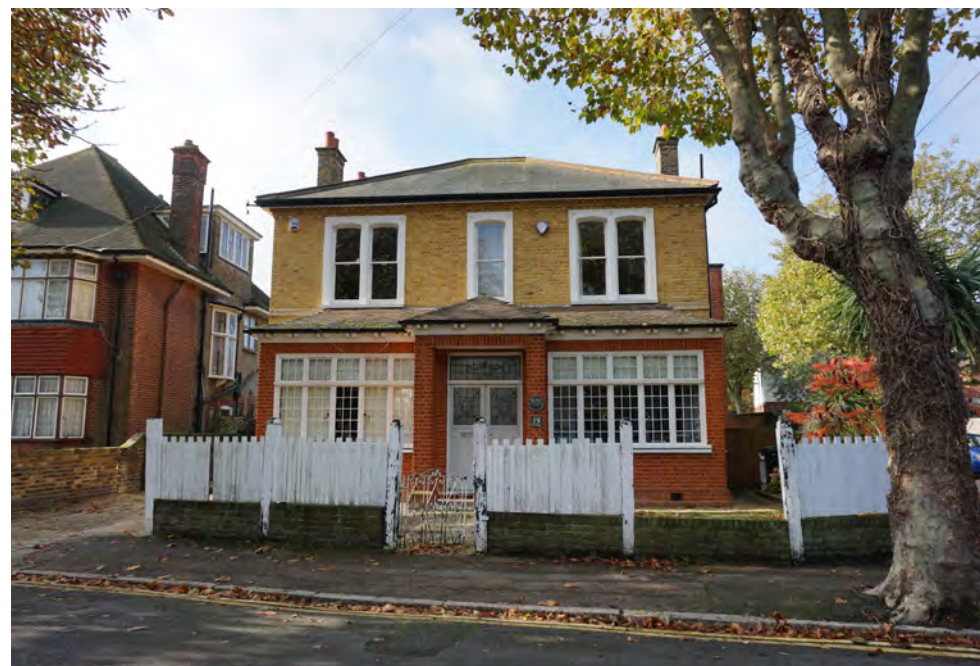
Address	Value	Designation
19 Park Crescent	Positive – though frontage could be improved	Article 4

The upper windows are timber sashes in robust stone surrounds and circle detailing. The main body of the house seems to be of a similar design to No.1 Park Crescent, though the property has been extended with a two large red brick square bays on the ground floor with small painted timber casements. The bays run into the structure of the porch and all are connected with a tiled hipped roof/canopy. The evidence therefore suggests that that this section of the house was added a few years after it was first constructed, though it is still an attractive feature. The timber and stained-glass porch doors also seem original to this element. The contrast in windows styles is also evident on the north elevation which faces the street, where an additional casement window has been added alongside the original sashes.

A two storey flat roofed red brick extension has also been added to the northern side of the building. It is also likely that this was a later addition as, although it is well detailed, it does not integrate so well with the existing building particularly at roof level.

Single storey ground floor extensions are also visible above the wall at this point.

A low brick wall has been retained to the front boundary and this has been topped with a picket fence which would not have been original to the property. It is in poor decorative condition. To its northern edge the property is bounded by a taller brick wall which appears in a good state of repair.

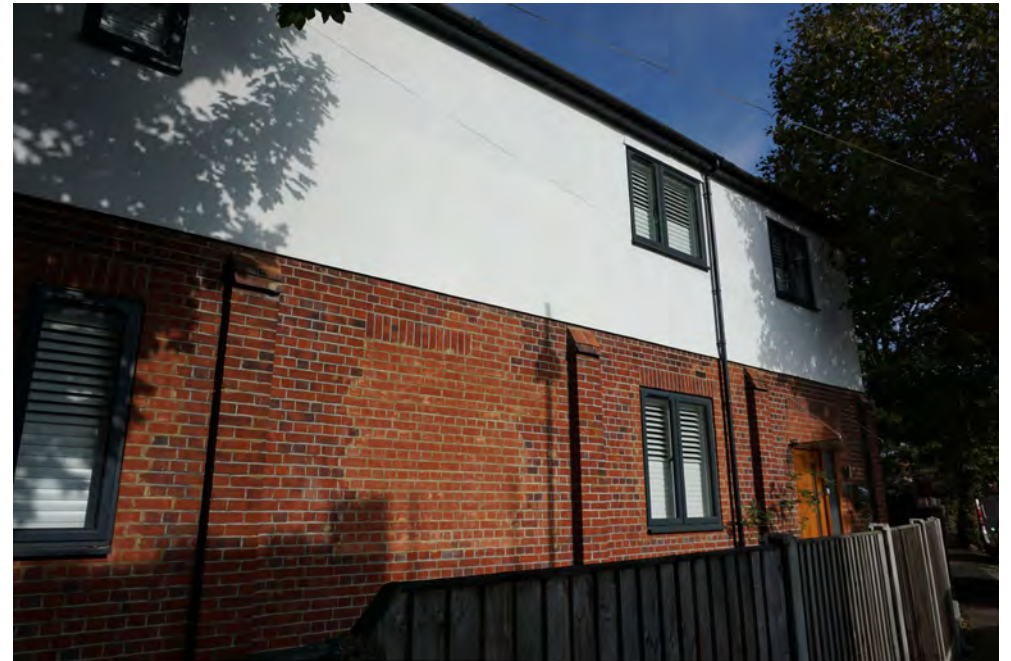
Extension to No.50 Avenue Road. in brick to the ground floor with render to first floor. Grey framed windows and stained timber door. Rather dominant on the streetscene to Park Crescent.

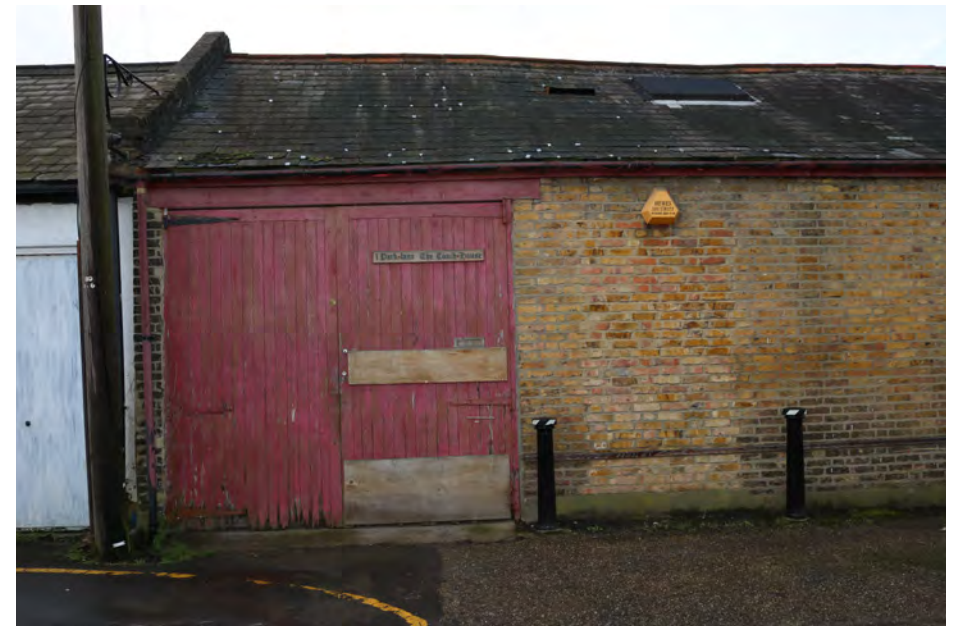
Address	Value	Designation
1 Park Lane The Coach House	Positive* – would benefit from improved condition	Article 4

Garage/store on Park Lane. From the materials used it appears historic and first appears on 1897 OS map. Single storey. Buff coloured brick. Slate roof. Red painted timber plank double doors with timber lintel. Evidence of a pedestrian door having been blocked to the right of double door. Rooflight(?)/vents added to roof. Condition is rather shabby with paintwork requiring refreshing and several metal tags added to slates to prevent slipping.
