# Milton Conservation Area Appraisal

# Southend-on-Sea: Milton Conservation Area Appraisal

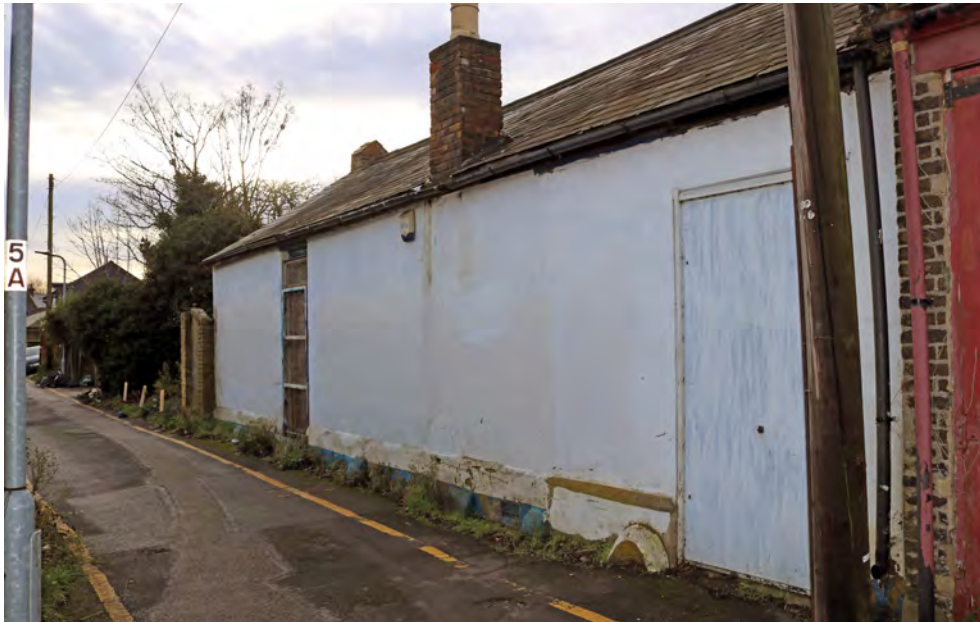
Address	Value	Designation
Building to the rear of 40 Park Road	Positive* – would benefit from replacement of door and window with sympathetic alternatives and improved condition	Article 4

Garage/store on Park Lane. From some materials used it appears historic and first appears on 1897 OS map. Single storey. Painted render. Slate roof and brick chimney. Modern doorway to right with door boarded over. Further doorway to left with unsympathetic metal grill over. Would benefit from replacement doors with more traditional alternatives in timber. Condition could also be improved.

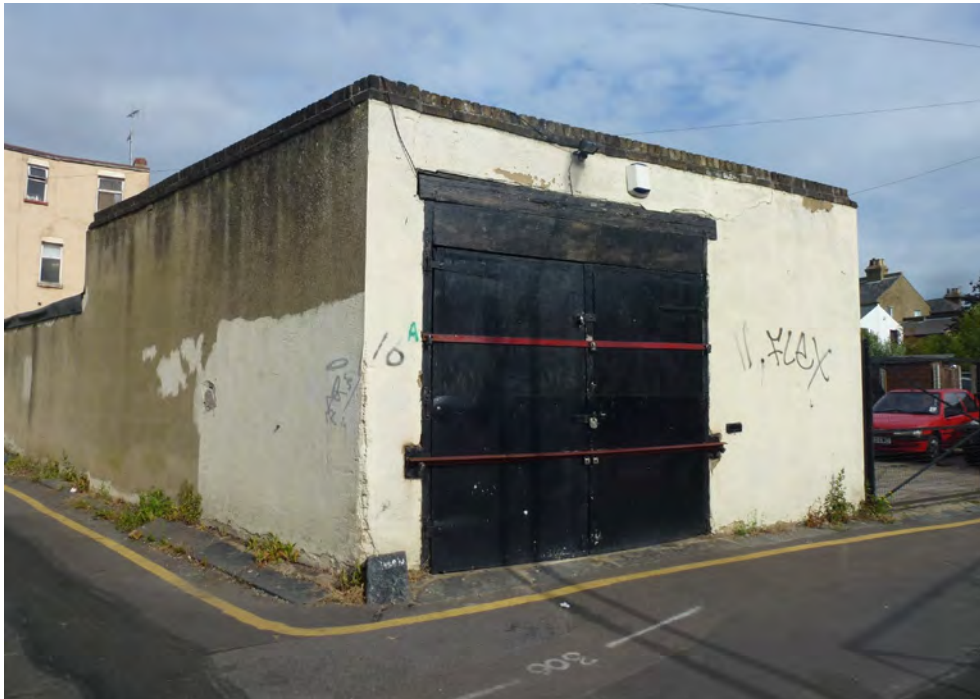
Address	Value	Designation
Building to the rear of 14 Park Road	Neutral – would benefit from improved condition.	Article 4

Garage/store on Park Lane. Possibly early 20th century. Single storey. Roof material not seen. Painted render which is cracked in places with peeling paint that requires improved condition. Large timber painted doors.

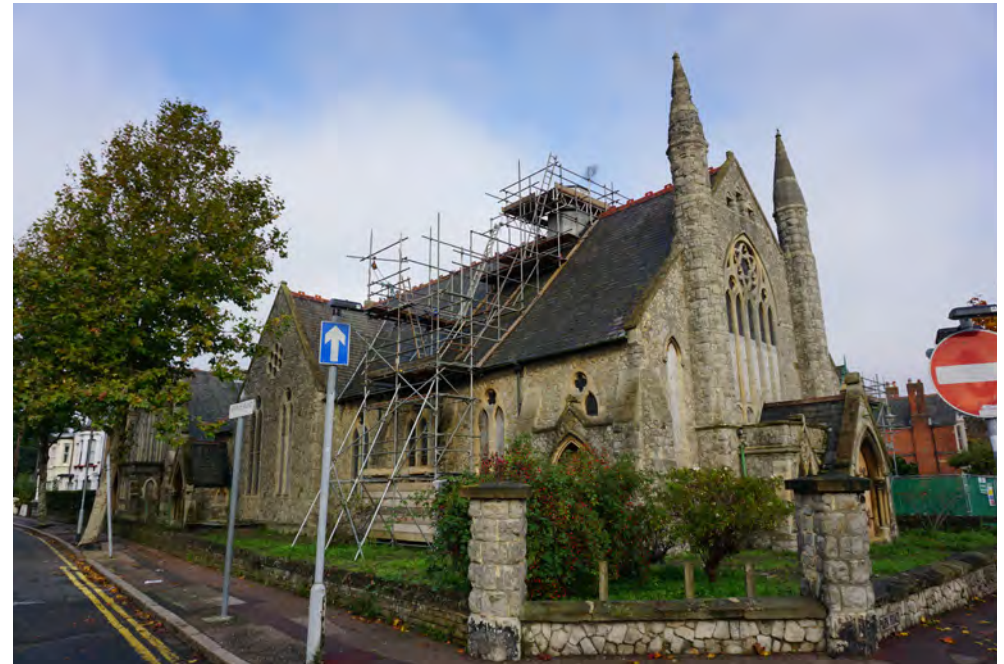
Address	Value	Designation
Park Road Methodist Church and Church Hall	Positive – though would benefit from reuse and repair	Grade II listed

The church has been vacant since 1997 and is now suffering from neglect. Some windows have been boarded up to prevent further damage.

A complex of church halls was added in 1902. These are yellow stock brick but the side facing the street is Kentish ragstone. The main church hall is also in the Early English Style to match the church. This building is also vacant, though very intact inside, and suffering from neglect.

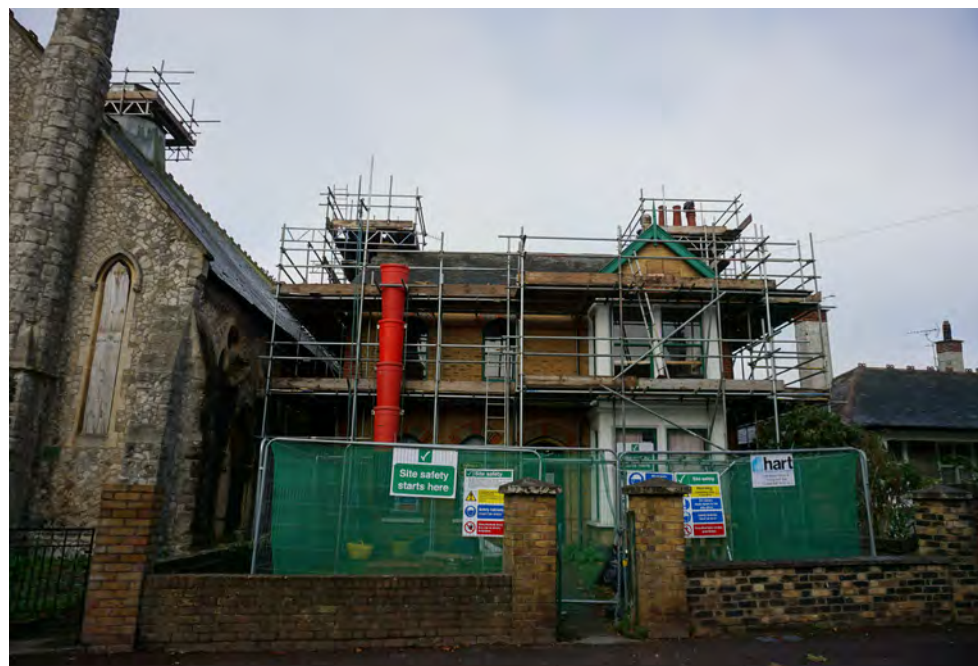
Late-Victorian two storey stock brick house with slate roof and full height square gabled bay. Decorative shaped red and grey brick arched lintels to windows and doors, red brick banding and quoins. Windows are Gothic in style (pointed arch) giving this property a distinctive character. Property intact including brickwork and timber sash windows which have been painted green. Recessed porch with timber panelled door with glazed upper panels.

Lawn to front enclosed by a low yellow stock brick wall with tall piers and coping stones. One of the coping stones has been lost and should be replaced. Undergoing renovation to convert it from two to three flats at the time of survey in 2019.

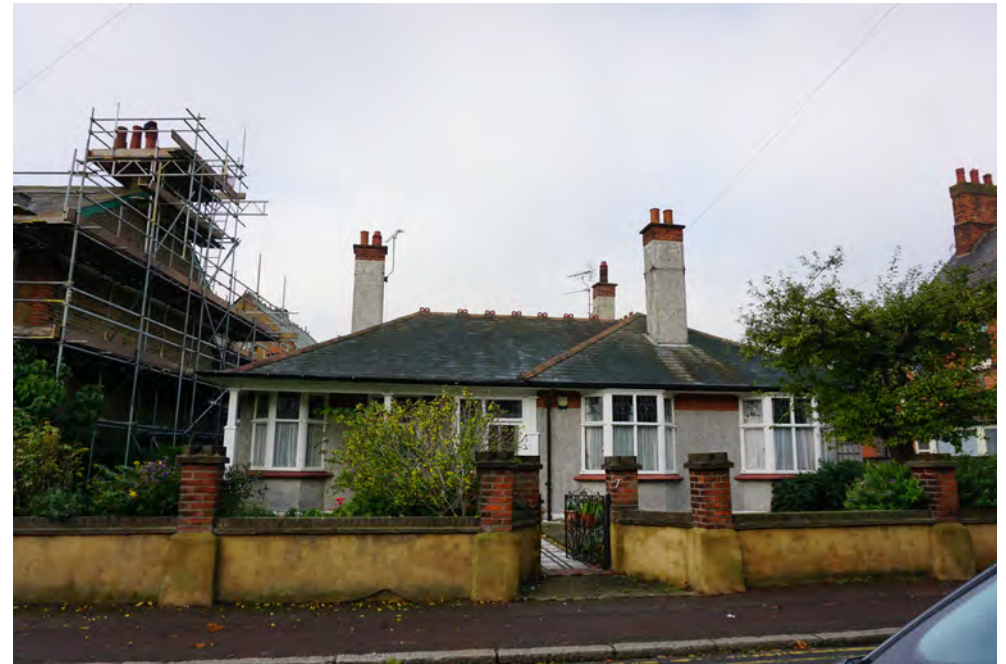
The original boundary wall also survives which is rendered with red brick coping and piers which are capped with tile laid flat and bricks laid in a cross pattern which is very distinctive. The garden has been retained on half the frontage which makes a positive contribution to the streetscene but the other half has been concreted for parking. This would benefit from a higher quality surfacing material.

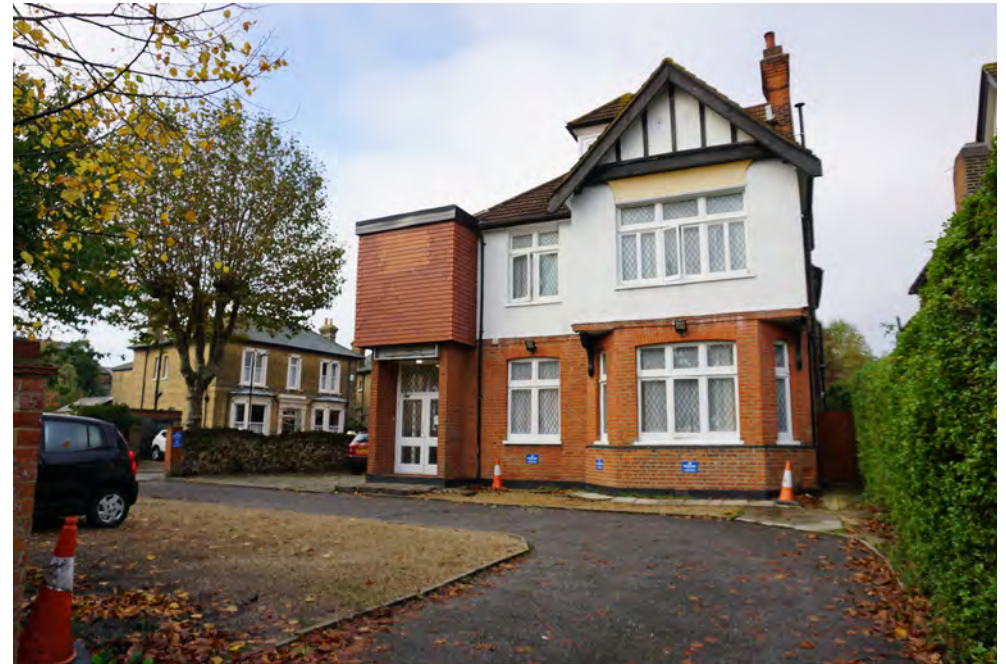
Address	Value	Designation
11 Park Road, Westpark Hotel	Positive* Side extensions: Negative	Article 4

The building is dominated by two unsympathetic first floor side extensions to the south, built c.1970s, which are detrimental to its historic character. The extensions are large with flat roofs and few windows, covered in tile hanging and in places they even cut into original features. There are also a number of dormers in the roof, some of which interfere with existing features, and are uncharacteristic of the Conservation Area.

The property has retained its original tall burr brick boundary wall and mature trees to the front which provides some screening to the large expanse of car parking.

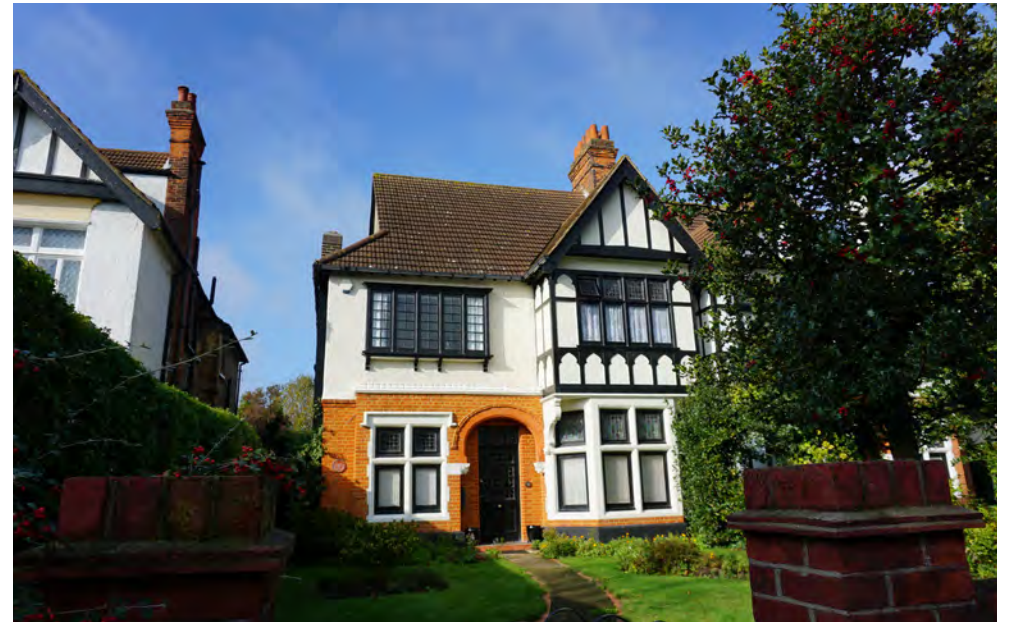
Forms a pair with No.15. Original roof replaced with concrete tiles. Original burr brick boundary wall survives and encloses front garden. Mature landscaping to front screens most of the property from the street.

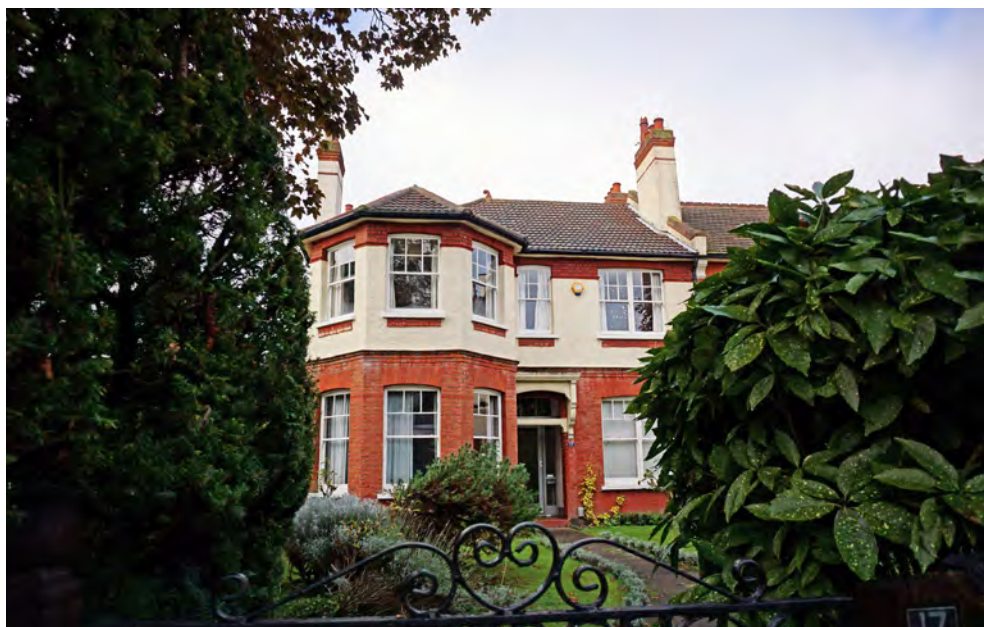
Forms a pair with No.19. Intact except that original roof replaced with concrete tiles and front door has been replaced with modern timber framed door which is mainly glazed. Original burr brick boundary wall survives and encloses front garden. Mature landscaping to front screens most of the property from the street.

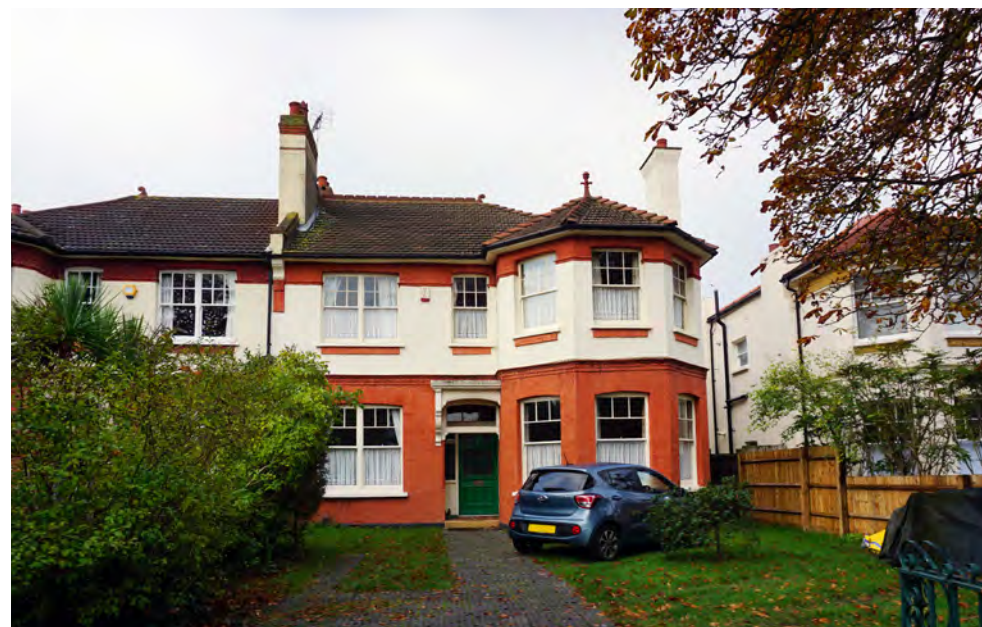
Forms a pair with No.17. Intact except that original roof replaced with concrete tiles. Original burr brick boundary wall survives and encloses front garden. Mature landscaping to front screens most of the property from the street. Minimal parking provided behind mostly retained front boundary wall is positively designed.

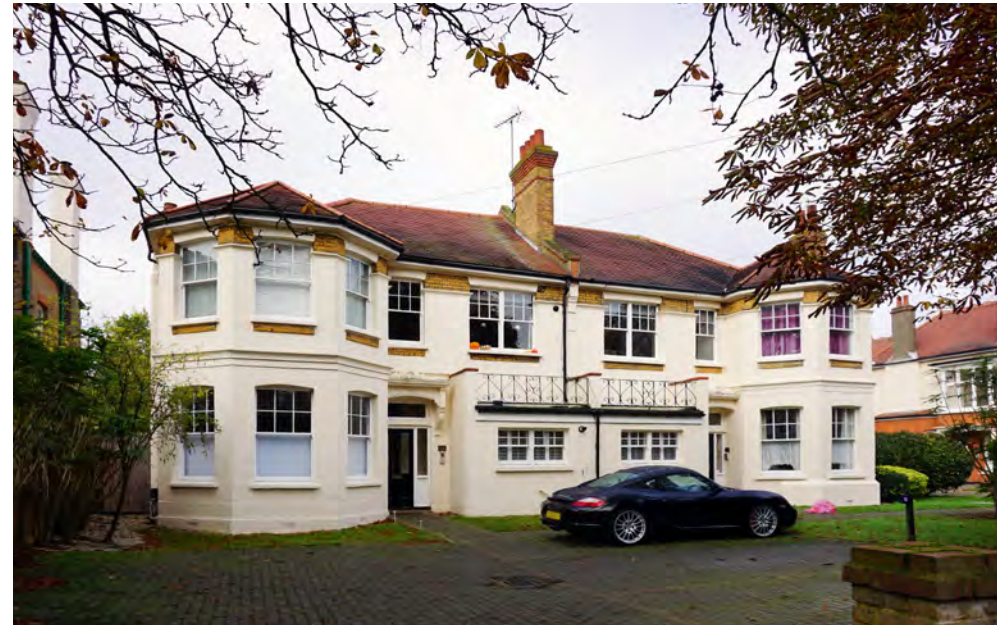
Pair of semis of same design as Nos.17-19 but converted into flats as part of the Parkgate development. Original brickwork painted. Recessed porches enclosed with modern, though traditional style, doors. A single storey extension between the doors. The shortened windows and flat roof with modern metal balustrade clearly identify this element as an extension and these should have been better detailed. Low yellow stock brick boundary wall provides enclosure to the street and helps to screen frontage from the street which has been partly block paved. Large trees on the frontage help to soften the building in the streetscene.

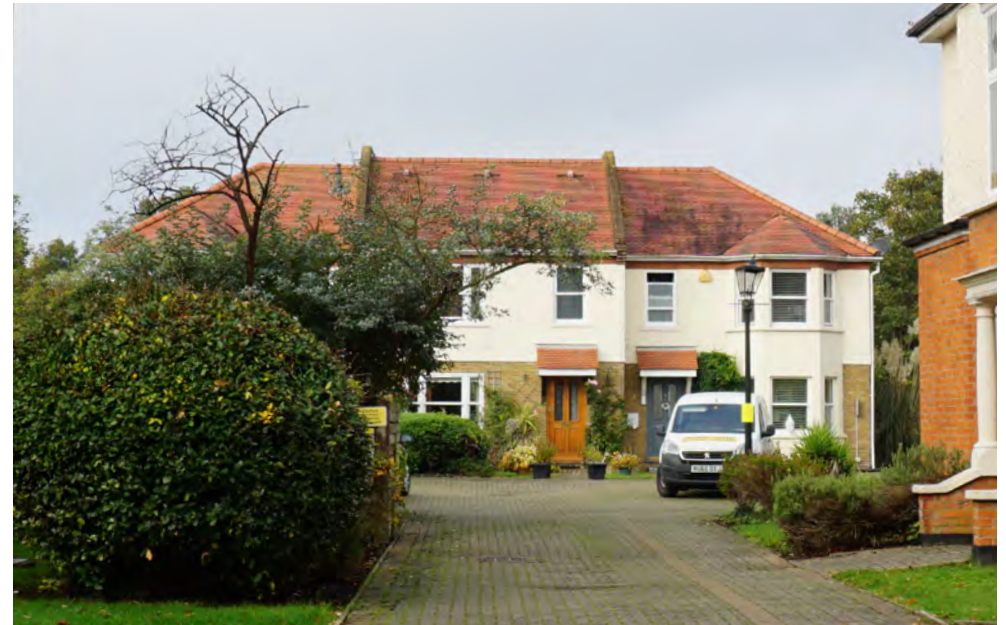
Modern development to the rear of the properties in Park Road. Designed to reference the surrounding historic buildings but whilst the materials are a good likeness the detailing is lacking and the proportions of the windows and floor heights too short. However, their location set well back from the street mitigates this to some extent. All properties are intact although some of the modern timber sash windows are in need of maintenance.

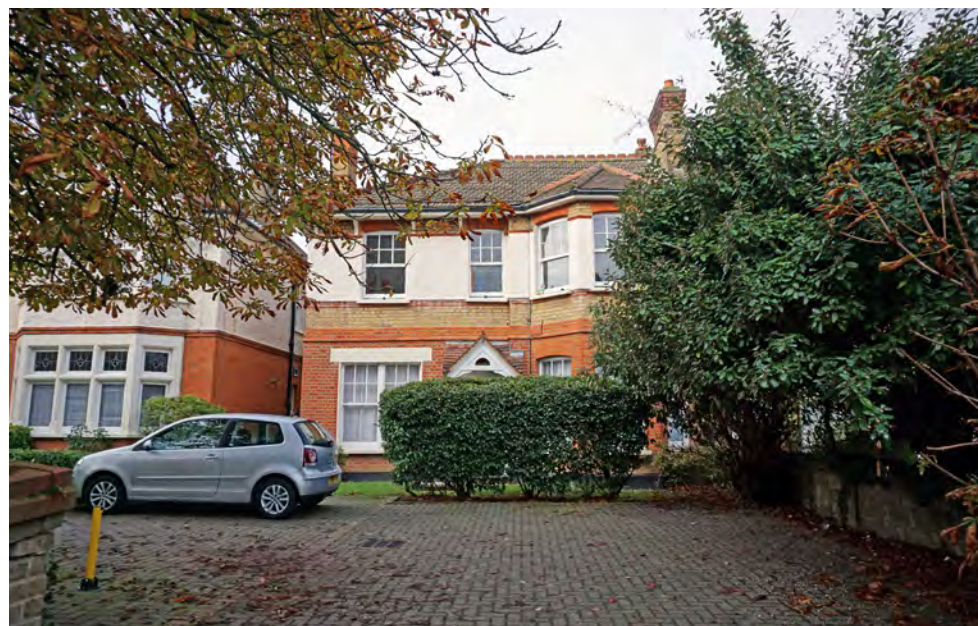
Forms a pair with 31 Park Road. Divided into three flats as part of the Parkgate development. Intact except for roof replaced with pantiles. Yellow stock brick wall provides enclosure to the street and help to screen block paved parking area and mature tree on the boundary provides softening for the building.

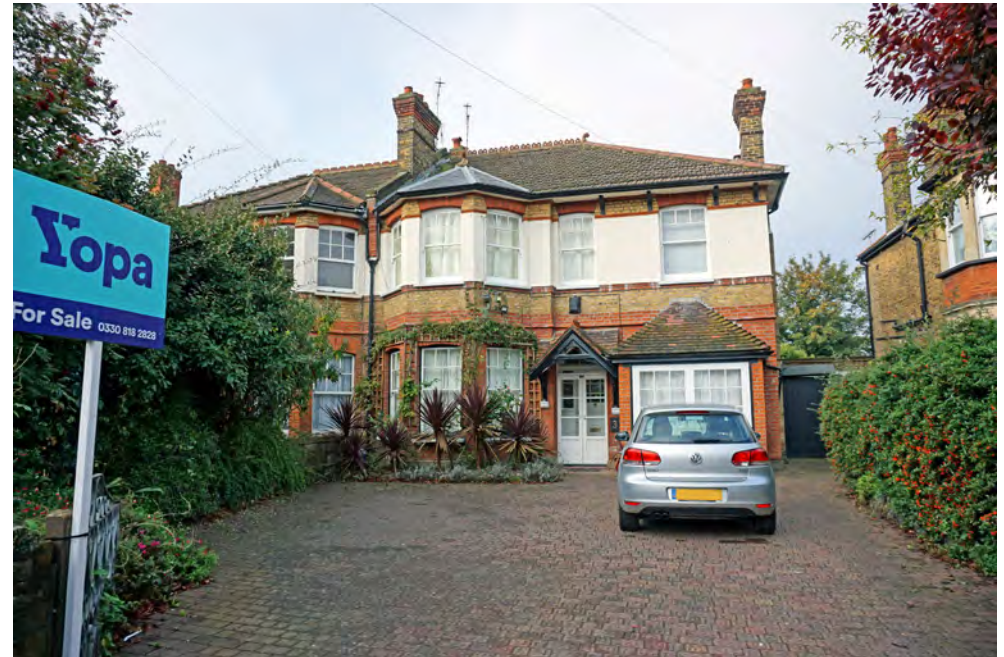
Forms a pair with 19-22 Parkgate. Original clay tile roof replaced with concrete tile and slate over bay, though tile remains to porch and single storey bay. Decorative ridge tiles. Small extension to the front forming a small square bay. Relatively inconspicuous in the streetscene. Porch has been filled in with timber and glazed doors, though relatively sympathetic. Yellow stock brick boundary wall provides good enclosure to the street and helps to screen block paved parking area. Landscaping on the frontage provides some softening for the street.

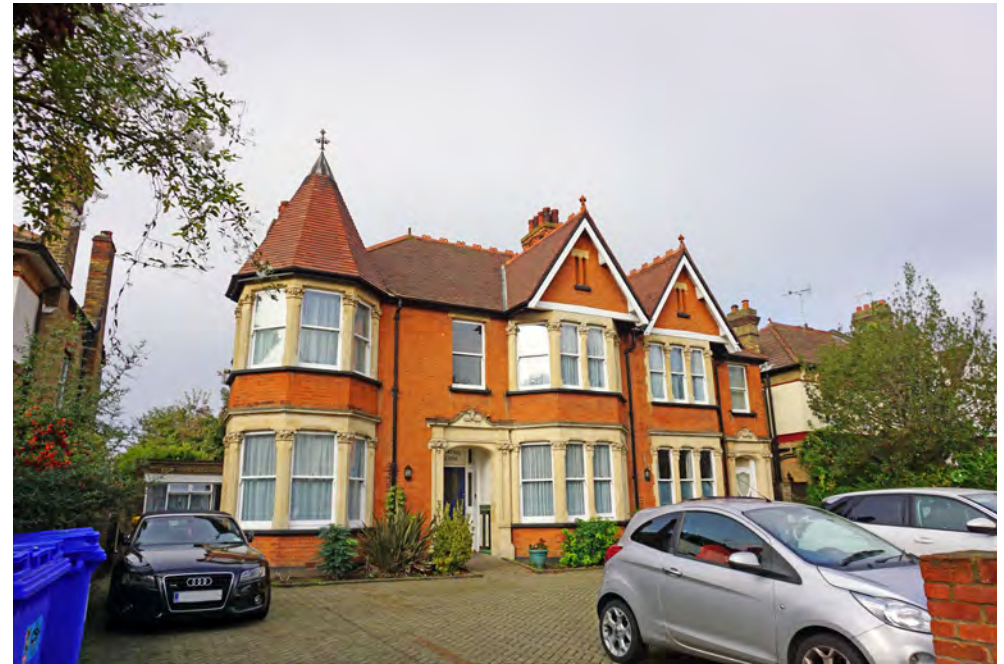
Both the turret and the bays have decorative stone surrounds with foliage detailing to the columns and simple timber sash windows. The stone detailing is also replicated on the porch surrounds. The original decorative timber front doors have been retained and make a positive contribution to the historic character of the building. Decorative tiling to interior walls of porch.

There is a low red brick boundary wall with yellow stock brick capping and tall piers and this provides good enclosure to the street. The frontage however is almost entirely block paved.

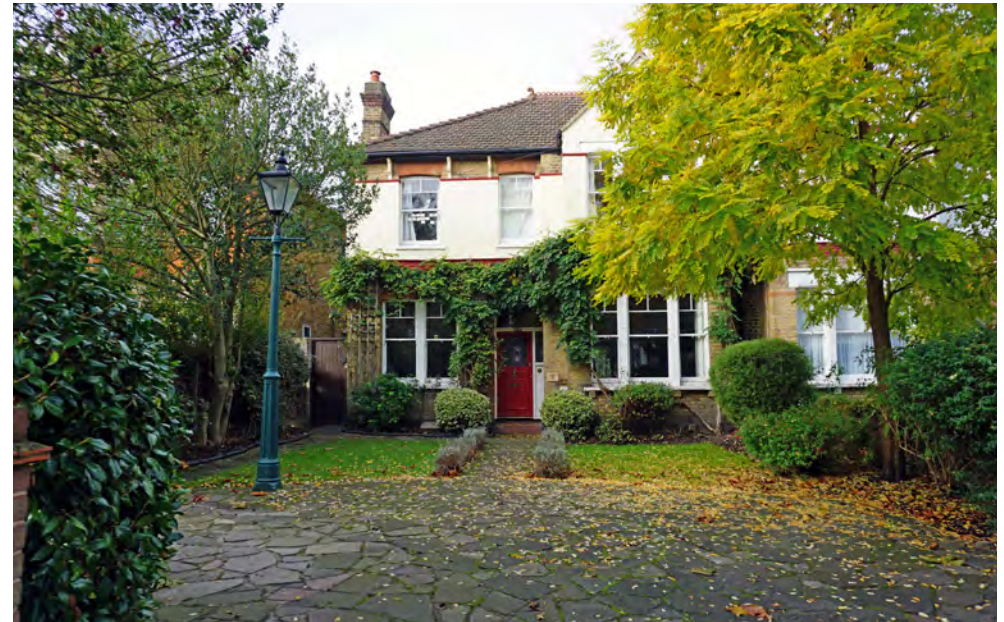
Address	Value	Designation
39 Park Road	Positive	Article 4

Divided into flats. Property intact except for concrete tiles to roof and timber casement window with louvres to first floor bay only. Planted front garden makes a positive contribution to the streetscene. Parking has been well accommodated on the frontage.

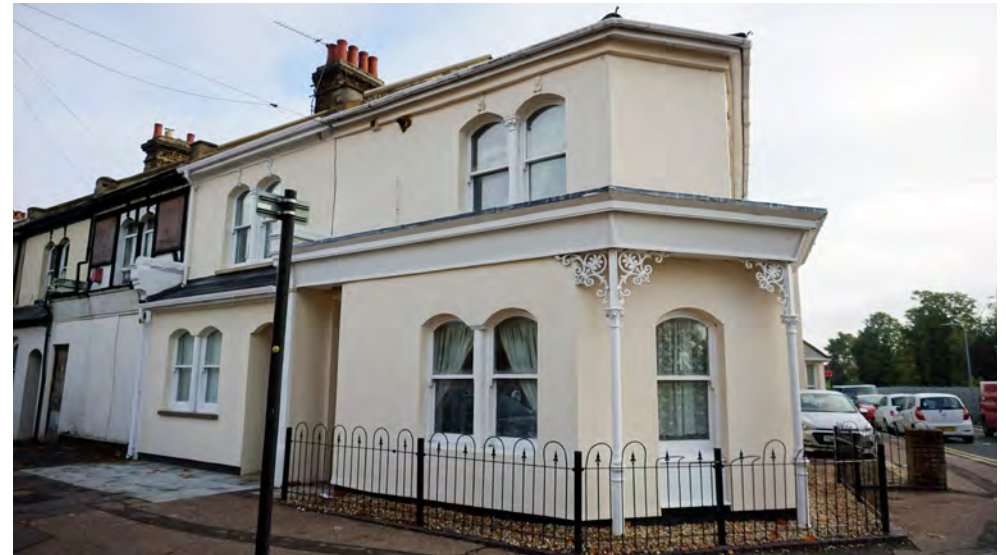
Address	Value	Designation
4 Park Road	Positive	N/A

Last remaining shop unit newly converted to residential. Sympathetic renovation with timber sash windows, door and window frames at ground floor replicating first floor arches. Slate roof retained. Timber sash windows remain at first floor.

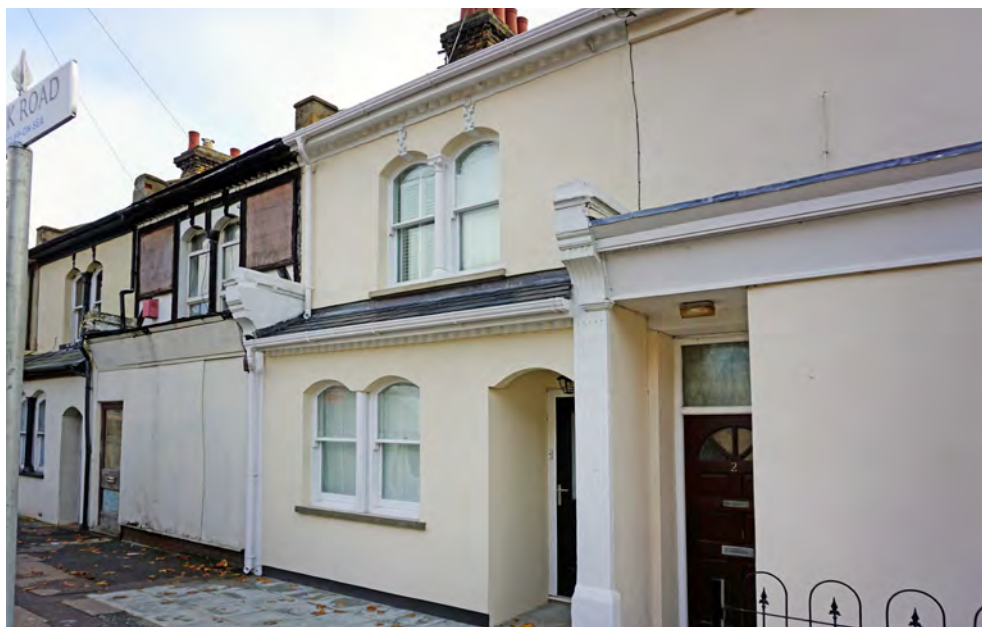
Address	Value	Designation
6 Park Road	Negative – requires significant reinstatement works	N/A

Slate roof remains but property has been rendered and decorated with black timber boarding which is out of character. Shopfront vacant and boarded up. First floor sash windows replaced with timber casements with central opening pane. Poor state of condition throughout.

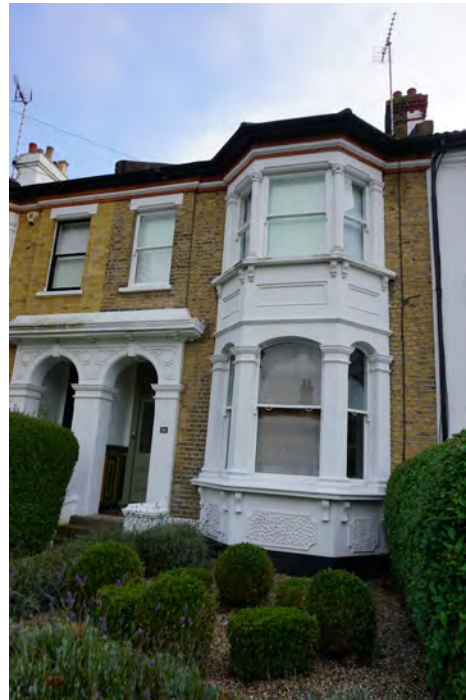
Address	Value	Designation
22 Park Road	Positive	Article 4

Slate has been replaced with concrete tile. Yellow stock brick with decorative red brick string course just below roofline. Timber sash windows have been painted black. Decorative black and white tile path. Low rendered wall with later red brick above defines the front boundary and a planted front garden and attractive tiled path make a positive contribution to the streetscene.

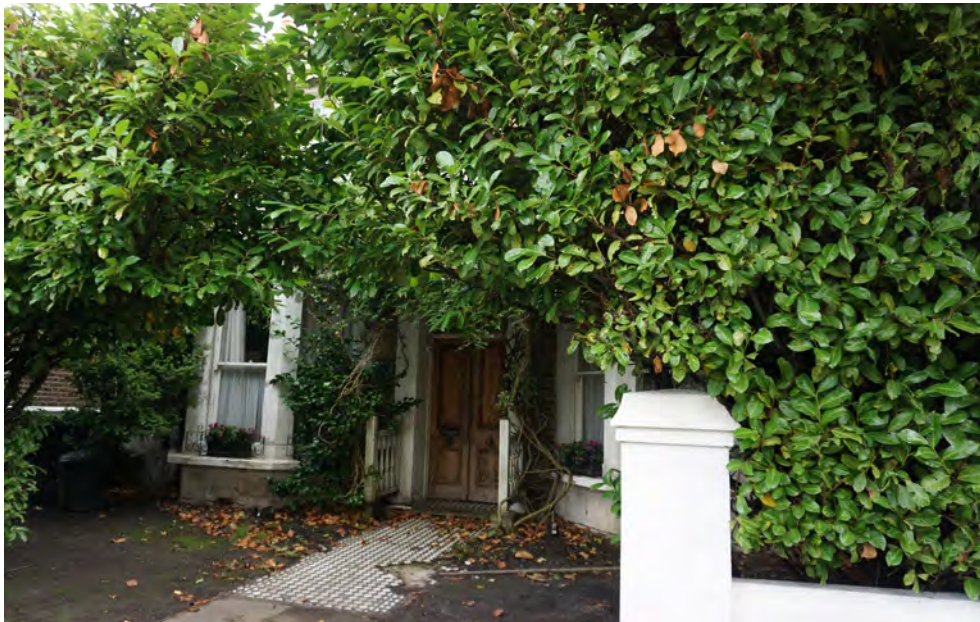
Address	Value	Designation
40 Park Road	Positive	Article 4

Property intact, timber sash windows are painted dark green. Low rendered wall to front boundary is topped with modern railings which provide good enclosure. Planted front garden and tiles path makes a positive contribution to the street.

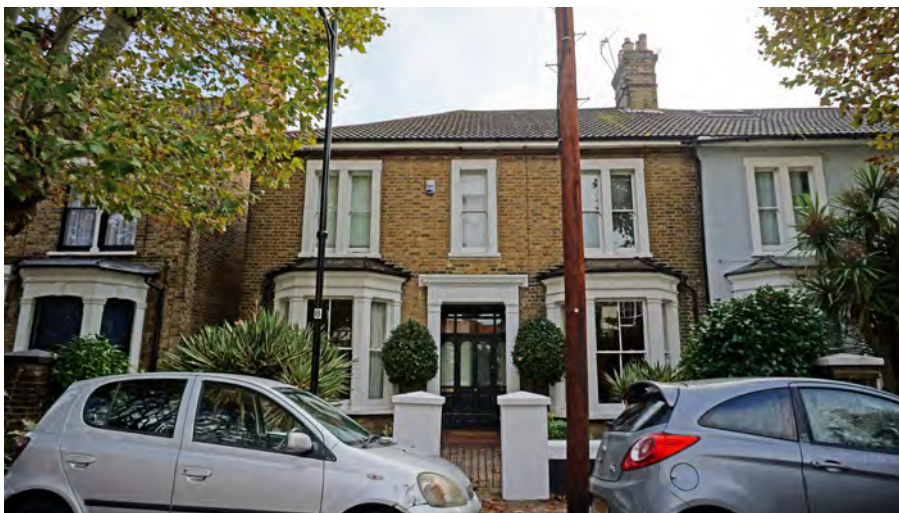
Address	Value	Designation
52 Park Road, 'Northlands House'	Positive	Article 4

Two storey double fronted yellow stock brick detached late-Victorian house similar in design to Nos.48 and 50 which also have single storey canted bays but with more elaborate Italianate style detailing to first floor. The roof, which would have been slate, has been replaced with concrete tile and a single hipped dormer added which is out of character with the streetscene. Timber sash windows have been painted black. Timber double doors (early or original) enclose porch.

Low rendered wall with tall brick piers to front enclosed the garden which is mostly hard surfaced. Divided into flats.

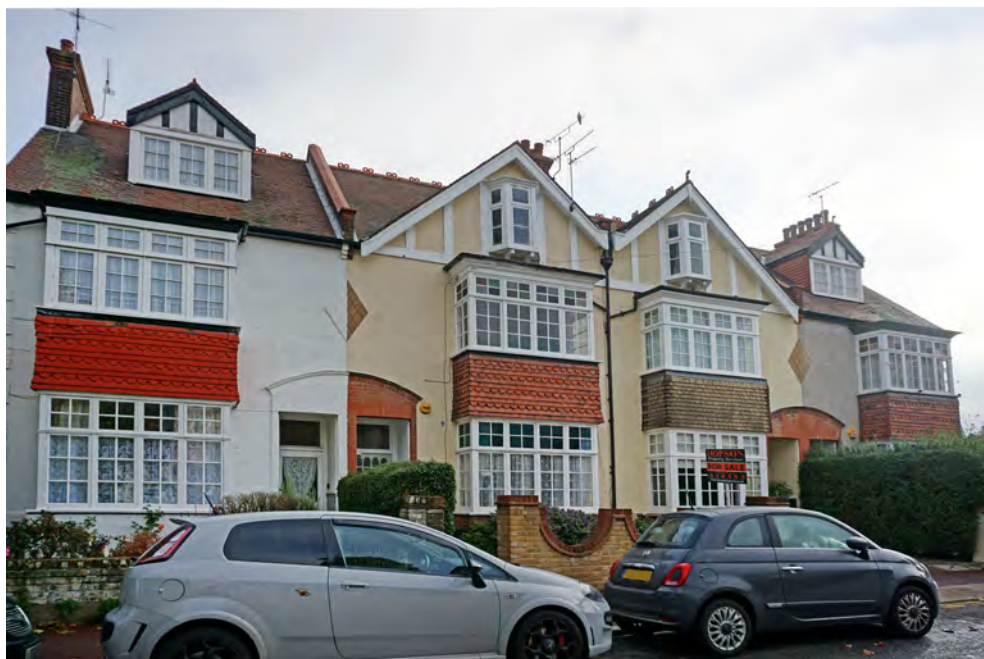
Address	Value	Designation	Description
60, 62, 64 and 66 Park Road	<p>No.60: Positive</p> <p>No.62: Positive – though frontage could be improved</p> <p>No.64: Positive</p> <p>No.66: Positive – though painted brickwork would benefit from removal of paint</p>	Article 4	<p>(Also see page 222 for architectural description)</p> <p><i>No.60 Description:</i> Property intact including original scalloped boundary wall.</p> <p><i>No.62 Description:</i> Property intact although stained glass detailing missing. Boundary wall has been demolished and frontage concreted which is detrimental to the streetscene.</p> <p><i>No.64 Description:</i> Property intact. Replacement scalloped boundary wall provides good enclosure to the street.</p> <p><i>No.66 Description:</i> Property intact apart from the brickwork arch to porch and half of the diamond shaped motif at first floor level have been painted. Timber windows to match adjacent properties have been reinstated and have significantly improved its character. Low brick wall to street and planted front garden.</p>

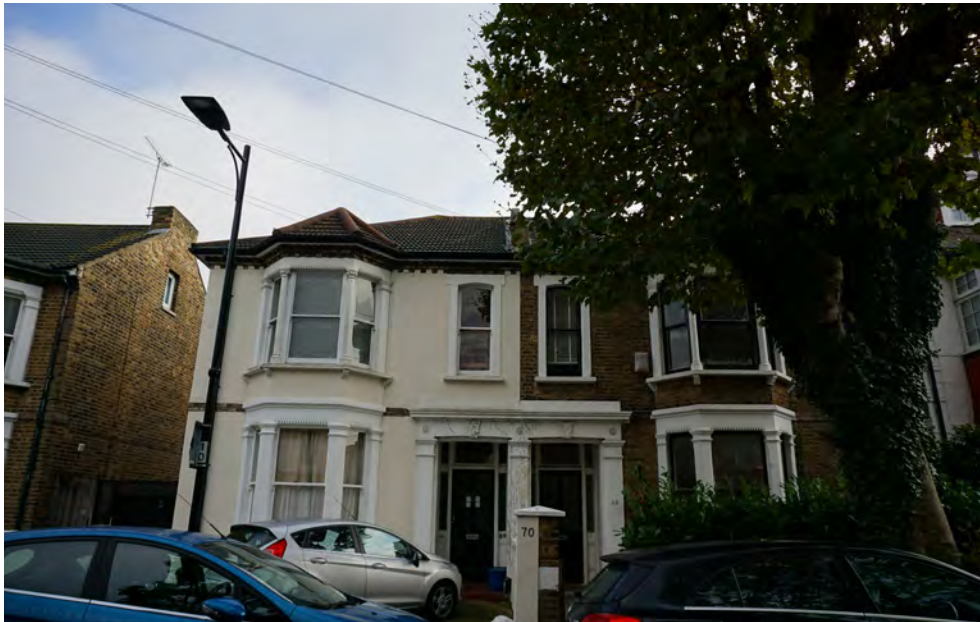
Address	Value	Designation
68 and 70 Park Road	<i>No.68</i> : Positive <i>No.70</i> : Positive – though frontage would benefit from improvement	Article 4

Property intact except that slate has been replaced with concrete tile. Front boundary comprises a decorative timber fence with laurel hedge.

Brickwork has been rendered and slate replaced with concrete tile. Timber sash windows remain. Front boundary wall has been demolished and the frontage paved which is detrimental to the Conservation Area and would benefit from soft landscaping.

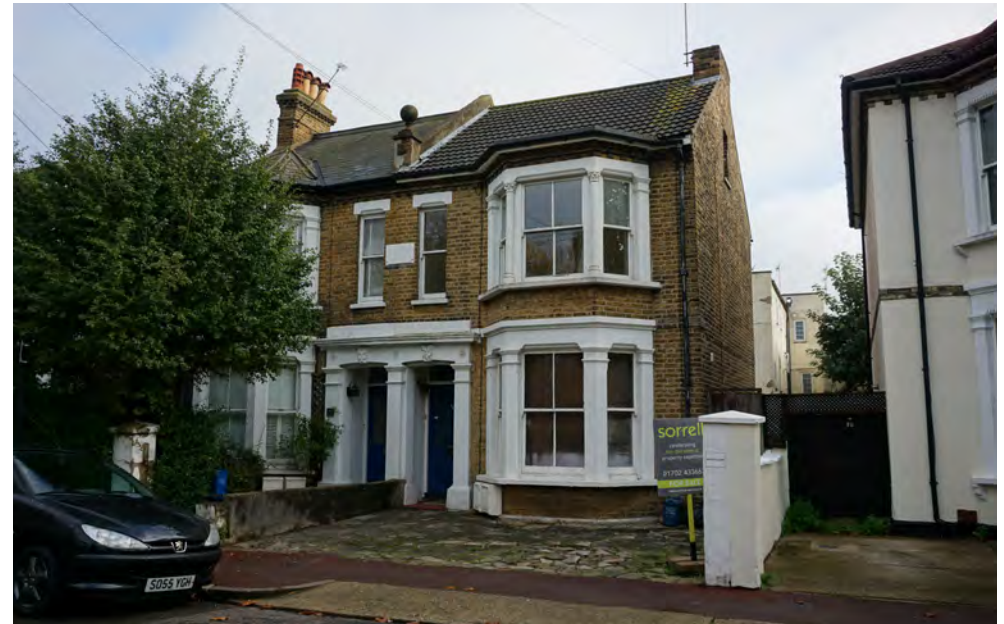
### *No.74 Description:*

Divided into flats. Intact except that slate has been replaced with concrete tile. Meter boxes visible on front elevation. Front boundary wall has been demolished and the frontage paved which is detrimental to the Conservation Area.

Property intact. Low rendered wall with tall piers to frontage provides enclosure to the street. Front wall would benefit from maintenance.

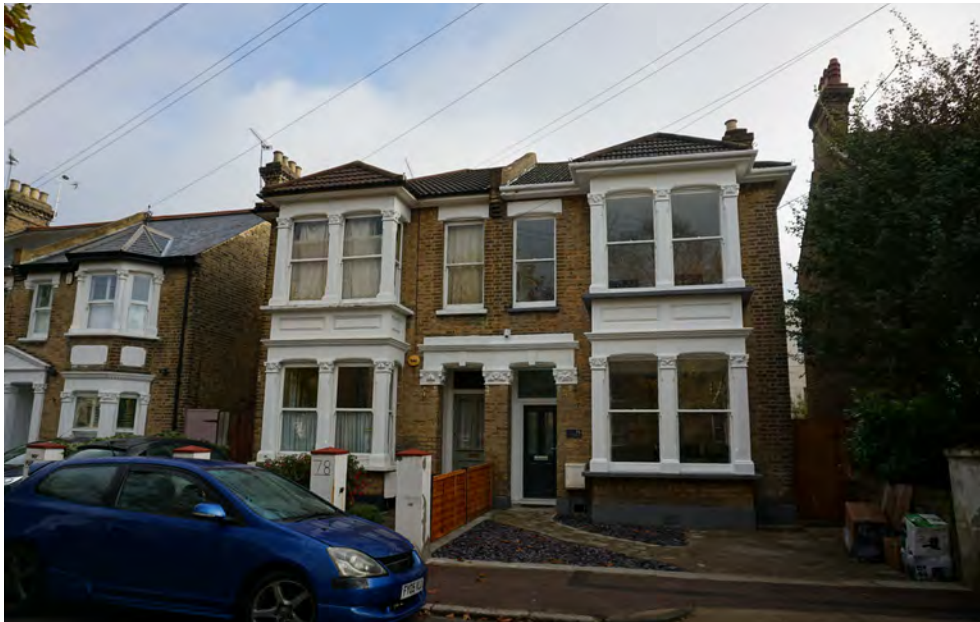
76 and 78 Park Road

Classed as HMO. Property intact except that slate has been replaced with concrete tile and door is a modern replacement (it is noticeably smaller than the one to No.78). Front boundary has been removed to make space for parking, with hard landscaping to the front, which would benefit from planting.

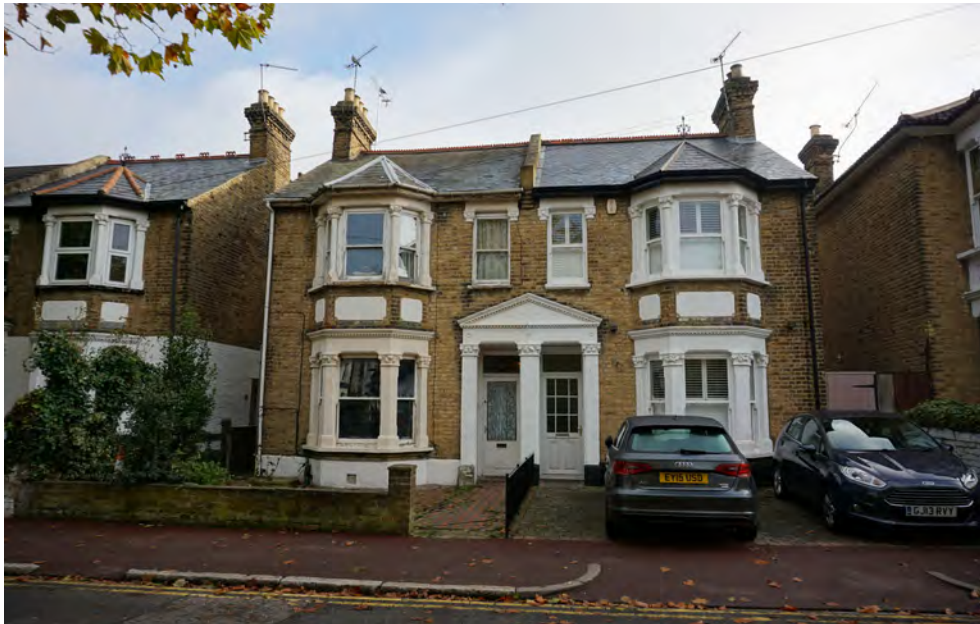
Address	Value	Designation
80 and 82 Park Road	<b>No.80:</b> Positive – though door would benefit from replacement with a more sympathetic design <b>No.82:</b> Positive – though door would benefit from replacement with a more sympathetic design	Article 4

Property intact, although front door is replacement uPVC which would benefit from replacement in timber. Front boundary wall has been removed and frontage block paved for parking. Frontage could be improved with landscaping to soften appearance.

Divided into flats. Property intact although front door is a later replacement with an overemphasis on glazing. Low yellow stock brick wall to frontage enclosing garden which is rather overgrown. Exterior of property would benefit from maintenance.

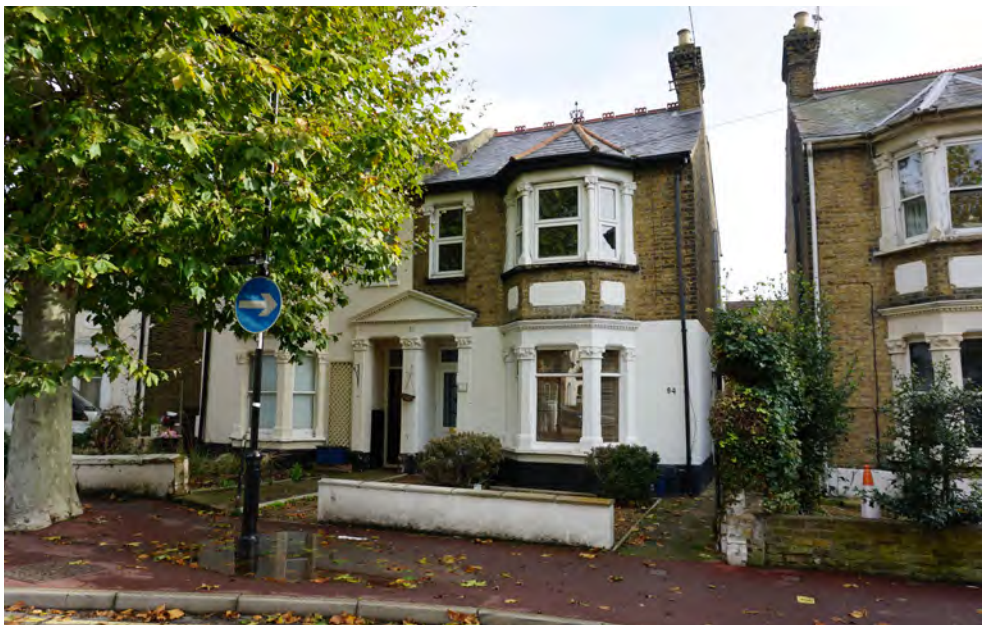
Address	Value	Designation
86 Park Road	Positive	Article 4

Brickwork has been rendered and slates replaced with concrete tile. Timber sash windows remain. Door may be modern but looks sympathetic. Low rendered wall enclosing planted front garden which makes a positive contribution to the street. Property and front garden in need of maintenance and repair.

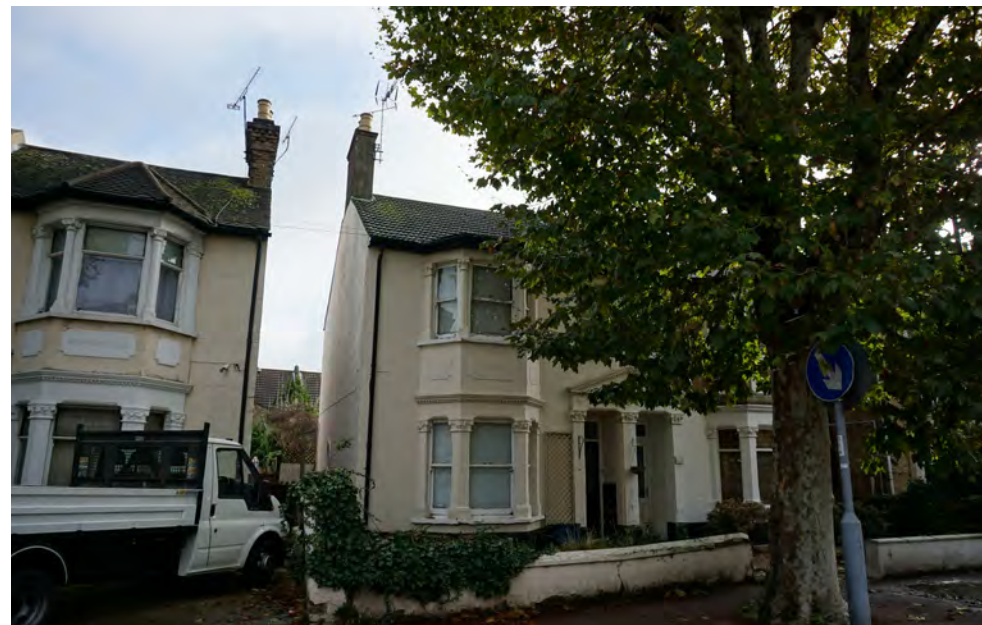
Address	Value	Designation	Description
88 and 90 Park Road	<p>No.88: Positive* – property would benefit from the reinstatement of traditional windows and frontage improvements</p> <p>No.90: Positive* – property would benefit from the reinstatement of traditional windows at ground floor and frontage improvements</p>	Article 4	<p>(Also see page 227 for architectural description)</p> <p><b>No.88 Description:</b> Brickwork has been rendered. Paintwork in need of maintenance. Sash windows have been replaced by timber framed windows with louvered fanlights. Modern door which is mainly glazed and unsympathetic. Slate roof now plain tiles. Front boundary wall has been demolished and frontage concreted which is detrimental to the street.</p> <p><b>No.90 Description:</b> Divided into flats. Brickwork has been rendered. Slate replaced by pantiles. Sash windows have been replaced by timber framed windows with louvered fanlights at ground floor only. Front boundary wall has been demolished and frontage concreted which is detrimental to the street. Property in need of maintenance.</p>

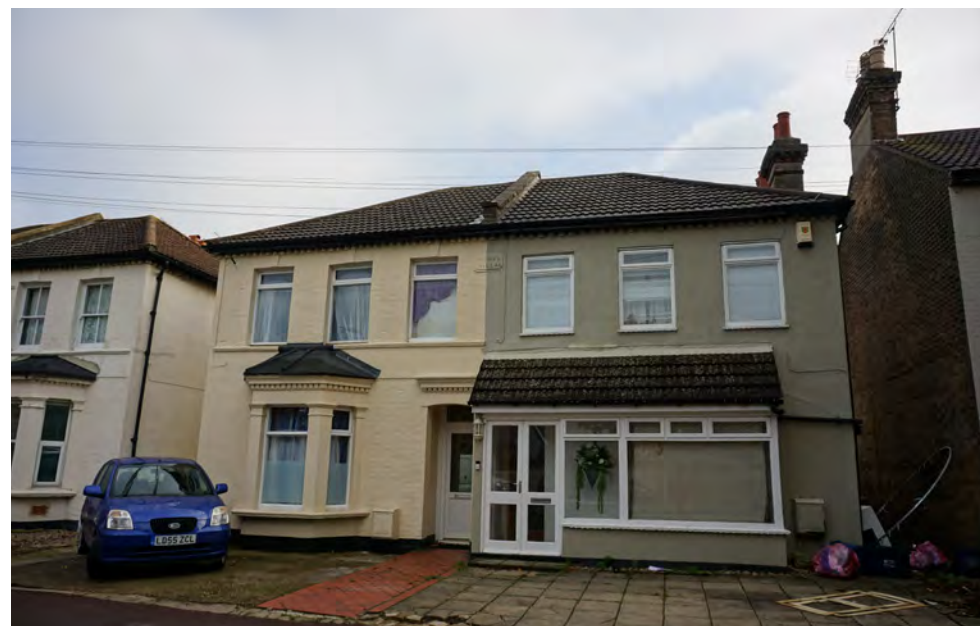
Address	Value	Designation
96 and 98 Park Road	No.96: Positive* – would benefit from reinstatement of sashes at ground floor and frontage improvements No.98: Positive	Article 4

Divided into flats. Brickwork has been painted and slate replaced with concrete tile. Sash windows to ground floor have been replaced with uPVC casements although timber sashes remain at first floor. Modern timber door. Meter boxes to front elevation. Boundary wall has been removed and frontage gravelled although tiled path has been retained.

Property intact aside from concrete tile replacing original slate. Possibly retains original front door. Low brick wall to front encloses garden. Tiled path has been retained. Garden area would benefit from maintenance.

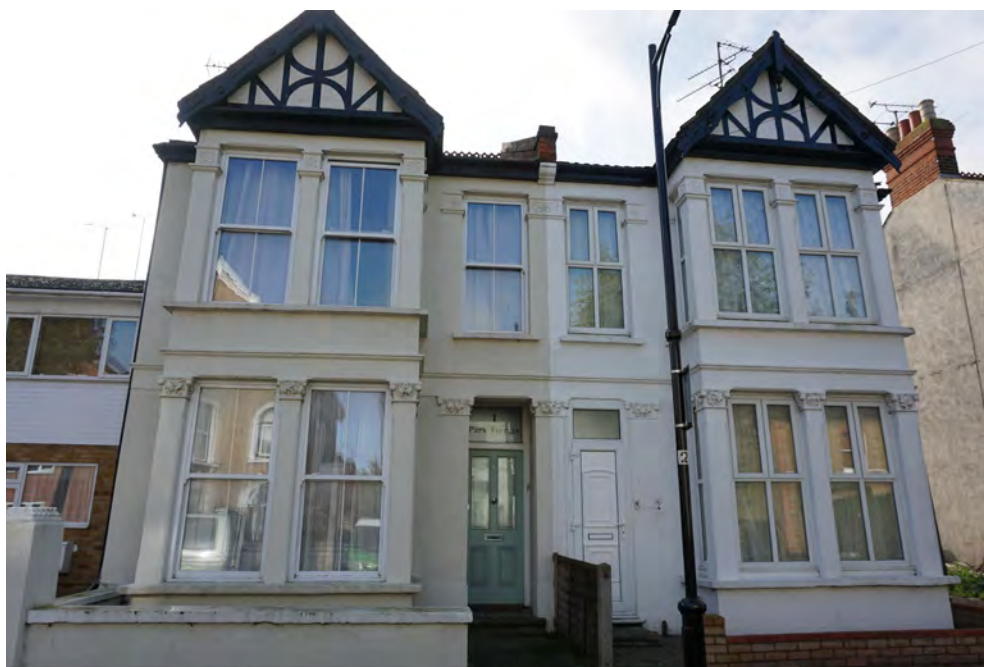
Address	Value	Designation
1 and 3 Park Terrace	No.1: Positive No.3: Positive* – would benefit from sash window and door reinstatement	Recommended Article 4 Direction

Forms a pair with No.3. Brickwork rendered. Timber sashes but central glazing bars 'stuck on' so the appearance is not entirely satisfactory. Front elevation would benefit from some repair works, particularly to sills. Retains original front door. The front garden area appears unkempt although the front boundary wall has been retained and provides good enclosure to the street.

Forms a pair with No.1. Brickwork rendered and slates replaced with concrete tiles. Timber sashes have been replaced with uPVC casements and uPVC front door encloses open porch, which are particularly out of keeping with the Conservation Area. Low brick wall to front boundary.

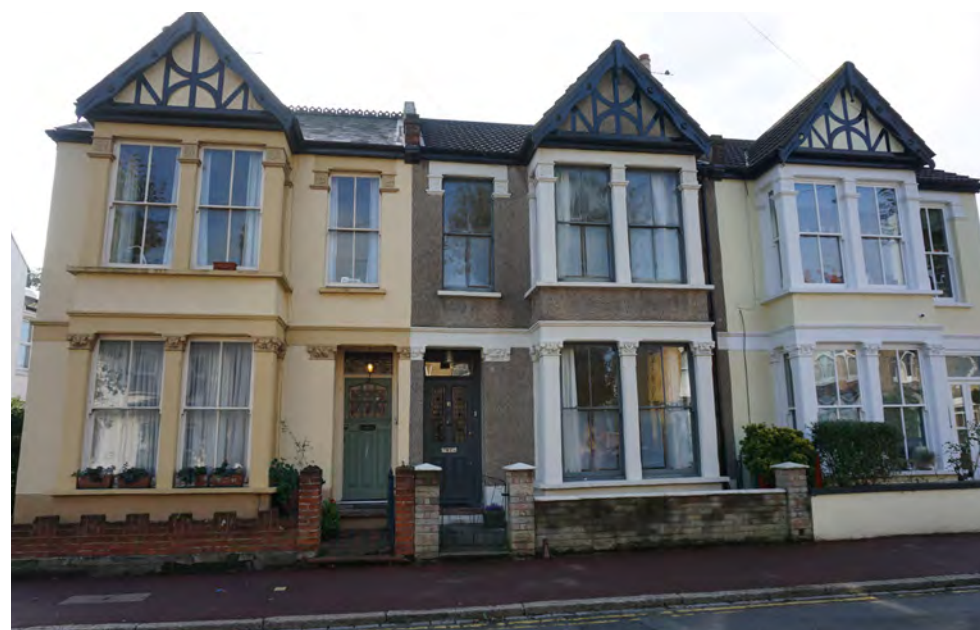
Address	Value	Designation
2 and 4 Park Terrace	No.2: Positive No.4: Positive* – Would benefit from timber sash window and door reinstatement. Frontage could be improved	Recommended Article 4 Direction

Forms a pair with No.4. Brickwork has been painted. Slate replaced with concrete tiles. Timber sash windows have been retained. Timber front door with glazed upper panels and fanlight retained. The front boundary wall has been topped with red brick and provides good enclosure to the street. The garden is planted and helps to soften the building.

Forms a pair with No.2. Brickwork and slate survives but unfortunately all windows and the front door have been replaced with uPVC. Chimney has been lost. The front boundary has been removed and the garden lost to hardstanding, which is detrimental to the property and Conservation Area.
