# Milton Conservation Area Appraisal

# Southend-on-Sea: Milton Conservation Area Appraisal

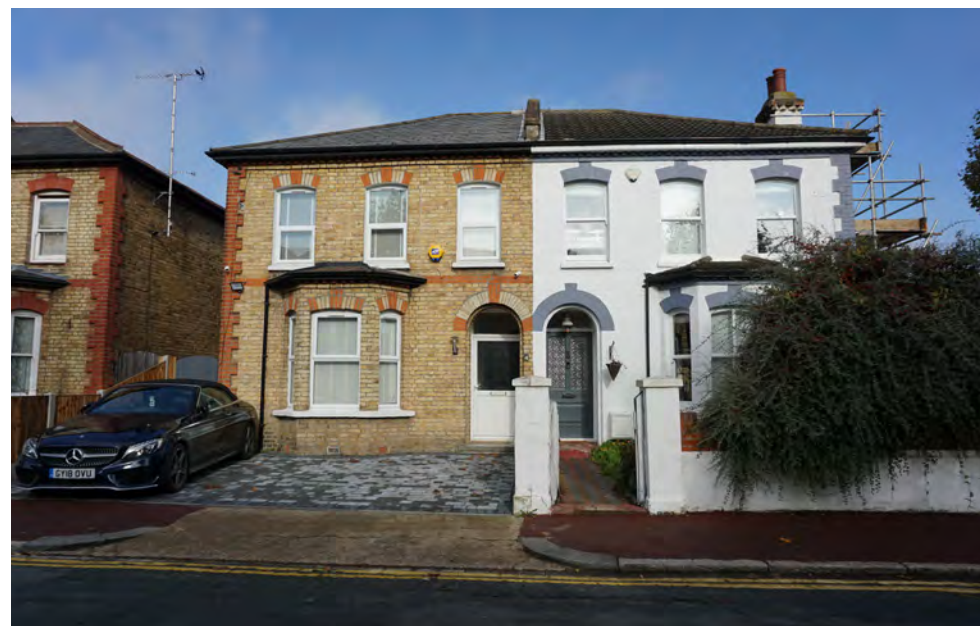
Address	Value	Designation
6 and 8 Park Terrace	No.6: Positive No.8: Positive	Recommended Article 4 Direction

Forms a pair with No.8. Brickwork and slate survive. Windows appear to be timber although not original as their proportions are rather heavy. Modern stained timber door looks slightly out-of-character. Chimney has been lost. A replacement brick front boundary wall has been constructed and provides good enclosure to the street although the proportions seem a little slim. Landscaped garden makes a positive contribution to the street.

Forms a pair with No.6. Brickwork has been rendered and slate replaced with concrete tiles. Chimney has been lost. Original timber sash windows survive, as does timber and stained-glass front door, and make a positive contribution to the character of the property. The front boundary has been removed and the garden lost to an unattractive area of hardstanding, to the detriment of property and the Conservation Area.

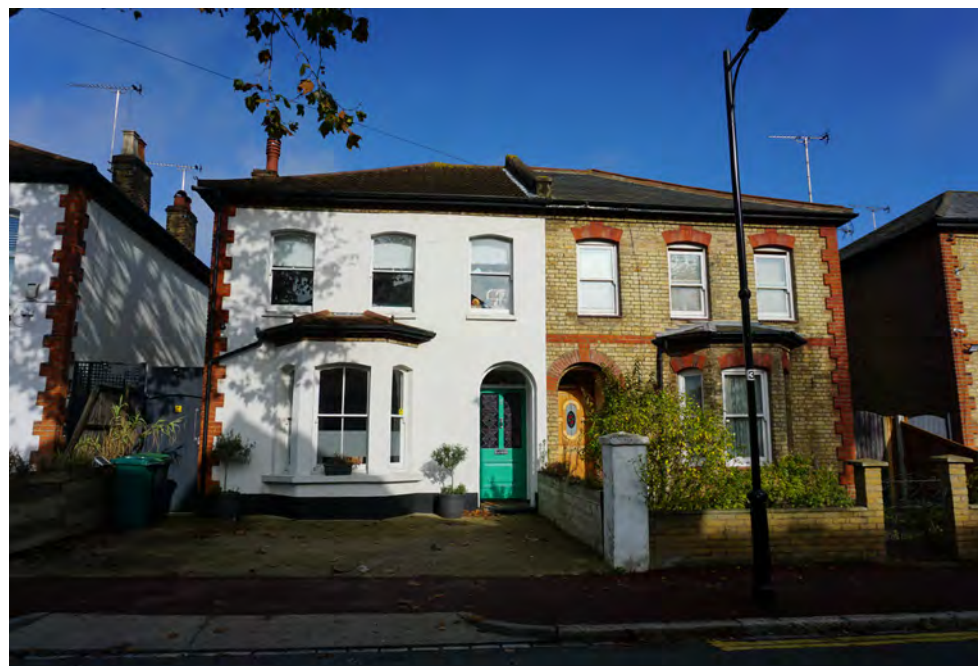
Address	Value	Designation
10 and 12 Park Terrace	No.10: Positive No.12: Positive* – would benefit from sash window reinstatement and reconstruction of original bay	Recommended Article 4 Direction

Forms a pair with No.12. Brickwork has been rendered and slates replaced with concrete tiles. Timber sash windows and timber door with stained-glass make a positive contribution to the street. The front boundary has been removed and the garden lost to hardstanding, although a good quality surface material has been used.

Forms a pair with No.10. Slate roof and chimney retained. Brickwork has been rendered and all the window openings have been altered in shape, including the bay, and replaced with modern uPVC casements of a different proportion and a square bay. This has been detrimental to the character of the existing property and impacts on its symmetry with No.10. The porch opening has been widened and a later timber and glazed tall door with sidelight inserted. Most of the front boundary has been removed and the garden lost to hardstanding.

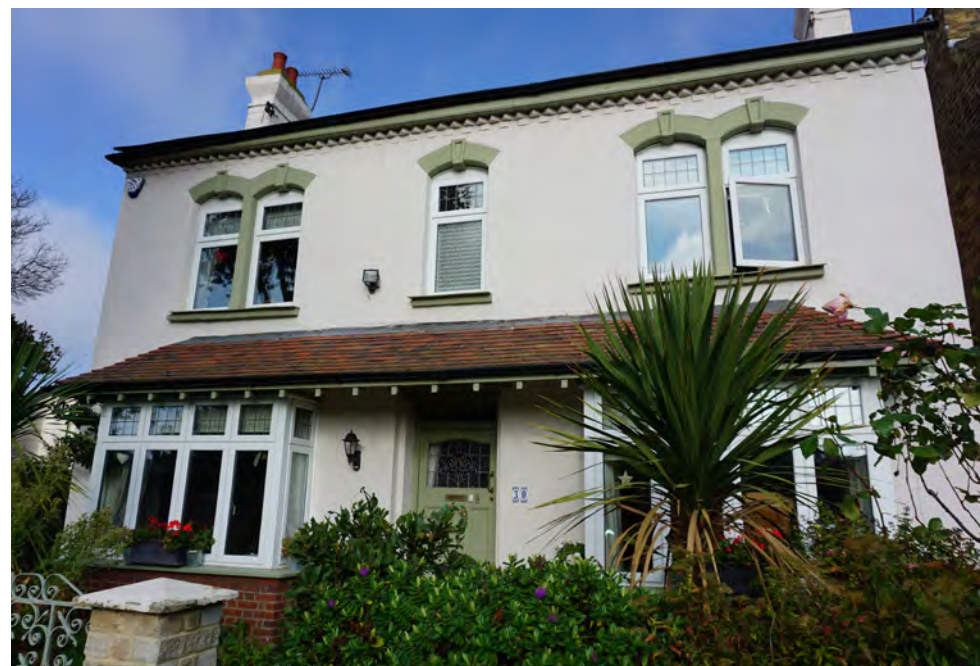
Address	Value	Designation
30 Park Terrace	Positive* – though would benefit from traditional window reinstatement	Recommended Article 4 Direction

Large double frontage detached property of originally the same design to Nos.26 and 28 but the bay windows to the ground floor were altered in 1938 and are more Edwardian in style than Victorian. The bays in this case are square with red brick plinths and casement windows. The bays are joined to each other by a hipped tiled canopy which also forms the open porch to the property. The front door with stained-glass upper panel also seems to date from this later era.

The property has been rendered and has clay tiles rather than slates. The original windows have been replaced with uPVC casements and would benefit from reinstatement in timber. The casement design is appropriate for the age of the house but the uPVC material is not appropriate for the Conservation Area.

Despite these modernisations the property makes a generally positive contribution to the local streetscene benefitting from an attractive landscaped front and side garden. There is a low brick front boundary wall, which is a modern replacement, and a taller rendered boundary wall which leads round onto the Avenue Road boundary and includes the street name.

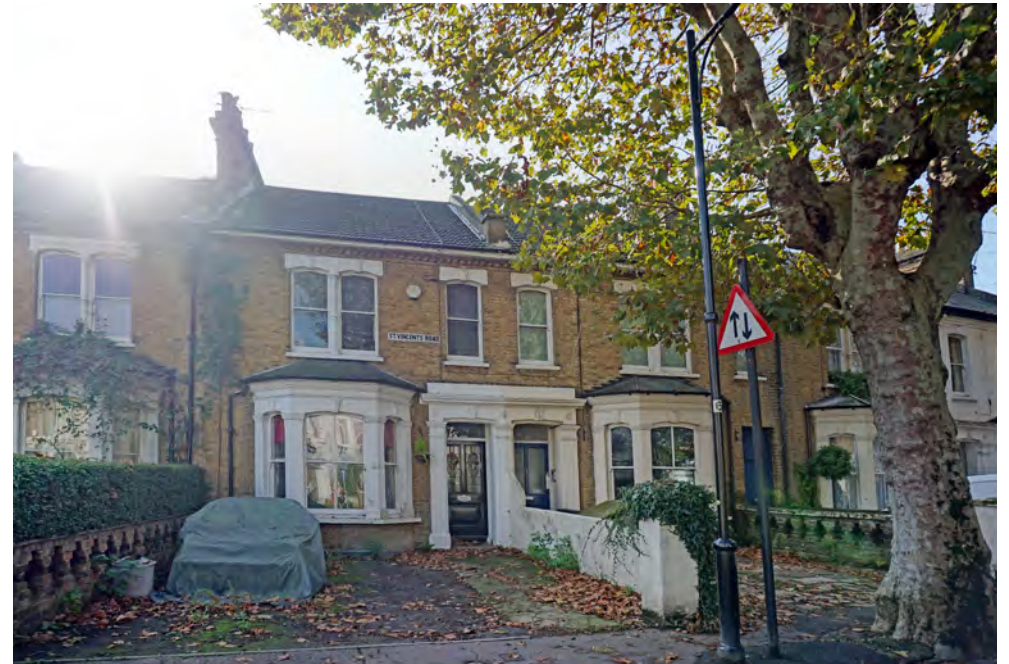
Property intact although slates replaced with concrete tiles. Ceramic road name inset into the wall at first floor level. The front boundary and garden have been lost to hardstanding and could be improved with landscaping or planting.

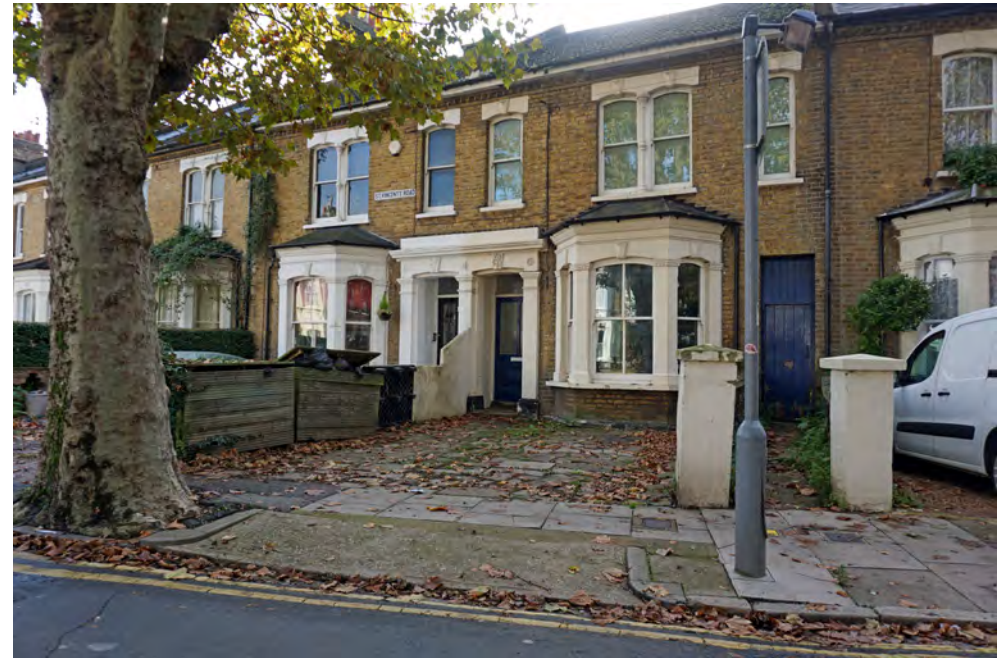
Address	Value	Designation
3 St. Vincent's Road	Positive	Article 4

Wider than adjacent properties because it includes additional accommodation at first floor (including an additional window) above access gate to rear of the properties. Property intact although slates replaced with concrete tiles. The front boundary and garden have been lost to an area of hardstanding and there are two large bin stores on the frontage. This has a detrimental impact on the property and Conservation Area. Property classed as HMO. Frontage could be improved.

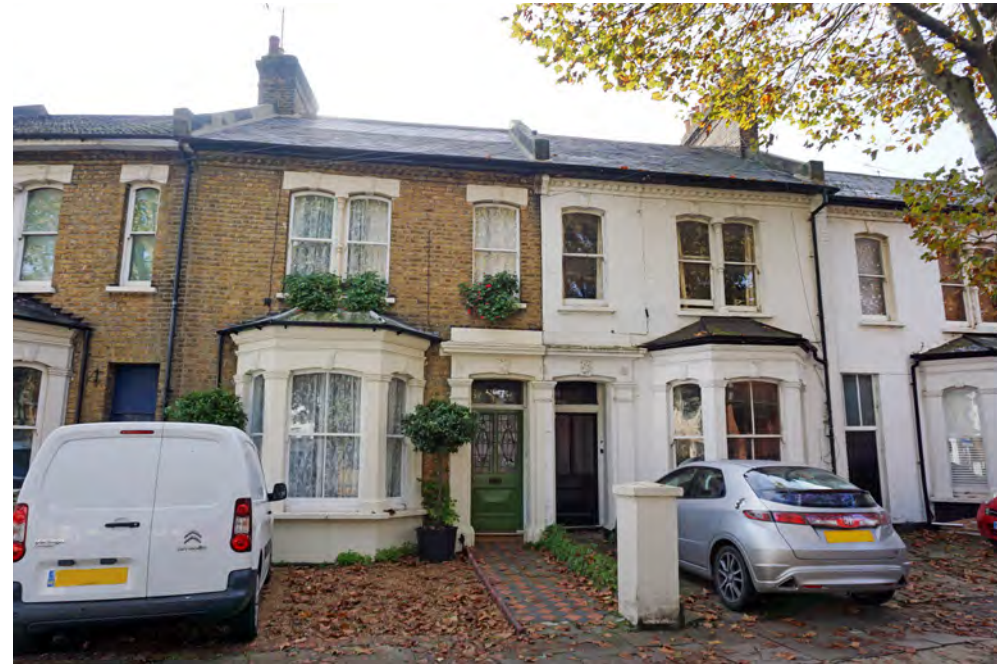
Address	Value	Designation
5 and 7 St. Vincent's Road	No.5: Positive No.7: Positive – though frontage could be improved	Article 4

Property intact including brickwork, slate roof and timber sashes and stained-glass front door. Attractive tiled path to front door. Boundary wall removed and surface gravelled.

Brickwork painted white although slate roof remains. White painted timber sliding sash windows remain, although some would benefit from maintenance to restore them, particularly sills at ground floor. Timber front door remains. The front boundary and garden lost to an area of hardstanding, which has a detrimental impact on the property and Conservation Area and would benefit from reinstatement, together with landscaping.

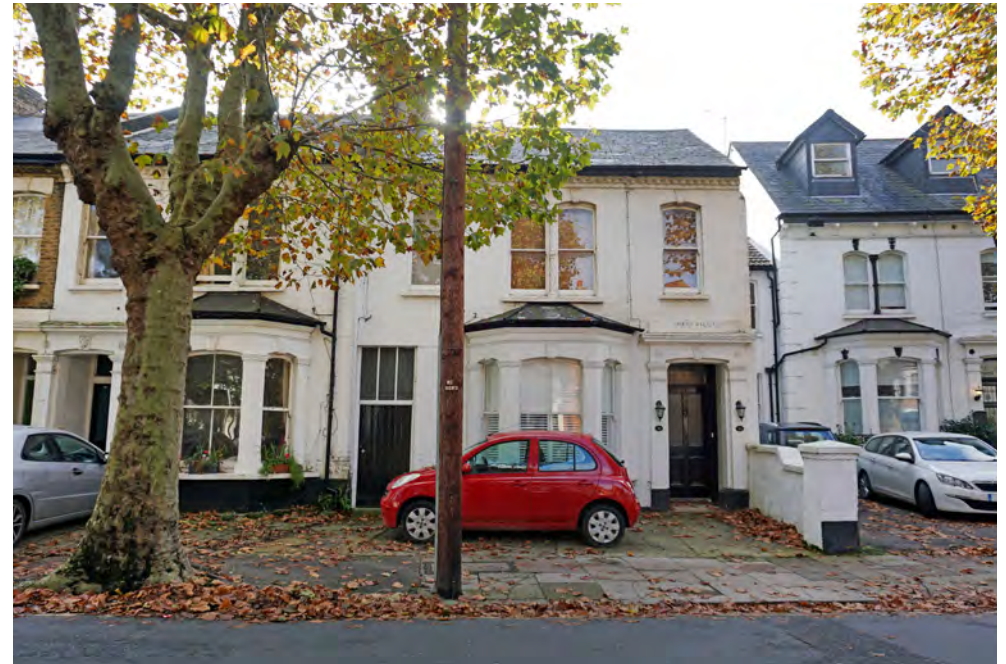
Address	Value	Designation
9 St. Vincent's Road 'West Villa'	Positive – though frontage could be improved	Article 4

Wider than adjacent properties because it includes additional accommodation at first floor (including an additional window) above access door to rear of the properties. Brickwork painted and slate roof retained. White painted timber sliding sash windows remain, although some would benefit from maintenance. Timber front door remains. Divided into flats.

The front boundary and garden lost to an area of hardstanding, which has a detrimental impact on the property and Conservation Area and would benefit from reinstatement, together with landscaping.

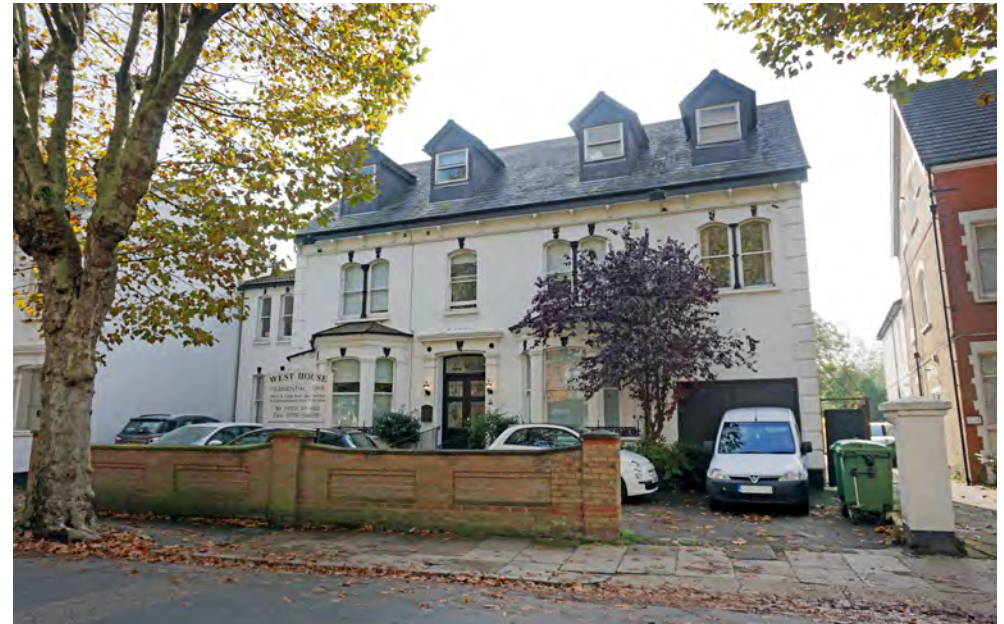
Address	Value	Designation
11 St. Vincent's Road 'West House' Nursing Home	Positive – though the site would benefit from more planting, a proper bin store (or moving the bin into the garage) and more landscaping to the frontage.	Article 4

It is a large two storey building with rooms in the roof and a side wing which is set back from the frontage and abuts the adjacent terrace. The side wing appears to be original (shown on OS plan 1890) but the four single pitched front dormers are a modern addition and are rather dominant in the roof slope. The building was also extended on the west side to include a garage (which only appears after OS 1920). This section is not subservient and rather upsets the symmetry of the building although is matched in well with the original detailing of the building.

The building has a slate roof but the original brickwork has been painted. It is double fronted with two single canted bays either side of the timber and stained-glass double front door. The bays unusually have decorative ironwork at sill level which is replicated on the other ground floor windows. There are a pair of curved topped Italianate windows above the bays and the garage and the property also includes other Italianate detailing such as decorative bracketing to the eaves and quoins.

The spacious frontage is tarmaced and used for parking and bin storage and has little area for soft landscaping but the building is enclosed by a modern brick boundary wall to most of the frontage.

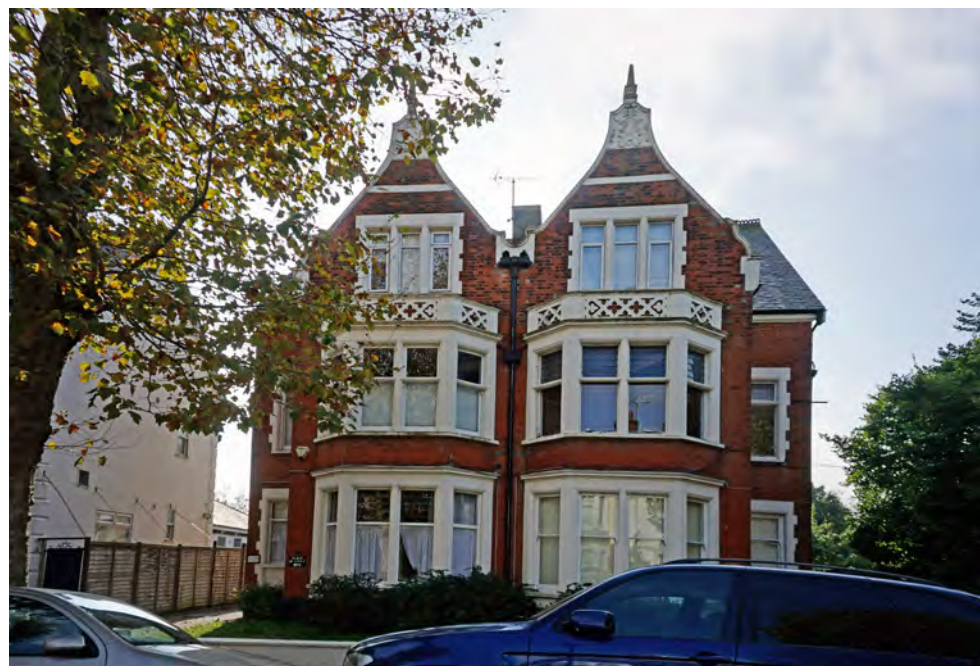
Only some of the windows in the bay have retained their original sash windows, the others have been replaced with modern louvers in timber frames or uPVC casements which are detrimental to the character of the buildings. At ground floor the original positions of the front doors are evident adjacent to the bays, these have since been replaced with single windows and new entrances formed to the rear.

There is a white painted front boundary wall to the front with landscaped garden area behind, and a driveway either side of the building.

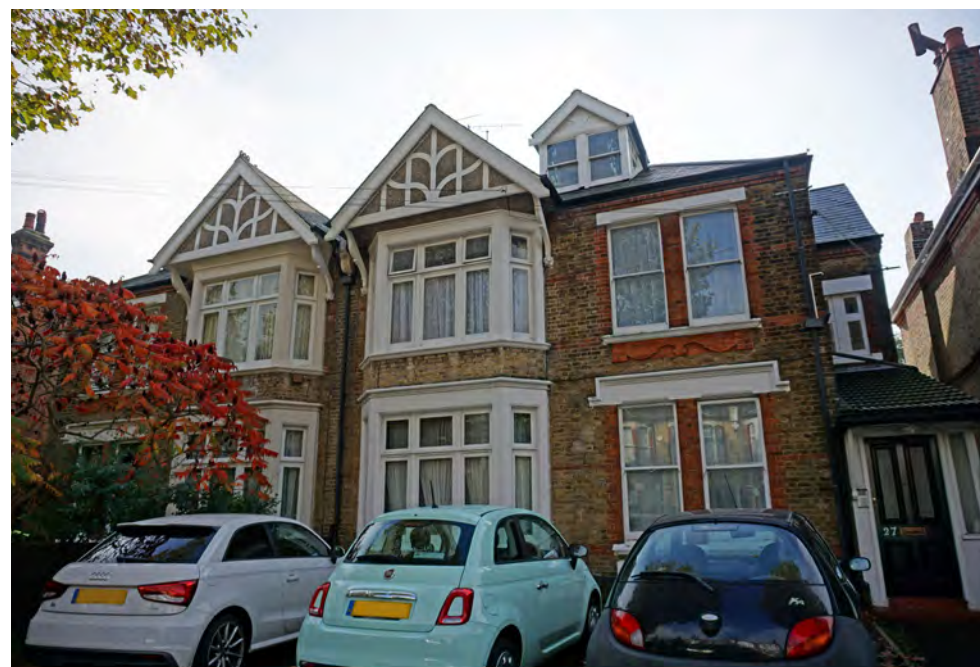
Address	Value	Designation
25-27 St Vincent's Road	Positive – frontage to No.27 could be improved	Article 4

The front doors and porches are located to the side of each house and this is the only area where the architecture differs between them. No.25 has an enclosed porch with heavy timber door with glazed upper panels and fanlights, set in a stone surround and topped with a small decorative balcony feature and No.27 has a later enclosed porch of a modest design with simple mono-pitched roof over the door.

The frontage of No.25 has an attractive landscaped garden which is enclosed with a yellow wall providing good enclosure to the street. No.27 has no front boundary with the garden converted to hardstanding. This would benefit from landscaping.

Both properties are divided into flats. The meter boxes on the front of No.27 are numerous and detrimental. These should be relocated if the opportunity arises. Properly designed bin storage would also be welcomed.

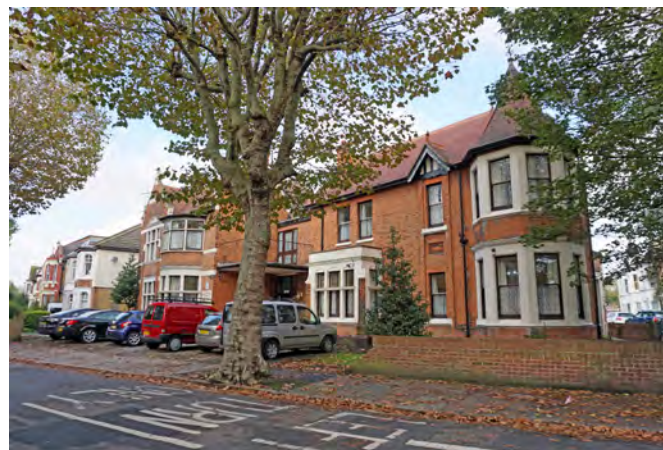
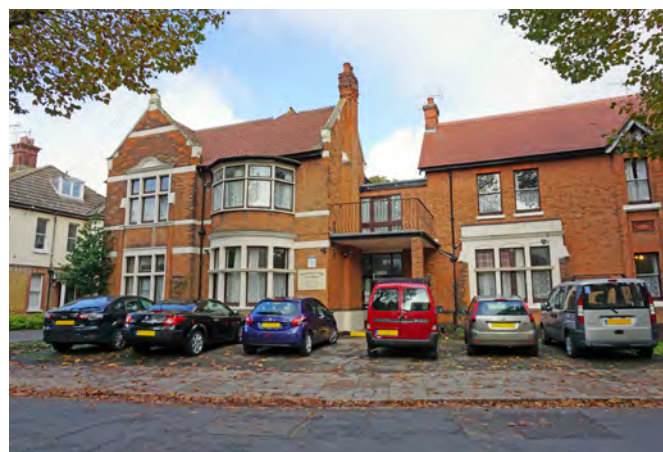
Originally two large detached Edwardian style houses built in 1898 now known as Arrandale Lodge, a residential care home. Red brick with clay tile roofs. The properties have been joined by a two-storey extension which is relatively subservient in the streetscene. The western most property, originally No.2 has a distinctive corner turret which marks the junction of St Vincent's Road and Avenue Road and provides an attractive landmark for the Conservation Area. This property also has a single square bay to the front and small half-timbered gable detail to a first-floor window. To Avenue Road, there is also a frontage and an unusual square bay which has been rotated 45-degrees and sited on the corner so that it addresses the street. It appears that the original front door to this property was also on this frontage and is recognised by a simple stone surround, though the door is currently boarded. A two-storey yellow stock brick element is also visible at the rear. Timber sash windows. This property is surrounded by a red brick wall and landscaped garden which contain a number of preserved trees. These together with the turret feature define the entrance to St Vincent's Road.

The second part of the nursing home, formerly No.4, is slightly different in character although was built around the same time. It has two strong features on the frontage: a large two-storey curved bay and a large projecting Dutch gable. Both are attractive features in the streetscene and manage to complement rather than compete with each other. Similar proportioned windows and decorative stone banding running through both features help to unite them.

Both properties are relatively intact, they have maintained the original brickwork and roofing materials and both have timber windows which have been stained/ painted brown.

The frontage to No.4 has been mostly replaced with a parking area which is detrimental to the Conservation Area. Soft landscaping would improve the appearance.

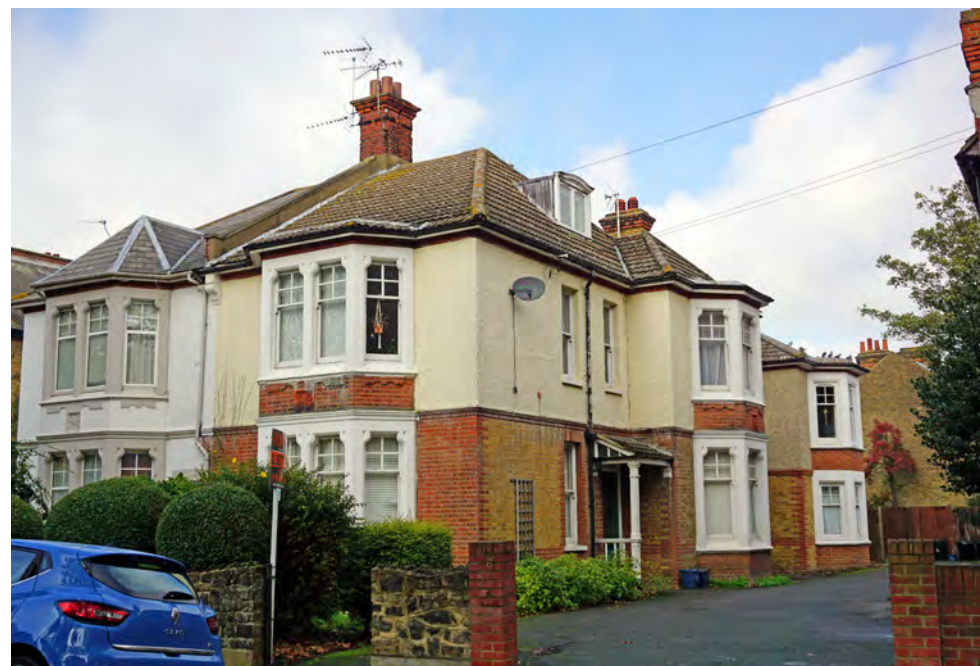
Divided into flats. Attractive timber sashes and front door retained but slates replaced by concrete tiles. Satellite dish to front part of the side elevation which can be seen easily from the street. Attractive planted front garden and original burr brick boundary wall provides good enclosure to the street.

Divided into flats. An additional front door has been added to the front elevation which unbalances the pair and appears rather squashed in. Slates retained but frontage has been rendered. Timber sashes replaced with uPVC windows. Frontage has been brick paved for parking although a red brick boundary wall still provides good enclosure to the street. Would benefit from soft landscaping or planting.

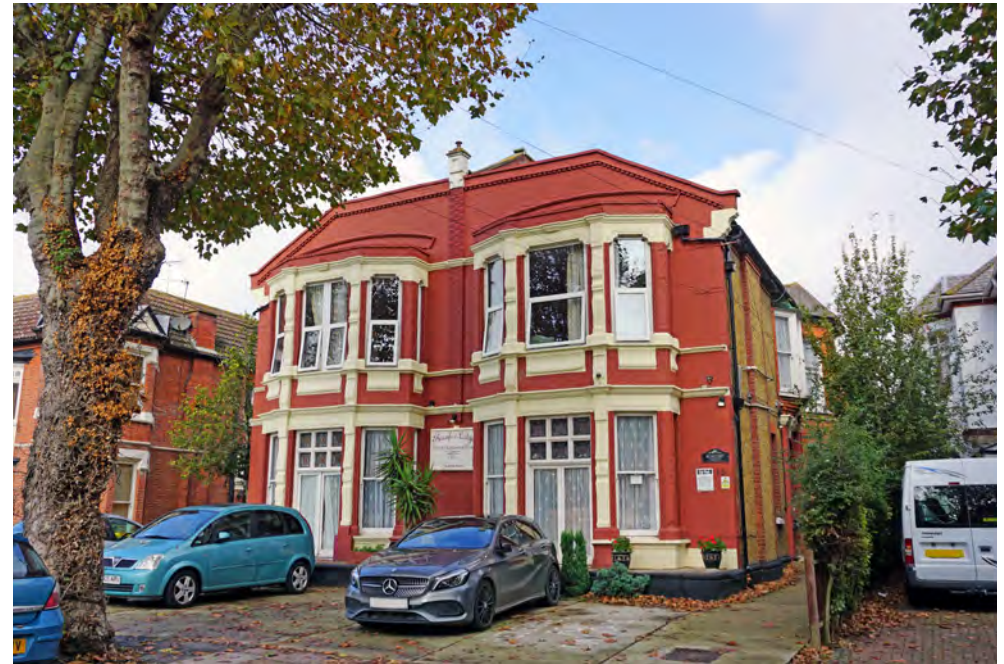
Address	Value	Designation
Beaufort Lodge, 10-12 St. Vincent's Road	Positive* – frontage could be improved and replacement of uPVC with timber sashes would be beneficial	Article 4

Pair of large semi detached houses built in 1894 now in use as a care/nursing home. Likely to have been red brick to the front (now unfortunately painted) and yellow stock brick to the sides. The design is unusual insofar as the front wall forms a parapet at roof level and the slate roof is hidden behind. The parapet is decorated with raised brickwork detail to the front. Each half has a large two storey canted bay with sculpted stone surrounds. The first floor windows have been recently replaced (post-April 2019) with unsympathetic uPVC top hung casements, which replaced attractive timber sashes which had sculpted detailing mirroring the shape of the lintels above. This is an unfortunate loss. At ground floor the central window is a taller double casement with decorative stained-glass in the top section. Timber sash windows are on the side flanks of the bay windows at ground floor.

Like Nos.6-8 St Vincent's Road the entrances are located to the side elevation and in this case they are within an archway below a canted bay feature at first floor.

The front boundary wall and garden to parking have been lost to parking which is detrimental to the character of the Conservation Area. The wheelie bins on the frontage are also an eyesore that could easily be rectified by their relocation to the rear.

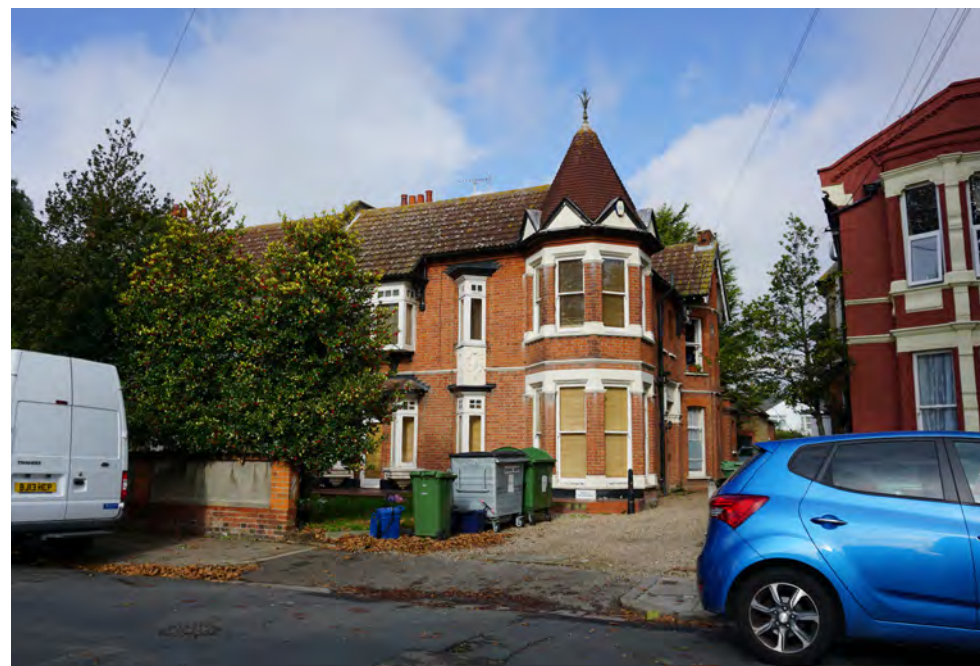
Address	Value	Designation
14-16 St. Vincent's Road	Positive	Article 4

Pair of large red brick semi-detached houses built in 1896. They are of an asymmetric design; No.14 has a distinctive turret feature on the corner decorated with small gables but No.16 has a square bay to ground floor and a canted bay with gable top to first floor. In between, the designs are identical and include an attractive run of triangular shaped oriel style windows to the ground floor (this type of window is usually found singularly at first floor), one of which is two storey and has a decorative motif in its central panel, and hanging square bays above the single windows. As with the properties across the road, there is a mix of sash and casement windows but each has their place within the overall design of the elevation. All the windows are timber and make a positive contribution to the Conservation Area.

There is a small door to the front between the triangle windows although the main door appears to be located to the side. Timber door to the side entrance of No.14 with glazed upper panel and fanlight.

The properties are intact except that the original roof covering has been replaced with concrete tiles.

Both properties are divided into flats but parking has been accommodated at the rear and a landscaped front garden and front wall to No.14 has been retained to the front. The wheelie bins to the frontage are, however, detrimental to the streetscene and would benefit from relocation or screening in some way.

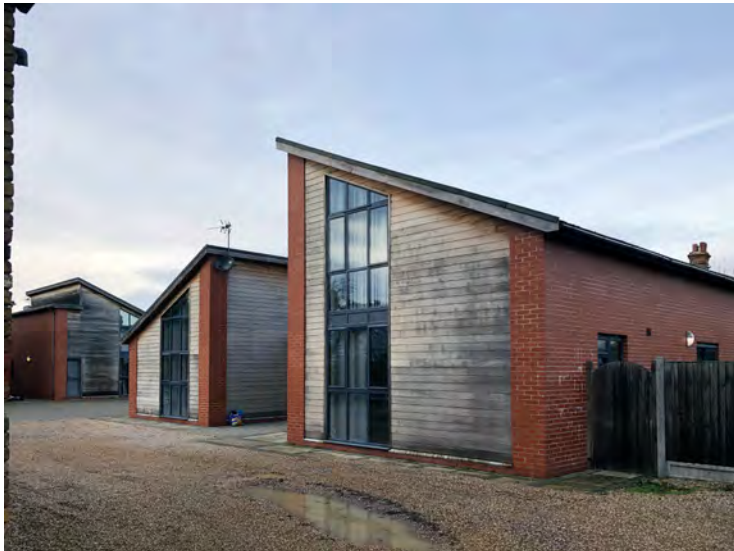
A development of three new houses on a cul-de-sac, which is the most recent development in the Conservation Area. It has no public impact as the site is hidden behind the houses on a site between St. Vincent's Road and Avenue Terrace. These buildings are timber clad and red brick and have sedum (green) mono-pitched roofs. The red brick references materials in the surrounding roads but essentially they have created a new character of their own.

In this area was originally a stable block.

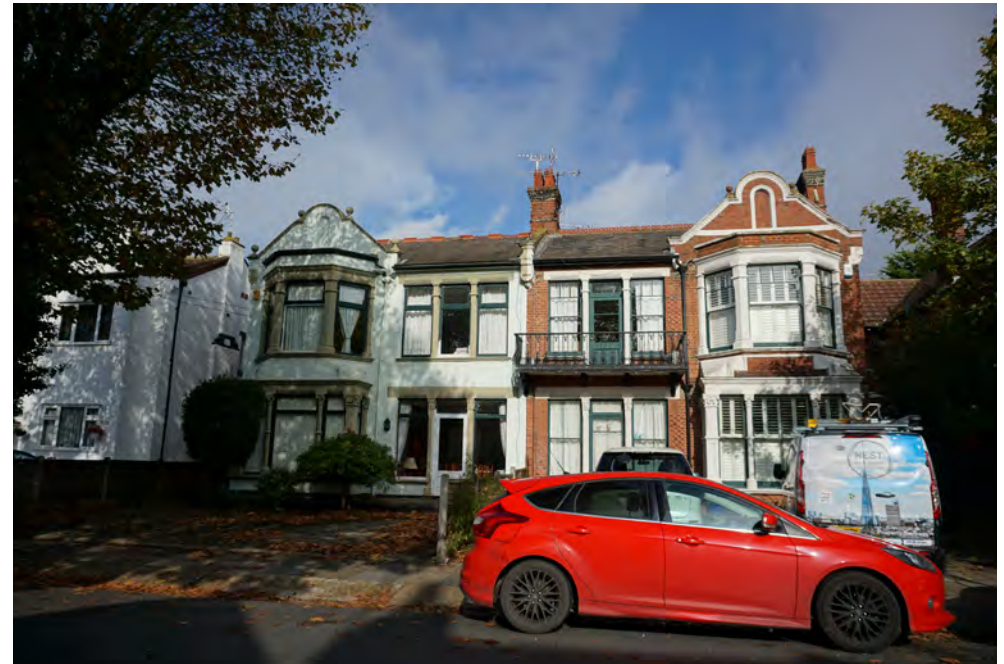
### *No.20 Description:*

Brickwork rendered. Sash windows replaced with timber casements, though these are not entirely out-of-keeping, although original door to ground floor survives. First floor balcony lost. Front boundary has been removed and the frontage paved for parking, however, there is some attractive landscaping on the frontage.

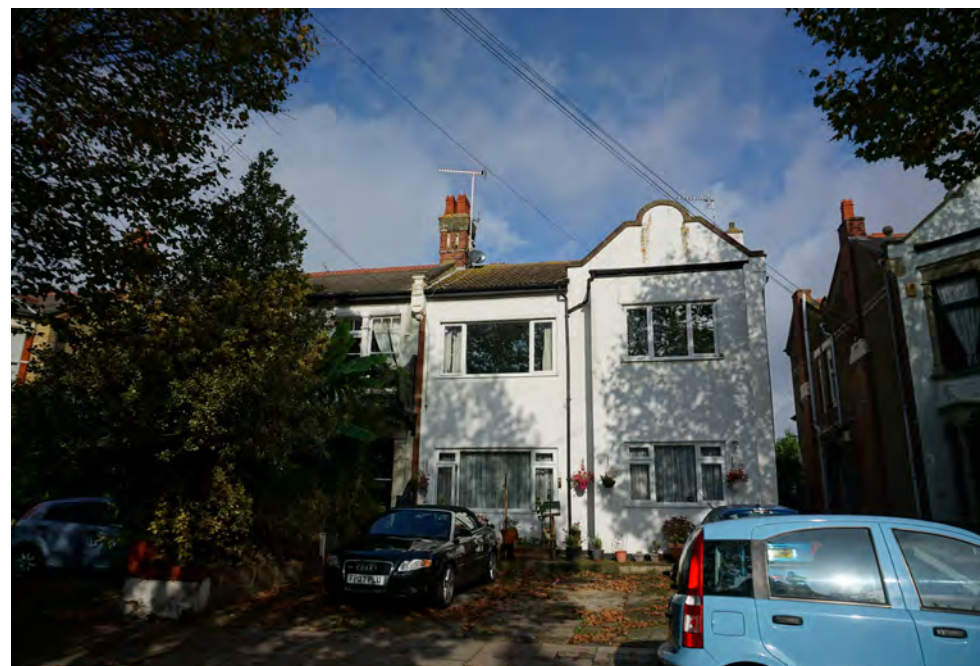
Address	Value	Designation
St. Vincent's Court, 22 St. Vincent's Road	Negative – could be improved by reinstatement of windows, doors, decorative features and bays to match No.24 St. Vincent's Road.	Article 4

Most of the original features from this property have been removed and as a result, its historic character has been severely compromised. It was originally a mirrored pair to No.24 (see description on the following page). The bay has been removed, the windows changed to modern styles and shapes, the slates have been replaced with concrete tiles and the frontage has been rendered. Only the profile of the Dutch gable remains.

The front garden and wall have also been removed and replaced by a concrete parking area which is detrimental to the streetscene. The ornamental tree on the frontage provides a small amount of greenery and should be retained.

This property is divided into flats.

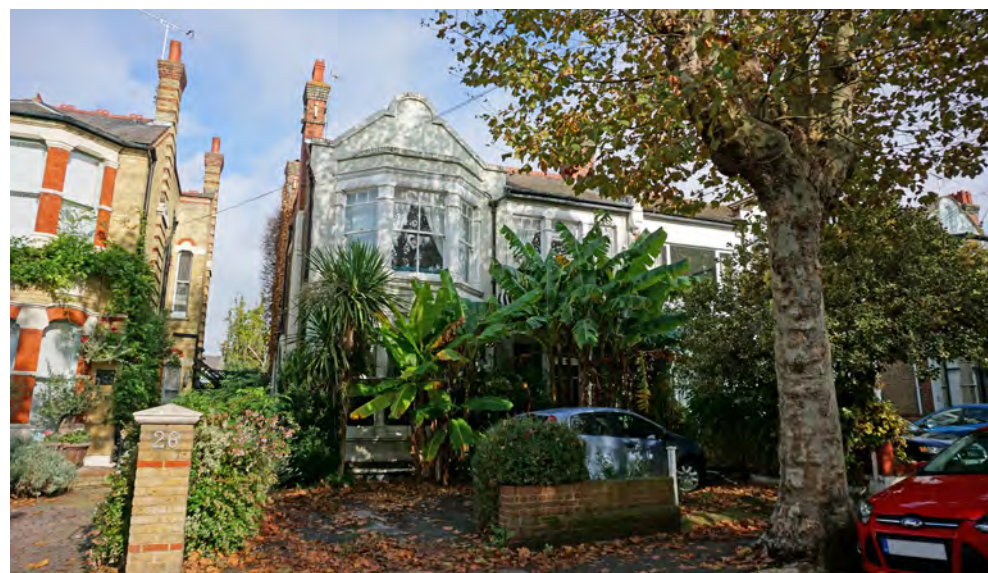
Address	Value	Designation
24 St. Vincent's Road	Positive	Article 4

Intact although the brickwork has been painted. This property has retained its original sashes to ground and first floor which make a positive contribution to the streetscene. Most of the frontage has been tarmaced for parking. Only a small section of a modern boundary wall has been built but it provides an area for planting and the additional planting adjacent to the building also provides some softening.

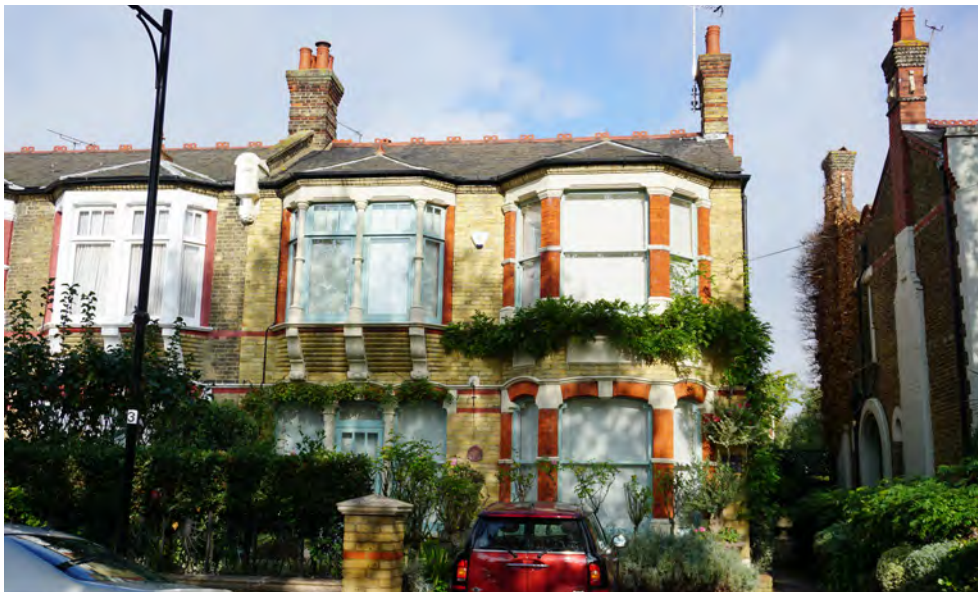
Property very well preserved, including brickwork, slate roof and original timber windows. Part of the frontage has been hard surfaced but in a high-quality material and a significant length of boundary wall (and railings) and landscaped front garden has been retained which makes an attractive setting for the building.

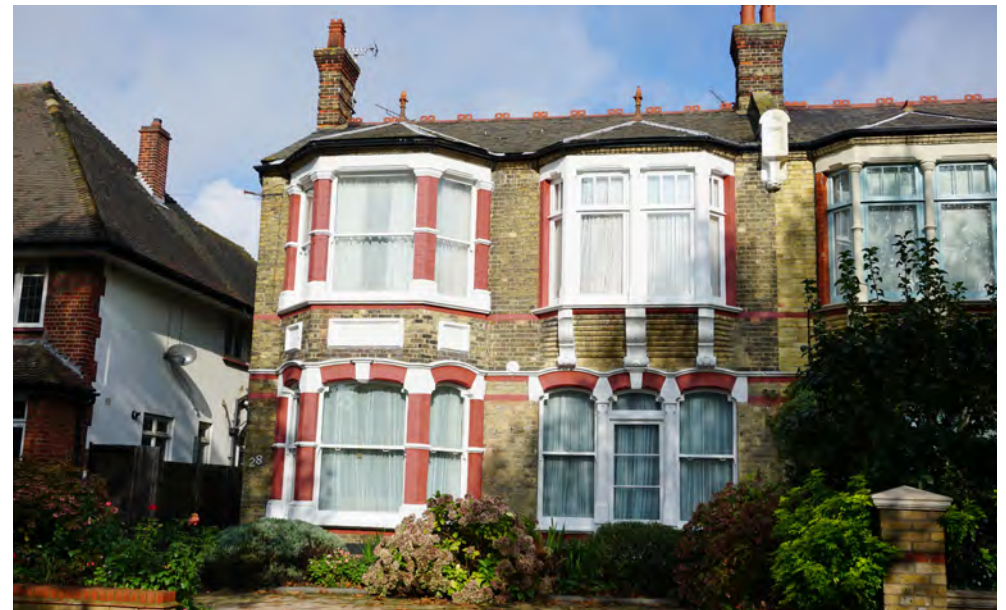
Address	Value	Designation
28 St. Vincent's Road	Positive	Article 4

Property intact including brickwork, slate roof and original timber windows, decorative ridge tiles and chimneys, although red brick details have been painted over in red. Most of the garden has been given over to parking although there are a couple of planting beds which make a valuable contribution to the setting of the building. There is also a small section of very low modern wall which would provide more enclosure if it were higher. It does, however, help to define the boundary of the property.

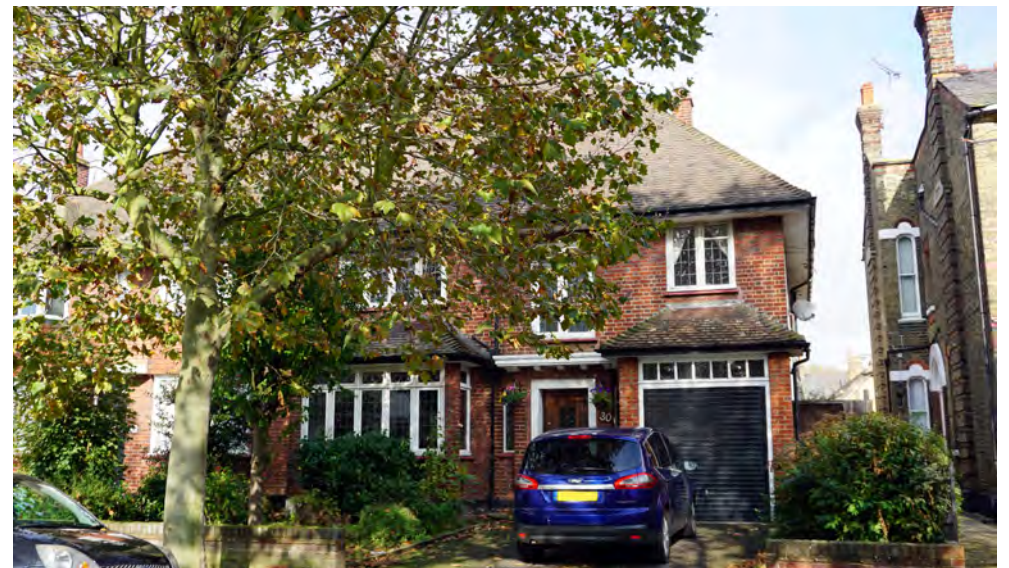
Forms an asymmetrical pair with No.32. Property intact, though with a small garage extension to the right hand side which integrates reasonably well. Single storey square bay window to left hand side. Timber plank door with small glazed panes. Part of the frontage has been tarmaced for parking but a significant amount of landscaped garden and red brick boundary was been retained which provides good enclosure to the street.

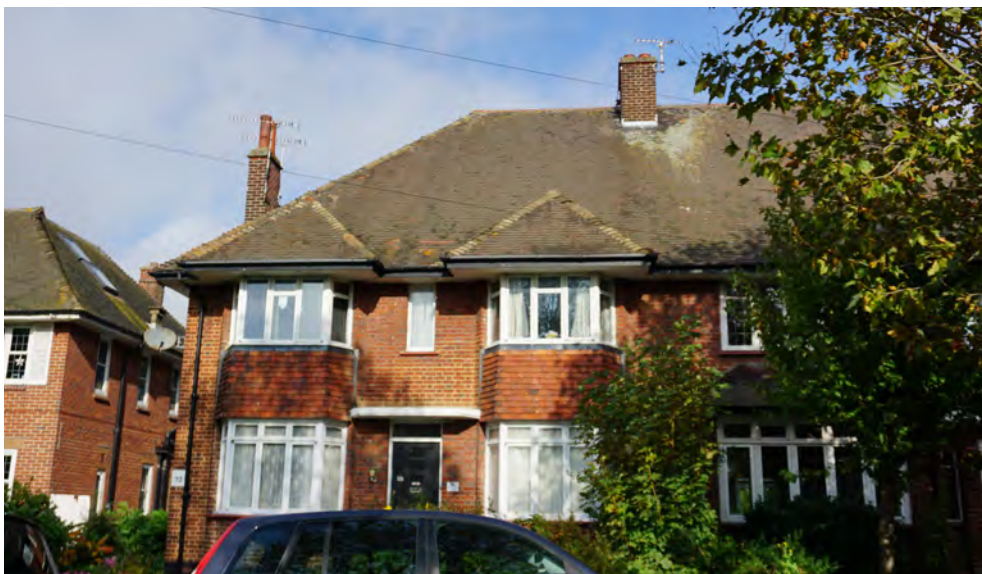
Address	Value	Designation
32 St. Vincent's Road	Positive	Article 4

Forms an asymmetric pair with No.30. Two storey canted bay windows either side of the central front door, each with tile hanging between the ground and first floor windows. Timber plank door with small glazed panels. Property intact including front garden and boundary wall. Divided into flats.

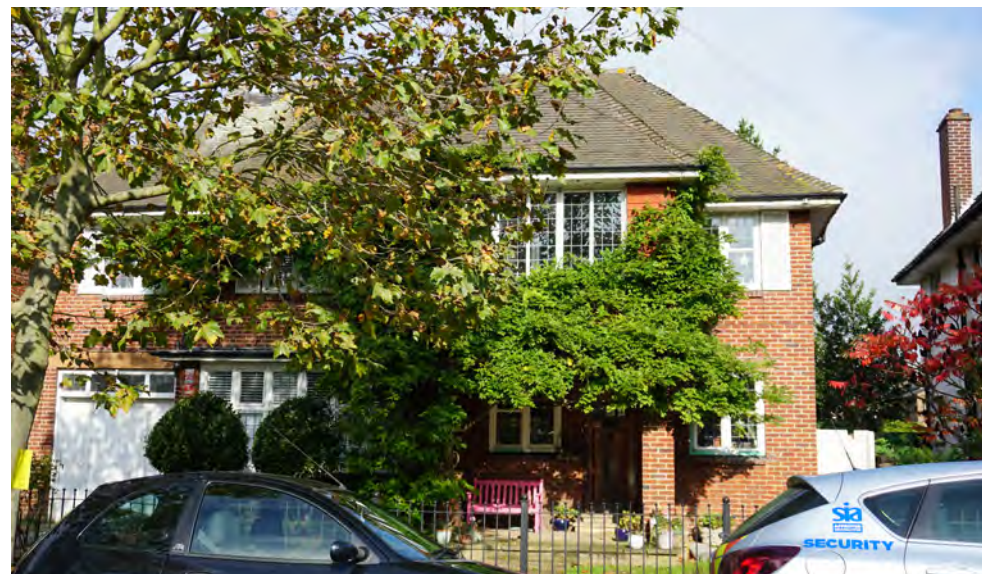
Address	Value	Designation
34 St. Vincent's Road	Positive	Article 4

Detached house with feature bay at first floor creating covered porch at ground floor. Property intact. Timber door with glazed upper panels. Small timber garage door to left hand side, with tile lintel appears to be original. Front wall has been replaced with low wall and metal railings which provides enclosure to the street. Landscaped frontage provides an attractive setting for the building.

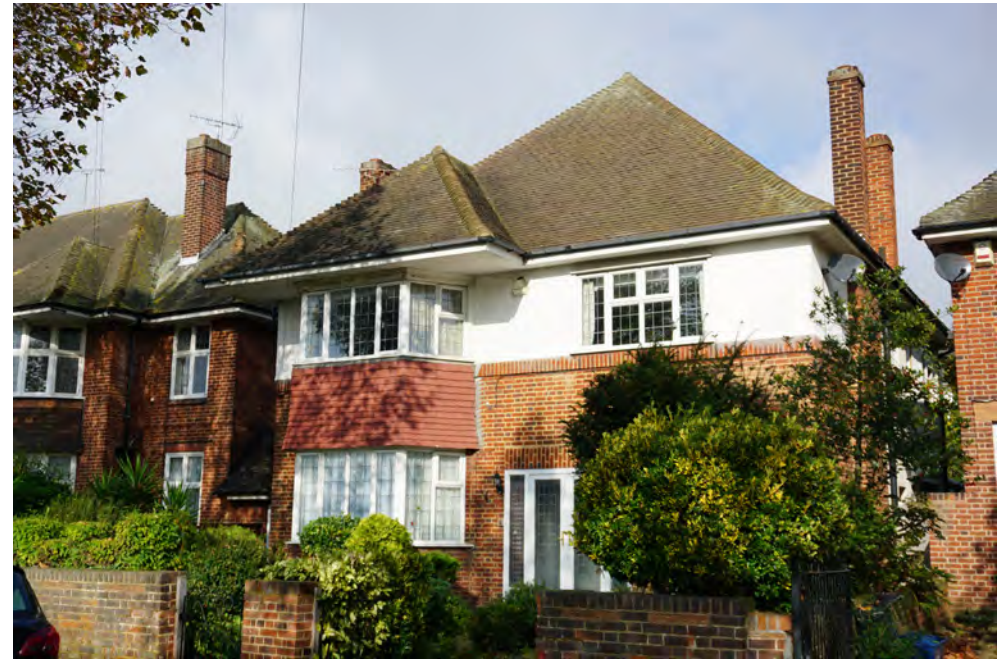
Address	Value	Designation
36 St. Vincent's Road	Positive* – would benefit from replacement with timber windows	Article 4

Detached houses with render to first floor which is not present in adjacent properties. Two storey bay is topped with over scaled gable increasing its presence in the streetscene. Tile hanging between ground and first floor windows on bay. Two entrances on the front elevation in uPVC, suggesting possibly that a window has been enlarged and the porch filled in. uPVC windows. Landscaped garden provides an attractive setting for the building.

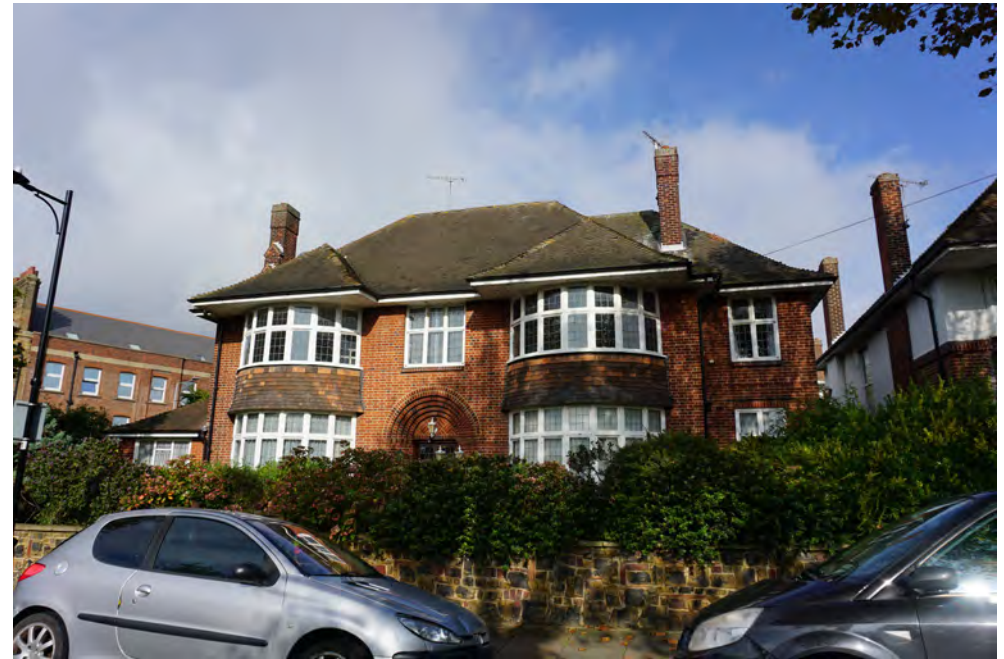
Address	Value	Designation
38 St. Vincent's Road	Positive	Article 4

Divided into flats. A pair of large two storey curved tile hung bays either side of a grand brick arched doorway give this property greater presence in the streetscene. Property intact with the addition of an unobtrusive single storey extension added to the side. Timber double doors with glazed upper panels.

Attractive burr brick boundary wall has been retained and provides enclosure for the landscaped garden. A white roller shutter within a gate provides the entrance to the parking area at the rear on Milton Road. A more traditional gate would have better integrated with the building.
