The Leas Conservation Area Appraisal

Southend-on-Sea: The Leas Conservation Area Appraisal

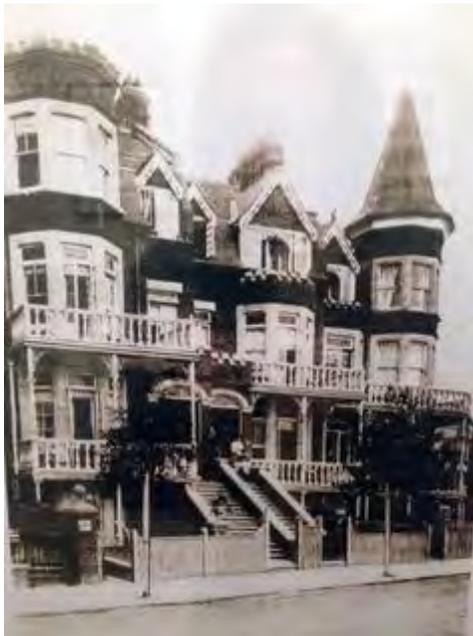
Grosvenor Court in the late-19th/early-20th century when it still retained its original conical roof on the turret, timber sash windows and timber balconies

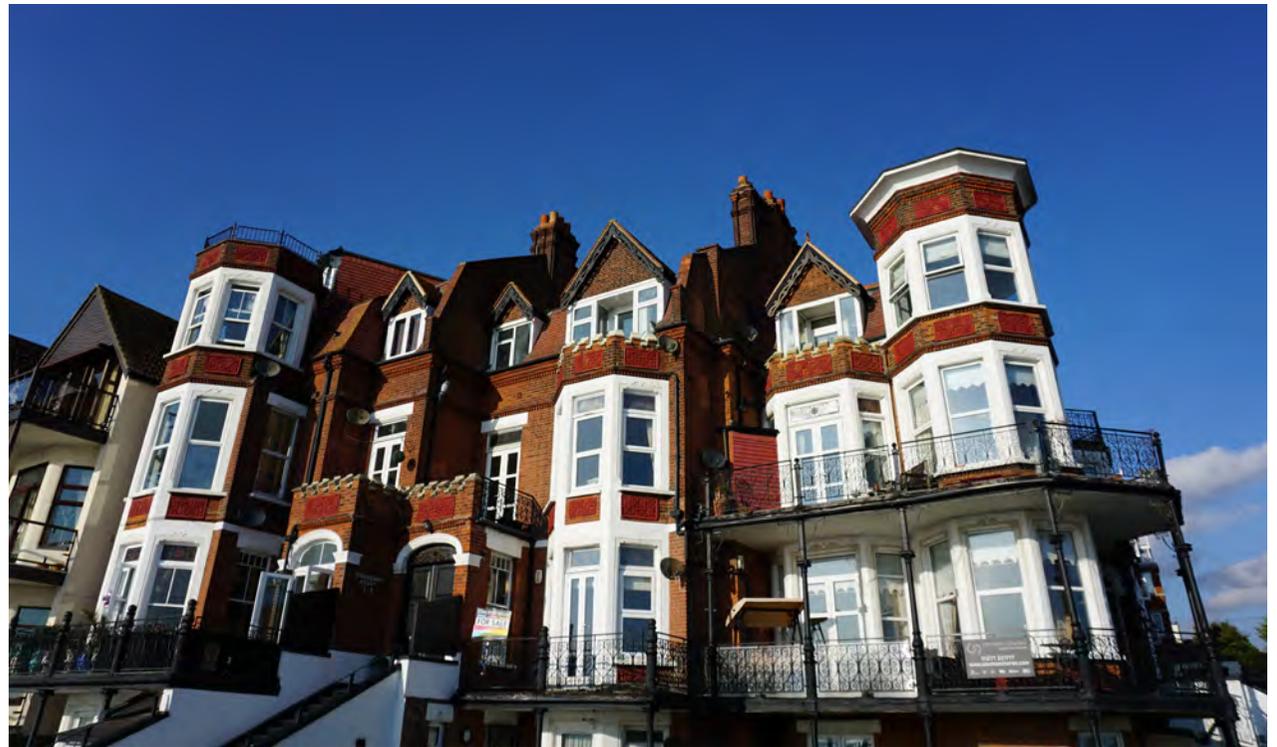
5.2.3 Grosvenor Court is a very fine red-brick building in a style very typical of the Conservation Area, built in 1901–1902. It has lost some original features, for example the tower had a fine pointed roof in the original design, many of the windows featured stained glass and the attic rooms had arched windows to light them. The building is largely unharmed by modernisation as the bricks remain unrendered and

the terracotta decorative panels survive in many places. Fine stained glass is still in place in the front door and its fanlights, as well as in two windows on the same elevation: one to the left of the porch and the other directly above it. The retrospective addition of ornate wrought iron balconies is not detrimental to the appearance of the building as they are in the same elaborate style as the house itself.

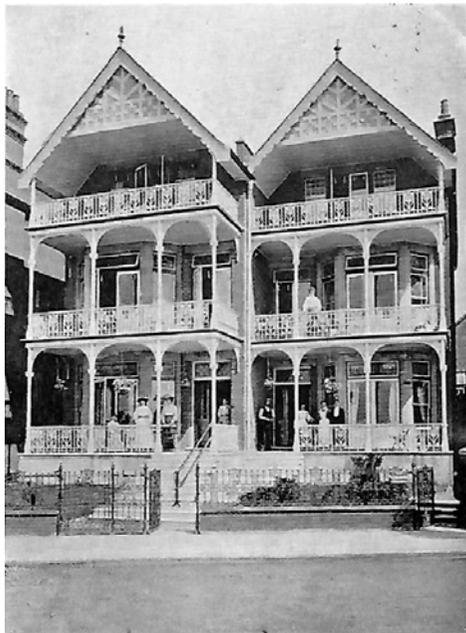
Two of the Mount Liell Courts buildings before extensive renovation

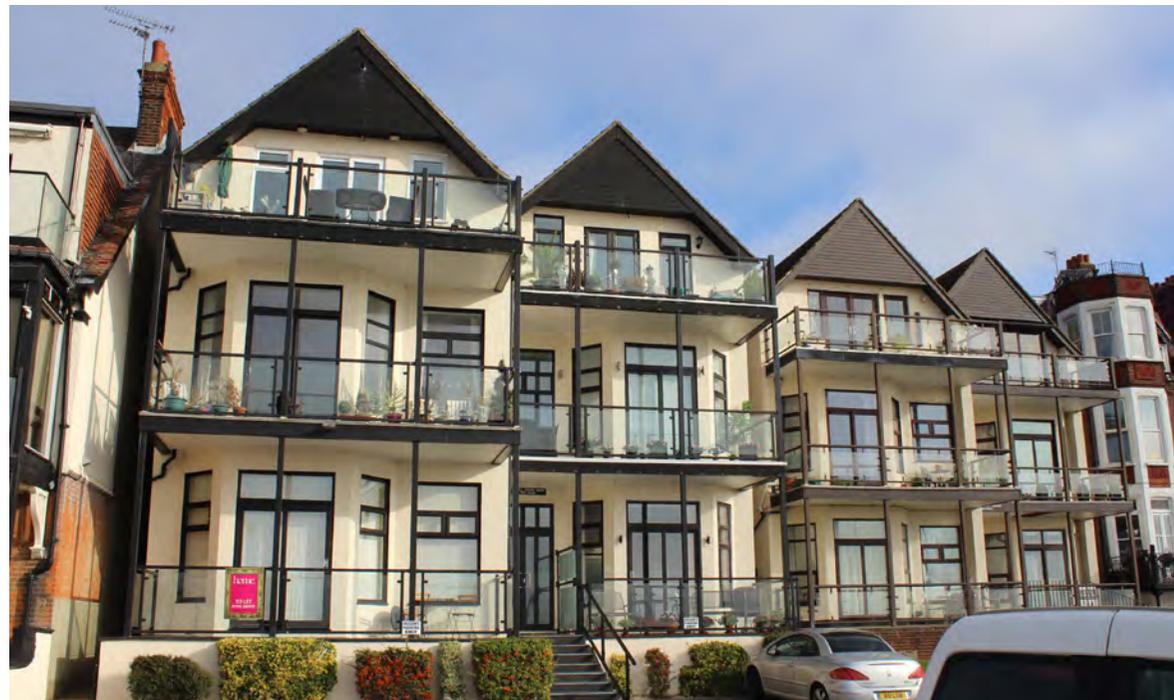
Mount Liell Courts

5.2.4 Mount Liell Court East and West appear to be entirely modern in their design, yet historic postcards, showing their distinctive roof design, and historic maps, which show their original footprint, imply that the original building structure still exists, albeit with extensive alteration works.

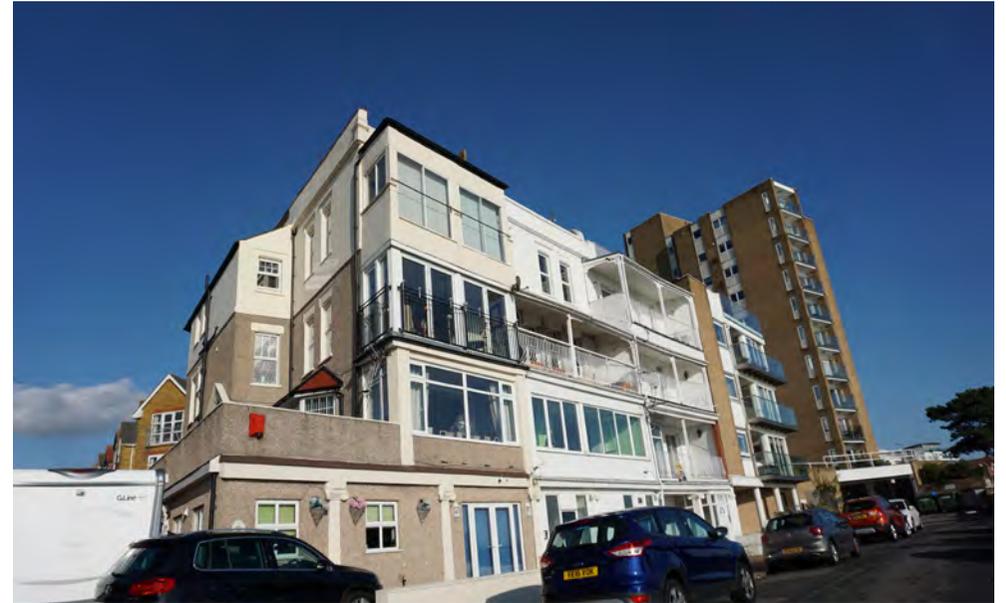
5.2.5 Nos.2 and 3 (1905) and the southern facing elevation of Palm Court is almost unrecognisable as an old building, let alone a coordinated design. Numerous balconies and extensions have been added and these have altered the original elevation completely. This is exacerbated by the problem of piecemeal addition which means that the changes have each been made to only one of the houses rather than to all, so that the elevation no longer reads as a whole. The only surviving evidence of the original design are the pilasters of the ionic colonnade that survive on the ground floor of the sea-facing elevation.

The sea facing elevation of Palm Court is almost unrecognisable as an historic building

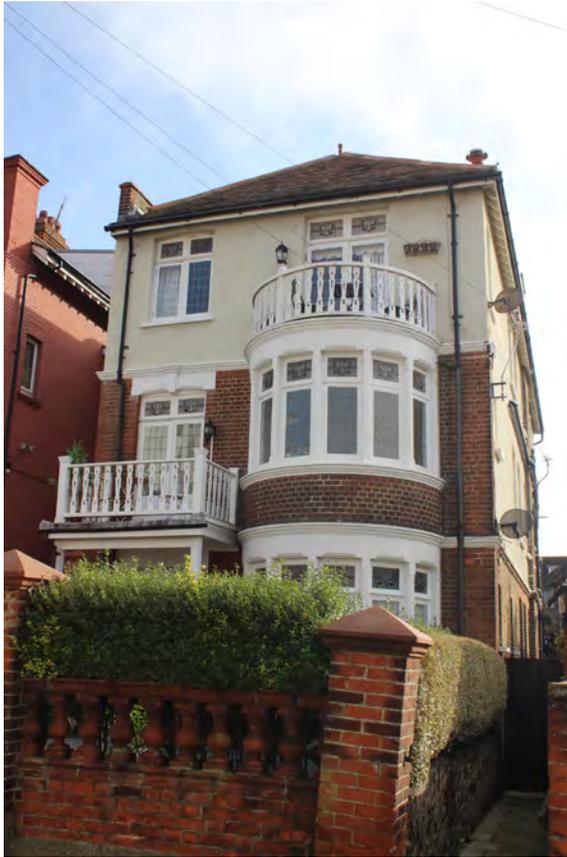
Good quality original features on Pembury Road, including a double height bay window, leaded and stained glass windows and timber balustrades

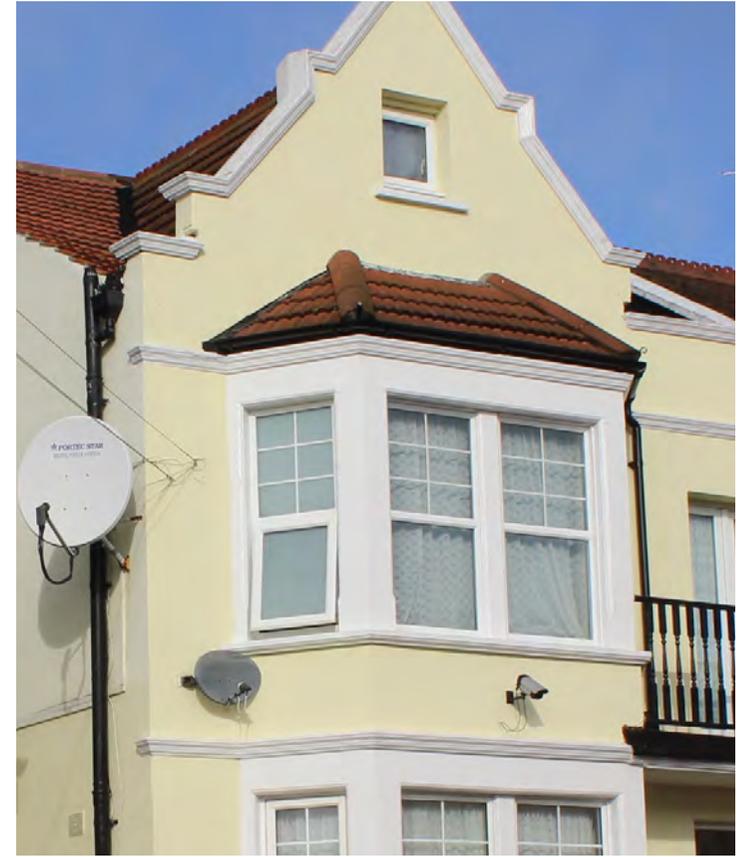
- 5.2.11 The houses have many of the characteristic features of the Conservation Area such as the combination of render and brick, timber porches, double-storey bay windows, decorative gables, ornamental ridge tiles and corner towers. The street is negatively impacted by the prevalence of uPVC window units, as well as excessive street wiring and satellite dishes. The street has been particularly impacted by the loss of original front gardens and boundary enclosures and their replacement with harstandings and driveways, owing to the division of houses into flats and the increased need for car parking.

Unsympathetic uPVC windows and satellite dishes on Pembury Road

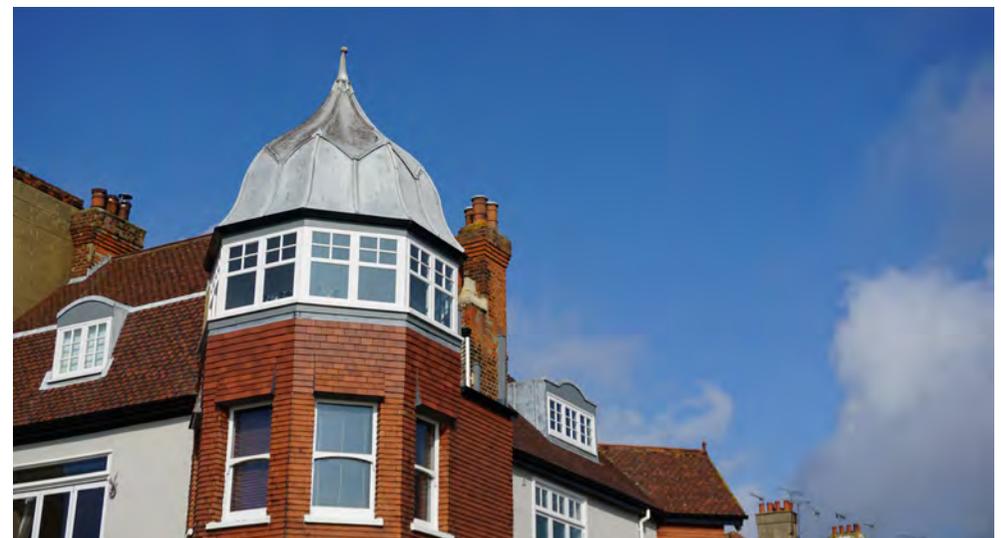
5.2.19 The house on the corner, Barton Towers, has a tower which retains its lead roof. Certain terracotta panels have been painted white. Double floor bay windows are typical, although there are also houses with no bay windows, which instead feature gable ends. White rendered walls (historically the walls were un-rendered brick) and slate roofs are dominant, however, a range of materials is used for ornament such as half-timbering, terracotta, slate and hung tiles.

The lead roof surviving on the corner tower of Barton Towers, Clifton Drive

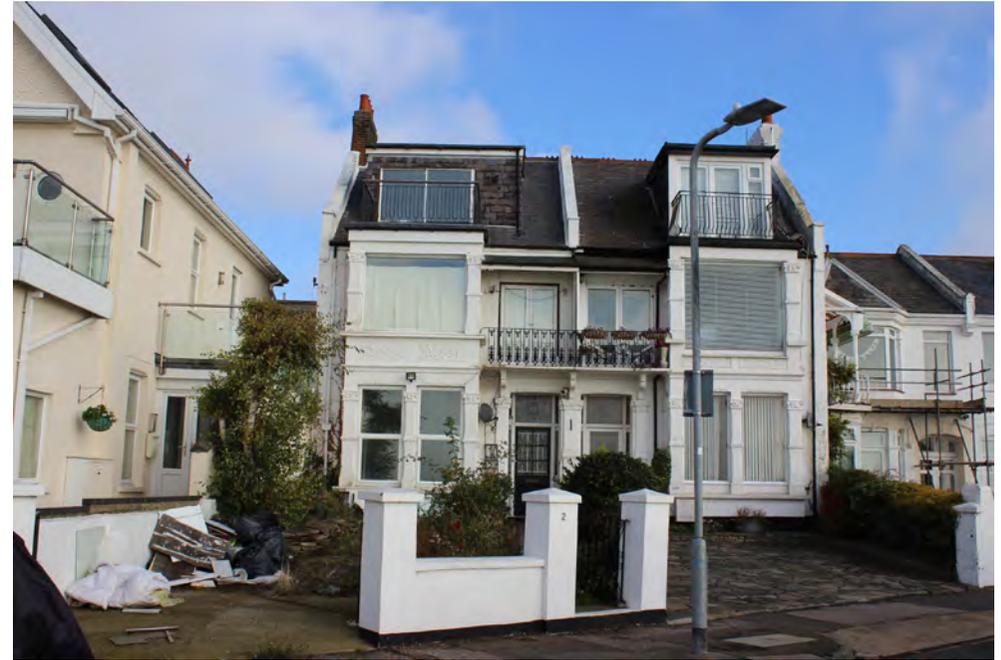
Nos.2 and 3 Clifton Drive

5.2.21 Nos.2–3 are also taller than their eastern neighbours and feature more elaborate decoration. These were designed for M. Kirkham by W.Y. Hobbiss. The design was submitted in March 1896 and plans, elevations and sections all survive. The original front elevation was very different from that which survives. The rectangular double height projecting bay windows were originally topped with a decorated pediment with small finials on each corner. The windows in the bays had ornate mullions, there was ornate decoration above all the windows and there were decorative panels between the windows on the ground and first floors. Much of this ornament has been lost or painted over. The front doors had pilasters with foliate capitals. Above the front doors were small independent balconies that have now been replaced by a much larger balcony that stretches between the two bay windows on the first floor.

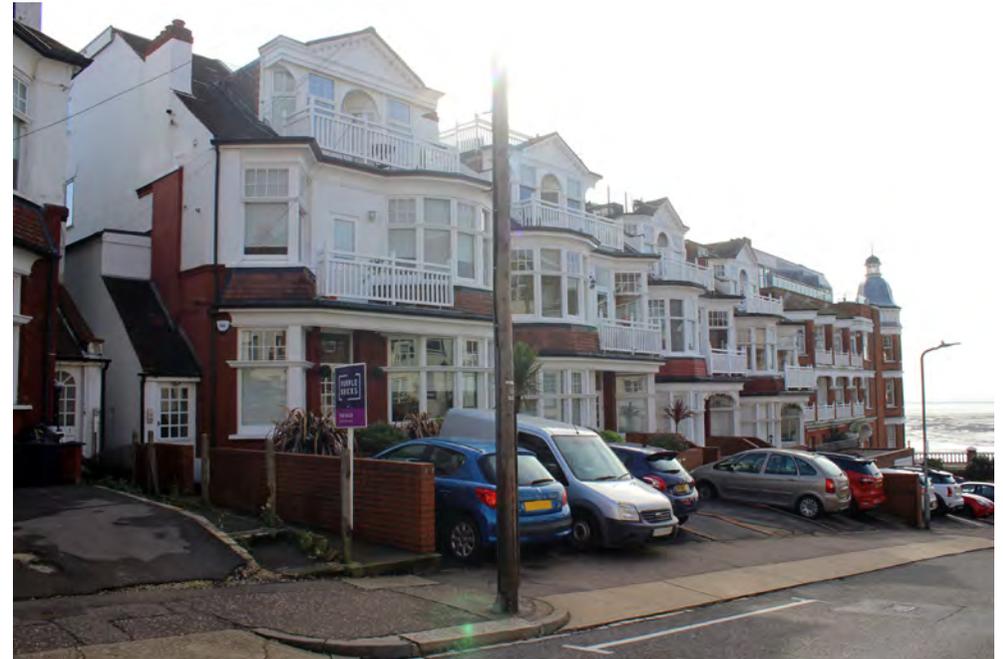
contrast to the prettiness of the houses and the gardens soften the streetscape. However, Nos.1–19 have all lost the full extent of their gardens and the enclosing walls. Minute front gardens have been retained in an attempt to cushion the houses from the road. However, the larger part of former gardens and boundary enclosures have been replaced by hardstanding surfaces for car parking; the small gardens are not large enough to stand up to the tall buildings and the hard landscaping and are therefore lost visually.

Nos.14–19 Palmeira Mansions, Palmeira Avenue showing the loss of former gardens to hardstanding and car parking

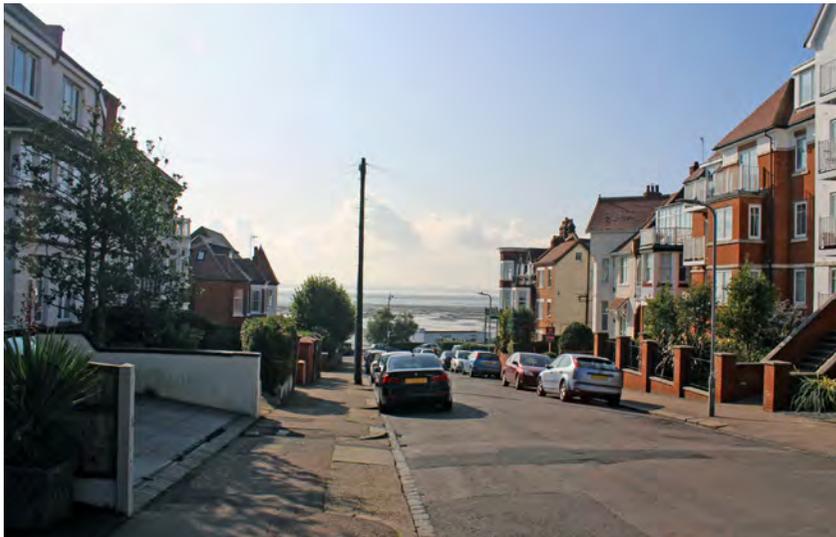
View of the sea looking south along Pembury Road; both the corner dwellings have a tower (although that on the right has lost its original roof)

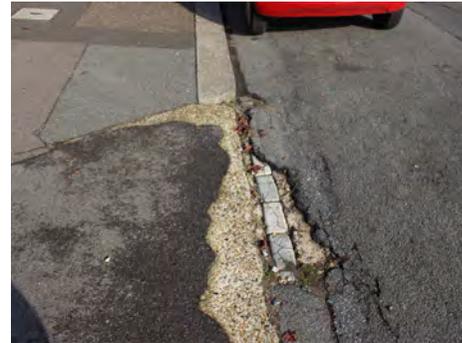
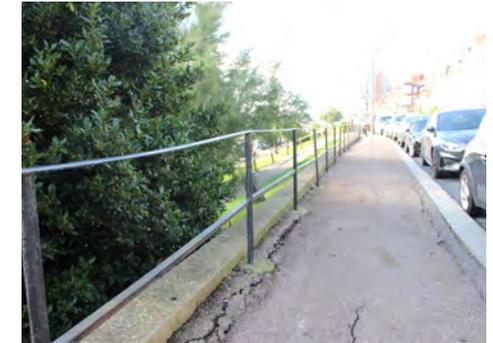
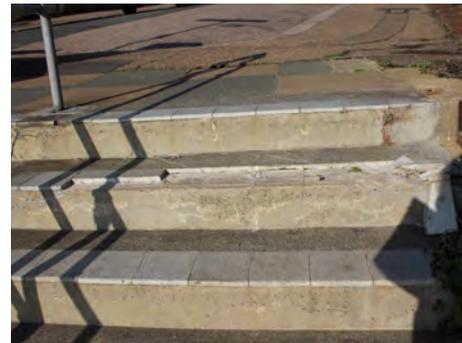
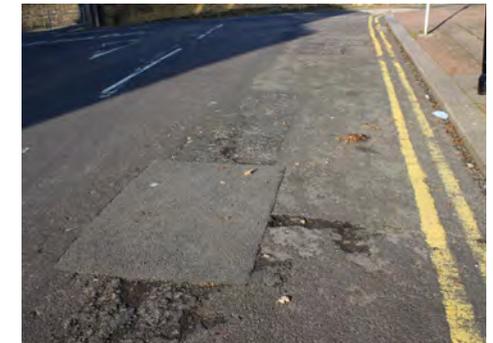
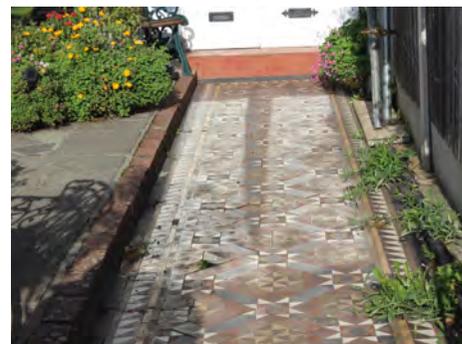
5.3.10 The road surfaces in the Conservation Area are a dark tarmac and vary in their state of repair; many are in need of resurfacing works and have been extensively patched. Road markings have been kept to a minimum, as is appropriate in a Conservation Area. Thick yellow double lines are generally kept at bay.

5.3.11 Many pavements in the Area are made of tarmac. They are in a poorer state of repair than the roads and extensive patching has a negative impact on the appearance of the streets. In places the paths are uneven and even broken, often owing to uncontrolled weed growth, and this could become dangerous with further neglect, especially with the slopes on many paths. The steps to the east of Argyll House and Crowstone House are in poor condition, with parts of treads missing, making them dangerous for the user. However, materials used for certain surfaces are well chosen, for example the use of coloured aggregate within the tarmac on Palmeira Avenue, which also incorporates seashells. This texture and colour has a softening effect and improves the appearance of the material.

Poor quality or poor condition surface treatments

- 6.3.11 Maintain or resurface damaged street surfaces and, if funding opportunities present themselves, reinstate stone kerbs where possible.
- 6.3.12 Road markings should be the minimum necessary for safety and yellow lines should be narrower widths and in primrose suitable for Conservation Areas.

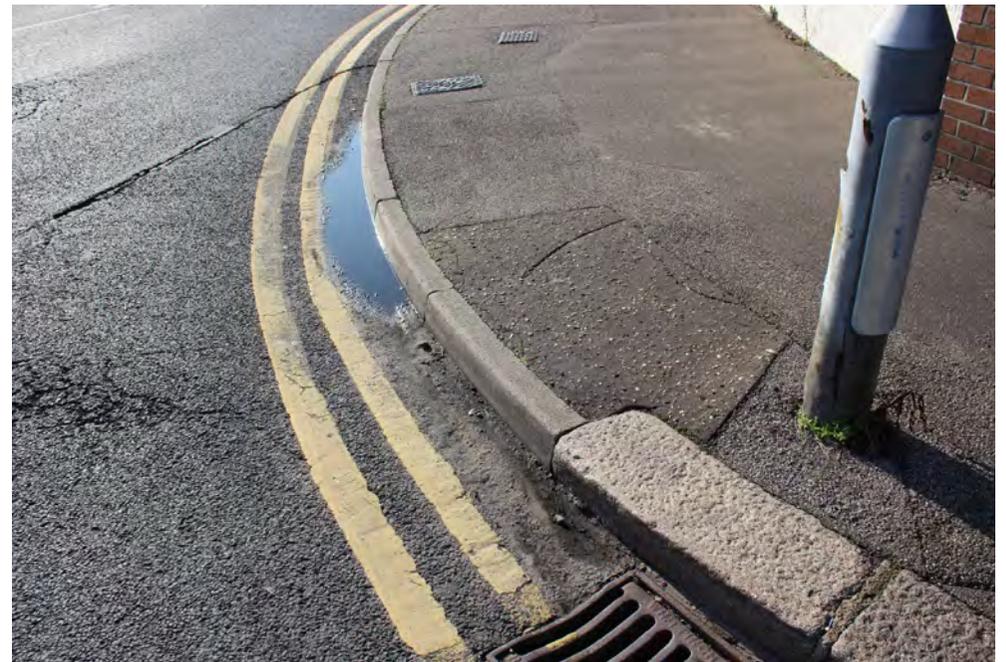
5.3.13 The wide granite stone kerbs in the area are both distinctive and original, being clearly visible in early postcards. In some places these have been lost, especially around curves and corners. They are an important part of the character of the Area and priority should be given to their retention and to reinstatement where they have disappeared.

The stone kerb has been lost on this corner

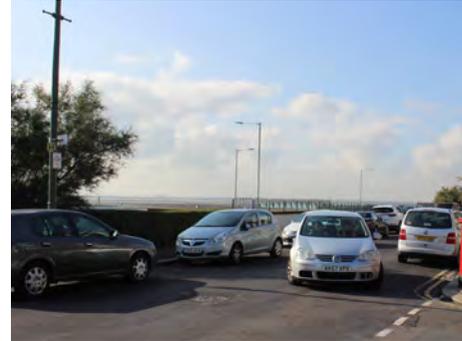
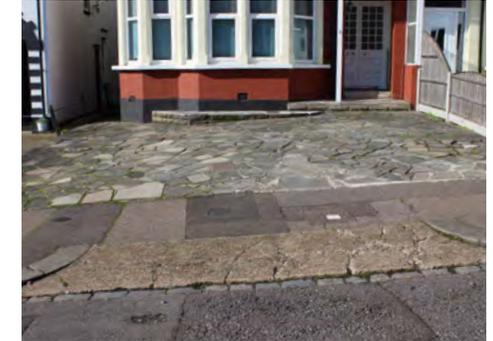
5.3.20 The proliferation of cars parked in the area impacts on the appearance of the Conservation Area, particularly in the way the sea views are often partially obscured from within the area by the cars parked on the side of the road. In addition, the number of cars parked along the sides of the roads and on front drives detracts from the architectural quality of some of the buildings.

Examples of cluttered parking and lost boundary enclosures

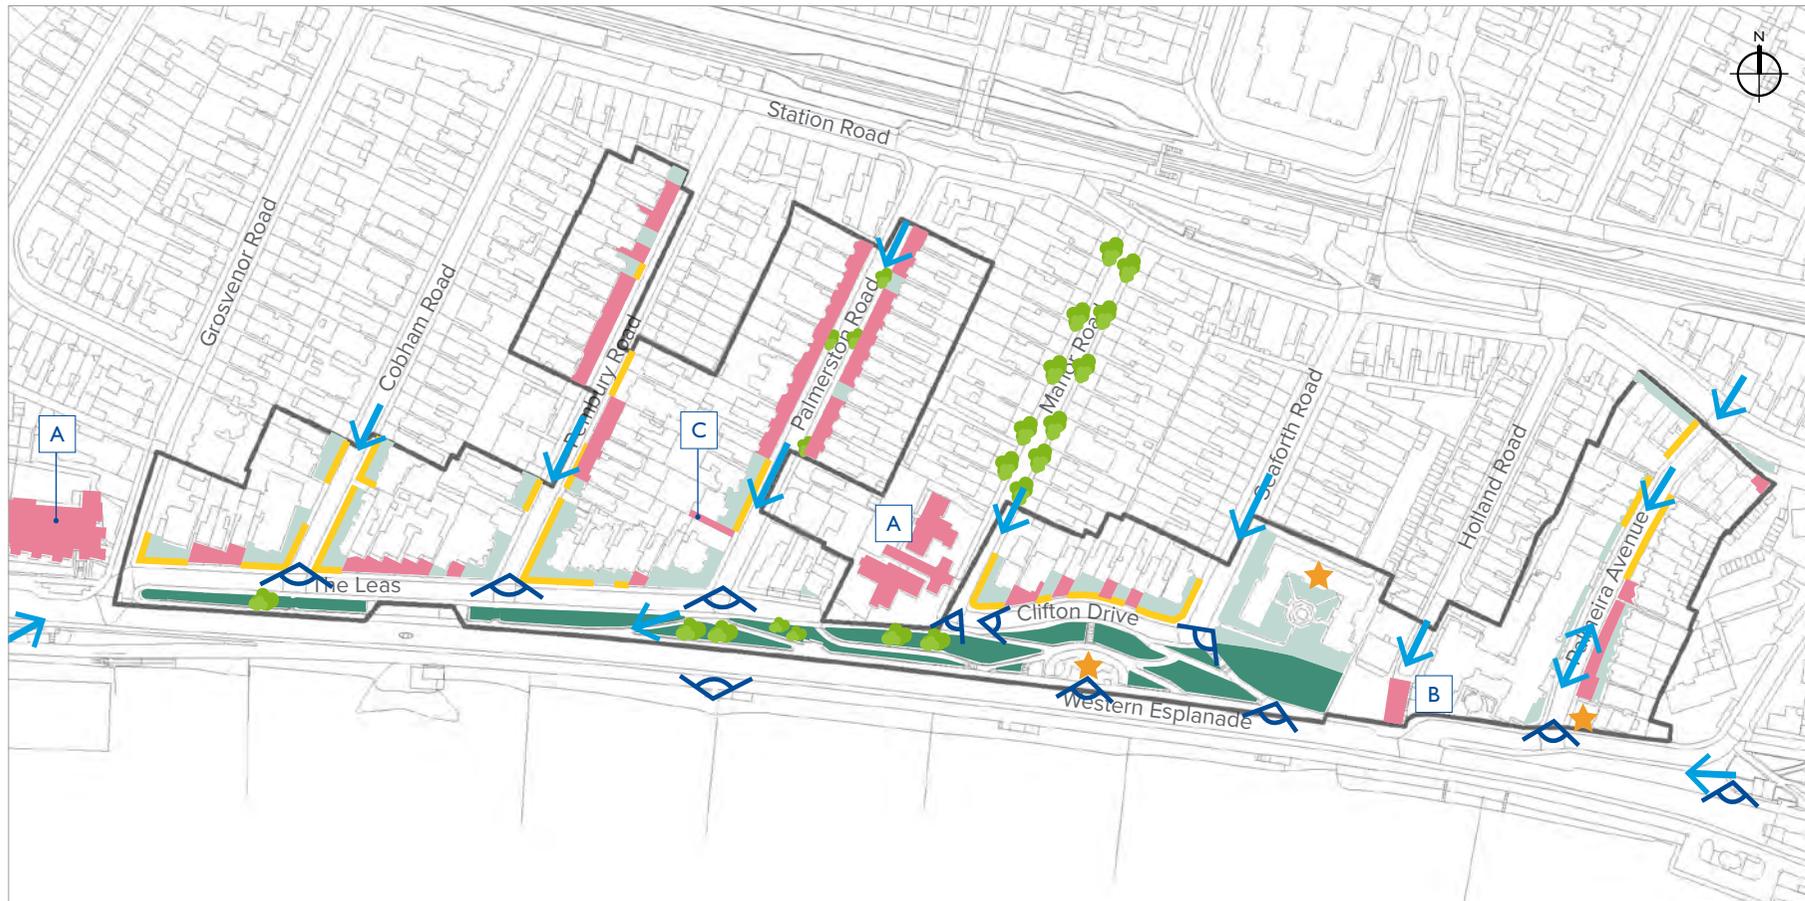
Map I: Townscape

- A Building of insensitive scale
- B Damaged, municipal steps and untidy scrub area
- C Collapsing wall to garden steps

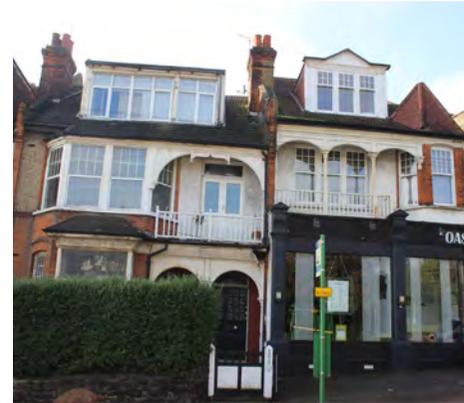
6.3.1 Whilst some properties are tidy and well looked after, other properties are rundown and neglected. This is often linked to vacancy and the provision of these buildings with a viable new use is advised. Properties along Station Road, in particular, feature cracked or peeling render and paintwork, damaged joinery or window lights and broken or redundant service boxes or satellite dishes. Many gardens across the Conservation Area are untended, and as a result, overgrown with weeds. Alleys between houses and garden steps are often also overgrown.

Poor condition of No.106 Station Road

- 6.3.7 Keeping buildings in good condition will ensure the area is an attractive and desirable place to live and work.
- 6.3.8 Undertake regular maintenance and checks to prevent problems from occurring and protect original features. This will also ensure small problems do not become bigger, more costly issues to fix.

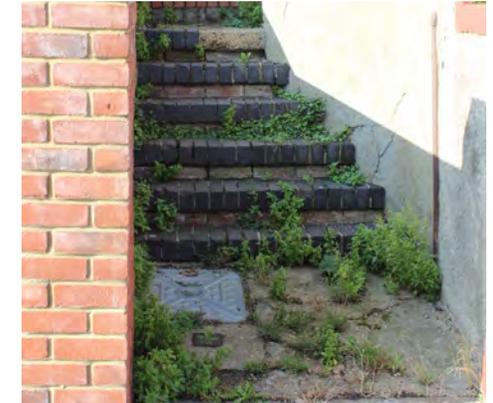
Overgrown garden steps to No.1 Palmerston Road

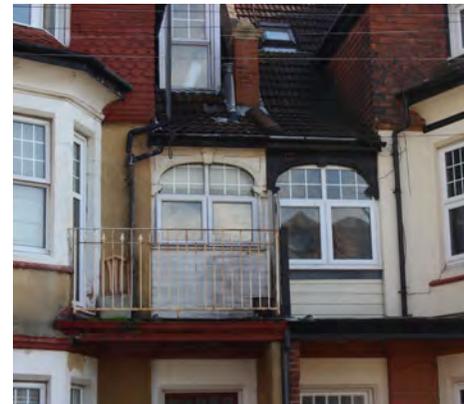
An example of poorly maintained balconies, the one on the right has been lost entirely

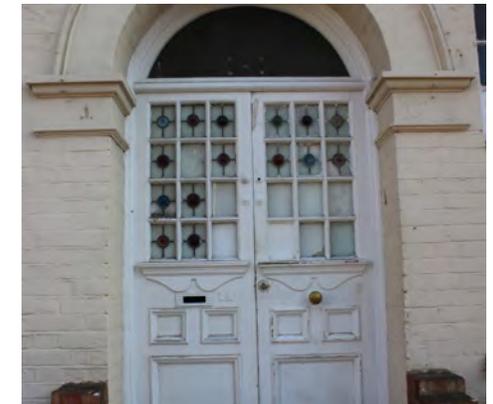
Decorative window lights to No.1a Palmeira Avenue missing and in disrepair

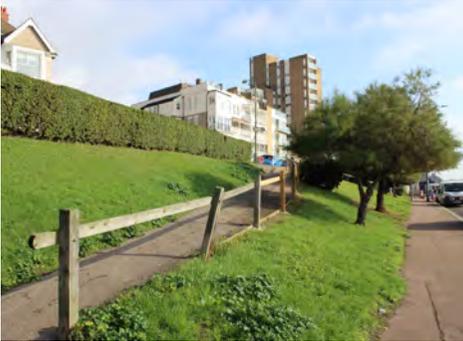
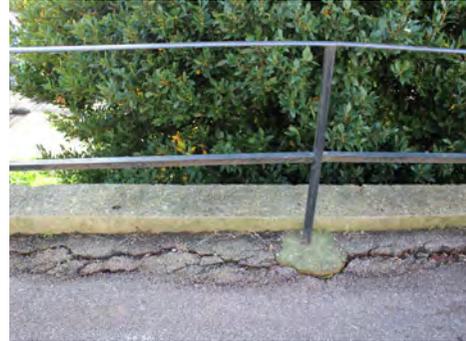
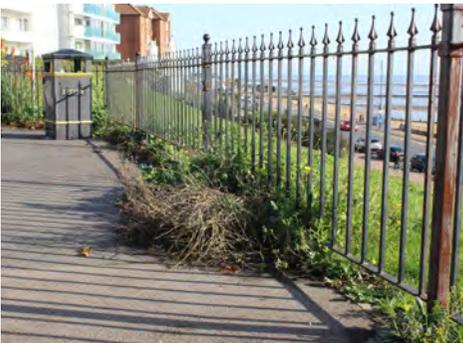
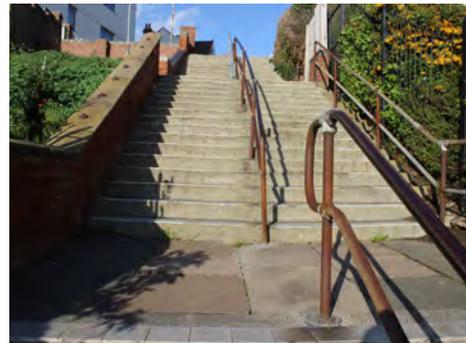
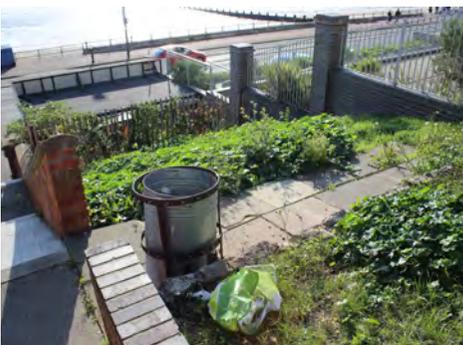
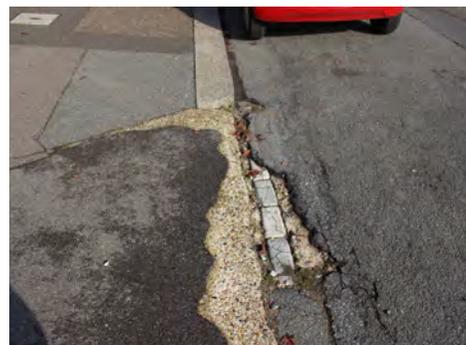
- 6.3.2 Maintenance of the public realm could be improved. The condition of the roads is poor; they have been patched and repaired and are in need of resurfacing work in many places. Pavements and paths are in even poorer repair and have been extensively patched and repaired. The surfaces are widely varied and this creates an untidy appearance within the street scene. Comprehensive resurfacing of all pavements would considerably improve the appearance of the area as a whole.

Degraded or unattractive public realm

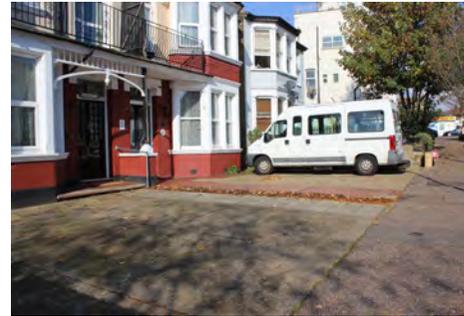
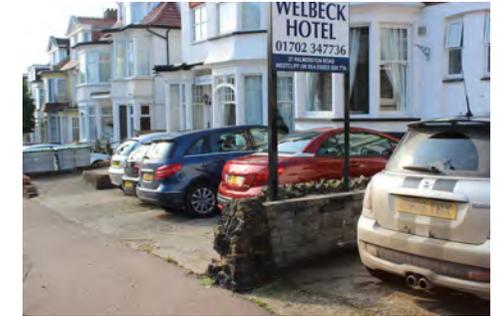
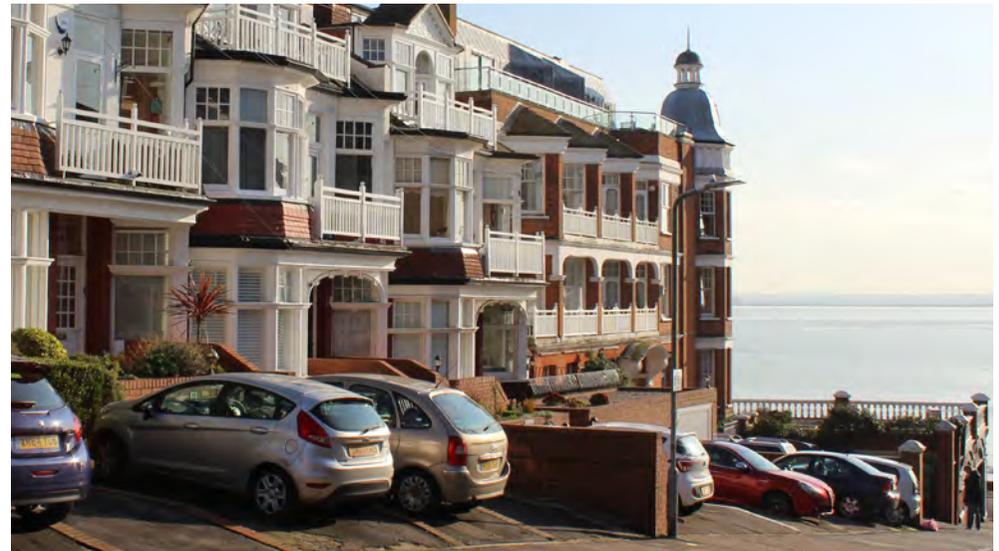
Examples of insensitive driveways/hardstandings replacing former gardens and boundary walls

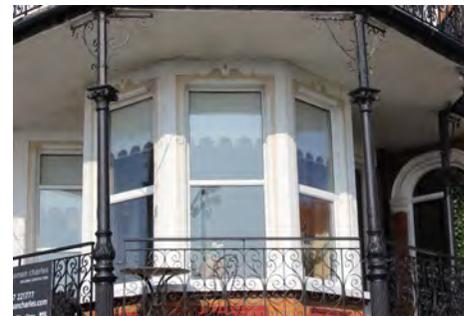
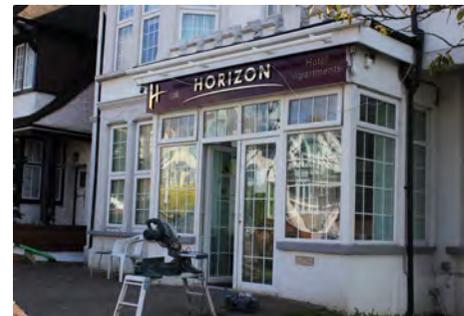
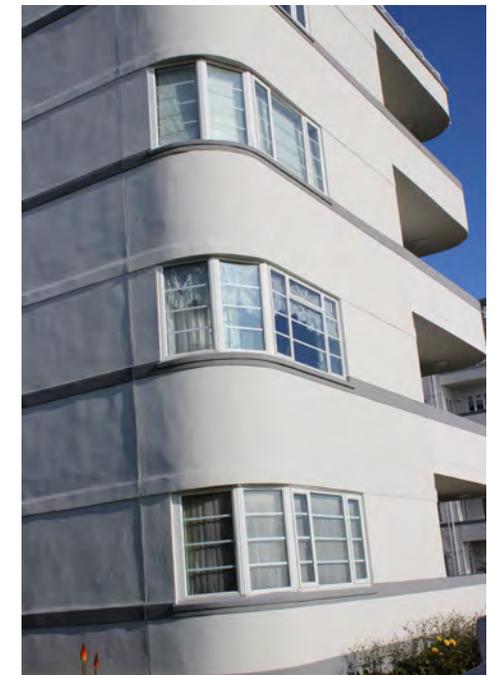
6.3.20 Where new windows have been installed, many have changed the original shape of the opening, completely altering the appearance of buildings and destroying their proportions. The sea air is abrasive to paintwork and this does mean buildings require extra maintenance, but, as well as detracting visually from the Conservation Area, the use of uPVC units reduces the breathability of traditionally constructed buildings by preventing moisture from egressing the building. Original materials were more permeable than modern materials, ensuring that moisture did not get trapped within walls, which would cause issues with damp. There have been issues with windows being changed in flats without planning permission.

Inappropriate uPVC units

6.3.30 If the original windows or doors have already been replaced with uPVC and these require replacement, the preference will be for replacement in timber in a design to match the original. However, it may be acceptable to replace existing uPVC windows and doors with uPVC provided that there is a marked improvement in the design which would provide an enhancement to the character and appearance of the Conservation Area. Replacements also must:

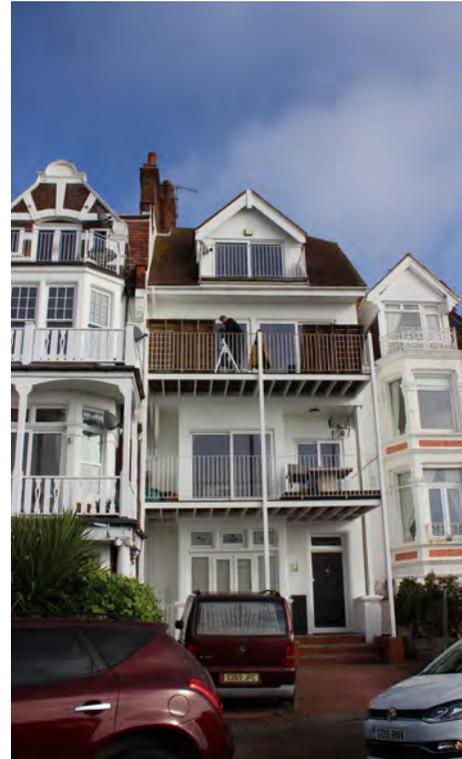
6.3.22 The panoramic sea views in this Conservation Area mean that there is also pressure for the installation of unsympathetic modern balconies and larger windows or doors: 6 The Leas is an example of this. Glazed balconies are particularly intrusive as their materiality is out of character with the Conservation Area; examples of these include 1 and 1a Clifton Drive and 15 The Leas. Very plain, thin metal railings also do not do justice to the more elaborate detailing on the historic buildings. This is contributing to loss of the character that made the area worthy of protection and changes of this type should be carefully considered and designed in such a way as to be as sympathetic as possible.

Unsympathetic balconies and inserted French doors at 6 The Leas

6.3.32 Where balconies have already been replaced and require further replacements, this should be done in a design which replicates an historic balcony. It should be constructed in timber or metal and should not be glazed. Designs with more intricate detailing are likely to be more appropriate than very plain designs. These replacements will be judged on a case by case basis.

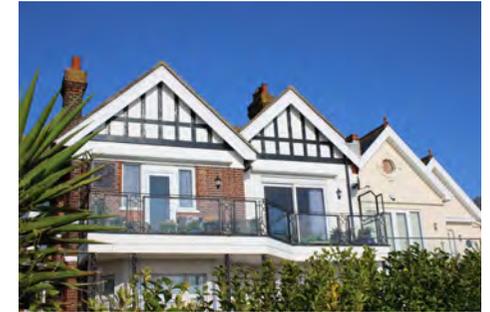
Unsympathetic glazed modern balconies and oversized uPVC doors at 2a Manor Road and 1 Clifton Drive

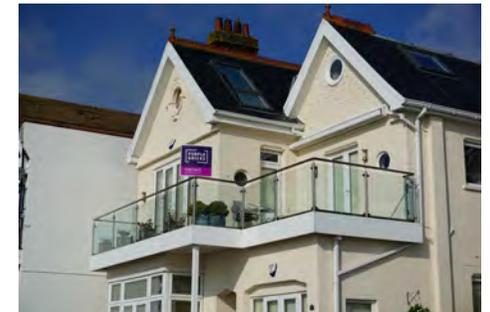
Unsympathetic glazed modern balcony at 15 The Leas

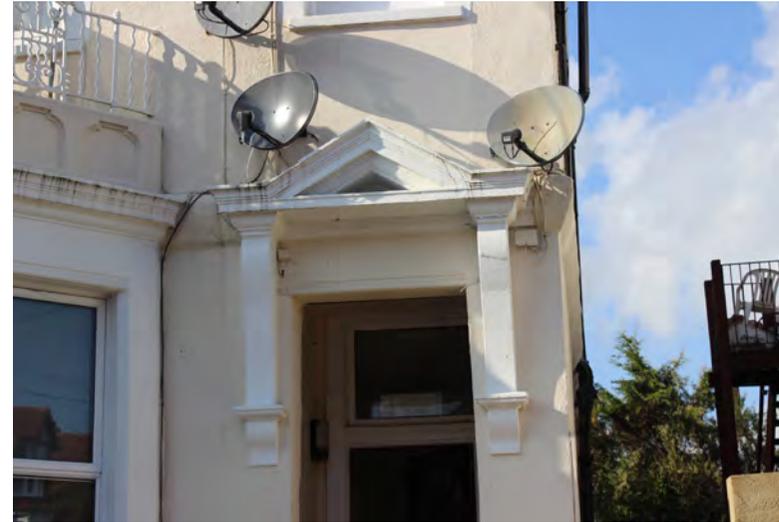
6.3.26 Minor modern alterations, which nonetheless detract from the character and visual interest of the Conservation Area, include a proliferation of satellite dishes and TV aerials, as well as the addition of modern canopies and excess signage. Other inappropriate alterations or pressures for change could include the alteration of original roof materials to concrete tiles, the painting over of original brickwork, the infilling of recessed porches, the addition of mansard roofs or additional floors to buildings and the infilling of balconies.

Excessive satellite dishes on a front elevation

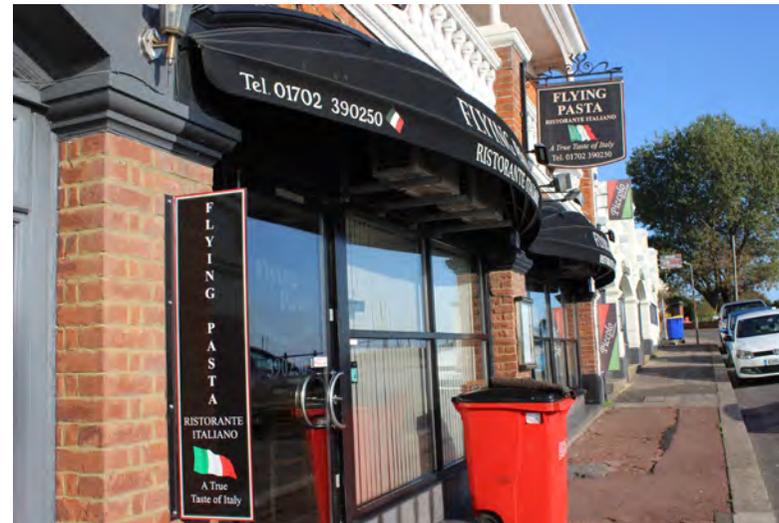
Cluttered modern signage, air handling units and canopies at 1-9 Shorefield Road

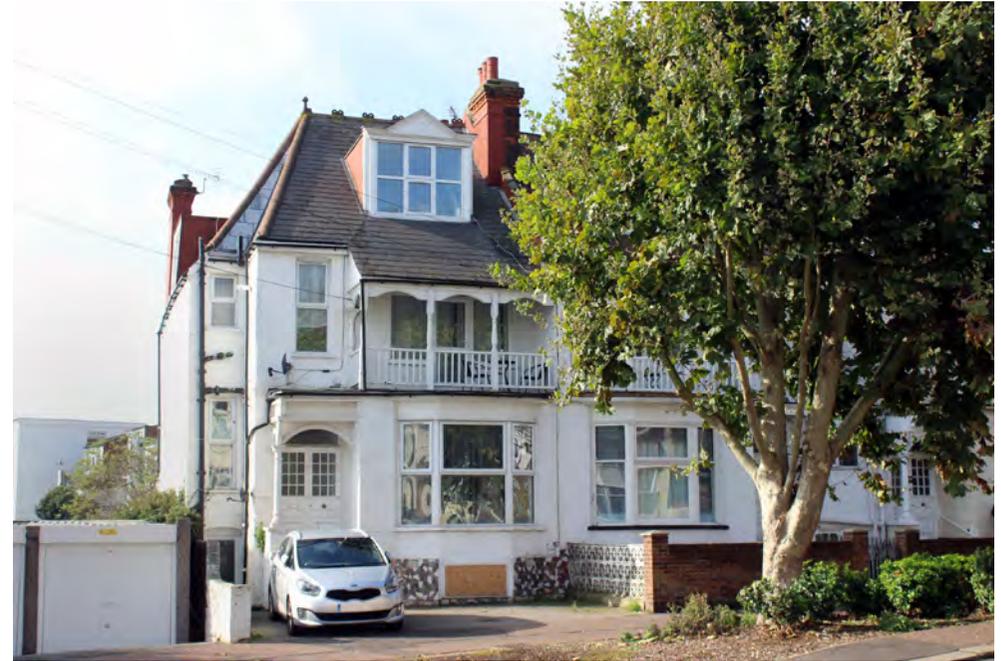
Address	Value	Designation
84 Station Road	Positive*	N/A

A mirroring pair with No.82. Rendered and painted walls. Steeply pitched hipped roof with red tiles. Brick chimney shared with No.84, remains unpainted. Original timber double door with multiple panes to top halves survives (though glazing painted out) under a porch, though supporting column has been replaced with a modern post. Timber and glazed door inserted on basement floor, presumably to access a flat. All timber sash windows replaced with unsympathetic uPVC units or timber replacements with glass louvers to the upper sections. Original timber balcony with moulded columns survives and dormer with pediment appears original and with original tile hanging on the sides, though windows replaced. Modern brick boundary wall retains enclosure but garden paved over.

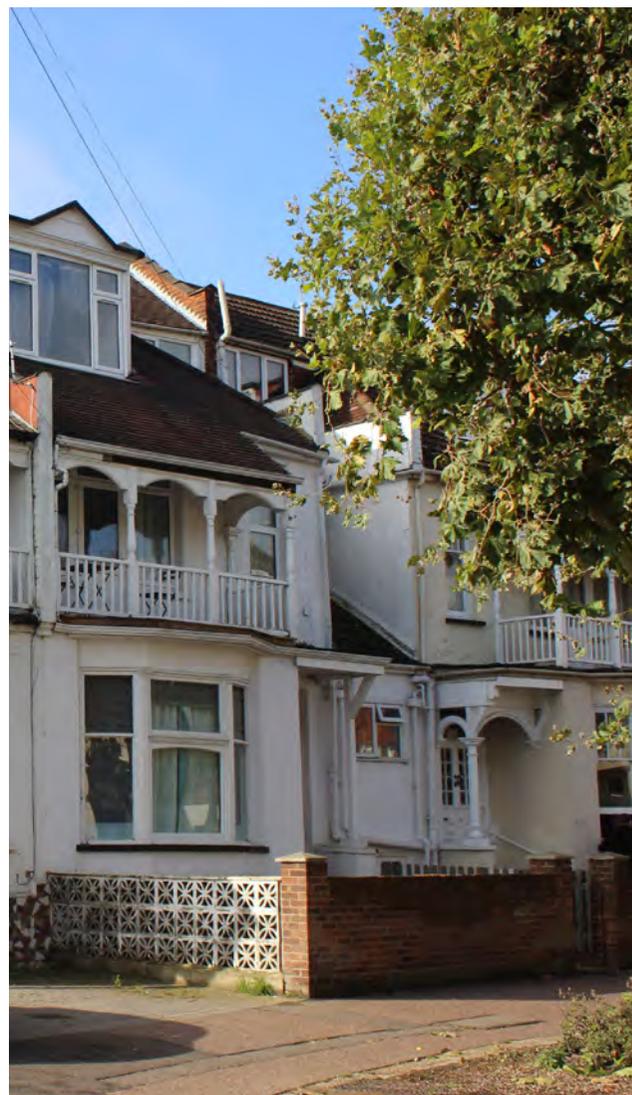
Address	Value	Designation
86 Station Road	Positive – though would benefit from replacement of uPVC top floor windows with timber	N/A

Similar in design to Nos.82 and 84. Brick painted to ground floor with rough cast render painted to first floor. Steeply pitched roof with unsympathetic replacement concrete tiles. Original timber double door with multiple panes to top halves survives under a porch supported on a column. Canted bay window to ground floor under balcony. Timber sash windows with small panes to the upper sashes survive on ground and first floors (with leaded lights to top half of central bay window on ground floor). Original timber balcony with moulded columns survives and dormer with pediment appears original, though dormer window replaced with uPVC. uPVC window also to the left-hand side of the roof. Modern brick boundary wall retains enclosure but garden paved over.

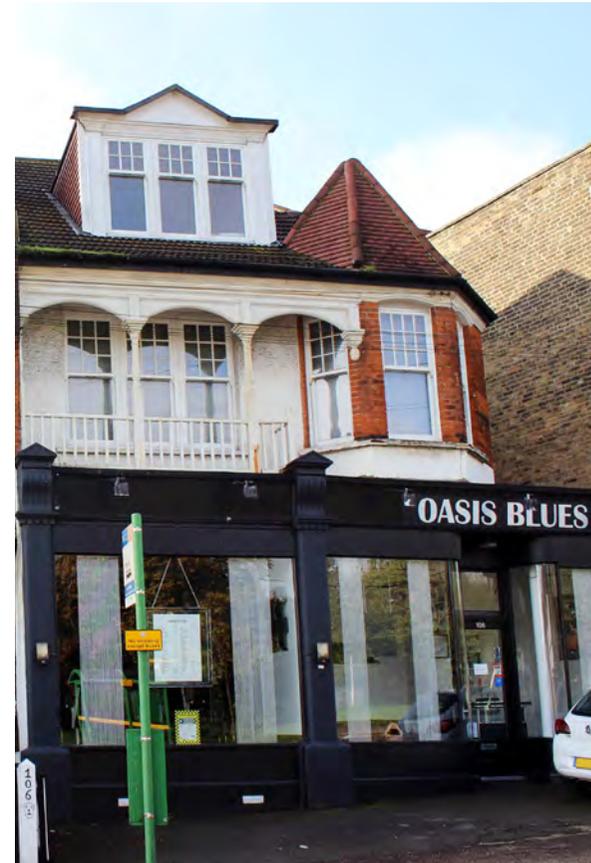
Very little change to the building as a whole with retention of windows, front door, roof, hanging tiles, balcony, garden, garden wall and front path. The brickwork has been painted red, which is inappropriate for the building. Removal of this paint would improve the appearance of the brickwork. The house also has excess surface wiring.

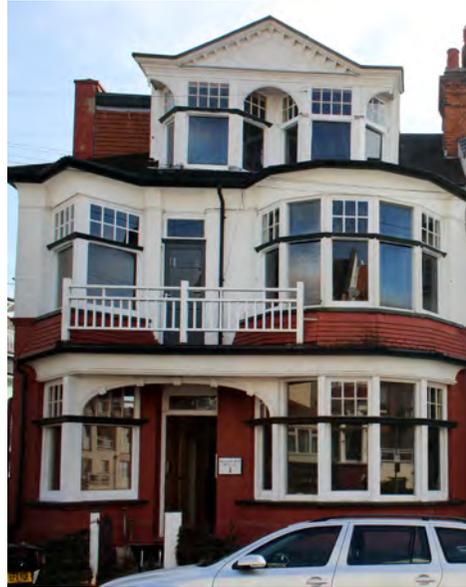
Address	Value	Designation
2 Palmeira Avenue	Positive	Locally Listed Building

This is a modern replica of the other houses on the street and integrates successfully within the street scene owing to its red brick materiality, use of hung tiles, first floor balcony, bay windows and attic dormer with pediment. It also retains a good boundary wall and garden. It is, however, lacking some minor detail, such as an absence of decoration on the pediment above the dormers. Two satellite dishes on the front detract from its otherwise tidy and well-maintained front elevation.

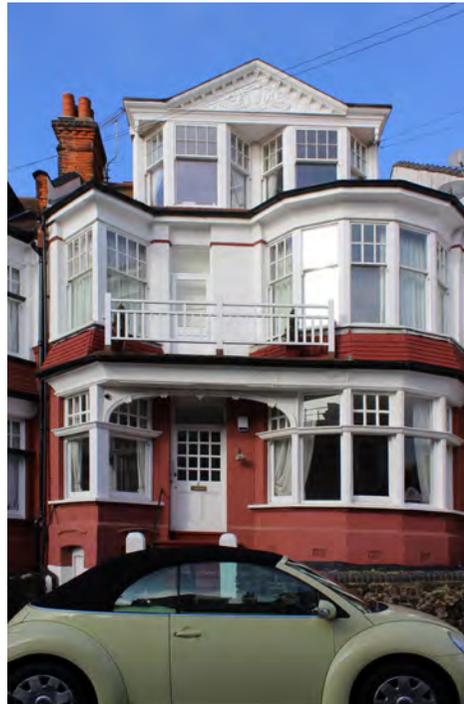
Address	Value	Designation
5 Palmeira Avenue	Positive	Locally Listed Building

Very little change to the building with retention of windows, front door, hanging tiles, balcony, garden and garden wall.

The building was difficult to survey owing to building works and scaffolding at the time of survey in 2019. However, the brickwork has, again, been painted red and the roof tiles replaced with concrete. Some of the paintwork was in disrepair.

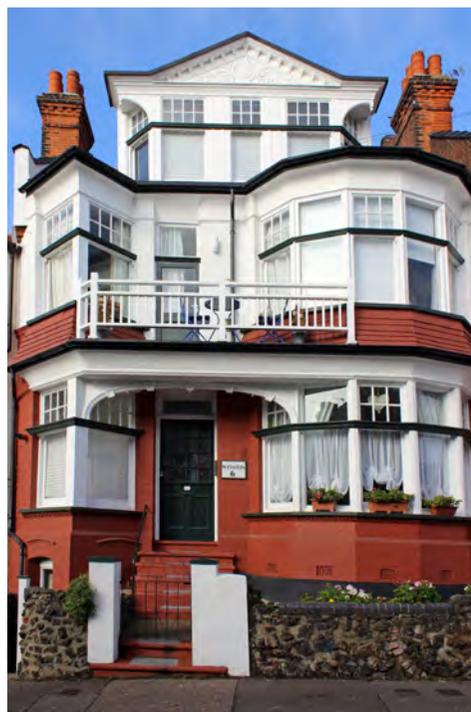
Address	Value	Designation
7 Palmeira Avenue	Positive	Locally Listed Building

- Inappropriate red painted brickwork and hanging tiles.
- Concrete roof tiles are not in keeping with the Area.
- Some requirement for maintenance, for example repainting of joinery and mouldings above windows.

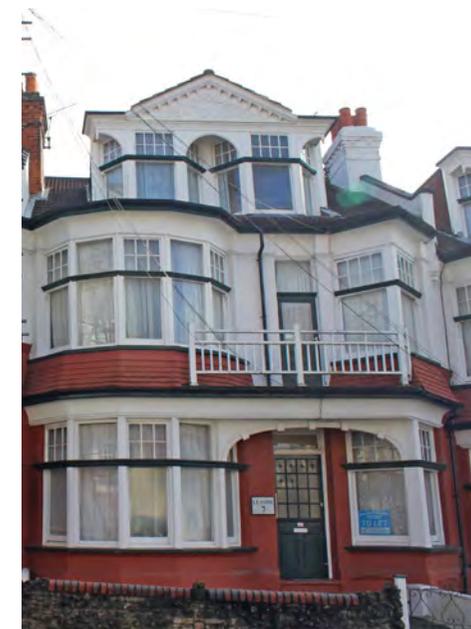
Address	Value	Designation
9 Palmeira Avenue	Positive	Locally Listed Building

- Roof tiles have been replaced with concrete.
- Some of the paintwork around windows is in need of renewal to prevent deterioration.

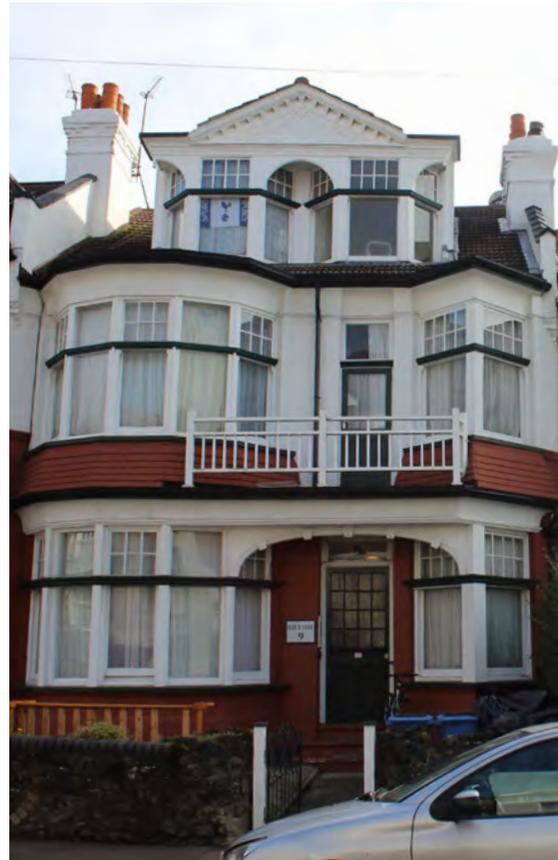
Address	Value	Designation
11 Palmeira Avenue	Positive*	Locally Listed Building

- Inappropriate concrete roof tiles.
 - Inappropriate painted brickwork.
 - The garden has been replaced with hardstanding for car parking and the boundary wall has been lost.
 - The replacement metal balcony is not in keeping with the others in the Avenue, which are timber. Besides its style, which does not match the others in the Avenue, it is in a deteriorated state with rust showing through the white paint.
 - Certain original small pane windows have been replaced (although fortunately not with uPVC units).
-

- The replacement door does not match the others and is obviously of modern design and this contributes to the erosion of character in the area.
 - The paintwork is in poor condition; the window frames in particular need painting and the hung tiles need cleaning and repairs.
 - There is some redundant surface wiring
