The Leas Conservation Area Appraisal

Southend-on-Sea: The Leas Conservation Area Appraisal

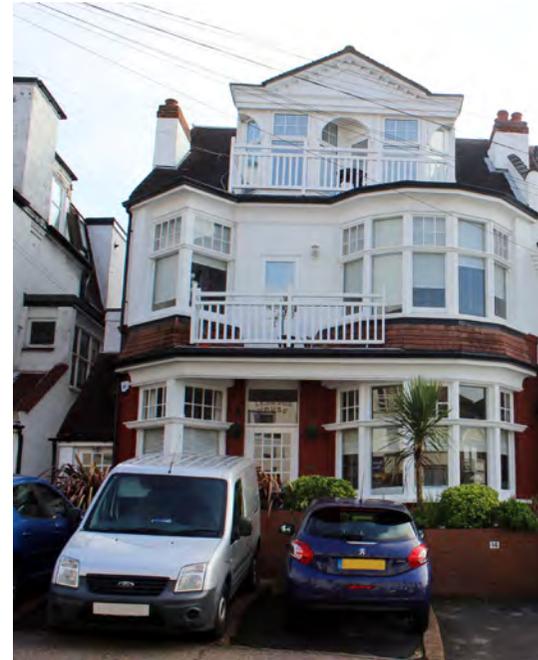
Address	Value	Designation
15 Palmeira Avenue	Positive*	Locally Listed Building

- The space in the roof has been extended, however, this top extension is not too noticeable from the street.
- The front garden and boundary has been lost to make way for parking, which is not in keeping with the rest of the street. The effect is softened by the retention of some planting but extension of this to other properties would have a seriously detrimental impact on the appearance of the Avenue.
- Loss of sculptural relief in pediment.
- Loss of arched timber spandrel detail from porch.

Another alteration, albeit of relatively sensitive design, is the addition of the roof-top terrace. This structure is set well back and discreet and the choice of white timber is in keeping with the rest of the Area.

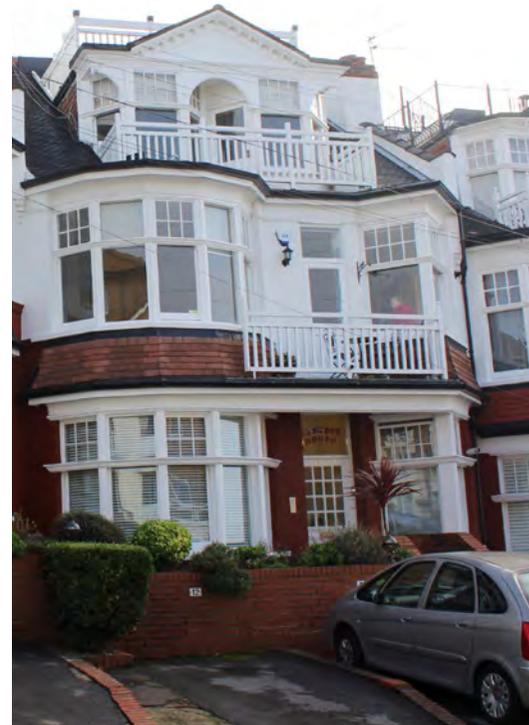
Address	Value	Designation
17 Palmeira Avenue	Positive	Locally Listed Building

The majority of details have been retained including windows, roof, hanging tiles and balcony. The door to No.17 has interesting original frosted and coloured glass panels.

- The space in the roof has been extended, however, this top extension is not too noticeable from the street.
- The front garden and boundary has been lost to make way for parking, which is not in keeping with the rest of the street. The effect is softened by the retention of some planting but extension of this to other properties would have a seriously detrimental impact on the other buildings.
- This property also has a roof-top terrace but the choice of materials for the balustrade, flimsy metal balusters is not very discreet and is clearly a later addition.

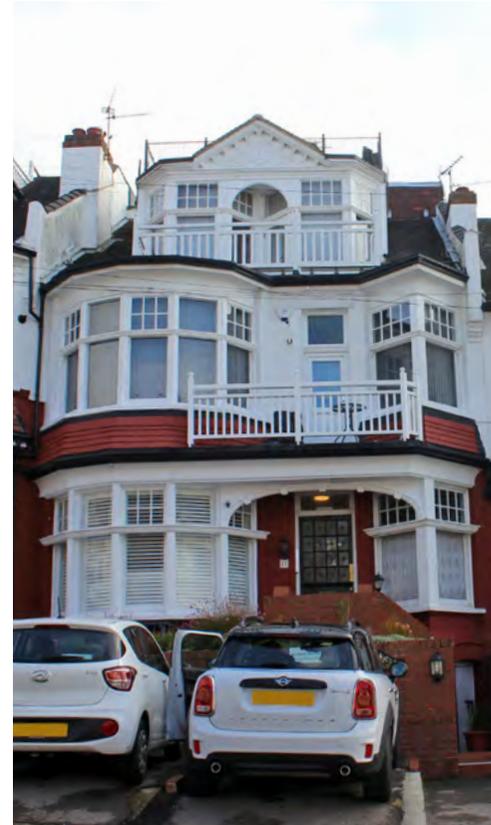
Address	Value	Designation
19 Palmeira Avenue	Positive	Locally Listed Building

- The original garden and front wall have been sacrificed for parking.
- The space in the roof has been extended and the extension clad in hanging tiles to match those below. This is quite discreet as is the additional window above and the roof balcony. However, the top extension is visible from the street and as such the choice of modern windows was a poor one. Their replacement with more sympathetic windows would enhance the appearance of the house.

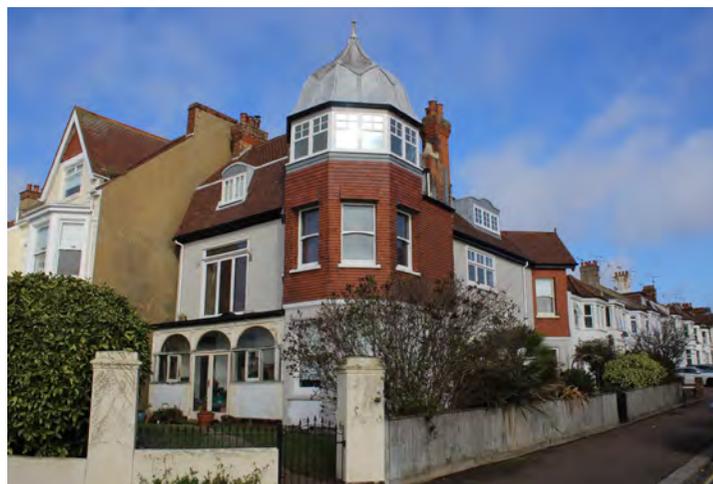
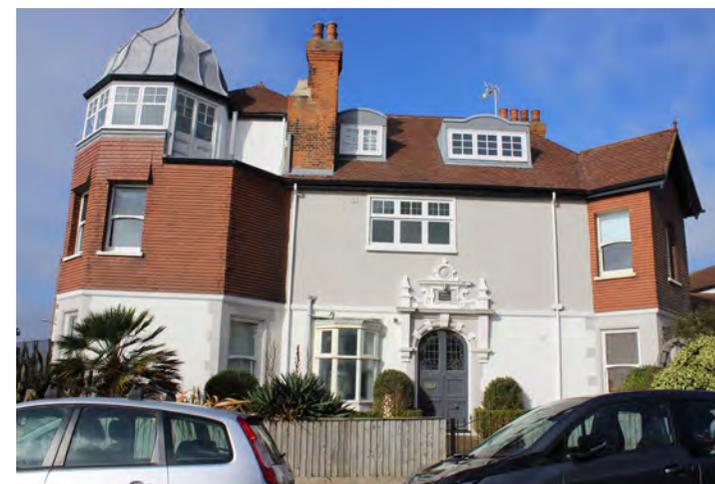
Address	Value	Designation
'Barton Towers', Seaforth Road	Positive*	N/A

Barton Towers is an elegant asymmetrical corner house. The three-storey house is mainly rendered with hanging tiles on the corner tower, part of the east elevation and the part of the gabled corner section that faces north-east onto Seaforth Road. The roof is mainly made of plain red tiles with an ogee Tudor style lead roof on the tower. The roof over the front part of the building, in front of the chimney of the Seaforth Road elevation, is of mansard profile. The remaining roof is pitched with dormer windows facing Seaforth Road. One tall and two smaller chimney stacks. There is a glazed triple arched veranda on the sea-facing elevation with a red plain tiled roof, which has probably been infilled from a veranda originally and is now not particularly in keeping. The main entrance is off Seaforth Road; the original timber doors have their original glass panels and a heavy ornamental surround with oversized classical features and scrolls. The building retains its garden and boundary wall facing Clifton Drive. There are various window shapes and designs, some of which are original and include a variety of sash and casement frames. The sash windows feature curved undersides to the top sash. The first floor French door on the south elevation appears to have been enlarged from the original.

There are several detracting features to the building (largely unsympathetic modern alterations):

- The building has suffered replacement of its some of fenestration with uPVC and the resulting coarser detailing of the frames detracts from the overall building, especially in the case of the clerestory window at the top floor of the corner tower.
- The building is in need of some maintenance work; the front veranda is in particularly poor condition with peeling paintwork exposing the timber beneath.
- The Seaforth Road elevation has lost its original boundary and features low timber paling instead.

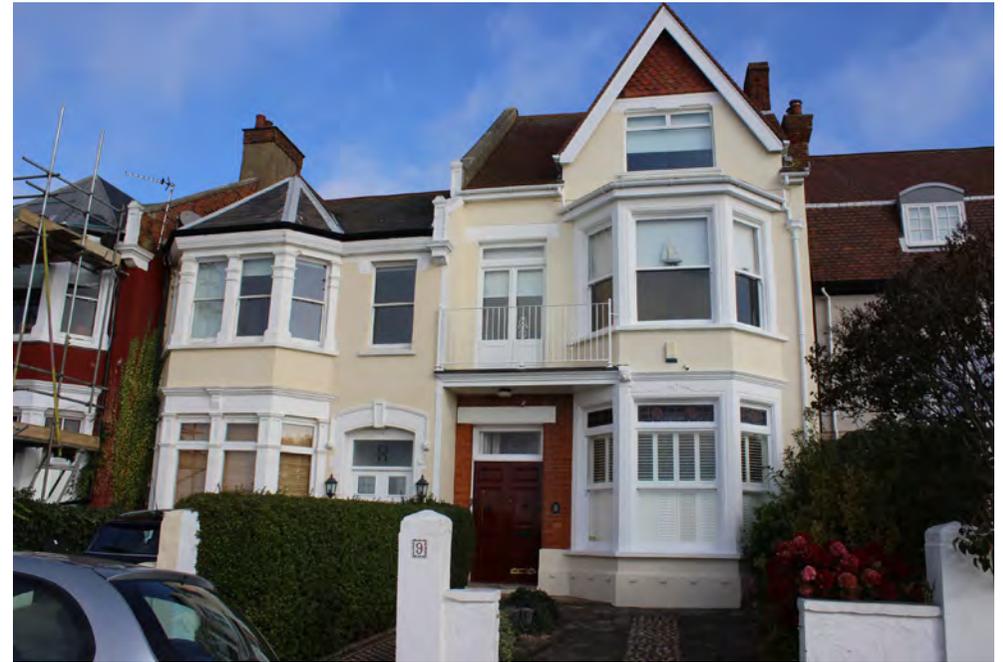
A tall house of two storeys plus an attic level. The house is two bays and mostly rendered apart from around the front door. The red roof tiles survive, as do the hanging tiles that decorate the gable. One small chimney stack on the east. To the right of the door is a double-height canted window topped by a gable with a smaller window. Above the door at first floor level is a pair of French windows with a metal balcony. The timber double door entrance has a fanlight above. The windows are timber sash windows and stained glass panels remain on the ground floor bay window but there is no evidence of them elsewhere. There is a front garden with planting and a fine example of an original tiled front path, all enclosed by an original boundary wall.

There have been a couple of minor modern alterations to the house:

- Part of the garden has been sacrificed for car parking, though some of the front boundary survives as well as garden planting and therefore the driveway is a relatively sensitive integration.
- Modern metal balcony in front of first floor French windows.

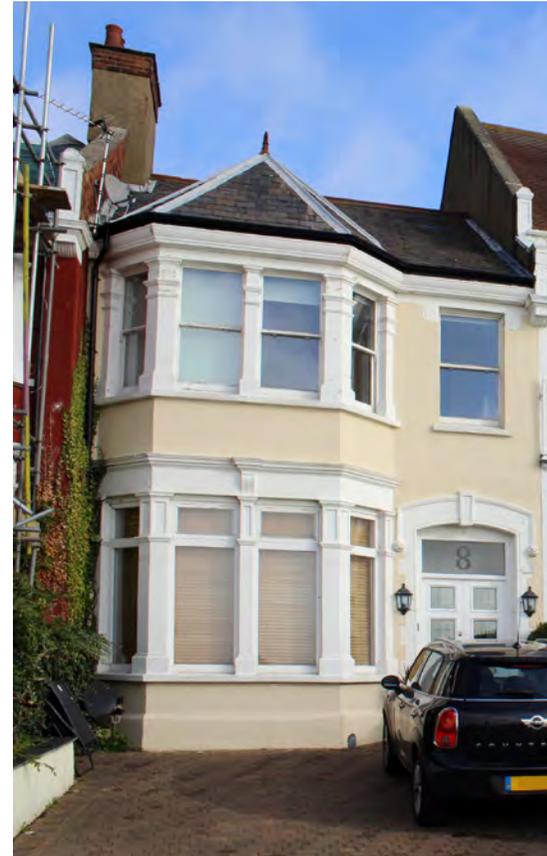
Address	Value	Designation
8 Clifton Drive	Positive	N/A

Small two storey, two bay house, which has cream rendered walls with white joinery and a slate roof. One shared chimney stack with No.7. The front is characterised by a double-height canted bay window. The mullions on all windows and timber joinery on the first floor have survived although the stained glass panels on the ground floor have been lost. The double front doors, and their hood mould, are an attractive feature.

There are several detracting features to the building (largely unsympathetic modern alterations):

- The front boundary has been lost and the front garden has been turned into hard standing with all soft landscaping eliminated. This is detrimental to the character of the Conservation Area and to the appearance of the building. However, it would be straightforward to reverse and would considerably enhance the appearance of the building.
- There is a satellite dish and TV aerial detracting from the overall appearance of the building.

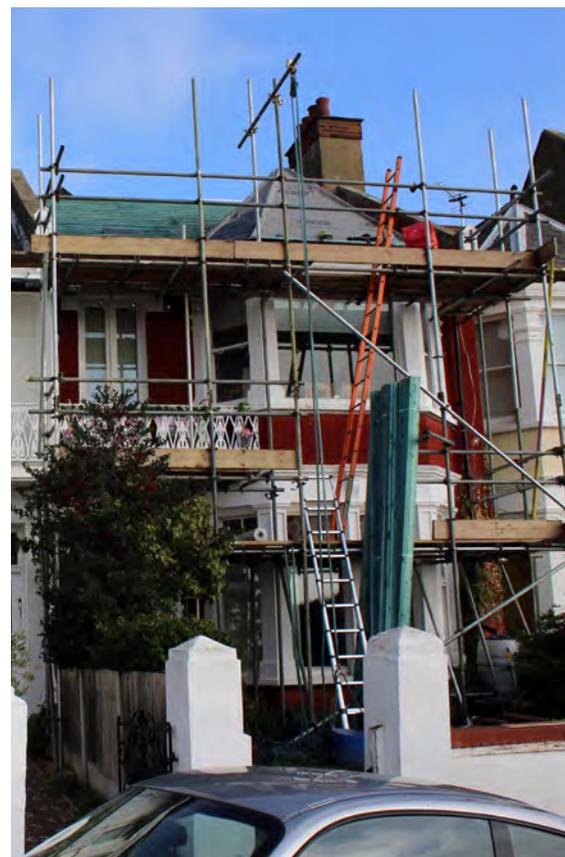
Address	Value	Designation
7 Clifton Drive	Positive*	N/A

Small two-storey, two bay house, with red painted brickwork and white joinery and a slate roof. One shared chimney stack with No.8. The front is characterised by a double-height canted bay window, most original mullions survive. The ground floor windows retain their stained glass panels. There are a pair of French windows with a white painted wrought iron balcony above the double front doors. The garden has survived along with part of the front wall, which contributes towards preservation of character in a greatly altered part of the Conservation Area.

There are several detracting features to the building (largely unsympathetic modern alterations):

- The red paint is uncharacteristic of the area.
- The central window on the first floor has lost its mullions which is inappropriate.
- On the ground floor the original stained-glass panels at the top of the windows remain but this positive feature is compromised by uPVC windows below, albeit an easily reversed change.

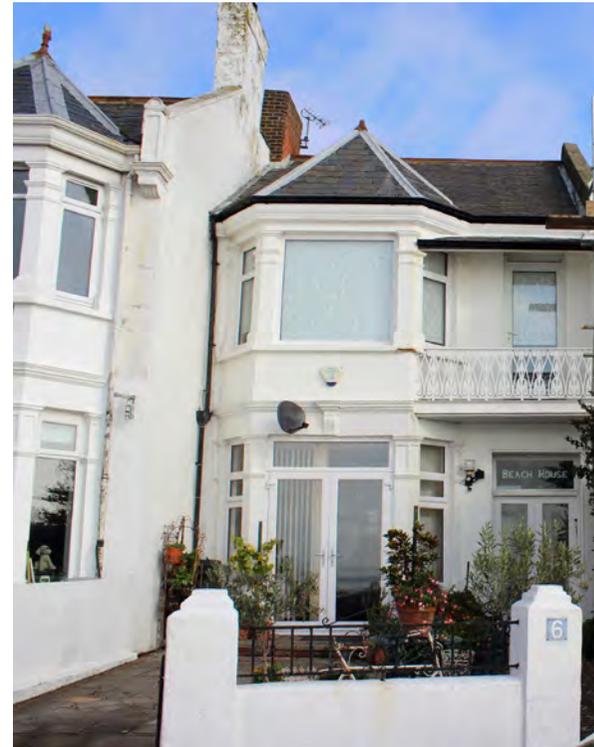
Address	Value	Designation
6 Clifton Drive	Positive*	N/A

There are several detracting features to the building (largely unsympathetic modern alterations):

- There are uPVC replacement windows throughout. These include a large picture window on the first floor bay which lacks glazing bars and is an overly large expanse of glazing for this period of building.
- The bay window has been extended down on the ground floor and unsympathetic uPVC patio doors inserted.
- There is a satellite dish on the front of the building, which is unsightly and should be relocated.
- Garden lawn and planting has been replaced with hardstanding for parking.

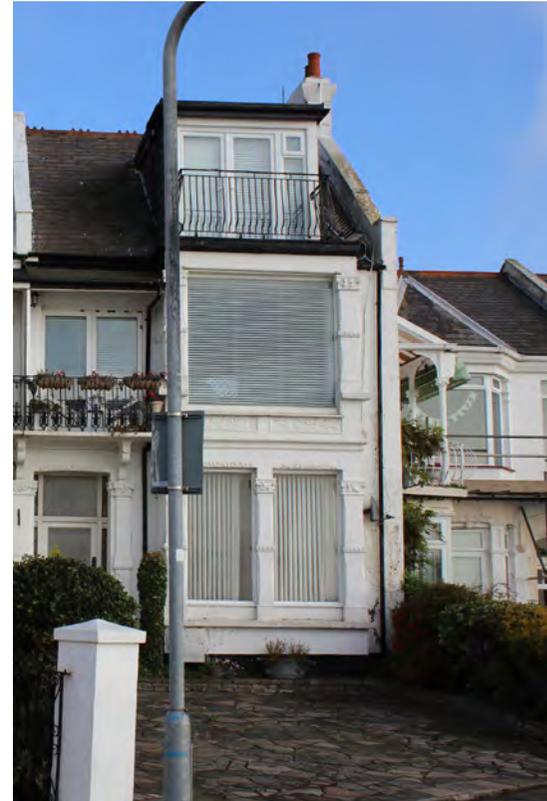
There are several detracting features to the building (largely unsympathetic modern alterations):

- The mullioned sash windows have been replaced by large picture windows, which adversely alter the character of the building, including the loss of the central mullion at first floor.
- The first floor cill to the bay window has been lowered, damaging the decorative panels between the first and ground floors.
- The first-floor balcony windows have been replaced with uPVC units.
- The pediment at the top of the rectangular double height bay has been replaced by large uPVC French doors, further eroding the original design.

- The house has lost its rough brick boundary wall and front garden, which is detrimental to the street as a whole.
- There is a satellite dish on the front of the building, which is unsightly and should be relocated.
- The render is in poor condition in places (on the east side of the front elevation).

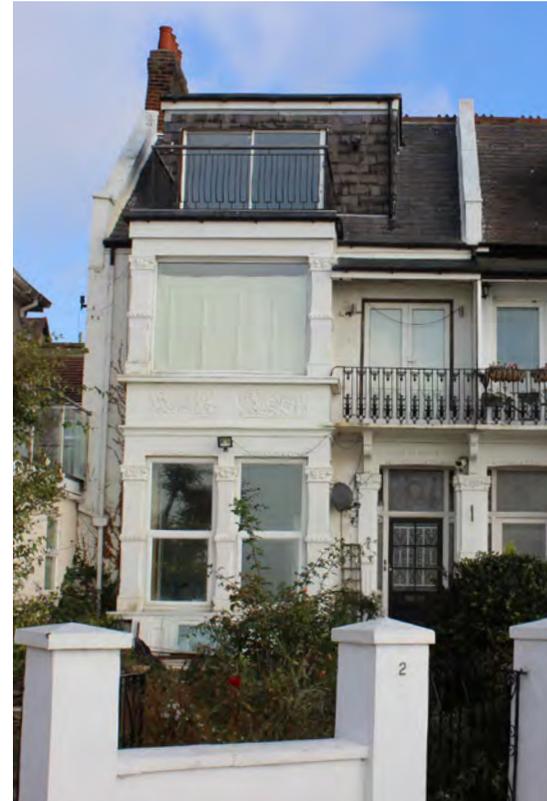
There are several detracting features to the building (largely unsympathetic modern alterations):

- The mullioned first floor windows have been replaced by large picture windows, which adversely alter the character of the building, including the loss of the central mullion.
- Ground floor sash windows replaced with uPVC top hung units.
- The first-floor balcony windows have been replaced with uPVC units.
- The pediment at the top of the rectangular double height bay has been replaced by an attic conversion lit by a large sliding patio door, eroding the remains of the original design still further.
- Whilst retaining part of its garden and part of its boundary wall, the garden is unkempt and features an untidy hardstanding for parking. It needs landscaping/ maintenance.
- There is a satellite dish on the front of the building, which is unsightly and should be relocated.
- The front elevation is marred by excess surface wiring.

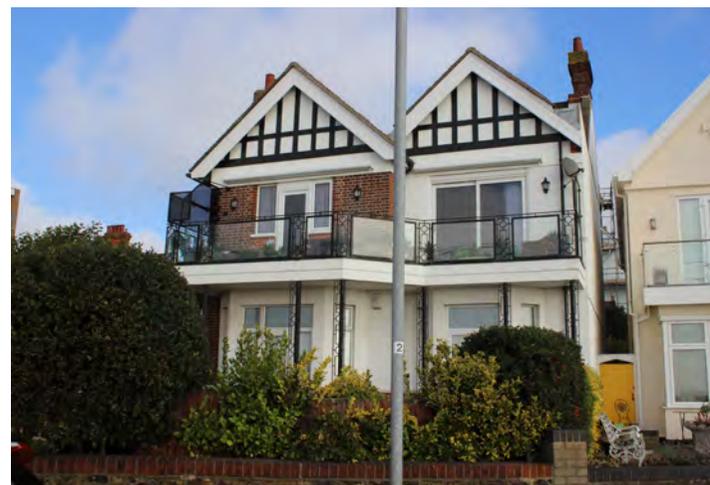
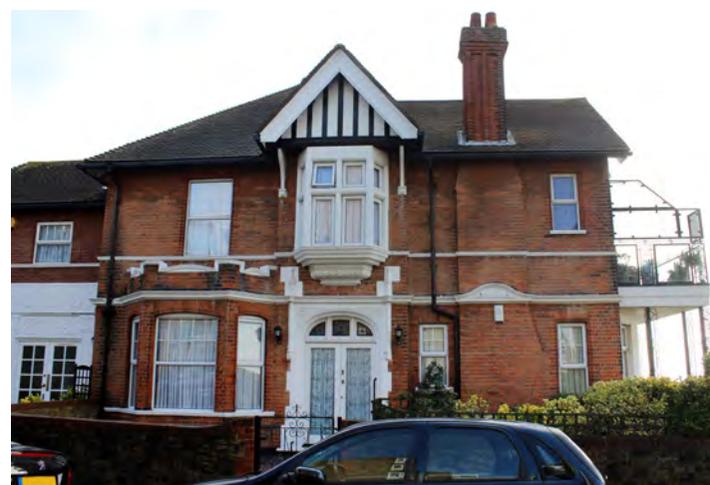
There are several detracting features to the building (largely unsympathetic modern alterations):

- The addition of a large glazed balcony across the whole of the first floor on the south elevation has resulted in the loss of the original crenellation to the left ground floor bay window.

- The balcony is accessed by sliding patio doors to the right and another door to the left of the front elevation, which has resulted in the loss of original details and features.
- The original windows have been replaced with insensitive uPVC units.

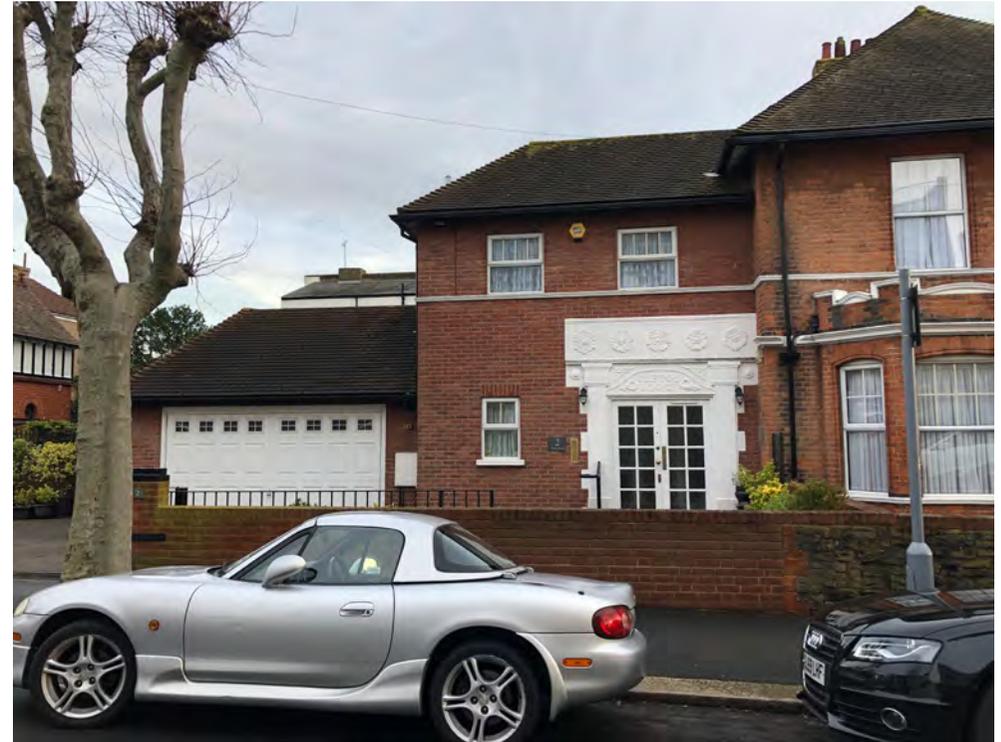
This building is situated behind No.2a and is built directly onto it. It is a relatively modern, low two-storey extension, which is not out of keeping with the street scene in general. The door surround integrates particularly well with the ornament to No.2a with the 'Clifton Lodge' inscription above the door and the moulded relief. The upper string course from No.2a is replicated across No.2. The building would benefit from traditional timber sash windows instead of uPVC units.

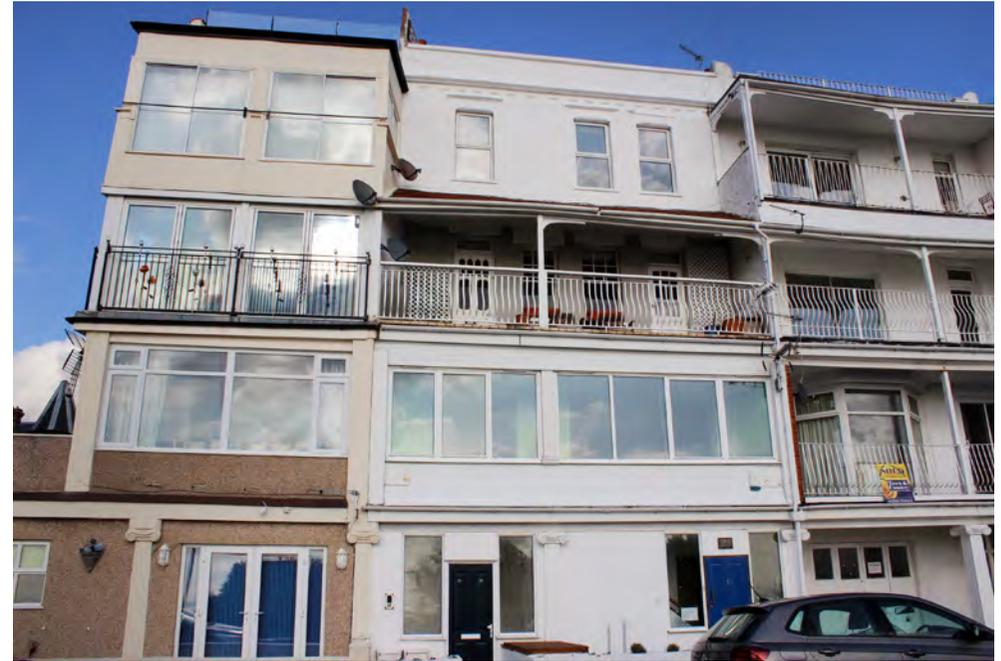
The building has undergone a number of unsympathetic changes:

- The windows have been completely replaced, mostly by large inappropriate uPVC units.
- All original ornamentation has been lost and the façade retains hardly any attractive features apart from the balconies.
- The first floor front elevation has been clad with uPVC horizontal boards with a strip of ribbon windows, completely obscuring the façade and the original building line.
- The white plastic rainwater goods are inappropriate for use in a Conservation Area.

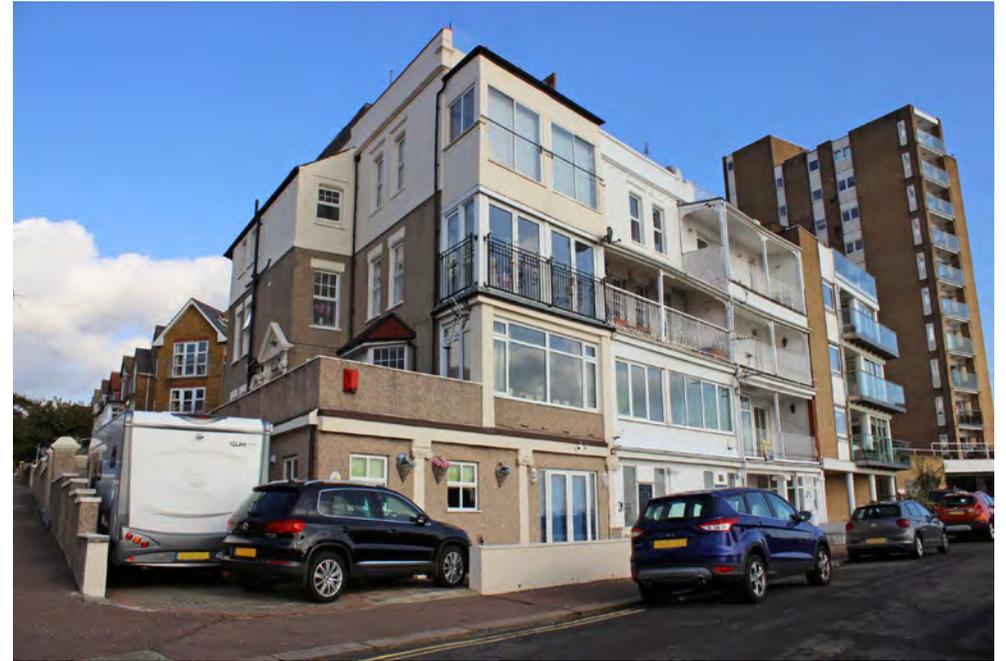
Most of this side of the house has been pebble-dashed, which is out of place with the predominant red brick and white detailing typical of the Area. This house retains some characterful decorative and architectural features including an imposing flight of stairs leading to the front double doors with an ornate door case decorated with ionic pilasters and a carved pediment. Beside the front door a stained-glass window survives with an ornate window case, although its decorative effect is somewhat reduced by piping above and beside it.

The building has undergone a number of unsympathetic changes:

- Replacement uPVC windows detract from the appearance of the building.
- The sea-facing façade appears to be completely modern, concealing a historic elevation beneath.

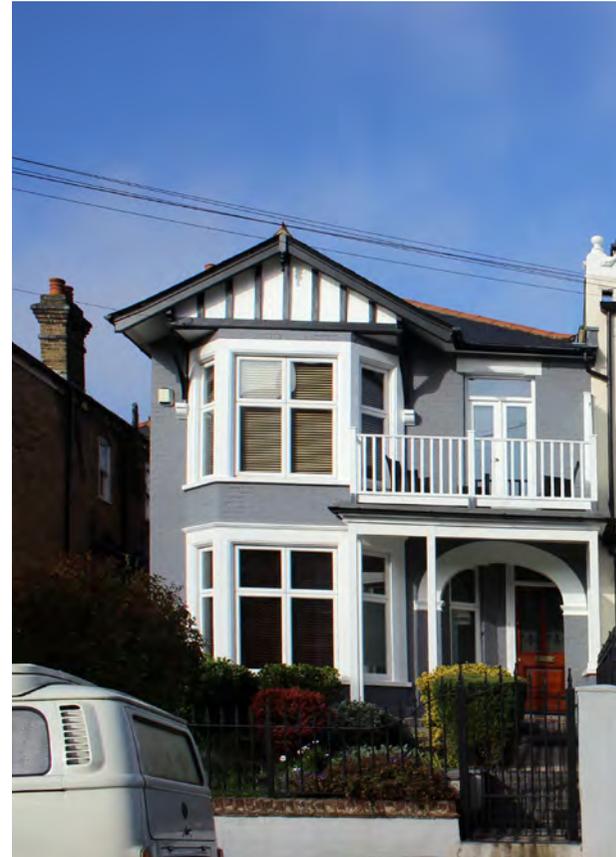
Address	Value	Designation
5 Palmerston Road	Positive*	N/A

Two-storey semi-detached house with double height canted bay with a gable end and finial above. The slate roof features two chimney stacks. An attractive, arched porch shelters the entrance and above this are French windows and a white-painted timber balcony. The front garden is well landscaped and extensively planted. An attractive porch defines the building and is in good condition.

The modern alteration which detracts significantly from the character of the house is the removal of traditional timber sash windows and replacement with uPVC units.

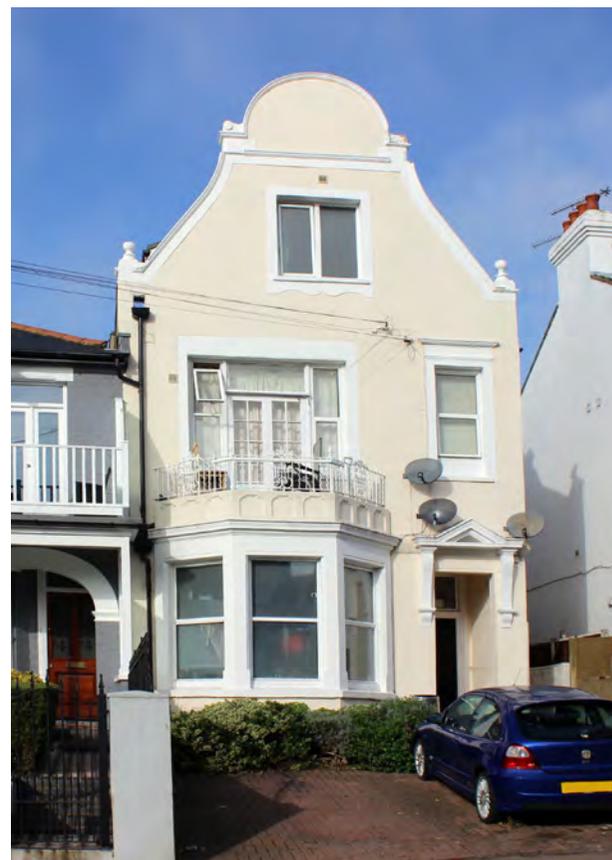
Address	Value	Designation
7 Palmerston Road	Positive*	N/A

There are a few detracting features to the building (largely unsympathetic modern alterations):

- The boundary wall has been lost and the front garden covered over with red brick, used for parking. The loss of the garden and boundary detracts from the character of the Conservation Area.
- There are three satellite dishes on the front of the building, which are unsightly and should be relocated.
- Surface wiring and cable wiring clutter the front elevation.
- uPVC window units have replaced all of the original timber sash windows.

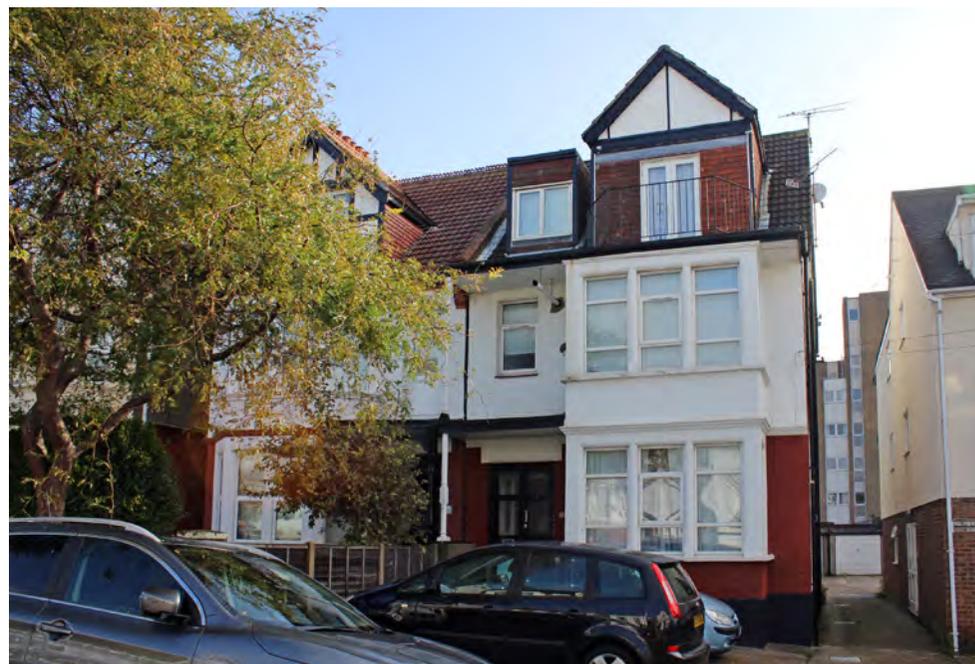
Address	Value	Designation
8 Palmerston Road	Positive*	N/A

There are a few detracting features to the building (largely unsympathetic modern alterations):

- The first-floor balcony has been lost, altering the original character and picturesque quality of the building.
- All windows have been replaced with uPVC window units.
- The roof features an intrusive flat-roofed dormer.
- The line of the eaves has been altered and there is a modern pipe inserted just below the eaves; its appearance is clumsy and its intrusion has damaged the render.
- The paintwork to the joinery is chipped in places or water-marked.
- The original roof tiles have been replaced with concrete tiles.
- There are unsightly satellite dishes and TV aerials visible from the front of the building; these should be rationalised.
- The front garden has been paved over like others in the street and would benefit from a more sympathetic use of materials and landscaping to enhance its impact on the streetscene.

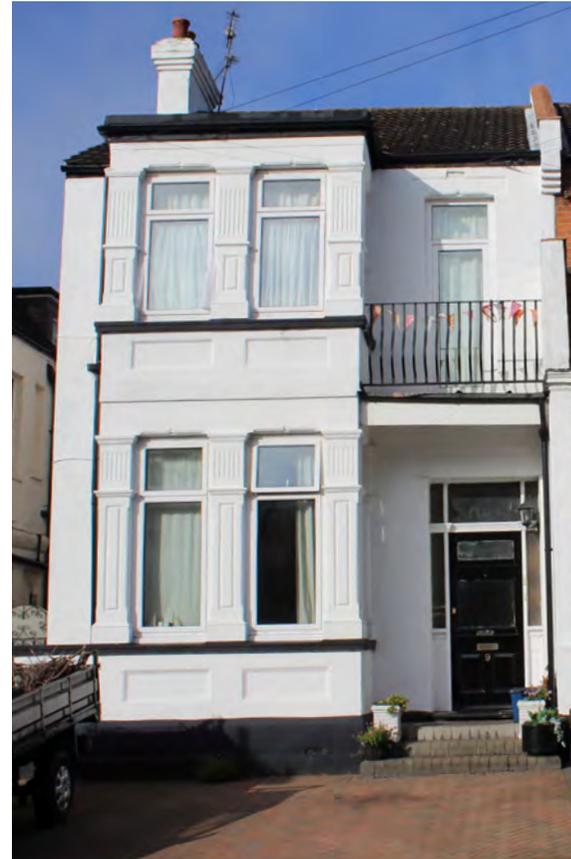
Address	Value	Designation
9 Palmerston Road	Positive*	N/A

The two-storey, two bay semi-detached property is in good condition. The walls are rendered and the roof has one chimney stack. Interesting features include the original front door and surrounding glazing and window surrounds, which feature moulded mullions (in keeping with the neighbouring property). There is a French window above the main entrance with a balcony (non-original).

There are a few detracting features to the building (largely unsympathetic modern alterations):

- The original windows have been replaced with uPVC.
- The front garden has been covered over and the boundary wall has been lost and would benefit from a more sympathetic use of materials, the reinstatement of the boundary wall and landscaping to enhance its impact on the streetscene.

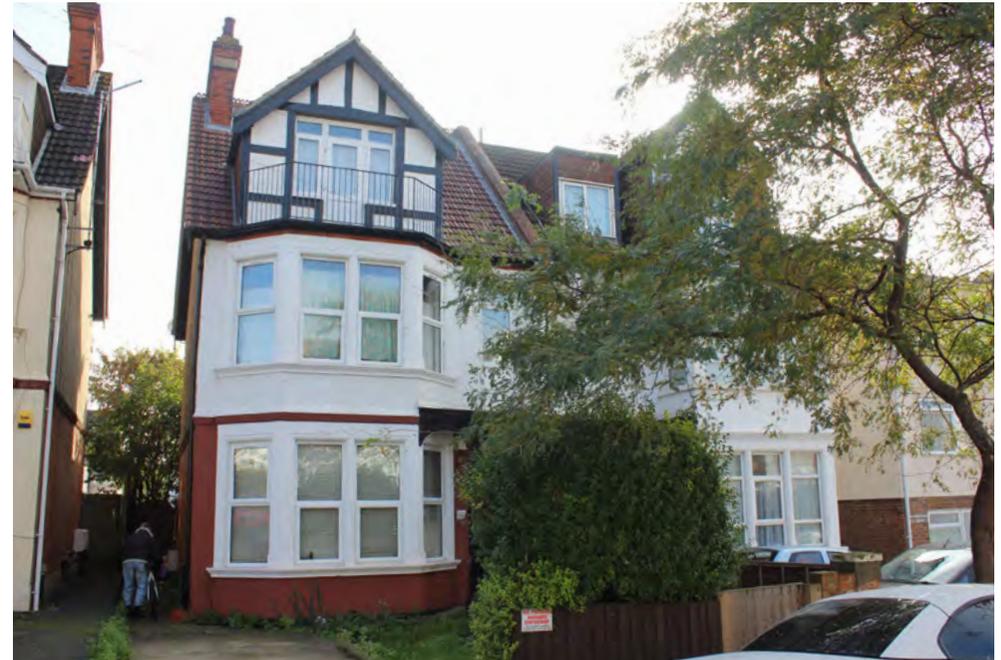
Address	Value	Designation
10 Palmerston Road	Positive*	N/A

There are a few detracting features to the building (largely unsympathetic modern alterations):

- The first-floor balcony has been lost, altering the original character and picturesque quality of the building.
- All windows have been replaced with uPVC window units.
- The original roof tiles have been replaced with concrete tiles.

- The front garden has been paved over like others in the street and would benefit from a more sympathetic use of materials and landscaping to enhance its impact on the streetscene.
- Like most of the properties in Palmerston Road, there is a concrete hardstanding to the frontage. It would benefit from the front garden being landscaped and reinstating the boundary wall would also enhance its quality.

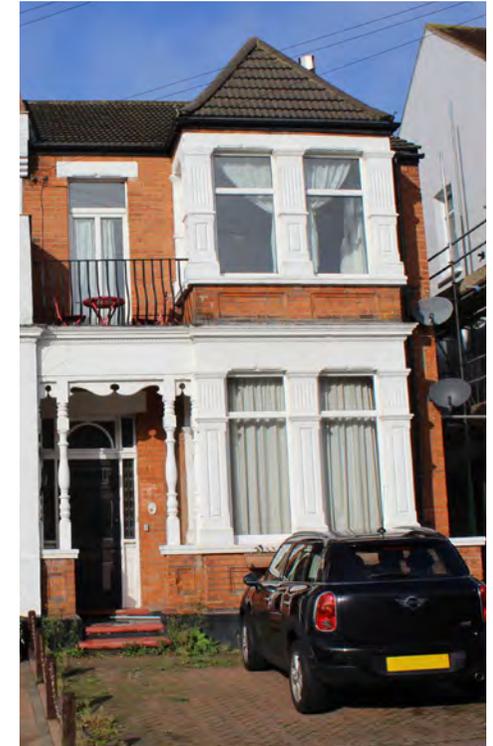
The two bay, two-storey semi-detached building, is in good condition. The walls are red brick and the joinery is painted white. Interesting features include the original front door, surrounding glazing and porch, supported on wooden columns.

There are a couple of detracting features to the building (largely unsympathetic modern alterations):

- Original windows have been replaced with uPVC units.
- The front garden has been covered over and the boundary wall has been lost; the hardstanding is overgrown with weeds. It would benefit from more sympathetic landscaping to enhance its impact on the streetscape.
- There are unsightly satellite dishes attached to the front elevation; these should be relocated.
- The original roof tiles have been replaced with concrete tiles.

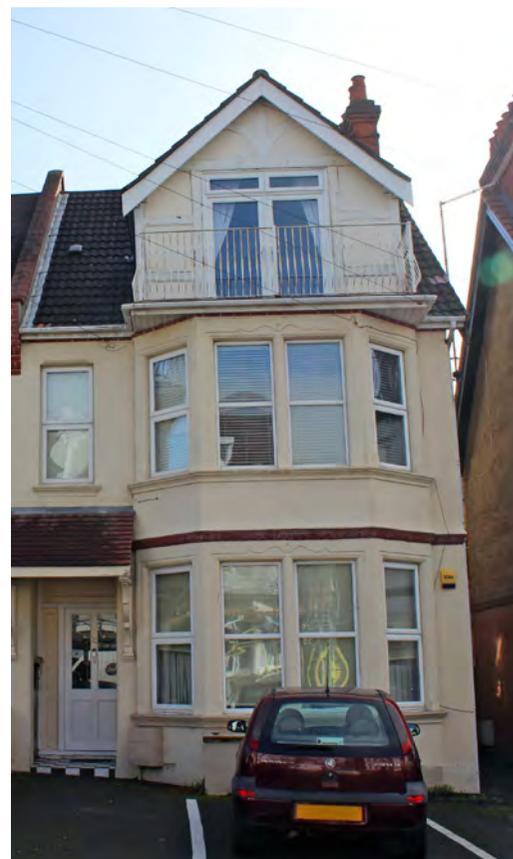
Address	Value	Designation
12 Palmerston Road	Positive*	N/A

There are a few detracting features to the building (largely unsympathetic modern alterations):

- All windows have been replaced with uPVC window units and a modern door has been added.
- The original roof tiles have been replaced with concrete tiles.
- Like most of the properties in Palmerston Road, there is a concrete hardstanding to the frontage. It would benefit from the front garden being landscaped and reinstating the boundary wall would also enhance its quality.
- The gabled dormer at the second floor is framed by a white painted metal balustrade, in need of some repainting.

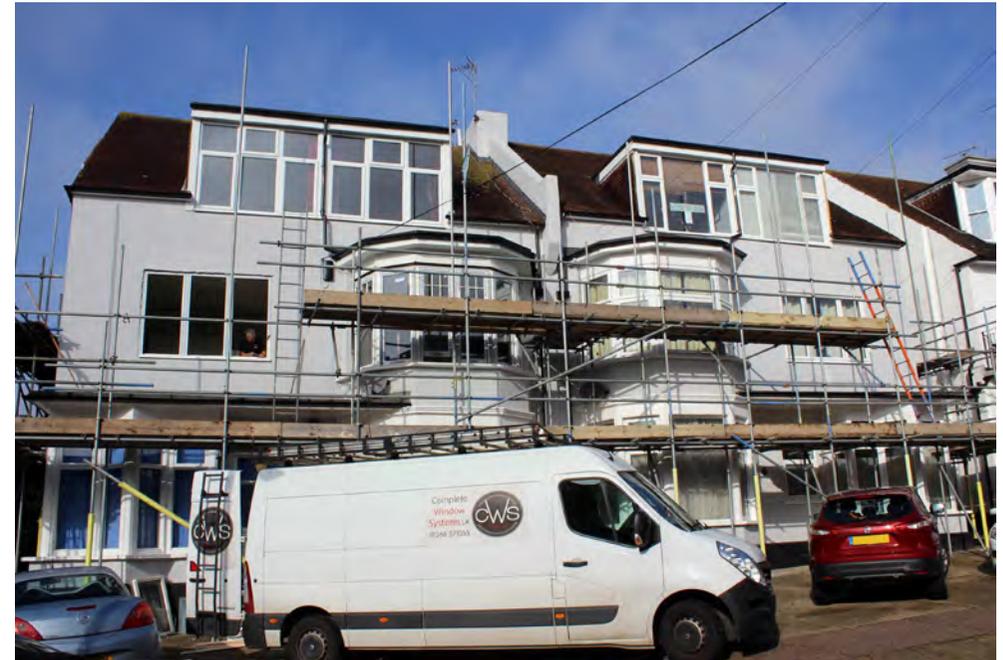
Address	Value	Designation
13–15 Palmerston Road	Neutral	N/A

The house has undergone substantial modern alterations which are generally unsympathetic:

- All original windows have been removed and replaced with uPVC units, though the proposals taking place are to install uPVC windows to the first floor which better match the original designs, which are sashes with small upper panes.
- The front garden area has been covered over with an unsympathetic surface material and the property would benefit from more sympathetic use of materials, the reinstatement of the boundary wall and better landscaping to enhance its appearance within the streetscape.
- The roofline has been altered by flat-roofed dormer extensions.

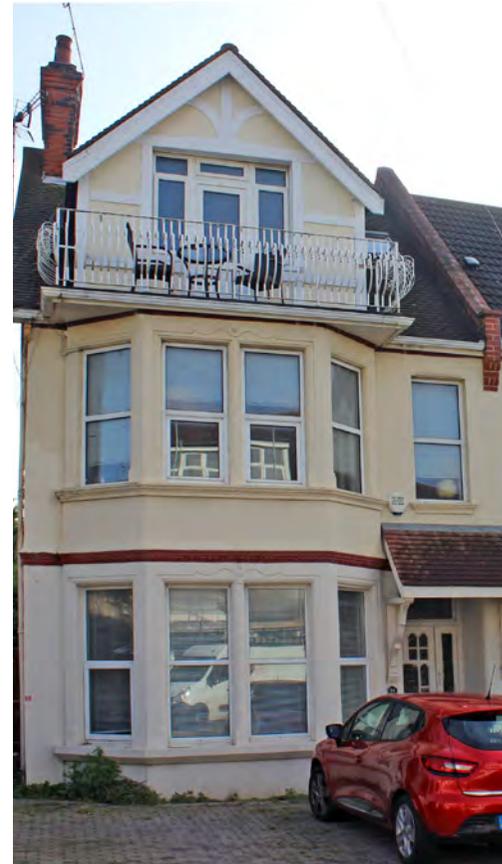
Address	Value	Designation
14 Palmerston Road	Positive*	N/A

The three-storey semi-detached building features a double-height canted bay window. The brick materiality has been rendered. No.14 and No.12 share a porch with a tiled pitched roof. The dormer has half-timbering at the front and hung-tile cladding at the sides, a gable roof and a balcony with iron railings. There is an egg and dart moulding above the ground floor windows. There is one chimney stack. The original front door appears to have been retained and is an attractive feature with its stained, patterned glazing. Original decorated glazed ceramic wall tiles have also been retained within the porch, as at No.12 Palmerston Road, although several are missing and would benefit from restoration.

There are a few detracting features to the building (largely unsympathetic modern alterations):

- All windows have been replaced with uPVC window units and a modern door has been added.
- The gabled dormer at the second floor is framed by a white painted metal balustrade, in need of some repainting.
- The boundary wall has been lost and the front garden largely covered with concrete, in a poor state of repair. It would benefit from the front garden being landscaped and reinstating the boundary wall would also enhance its quality.

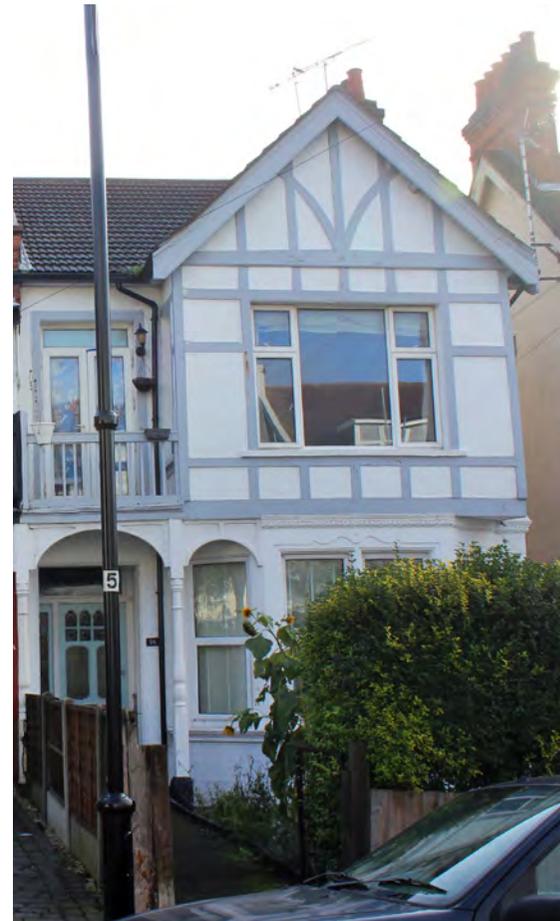
The building has a planted front garden and a fence and hedge boundary, which makes an attractive addition to the street.

Whilst the house is in good condition and has undergone few modern alterations, the original roof tiles have been replaced within concrete tiles and the modern uPVC windows are a detrimental feature.

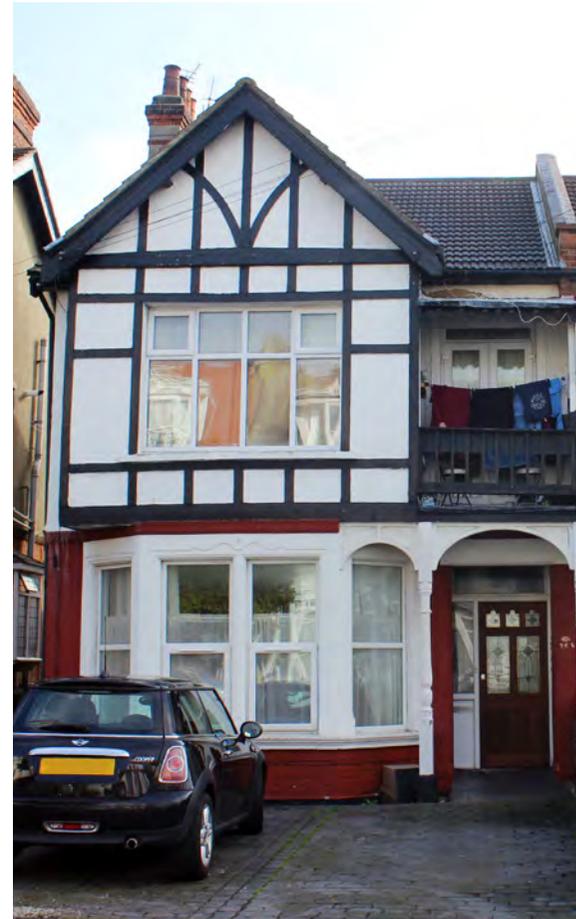
There are a couple of detracting features to the building (largely unsympathetic modern alterations):

- The windows have been replaced with uPVC units, which detract from the appearance of the building.
- The original roof tiles have been replaced with concrete tiles.
- The addition of a canopy above the first-floor balcony has caused damage to the render through water ingress.
- Untidy surface wiring detracts from the character of the building.
- The boundary wall has been lost and the front garden area concreted over and used for parking.

- It would benefit from the front garden being landscaped and reinstating the boundary wall would also enhance its quality.

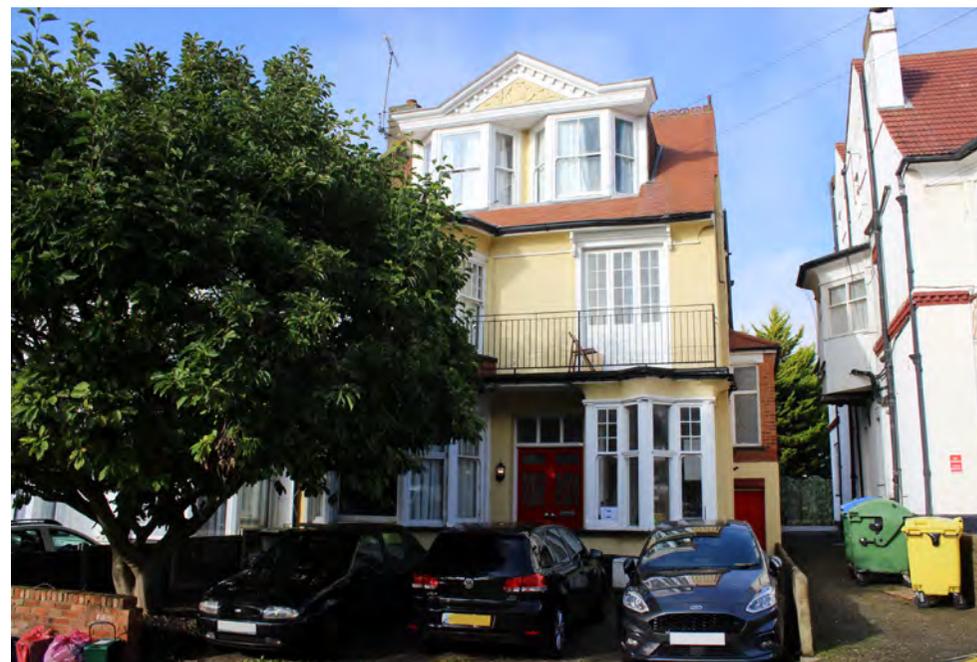
The house is in good condition and there are no major detracting features, except the boundary wall has been lost and the front garden area has been paved over for parking.

It would benefit from the front garden being landscaped and reinstating the boundary wall would also enhance its quality.

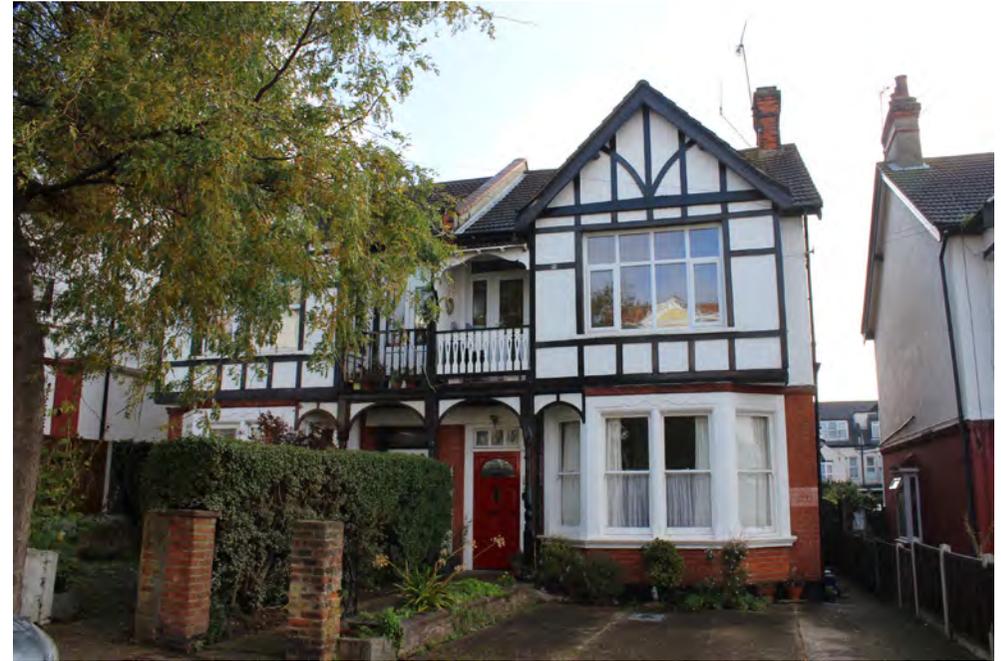
Address	Value	Designation
20 Palmerston Road, 'Hillcrest'	Positive*	N/A

There are a couple of detracting features to the building (largely unsympathetic modern alterations):

- The first floor windows and balcony door have been replaced with uPVC units, which detract from the appearance of the building.
- The original roof tiles have been replaced with concrete tiles.
- Whilst some planting remains at the base of the house and two brick gate pillars remain, the rest of the front garden has been concreted over for car parking and the boundary has been removed.

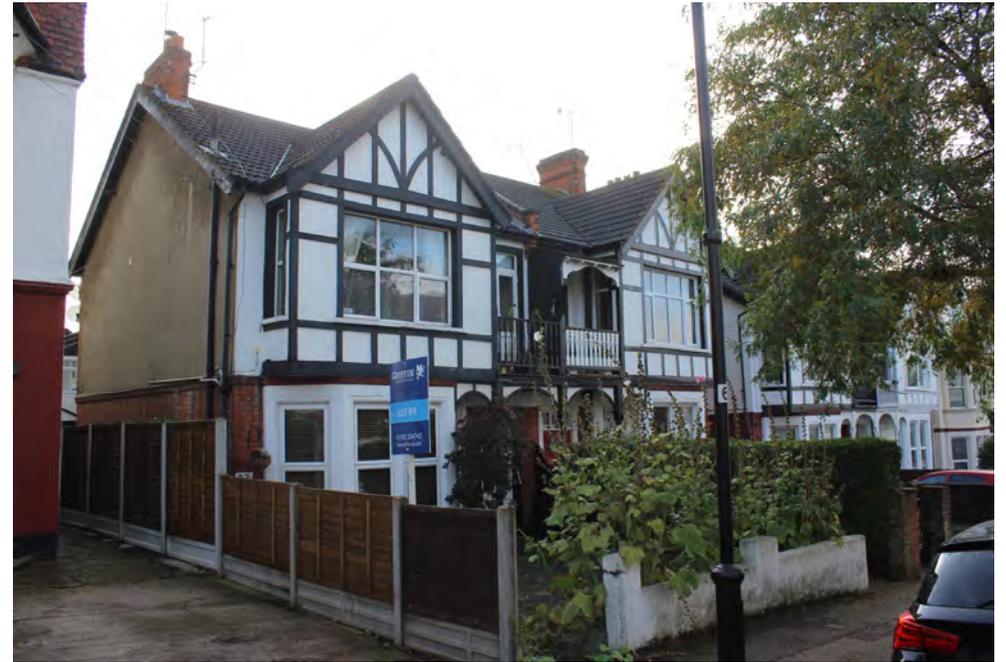
There are a couple of detracting features to the building (largely unsympathetic modern alterations):

- The windows have been replaced with uPVC units, which detract from the appearance of the building.
- The original roof tiles have been replaced with concrete tiles.
- The house retains a boundary wall.

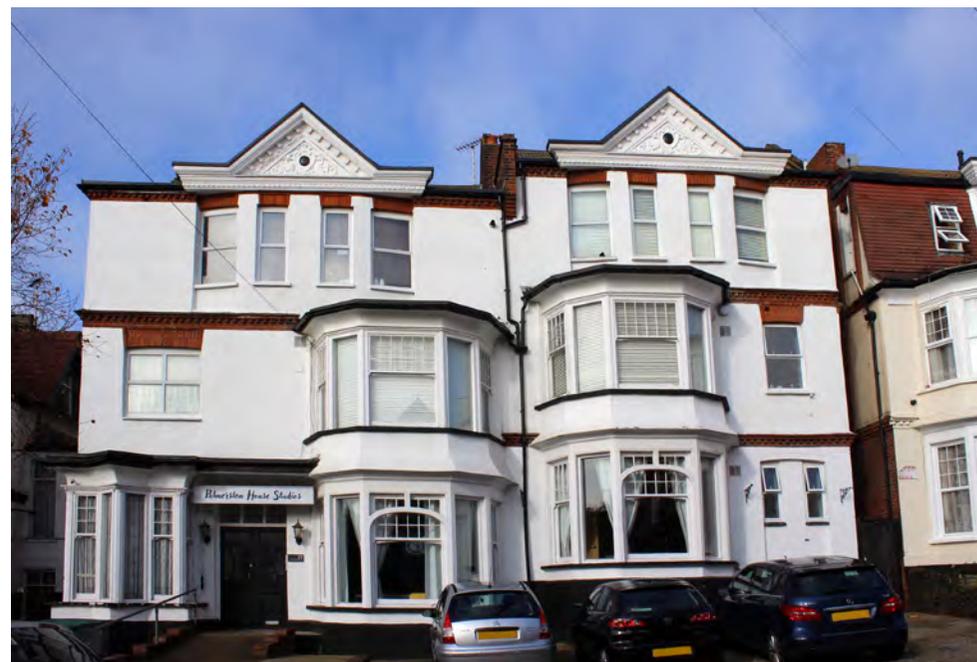
Address	Value	Designation
23–25 Palmerston Road. 'Palmerston House'	Positive*	N/A

There are a few detracting features to the building (largely unsympathetic modern alterations):

- There are a few uPVC window replacements, particularly at second floor level, as well as some of the smaller windows at ground and first floor level.
- Door to No.25 blocked up and two small windows inserted.
- Some of the paintwork to timber joinery is in need of maintenance.
- The area to the front of the property has been hard surfaced and is in use for off street parking. This has impacted on the appearance of the property, which, like others on Palmerston Road, would benefit from landscaping and the reinstatement of a boundary enclosure.
