The Leas Conservation Area Appraisal

Southend-on-Sea: The Leas Conservation Area Appraisal

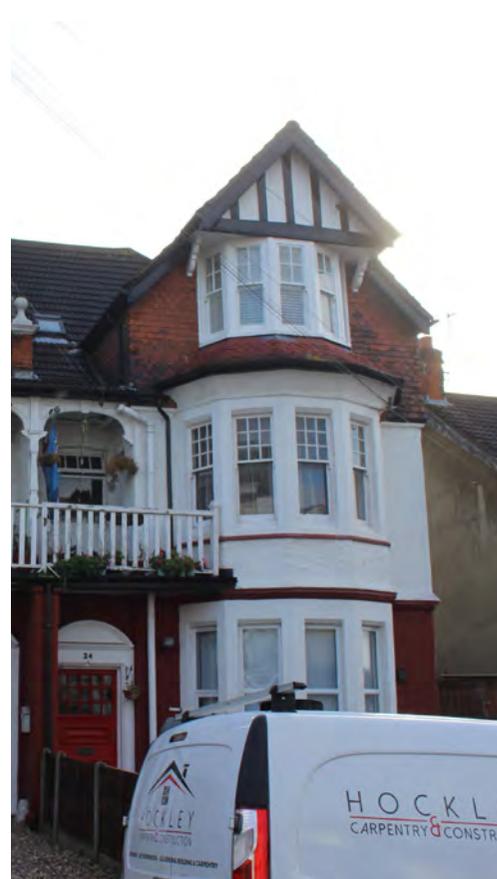
Address	Value	Designation
24 Palmerston Road	Positive – though would benefit from enhancement of unsympathetic changes detailed below	N/A

There are a few detracting features to the building (largely unsympathetic modern alterations):

- The uPVC window replacements at ground floor level detract from the character of the building.
- The original balcony door has been replaced with a window.
- The original roof tiles have been lost and replaced with concrete tiles.
- The property has been converted to flats and the front wall and garden have been lost to hardstanding. It would benefit from the front garden being landscaped and reinstating the boundary wall would also enhance its quality.
- The paintwork to the ornamental tiles and the joinery is in disrepair and needs maintenance.

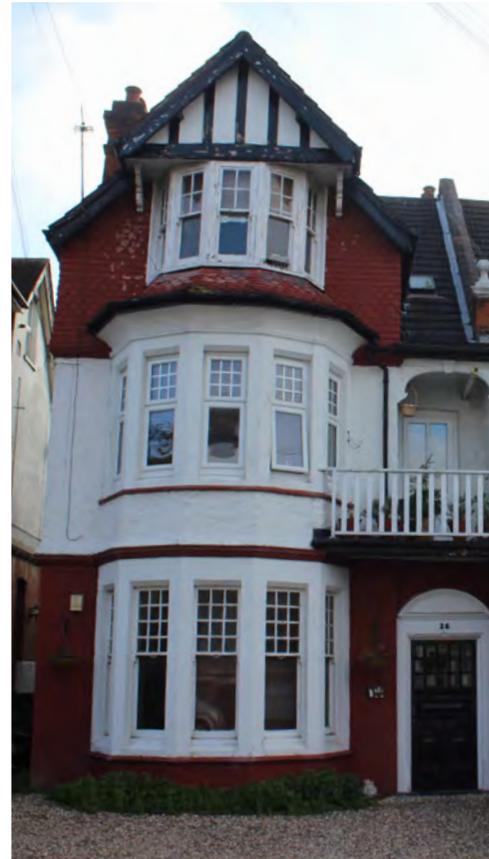
Address	Value	Designation
26 Palmerston Road	Positive – though would benefit from enhancement of unsympathetic changes detailed below	N/A

There are a few detracting features to the building (largely unsympathetic modern alterations):

- The uPVC window replacements at first floor level detract from the character of the building.
- The balcony doors have been replaced with uPVC units.
- The original roof tiles have been replaced with concrete tiles.
- The property has been converted to flats and the front wall and garden have been lost. It would benefit from the front garden being landscaped and reinstating the boundary wall would also enhance its quality.
- The paintwork to the ornamental tiles and the joinery is in disrepair and needs maintenance.

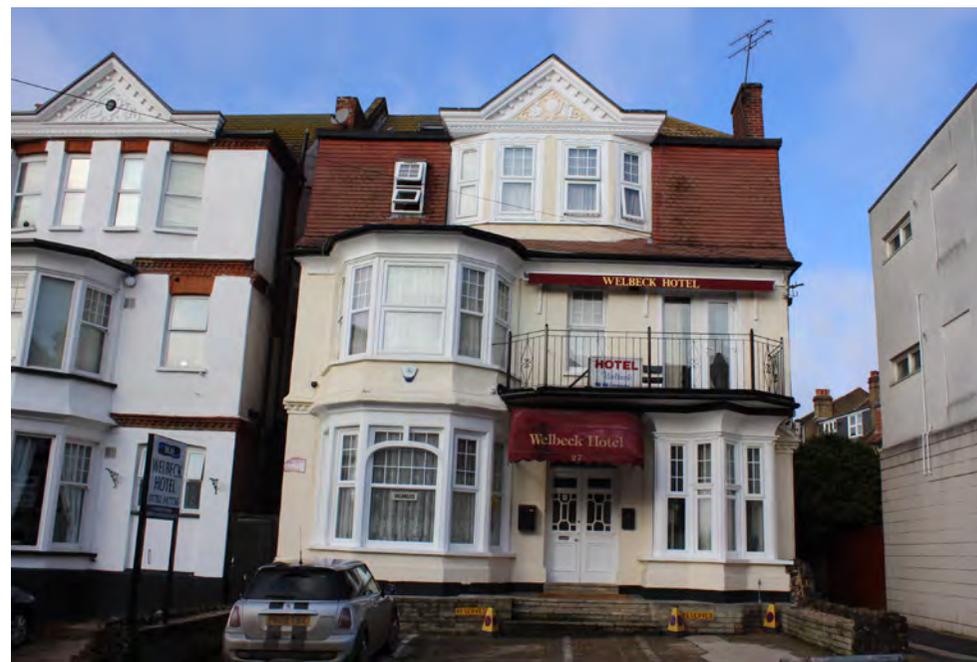
Address	Value	Designation
27 Palmerston Road, 'The Welbeck Hotel'	Positive*	N/A

There are a couple of detracting features to the building (largely unsympathetic modern alterations):

- Timber sash windows have been replaced with uPVC units.
- A small window has been added to the left of the dormer window.
- The area to the front of the property has been hard surfaced and is in use for off street parking. This has impacted on the appearance of the property, which, like others on Palmerston Road, would benefit from landscaping and the reinstatement of a boundary enclosure.
- The Dutch canopy over the main door is not in keeping.

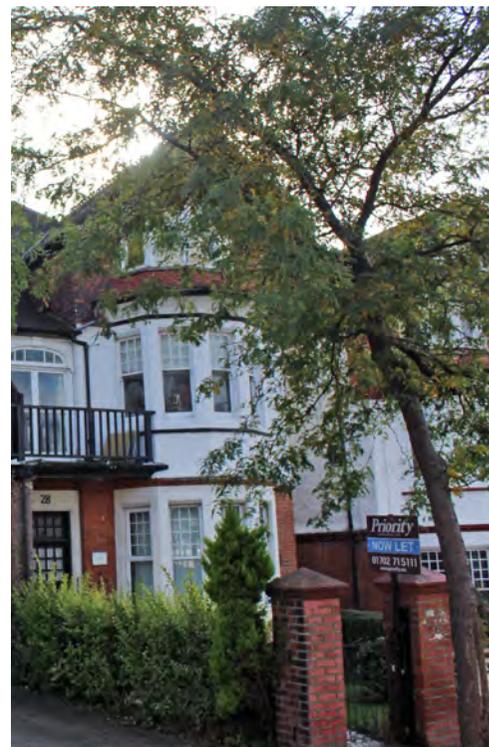
Address	Value	Designation
28 Palmerston Road	Positive – though would benefit from the replacement of uPVC windows and doors with timber	N/A

The building's character within the street scene is positive, due in part to the front garden and boundary wall. The wall defines the space well and planting in the front garden compliments the building, although is in need of upkeep. The original ceramic tiling with an asymmetric pattern lines the path to the front door. This is generally well preserved, aside from some weed growth, but would benefit from maintenance.

There are a few detracting features to the building (largely unsympathetic modern alterations):

- The uPVC window replacements at ground and third floor level detract from the character of the building.
- The balcony space has been enclosed with uPVC French doors.

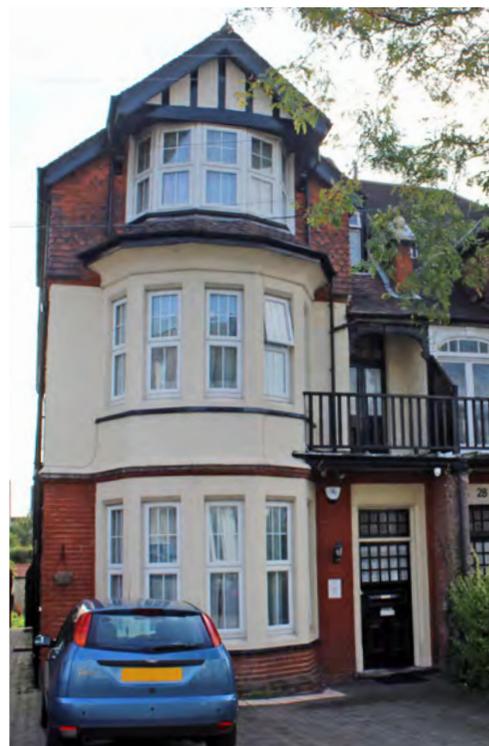
There are a few detracting features to the building (largely unsympathetic modern alterations):

- The uPVC window replacements of all windows detract from the character of the building.
- A small, modern dormer, with uPVC window has been added to the roof.
- The area to the front of the property has been hard surfaced and is in use for off street parking. This has impacted on the appearance of the property, which, like others on Palmerston Road, would benefit from landscaping and the reinstatement of a boundary enclosure

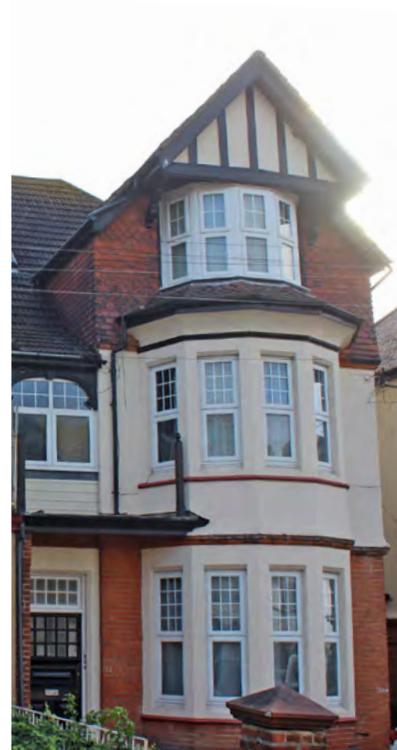
Address	Value	Designation
32 Palmerston Road	Positive*	N/A

There are a few detracting features to the building (largely unsympathetic modern alterations):

- The original sliding timber sash windows have been replaced with uPVC window units, which detract from the character of the building.
- The original roof tiles have been replaced with concrete tiles.
- The balustrade has been removed and the balcony partly infilled.
- The brick column in the roof between Nos.32 and 34 has lost its ball finial.

- The area to the front of the property has been hard surfaced and is in use for off street parking. This has impacted on the appearance of the property, which, like others on Palmerston Road, would benefit from landscaping and the reinstatement of a boundary enclosure.

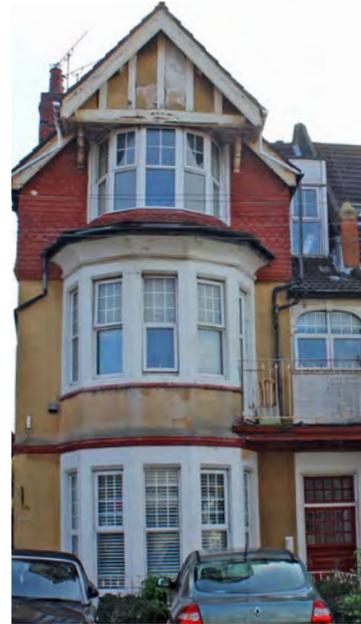
- The original sliding timber sash windows have been replaced with uPVC window units, which detract from the character of the building.
- The render is cracked and in poor condition and joinery needs repainting.

- A small dormer has been added above the balcony and is an unappealing addition.
- The original roof tiles have been replaced with concrete tiles.
- The balcony has been partly infilled and the railings are rusted.

- The brick column in the roof between Nos.32 and 34 has lost its ball finial.
- Satellite dishes/aerials are visible from the front of the house; these should be rationalised and relocated where possible.

- Excessive street cabling and surface wiring clutters the front elevation.
- The area to the front of the property has been hard surfaced and is in use for off street parking. This has impacted on the appearance of the property, which, like others on Palmerston Road, would benefit from landscaping and the reinstatement of a boundary enclosure.

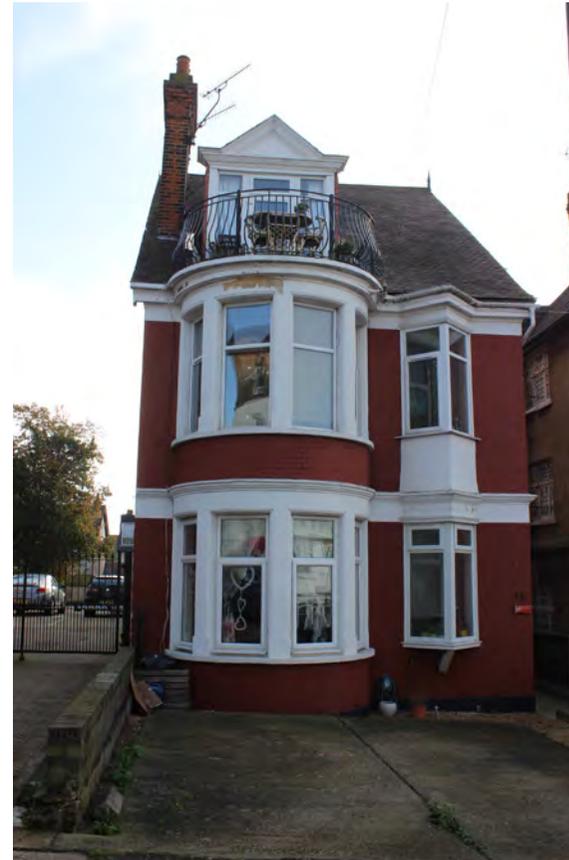
Address	Value	Designation
36 Palmerston Road	Positive*	N/A

There are a few detracting features to the building (largely unsympathetic modern alterations):

- The original sliding timber sash windows have been replaced with uPVC window units, which detract from the character of the building.
- The paintwork to the window surrounds is peeling and needs maintenance.
- The area to the front of the property has been hard surfaced and is in use for off street parking. This has impacted on the appearance of the property, which, like others on Palmerston Road, would benefit from landscaping and the reinstatement of a boundary enclosure.

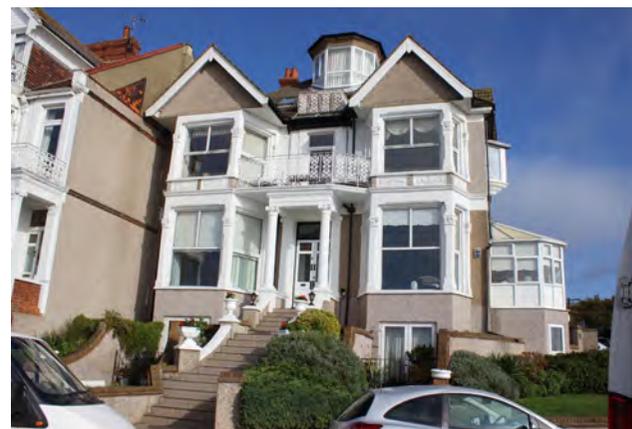
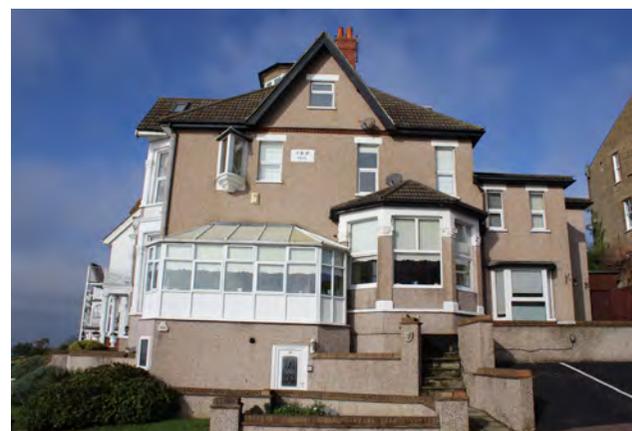
There are a few detracting features to the building (largely unsympathetic modern alterations):

- The pebble-dash render detracts significantly from the building's appearance.
- The original sliding timber sash windows have been replaced with uPVC window units, which detract from the character of the building.

- The original roof tiles have been changed to concrete.
- The uPVC conservatory on the Palmerston Road elevation is unsympathetic.
- Two satellite dishes are visible from Palmerston Road and should be relocated out of sight if possible.

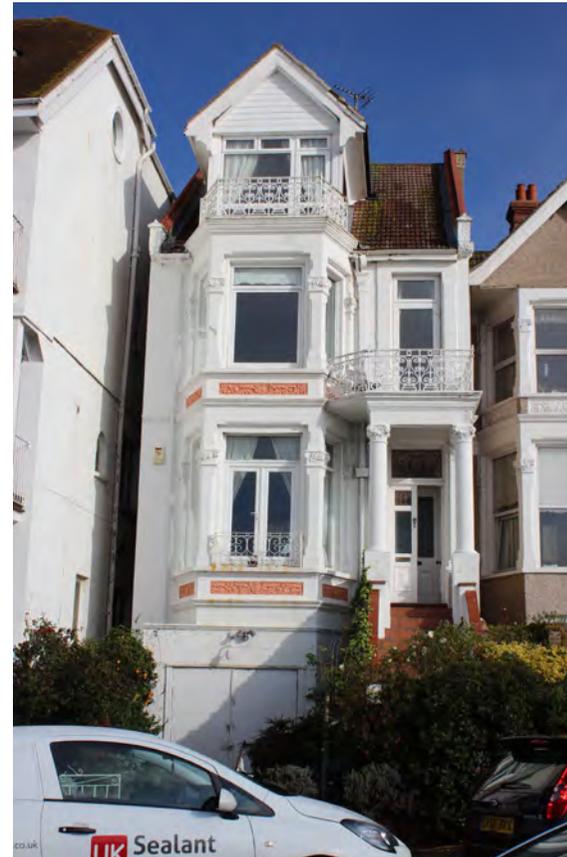
There are a few detracting features to the building (largely unsympathetic modern alterations):

- The original sliding timber sash windows have been replaced with uPVC window units, which detract from the character of the building.
- The original roof tiles have been replaced with concrete.
- Horizontal boards have inserted in the gable.
- The garage feature is unsympathetic and needs repainting and tidying.

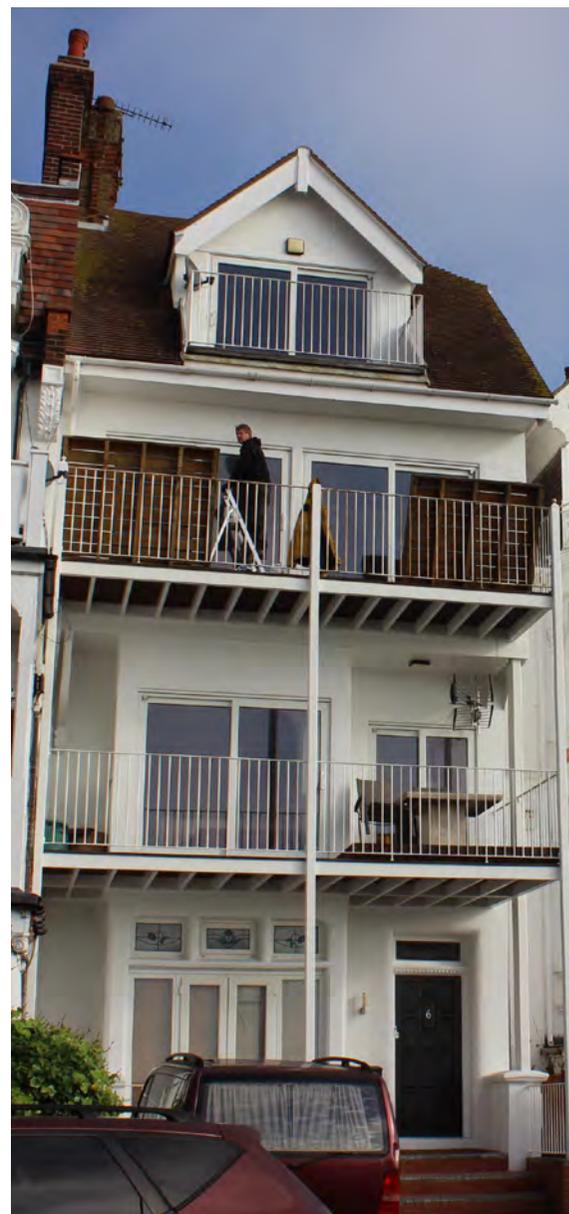
Address	Value	Designation
6 The Leas	Neutral	N/A

This house is a tall, narrow building of four storeys including an attic with a gable-roofed dormer window. The house is rendered white and has red roof tiles. There is a double-height square bay window. The house has been substantially altered, these alterations include:

- The original sliding timber sash windows have been replaced with uPVC window units, which detract from the character of the building.
- Balconies have been added to all three upper floors, which is out of character for the Area; their utilitarian style contrasts to historic ornate balconies elsewhere which are characteristic.
- The large sliding patio doors which have been installed to access the balconies on all floors are not in keeping with the smaller detailed, often highly decorative windows that are a prominent feature of the Area.
- The original front door has been lost.
- The house has lost its front boundary and garden to a concrete hard-standing, which is inappropriate and contributes towards the erosion of the character of the Conservation Area.

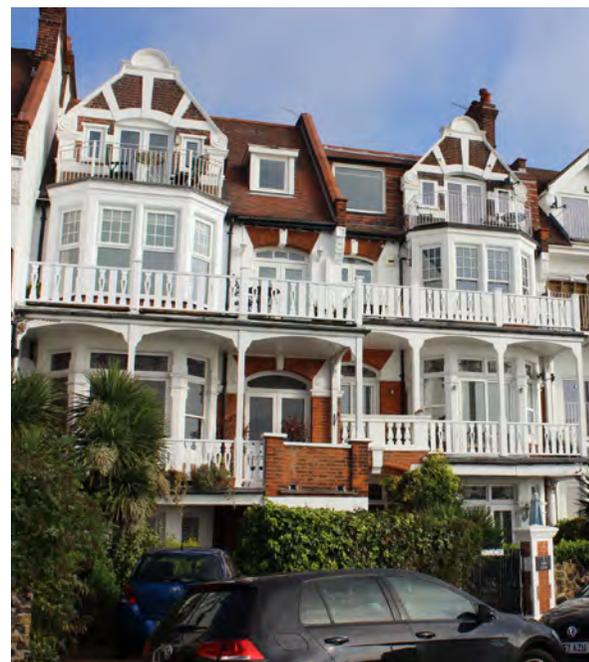
Address	Value	Designation
7 The Leas, 'Runnemede'	Positive – though would benefit from the replacement of unsympathetic features detailed below	N/A

The ground and first floor have ornamental white-painted timber balconies; the third-floor balconies are modern. Mansard roof added to the right-hand house with window to the side of the gable is out of keeping.

The character of the house within the streetscene is positive, having retained most of its rustic front wall apart from a gap to enable parking. The parking area is covered with gravel, which is a relatively sympathetic choice, but would benefit from more extensive planting.

There are a few detracting features to the building (largely unsympathetic modern alterations):

- Most of the original sliding timber sash windows have been replaced with uPVC window units, which detract from the character of the building.
- Doors are replacements.
- There are two unsympathetic, flat-roofed dormer windows in the roof, the eastern dormer forms part of an extension and hung tiles have been applied to the extension.
- Modern third floor balconies.

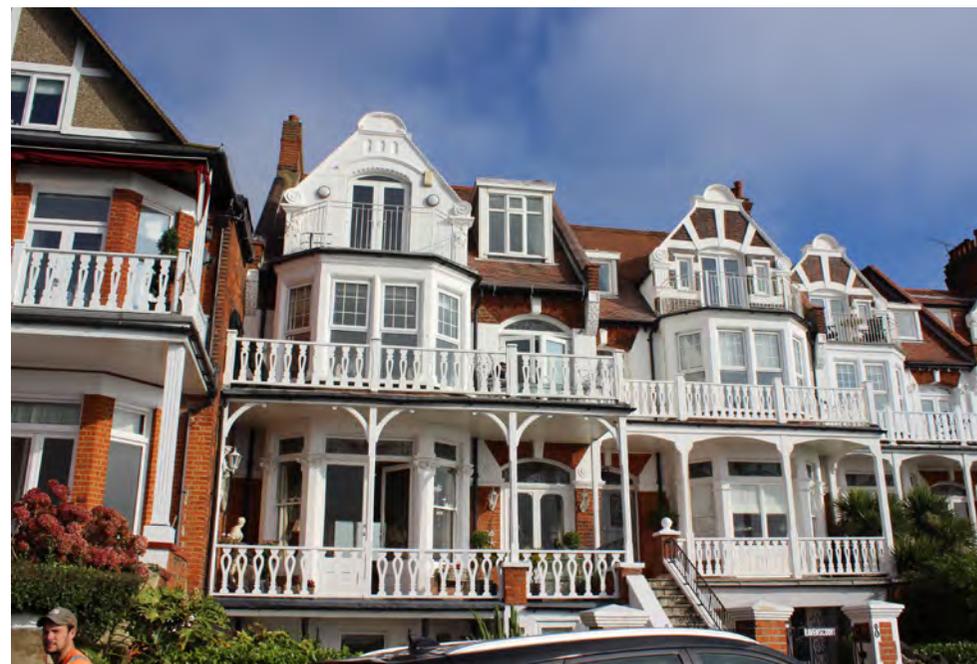
The ground and first floor have ornamental white-painted timber balconies; the second-floor balconies are modern. Large dormer window added to left-hand house detracts from the adjacent gable.

There are a few detracting features to the building (largely unsympathetic modern alterations):

- Most of the original sliding timber sash windows except those at ground floor level have been replaced with uPVC window units, which detract from the character of the building.
- There are two unsympathetic, flat-roofed dormer windows in the roof.
- Modern third floor balconies.

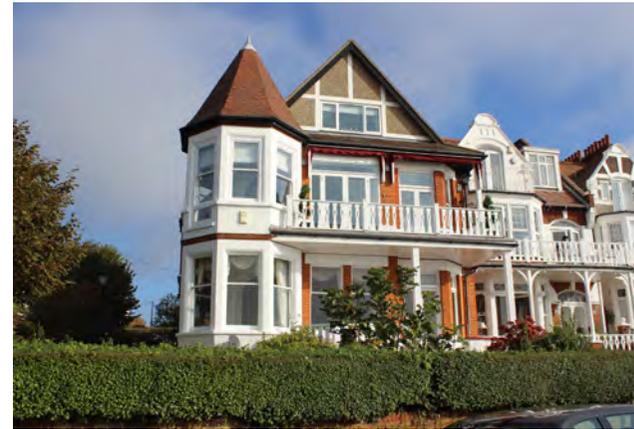
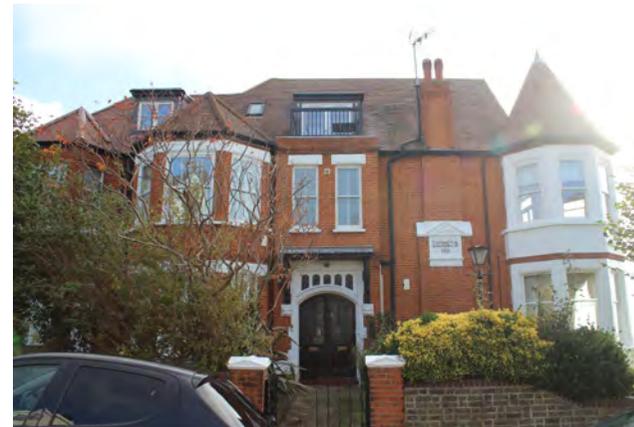
There are a few detracting features to the building (largely unsympathetic modern alterations):

- The replacements of certain timber sashes or French windows with uPVC units (first and second floor of Clifton Drive elevation).

- Whilst the bay extension is of sensitive design and materials, its flat roof is at odds with the style of the rest of the house.
- The flat-roofed dormers facing Pembury Road.
- The pebbledash render in the gable facing Clifton Drive.

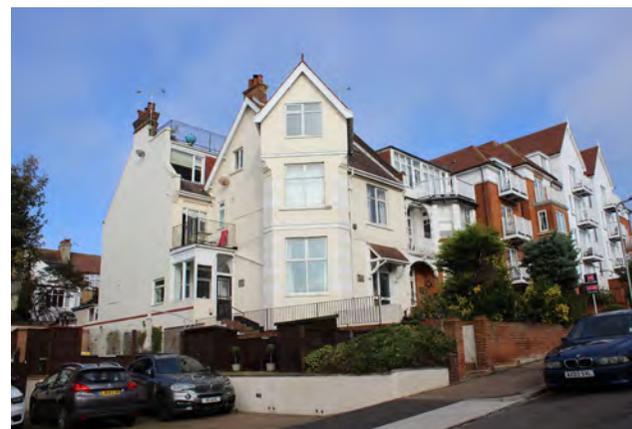
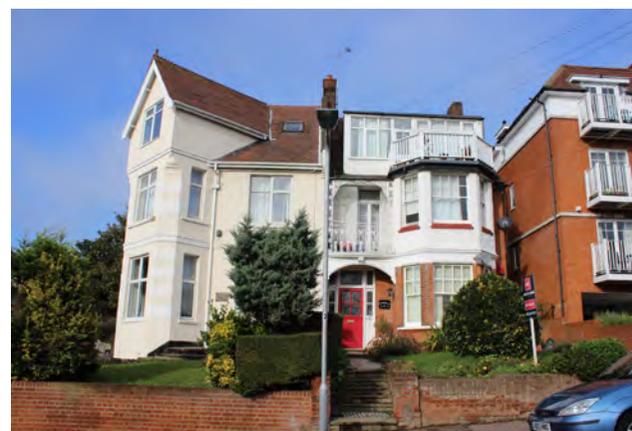
There are a few detracting features to the building (largely unsympathetic modern alterations):

- The almost wholesale replacements of timber sashes with uPVC units.
- The unattractive and excessively large flat-roofed dormer extension facing Pembury Road which contains a panel of uPVC windows and a door.

- A balcony with white painted timber balustrade has been created in front of the dormer, on top of the canted bay. This detracts from the aesthetic quality of the property's façade and is not in keeping with the ornate white iron balcony at the first floor.
- Several satellite dishes and TV aerials are visible from the street and these should be relocated where possible.

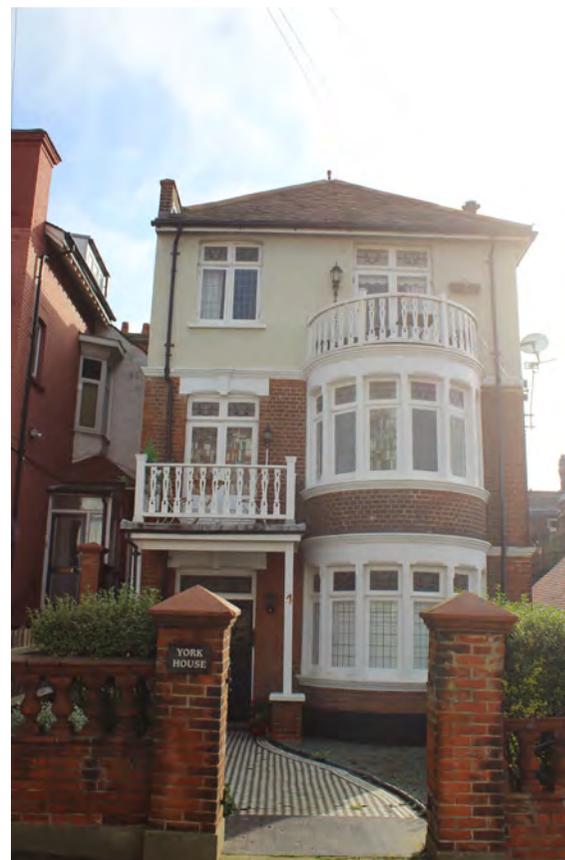
A red brick boundary wall with a balustrade and gate piers encloses a front garden. The garden is edged to one side by an original black and white tiled path of a geometric design that leads from the timber front gate to the original front door; the rest has gravel surfacing.

The only detracting feature is the satellite dish to the eastern side of the property, at second floor level.

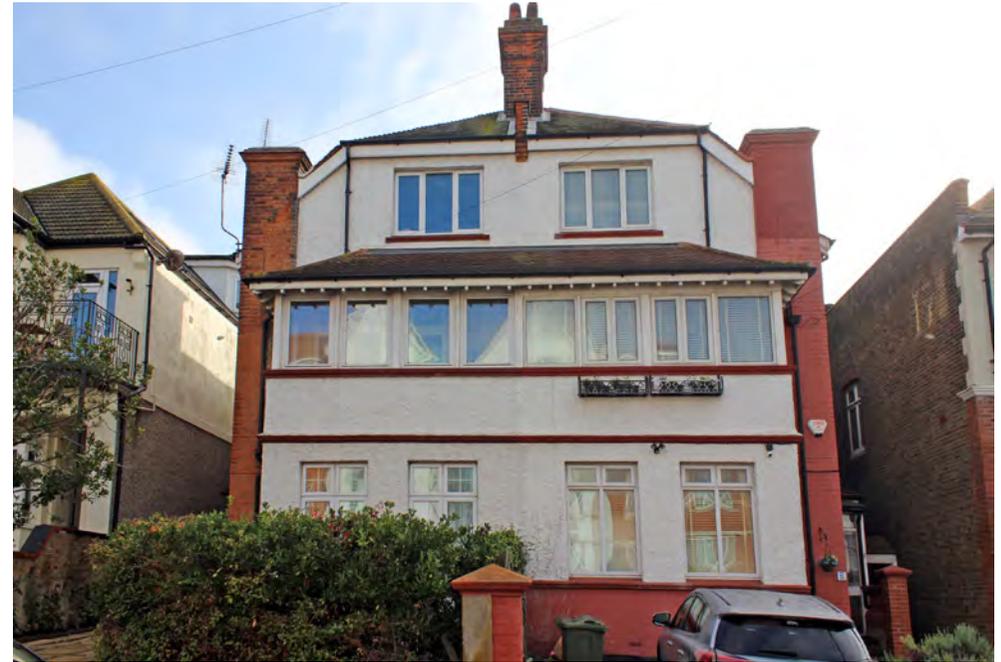
Address	Value	Designation
6–8 Pembury Road	Neutral	N/A

There are a few detracting features to the building (largely unsympathetic modern alterations):

- The fenestration has been dramatically altered and uPVC units have been used across the building.
- Small sections of boundary wall or hedge remain and some garden planting but the gardens and boundaries have largely been replaced by insensitive driveways.
- Cluttered TV aerials visible from the street.

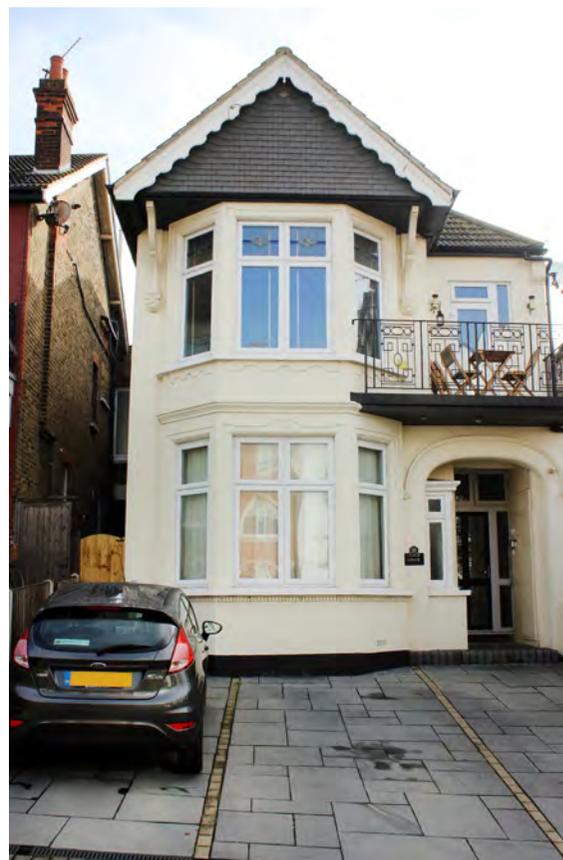
Address	Value	Designation
10 Pembury Road	Positive*	N/A

There are a few detracting features to the building (largely unsympathetic modern alterations):

- The original sliding timber sash windows have been replaced with uPVC window units, which detract from the character of the building.
- The balcony door has been replaced by a uPVC door.
- The fussy modern balcony is out of keeping with the traditional balconies in the Area.
- The original roof tiles have been replaced by concrete.
- The house has lost its front boundary and garden to hard-standing, which is inappropriate and contributes towards the erosion of the character of the Conservation Area.

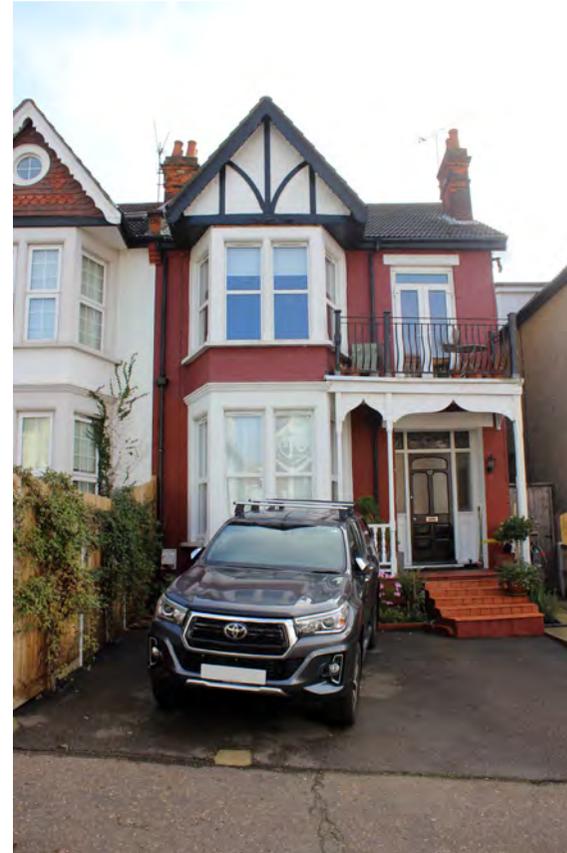
Address	Value	Designation
12 Pembury Road	Positive*	N/A

There are a few detracting features to the building (largely unsympathetic modern alterations):

- The original sliding timber sash windows have been replaced with uPVC window units, which detract from the character of the building.
- The original roof tiles have been replaced by concrete.
- The house has lost its front boundary and garden to hard-standing, which is inappropriate and contributes towards the erosion of the character of the Conservation Area.

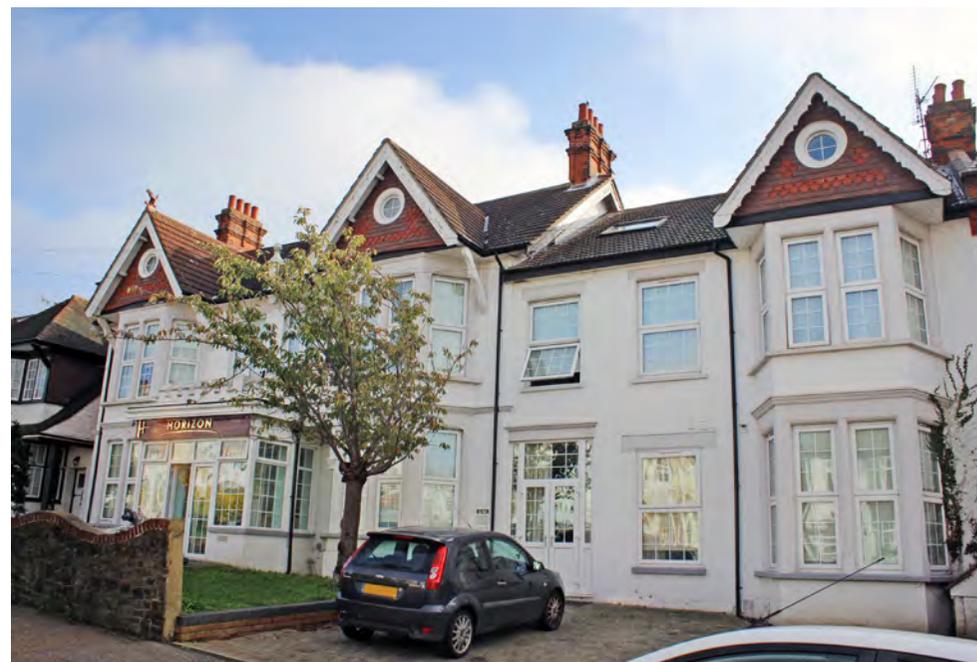
Address	Value	Designation
14 –18 Pembury Road. 'Horizon'	Positive*	N/A

The building has suffered from recent modernisation, detracting features include:

- The replacement of all sliding sash timber windows with particularly intrusive uPVC units, which detract from the character of the building. This has been carried out since the 2009 Appraisal.
- Porch to No.16 infilled with uPVC double doors.
- Large uPVC porch added to No.16/18.
- The original roof tiles have been replaced by concrete.
- The house has lost part of its front boundary wall and garden to hard-standing (in front of No.14), which is inappropriate and contributes towards the erosion of the character of the Conservation Area. It would benefit from the front garden being further landscaped and reinstating the lost part of the boundary wall would also enhance its quality.

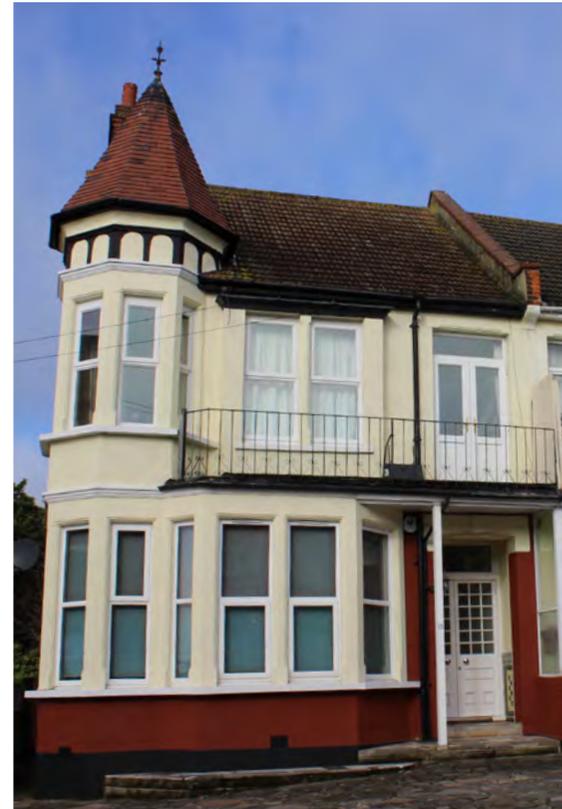
Address	Value	Designation
15 Pembury Road	Positive*	N/A

There are a few detracting features to the building (largely unsympathetic modern alterations):

- The replacement of all sliding sash timber windows with uPVC units, which detract from the character of the building.
- The balcony doors have been replaced with uPVC units.
- The joinery detail to the porch, found on neighbouring properties, has been lost.
- The modern balustrade to the balcony is not typical for the Conservation Area.
- The original roof tiles have been replaced by concrete.
- The house has lost its front boundary wall and garden to hard-standing, which is inappropriate and contributes towards the erosion of the character of the Conservation Area. It would benefit from the front garden being landscaped and reinstating the boundary wall would also enhance its quality.

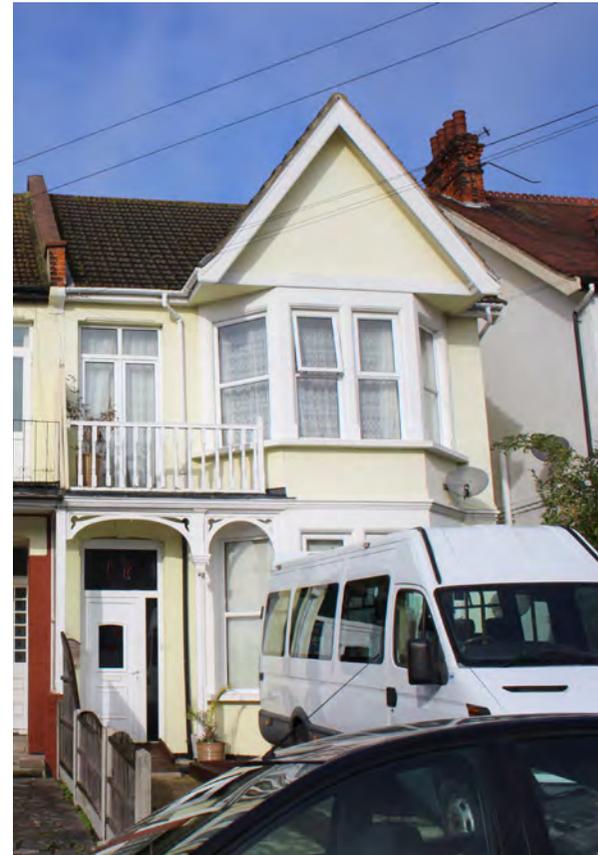
Address	Value	Designation
17 Pembury Road	Positive*	N/A

There are a few detracting features to the building (largely unsympathetic modern alterations):

- The replacement of all sliding sash timber windows with uPVC units, which detract from the character of the building.
- The original front door has been lost and porch infilled with uPVC unit.
- The balcony doors have been replaced with uPVC units.
- The original roof tiles have been replaced by concrete.

- The house has lost its front boundary wall and garden to hard-standing, which is inappropriate and contributes towards the erosion of the character of the Conservation Area. It would benefit from the front garden being landscaped and reinstating the boundary wall would also enhance its quality.

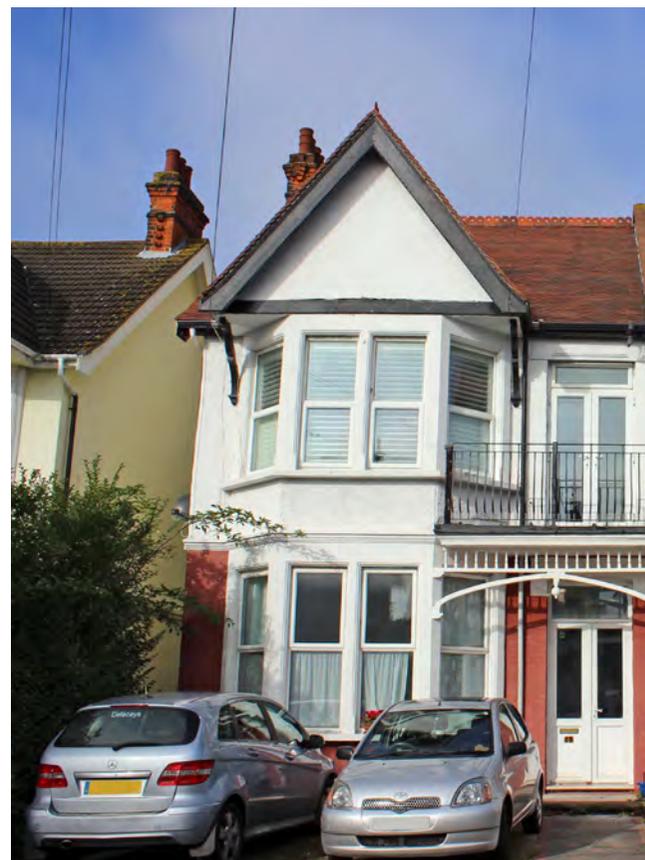
There are a few detracting features to the building (largely unsympathetic modern alterations):

- The replacement of all sliding sash timber windows with uPVC units, which detract from the character of the building.
- The original front door has been lost and replaced with uPVC.
- The balcony doors have been replaced with uPVC units.

- The house has lost its front boundary wall and garden to hard-standing, which is inappropriate and contributes towards the erosion of the character of the Conservation Area. It would benefit from the front garden being landscaped and reinstating the boundary wall would also enhance its quality.

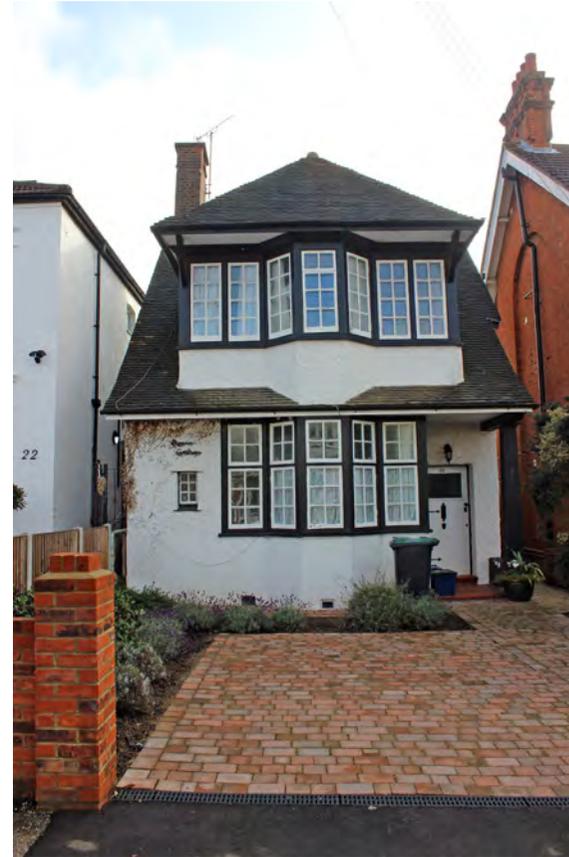
A detached property of two storeys with a ground floor bay window and a first-floor dormer with a similar bay arrangement and additional framing windows. The building is unique within the streetscene and recognised by Local Listing. The two storey building is reflective of the Arts and Crafts movement with its deep roofs and overhanging eaves. It was designed by Parker and Unwin in 1903, English architects and urban planners associated with the Arts and Crafts movement and garden cities phenomenon. Original features have been well retained such as the roof tiles, the multi-paned windows and timber door with glazed upper panel.

Whilst some planted beds remain, most of the garden has been lost to brick surface treatment for car parking.

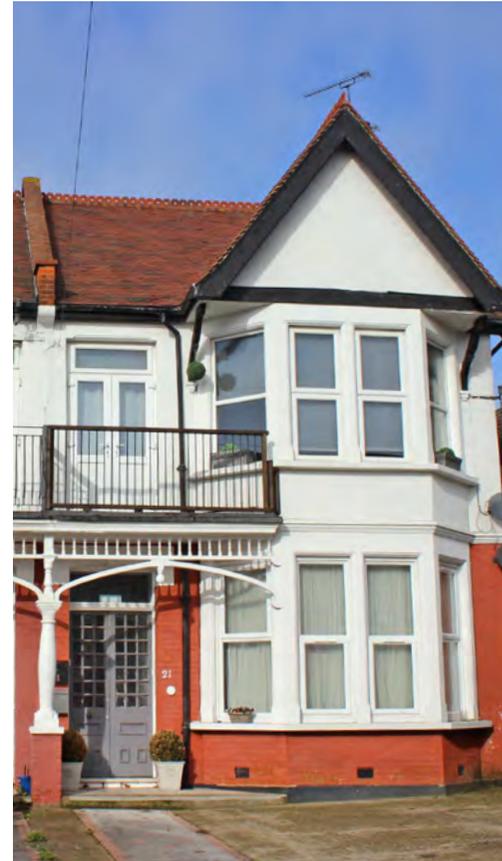
Address	Value	Designation
21 Pembury Road	Positive*	N/A

There are a few detracting features to the building (largely unsympathetic modern alterations):

- The replacement of all sliding sash timber windows with uPVC units, which detract from the character of the building.
- The balcony doors have been replaced with uPVC units.
- The house has lost its front boundary wall and garden to hard-standing, which is inappropriate and contributes towards the erosion of the character of the Conservation Area. It would benefit from the front garden being landscaped and reinstating the boundary wall would also enhance its quality.

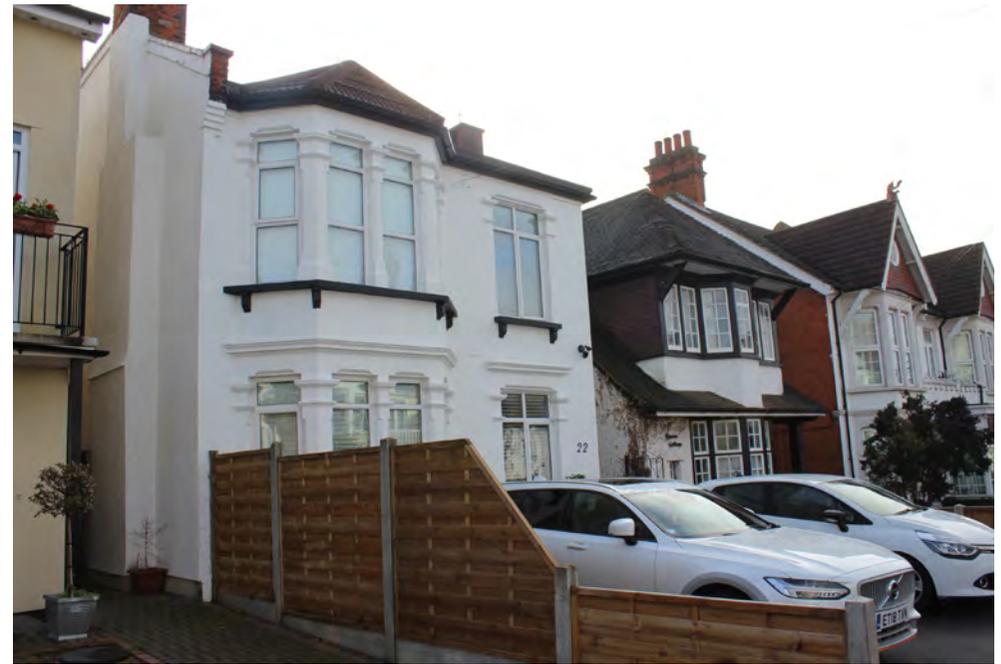
Address	Value	Designation
22 Pembury Road	Positive*	N/A

The building has suffered from recent modernisation, detracting features include:

- The replacement of all sliding sash timber windows with uPVC units, which detract from the character of the building.
- The original roof tiles have been replaced by concrete.
- The house has lost its front boundary wall and garden to hard-standing (in front of No.14), which is inappropriate and contributes towards the erosion of the character of the Conservation Area. It would benefit from the front garden being landscaped and reinstating the boundary wall would also enhance its quality.

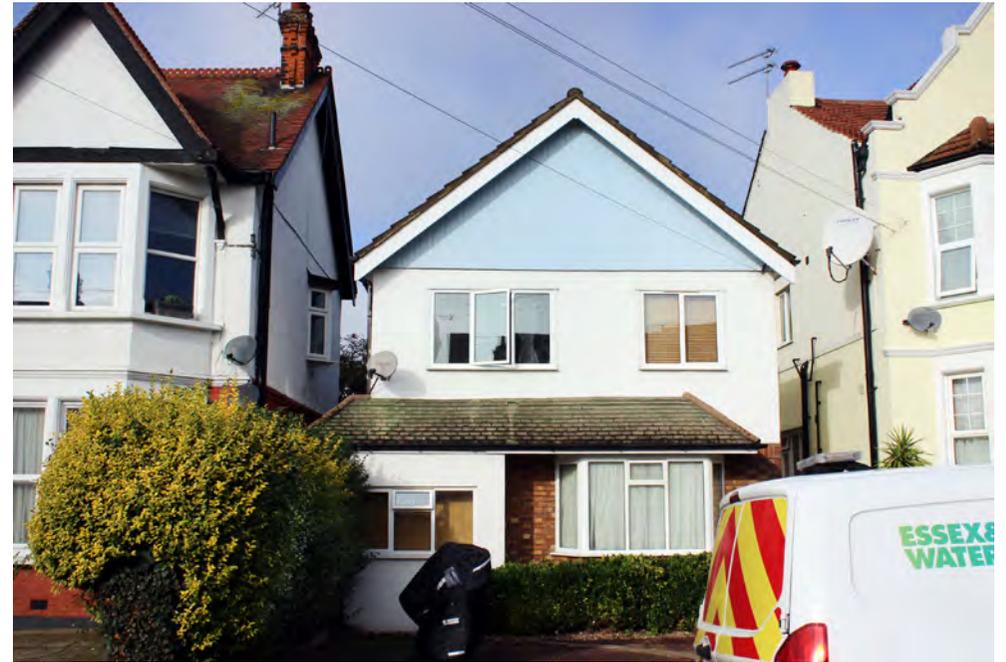
Address	Value	Designation
Argos	Neutral	N/A

Modern detached house of smaller scale than neighbouring properties. The two storey house is brick, although its walls are largely clad in render and the gable end in timber. Besides its scale, the house is out of context within the Conservation Area; it has few defining features or features of architectural interest. The front elevation has a ground floor bay window and a tiled porch sheltering an off-centre entrance porch. The windows are uPVC units, there is no garden or boundary wall and the front elevation features a satellite dish.

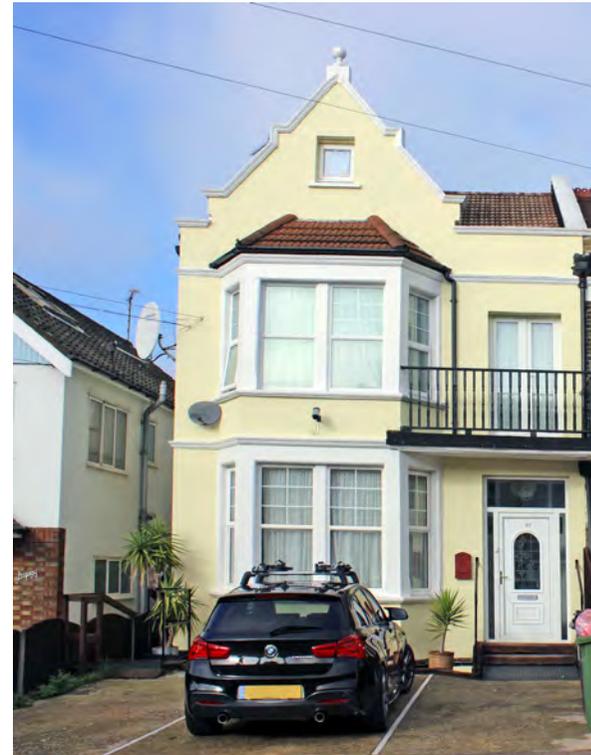
Address	Value	Designation
23 Pembury Road	Positive*	N/A

There are a few detracting features to the building (largely unsympathetic modern alterations):

- The replacement of all sliding sash timber windows with uPVC units, which detract from the character of the building.
- The original door has been lost and replaced with a modern door, which features plain hand rails.
- Original roof tiles have been replaced with concrete.
- The balcony doors have been replaced with uPVC units.
- Two satellite dishes are visible from the street and these should be relocated where possible.
- The house has lost its front boundary wall and garden to hard-standing, which is inappropriate and contributes towards the erosion of the character of the Conservation Area. It would benefit from the front garden being landscaped and reinstating the boundary wall would also enhance its quality.

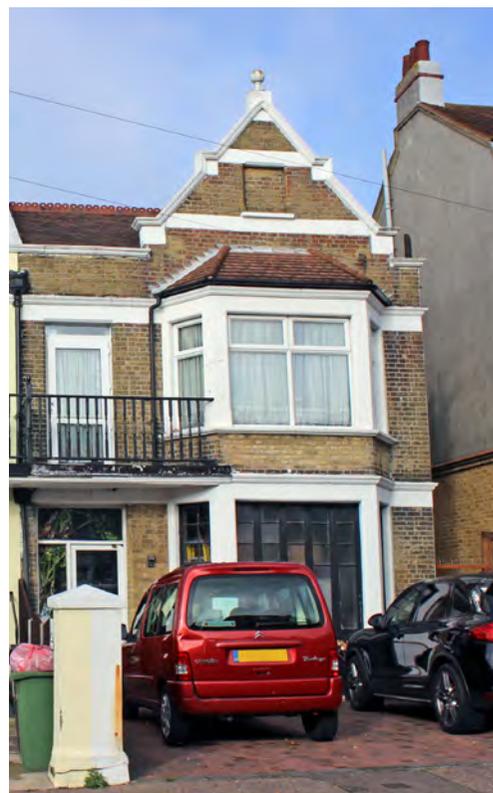
Address	Value	Designation
25 Pembury Road	Positive*	N/A

There are a few detracting features to the building (largely unsympathetic modern alterations):

- The replacement of sliding sash timber windows with uPVC units, which detract from the character of the building.
- The original door has been lost and replaced with a modern door.
- The balcony doors have been replaced with a uPVC unit.
- At ground floor it appears that the bay window was at one time extended to create doors with long, thin panels, painted black. These now seem to have been sealed.
- The house has lost its front boundary wall and garden to hard-standing, which is inappropriate and contributes towards the erosion of the character of the Conservation Area. It would benefit from the front garden being landscaped and reinstating the boundary wall would also enhance its quality.

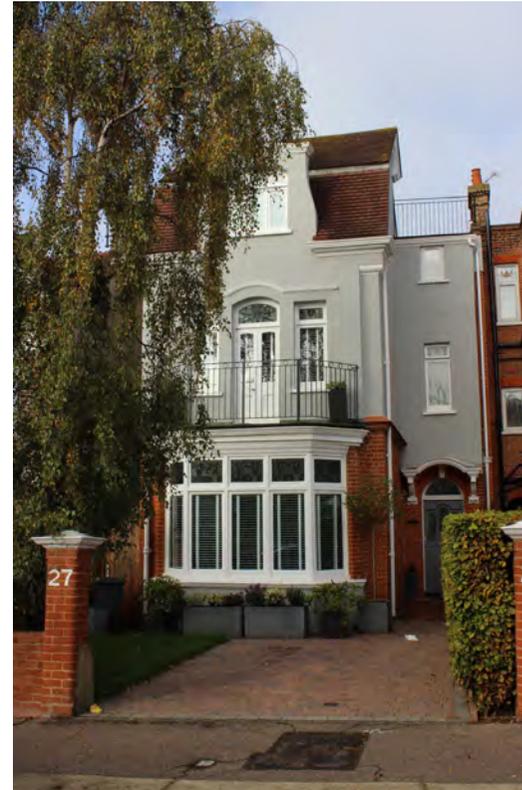
Address	Value	Designation
27 Pembury Road	Positive	N/A

The house has some sense of enclosure in the form of wide brick entrance piers to a driveway and some planting and lawn remains.

The house has been modernised and manicured, whilst the windows retain elements of original glass, they have also been modernised and balustrades to balconies are modern and out of character for the Conservation Area.

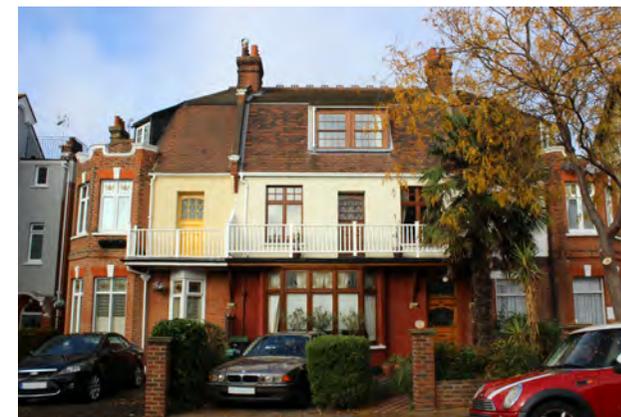
Address	Value	Designation
29–33 Pembury Road	Nos.29 and 31: Positive – though would benefit from placement of any unsympathetic features described below No.33: Positive*	N/A

- The replacement of certain timber windows with uPVC units, which detract from the character of the building.
- The first-floor balcony to No.33, found on the neighbouring properties, has been removed. The original balcony door has been lost and replaced with white uPVC, bounded by a white painted wooden balustrade.

- No.33 features an additional modern door, clearly indicating the building's multiple occupancy.
- A satellite dish is visible from the street at No.33, this should be relocated where possible.

- No.33 has lost its front boundary wall and garden to hard-standing, which is inappropriate and contributes towards the erosion of the character of the Conservation Area. It would benefit from the front garden being landscaped and reinstating the boundary wall would also enhance its quality.

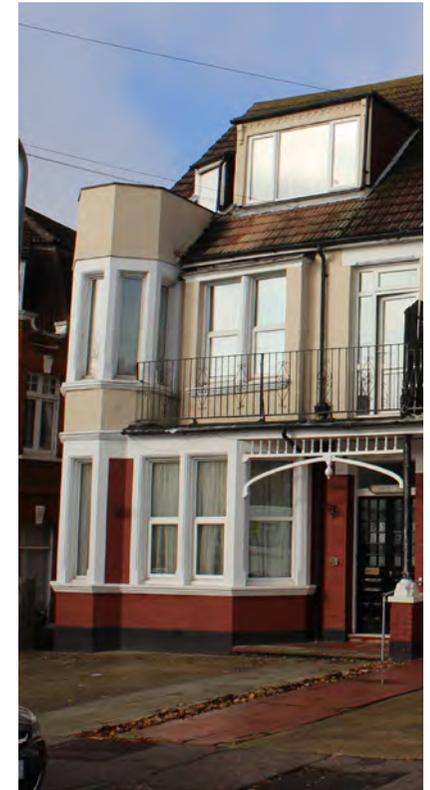
Address	Value	Designation
35 Pembury Road	Positive*	N/A

- The replacement of all original sliding sash timber windows with uPVC units, which detract from the character of the building.
- The balcony doors have been replaced with uPVC units.
- The porch timber column needs repainting.
- The tower most likely originally had a pointed slate or lead roof, which has been lost.

- The two flat roofed dormers in the roof; the larger one in particular dominates the roof.
- The original roof tiles have been replaced with concrete.
- The house has lost its front boundary wall and garden to hard-standing, which is inappropriate and contributes towards the erosion of the character of the Conservation Area. It would benefit from the front garden being landscaped and reinstating the boundary wall would also enhance its quality.

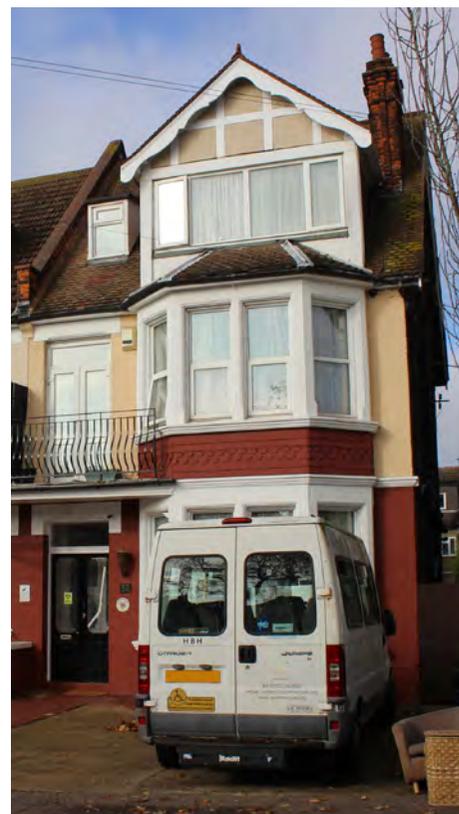
Address	Value	Designation
37 Pembury Road	Positive*	N/A

There are a few detracting features to the building (largely unsympathetic modern alterations):

- The replacement of all sliding sash timber windows with uPVC units, which detract from the character of the building.
- The original detailing to the porch, mirroring that of No.35, has been lost.
- The flat roofed dormer in the roof detracts from the character of the building.
- The balcony doors have been replaced with uPVC units.

- The house has lost its front boundary wall and garden to hard-standing, which is inappropriate and contributes towards the erosion of the character of the Conservation Area. It would benefit from the front garden being landscaped and reinstating the boundary wall would also enhance its quality.
