The Leas Conservation Area Appraisal

Southend-on-Sea: The Leas Conservation Area Appraisal

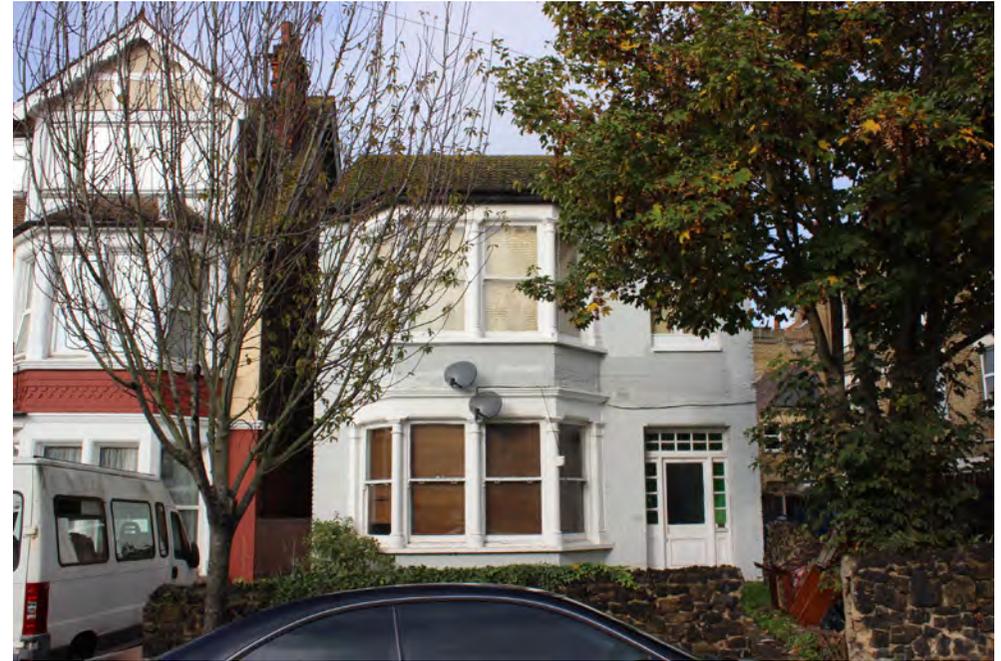
There are a few detracting features to the building (largely unsympathetic modern alterations):

- The garden could be enhanced by some good quality landscaping.
- Two satellite dishes adorn the front of the property.
- The roof covering has been replaced with concrete tiles.
- The house has lost any original porch and/or balcony.
- The condition of the house is poor and it needs maintenance, the paintwork and garden in particular.

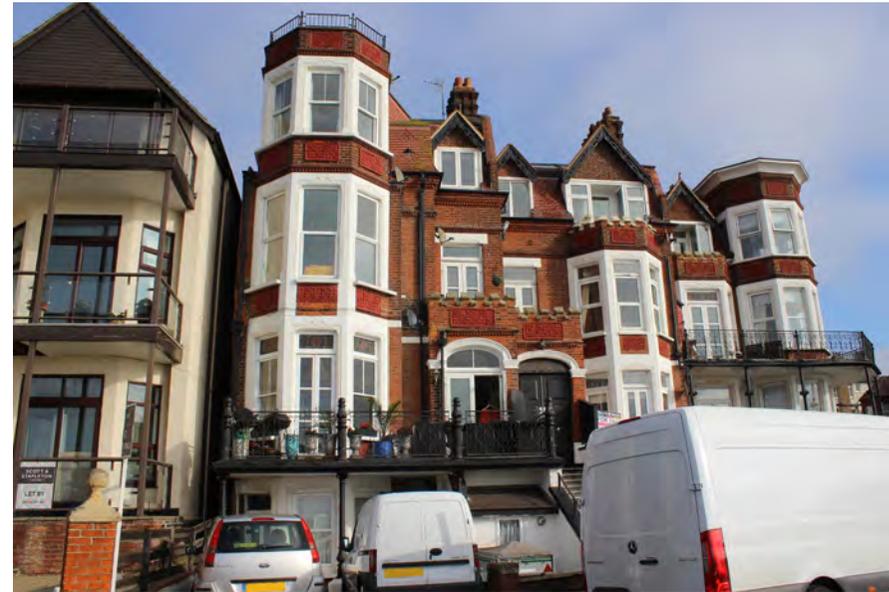
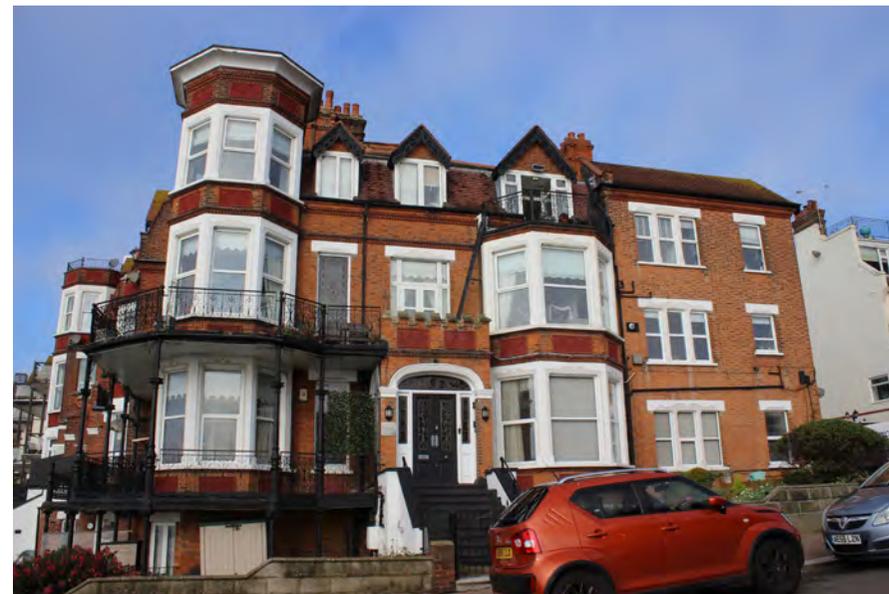
10–16 The Leas, 1–5 Cobham Road, 18–21 The Leas

The building has well-landscaped front gardens with a boundary enclosure, although the concrete block boundary wall is insensitive and should be replaced with a more sensitive brick wall or hedge.

- Most of the original windows, which were characterful for their patterned, stained glass, have been replaced with uPVC and this has removed much of the character inherent in the design of the building.

- The western entrance in The Leas elevation has been converted to a window.
- Whilst most of the garden survives, a small section of the front garden has been converted to a parking space, which dilutes the character of the building and the Conservation Area.

- The concrete blocks of the boundary wall are unattractive and inappropriate for the Conservation Area.

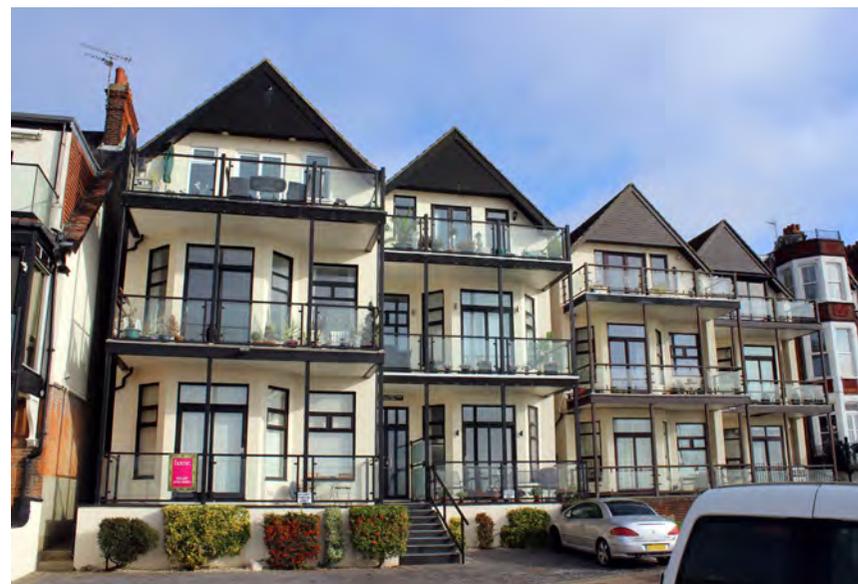
Address	Value	Designation
'Mount Liell Court East' 11–12 The Leas 'Mount Liell Court West' 13–14 The Leas	Positive*	N/A

Many changes have erased the evidence of their age:

- All the windows have been replaced with dark metal frames.
- Modern dark metal and glass balconies have been added to all three floors.
- The original balconies that were directly under the gables have been lost.
- The roof is covered in pantiles, which is very unusual in the Conservation Area, where most roofs have a plain tile or slate finish.

- The loss of the front boundary is a further erosion of character, and the lawn is not in keeping with the style of planting in the Area. It would benefit from the front garden being landscaped and reinstating the boundary wall would also enhance its quality.

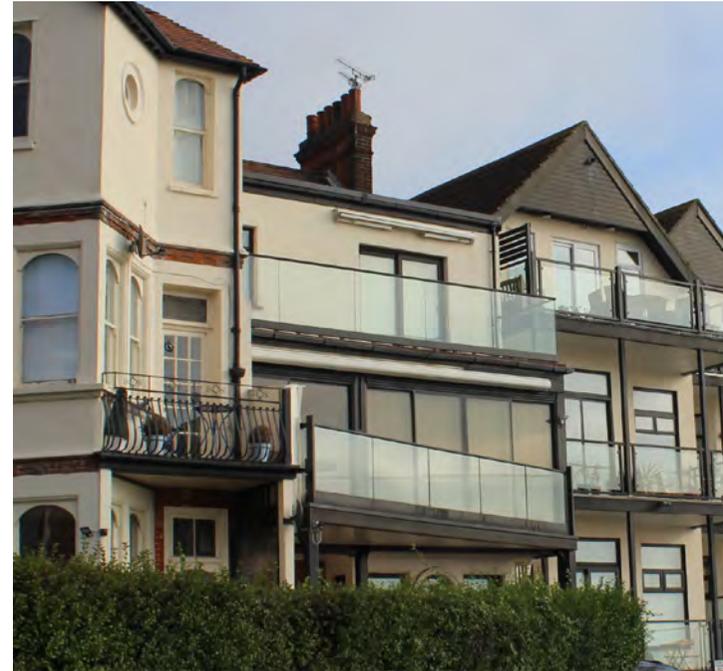
The front elevation of this three-storey building has almost been lost under numerous extensions and balconies. The building is rendered apart from the ground floor, which exhibits some exposed red brick. What does remain is an attractive round-arched entrance with alternating red brick and white banding and two framing columns. There is also a Venetian window, although the window units have been replaced. The substantial unsympathetic, modern changes, which detract from the character of the building include:

- A glazed first floor veranda with a metal and glazed corner balcony leading off it in a diagonal arrangement, which is out of character with the Conservation Area.
- Another metal and glazed balcony above at first floor level.
- The boundary wall and garden have disappeared. The garden has been replaced by a brick driveway, which is not in keeping with the character of the Conservation Area and adds to the erosion of the overall character of the building. It would benefit from the front garden being landscaped and reinstating the boundary wall would also enhance its quality.

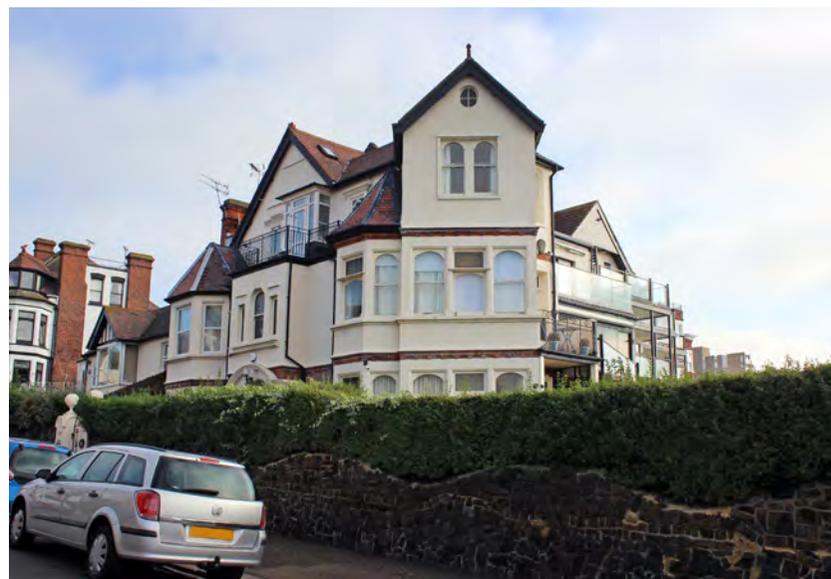
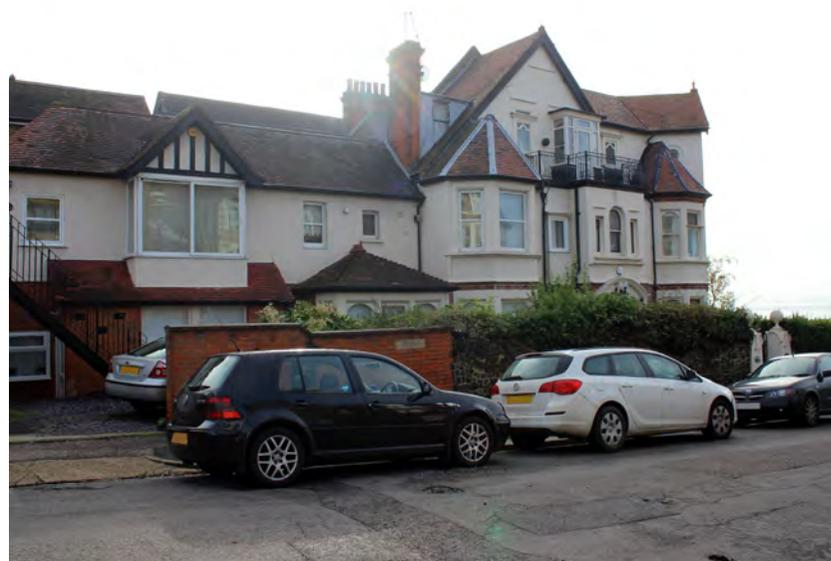
Address	Value	Designation
16 The Leas	Positive*	N/A

The garden survives and is well-landscaped; it is surrounded by an original rustic boundary wall and a high hedge, the entrance to the house is announced by two gate piers with ball finials.

The main unsympathetic modern alteration to the building is the replacement of some of the historic windows with uPVC units, which has removed much of the character inherent in the design of the building.

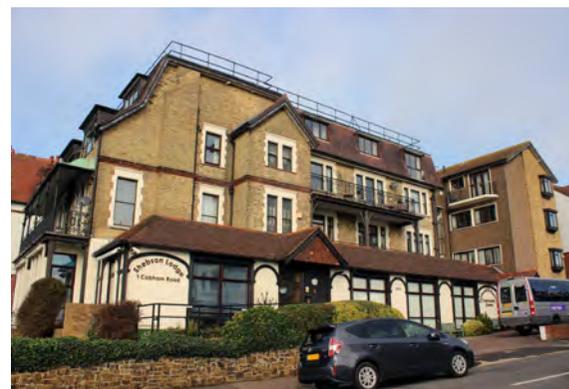
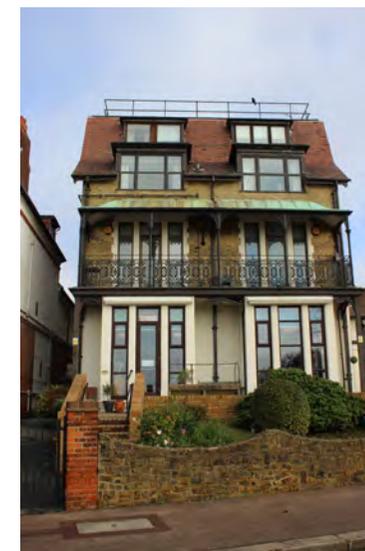
Address	Value	Designation
'Shebson Lodge', Southend and Westcliff Community Centre 1 Cobham Road	Positive* North range: Neutral	N/A

The Cobham Road elevation is less cohesive in appearance and shows evidence of a number of alterations and extensions. The elevation is yellow stock brick, with a rendered ground storey. There is a three-storey square bay with a gable roof and part of the roof is half-hipped with flat-roofed dormers. The first and second floors are demarcated by a red brick string course. The windows are picked out by white surrounds. The tiled mansard roof may be a later insertion.

The building retains most of its garden and original boundary wall, which contributes significantly to the streetscene, although part of the original wall and garden on the Cobham Road side has been removed to incorporate car parking.

There are several detracting features to the building (largely unsympathetic modern alterations):

- The building has inappropriate replacement windows and the ground floor extension has obscured much of the original appearance of the side of the building.
- The alterations and extensions to the Cobham Road elevation contribute to the erosion of the building's character: there is a ground floor entrance extension, a modern four storey block that appears to have been built in the 1980s and a linking staircase block between the modern block and the older one.
- The Cobham Road side has lost a significant proportion of its garden and original boundary wall, which adds to the erosion of the overall character of the building. It would benefit from the front garden being landscaped and reinstating the boundary wall would also enhance its quality.

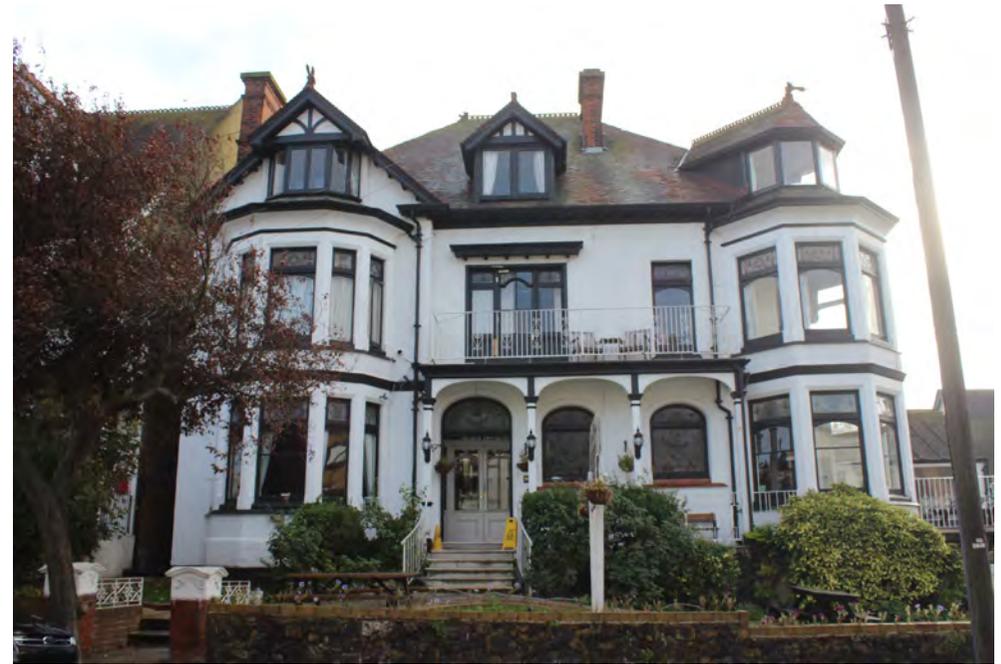
Address	Value	Designation
18 The Leas 'Kingsclere'	Positive*	N/A

There are a couple of detracting features to the building (largely unsympathetic modern alterations):

- The uPVC windows on the first and second floor are inappropriate.
- The house has unfortunately lost its front boundary and garden, which detracts slightly from its overall charm within the streetscene.
- The satellite dishes on the side wall as well as the lights and cameras on the front elevation are conspicuous and detract from the character of the building.

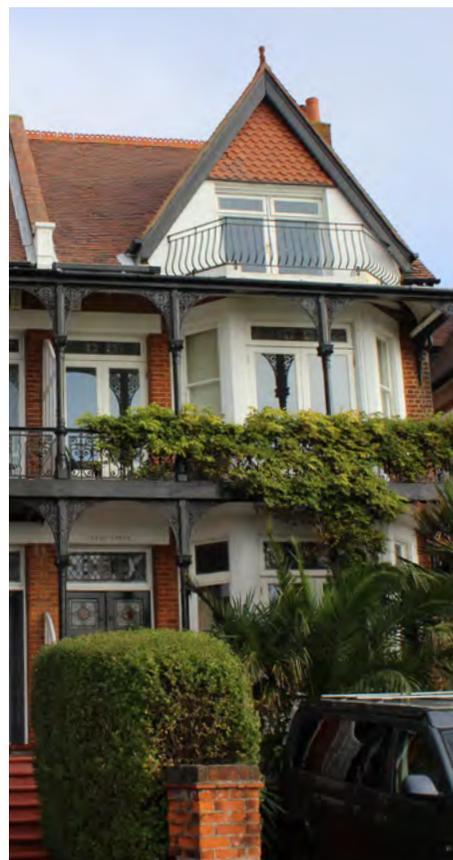
Address	Value	Designation
20 The Leas	Positive	N/A

No.20 is the semi-detached pair of No.19 and also relatively unspoiled by change. The red brick building features a double-height, canted bay window and, above, a roof with a gable end and hung tile detailing. The hipped, red tiled roof features ornamental ridge tiles. The original door survives, incorporating stained, patterned glazing in its upper panels and a similarly glazed fanlight above; the building also retains decorative glazing in the window fanlights at ground and first floor level.

There are a couple of detracting features to the building:

- The loss of the gardens and boundaries for car parking could have been achieved more successfully with the choice of a softer surfacing material such as gravel, the retention of a portion of the front wall, with a narrower access for vehicles.
- Certain roof tiles and hung tiles in the gable are damaged and would benefit from replacement.
- The solid balustrade at second floor level is out-of-keeping.

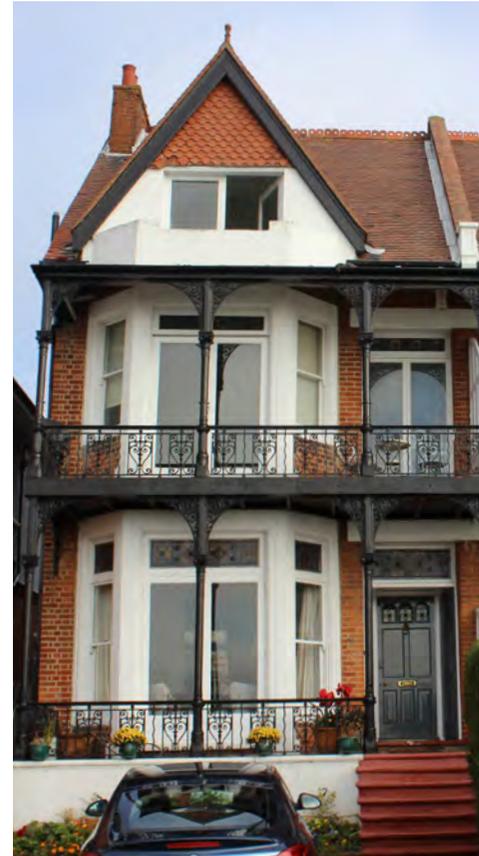
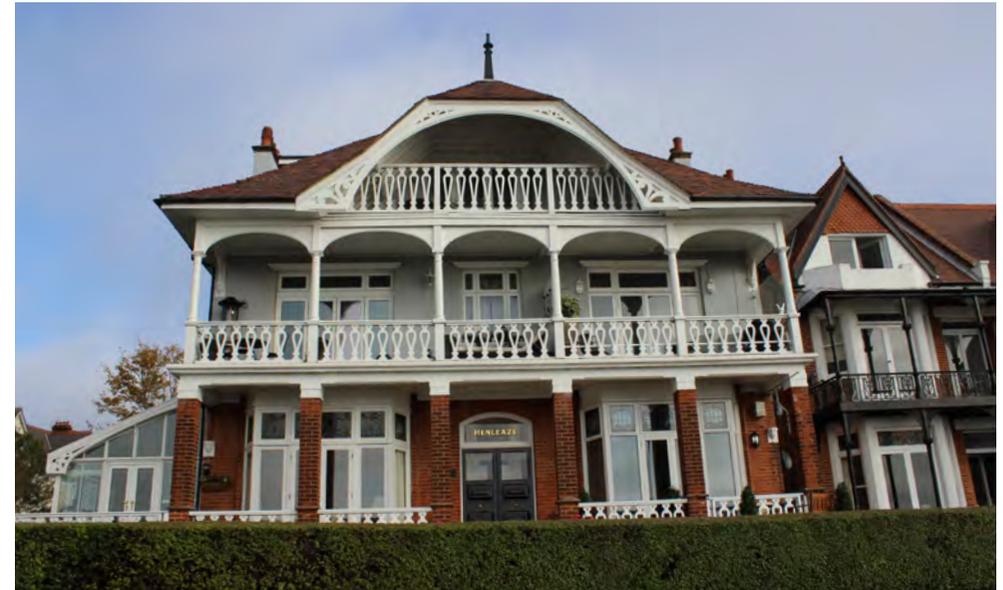
Address	Value	Designation
21 The Leas 'Henleaze'	Positive – though would benefit from the replacement of the uPVC windows with timber	N/A

No.21 The Leas, or "Henleaze", is a distinctive feature of the street-scene. The large building is three-storeys high; the ground floor is red brick and the first floor rendered. The red-tiled, pitched roof incorporates a central curved shape gable of unique design. The ground, first and second floors all have balconies with decorative timber balustrades, painted white. The first-floor balcony incorporates round arches as part of the structure. The double front doors appear to be original and the stained glazed panels above the windows have also survived.

The Grosvenor Road elevation also combines red brick and rendered materiality. It has a double-height bay with a half-timbered gable end and a tall chimney stack. Modern alterations including a one-storey, glazed extension and two flat-roofed dormers.

The brick boundary wall and hedge above survives as do landscaped gardens, which both contribute positively to the streetscene.

There are a couple of detracting features to the building (largely unsympathetic modern alterations):

- The windows have been replaced with uPVC and this detracts from the character of the building.
- The flat-roofed dormers in the side disrupt the original roof line.
