Leigh Conservation Area Appraisal

Southend-on-Sea: Leigh Conservation Area Appraisal Contents

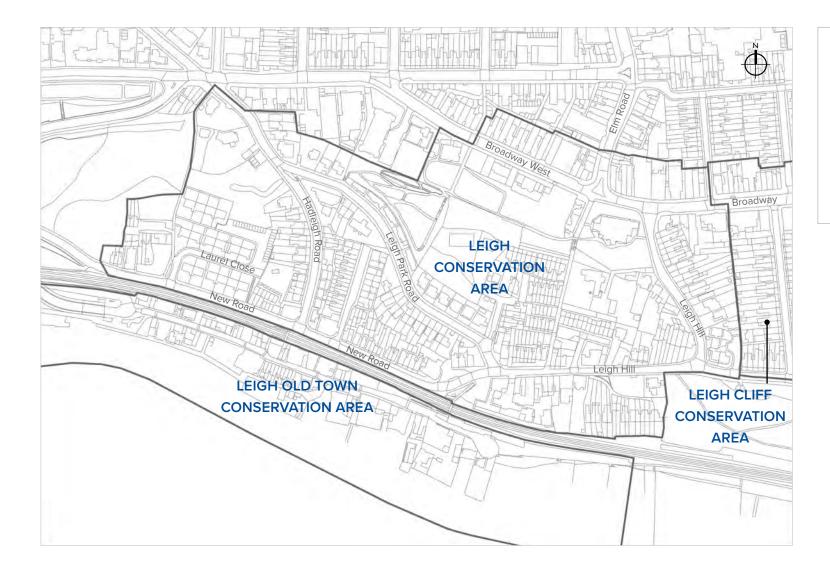
Map A: Boundary

Conservation Area
 Boundary

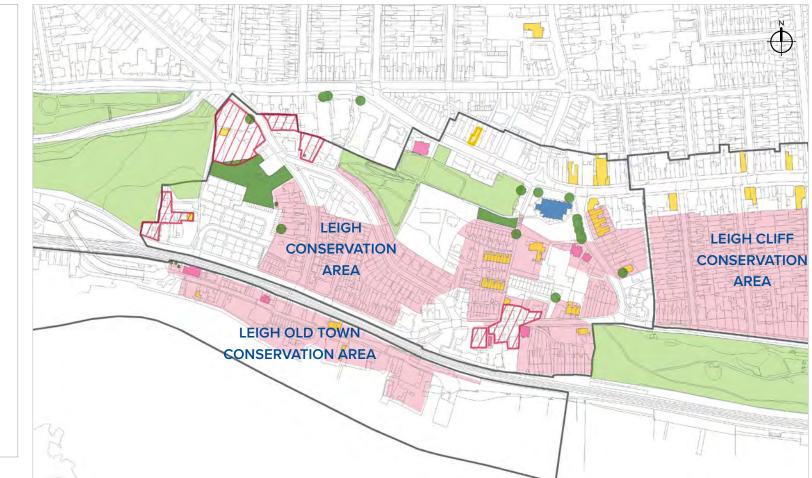
- 3.3.1 Designations for the Leigh Conservation Area are shown on Map B.
- 3.3.2 As a Conservation Area, Leigh is a designated heritage asset in its own right. It also contains other designated heritage assets, including listed buildings, and non-designated heritage assets, such as locally listed buildings.
- 3.3.3 Further information on Southend's Listed and Locally Listed Buildings and article 4 directions can be found on the Council's website: <u>www.southend.gov.uk/planning</u>.

- 3.3.27 Map B also shows tree protection orders (TPOs) in dark green, which are placed to prohibit works to cut down, lop, uproot or damage important trees. All trees within Conservation Areas, whether they have a TPO or not, are protected and consent must be given by SBC prior to works being carried out so that the Council have sufficient time to decide whether the designation of a TPO is needed.

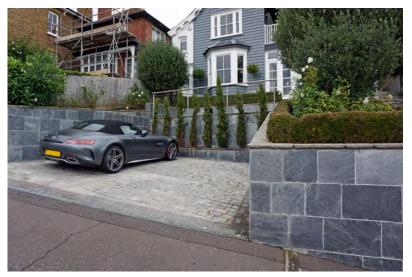
Driveway converted from a front garden and carved into the hill, giving it a dominating appearance from the road

- 5.2.28 Only a limited number of front gardens have been paved over for car parking, reflecting the success of the Article 4 Direction restricting permitted development rights. Driveways have often been paved with granite sets, continuing the use of a traditional material which is to be found in the Old Town, although some of a harsh dark grey colour are visually intrusive. On Leigh Park Road and Leigh Hill off-street parking has been carved out of the sloping gardens at some of the properties, which is inappropriate and creates a dominating appearance from the street. Driveways are always more successful when part of the boundary treatment and front garden is retained and planting is used to soften the area. Materials and details are also important as solid paving can appear overbearing.

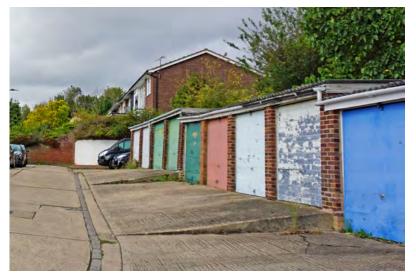
Run down garages on Laurel Close

- 5.2.27 Garages are not a prominent feature of the Area, but those that exist are largely run down and unattractive. Those at Laurel Close are surrounded by cracked concrete surfacing and are gloomy in contrast to the well maintained gardens of the close itself.

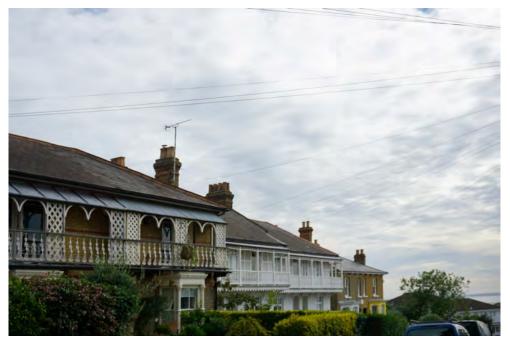
Overhead cables on Leigh Hill

5.2.41 Very much a feature of the Conservation Area, overhead cables are excessively obtrusive to the east of The Ship and up Leigh Park Road, on Leigh Hill, at the bottom of Uttons Avenue, and in Hadleigh Road. They tend to be particularly intrusive in hilly locations, since the eye tends to be drawn to them when looking up and down hill, due to their linear nature.

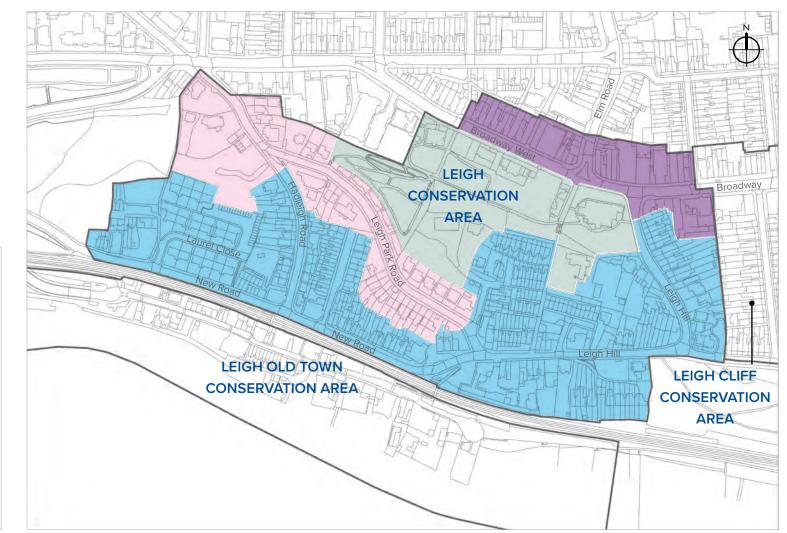
5.3.1 The Conservation Area can be divided into five character areas, the essential features of which are described below. The areas are shown on Map K.

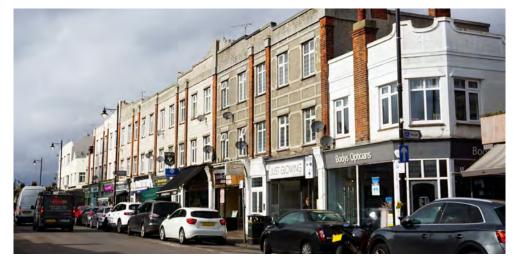
Shops on the north side of Broadway West

5.3.5 This is an extension to Broadway that was created in the late 1920s, running to the north of the former Rectory, now the Library, and removing its stable yard and outbuildings, with the result that the building is now effectively re-orientated and entered from its rear elevation. Today this edge of the Conservation Area is overshadowed by the two blocks of St. Clements Court and more particularly by the later St. Clements Court East which rises to 12 storeys and is less architecturally prepossessing than the earlier building. To the north side of Broadway West there is a parade of shops between Rectory Grove and Elm Road, given a lively and attractive appearance by striped awnings over several shopfronts.

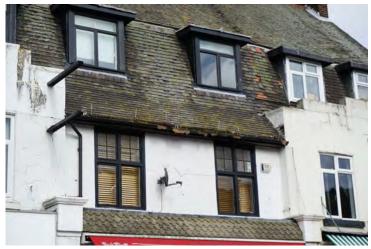
Buildings in poor decorative condition, with pigeon netting and blocked gutters on Broadway West

- 6.3.1 Most buildings within the Conservation Area are in good condition. There are a few that are in poor decorative condition, which are mainly concentrated on Broadway West and New Road, with one or two on the east-west section of Leigh Hill. Peeling or dirty paintwork is the most common issue, though there are some gutters clogged with vegetation growth, which can lead to blockages and therefore problems with leaks and damp if left untended to. Pigeons must be an issue as there are several buildings on Broadway West with netting on the upper floors to prevent roosting on buildings. The redecoration of buildings in poor condition would provide a key enhancement.

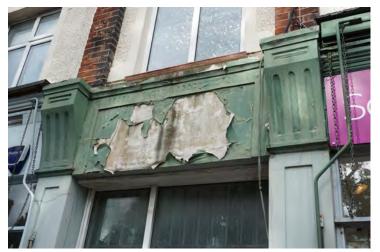
Peeling paint on a building on Broadway West

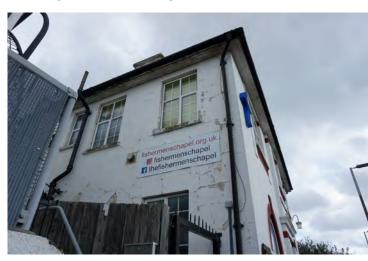
Peeling paint on the Fishermen's Chapel on New Road

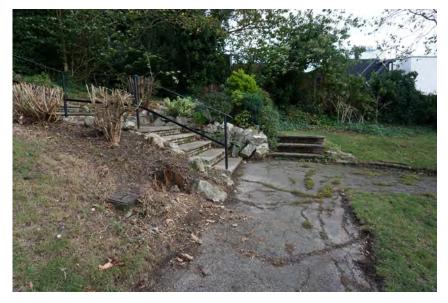
Untidy beds and pathways in the public gardens

- 6.3.46 Planting in the public gardens is, in places, somewhat neglected, with untidy beds and edges to paths unmaintained.
- 6.3.47 Small front gardens are an important feature within the Conservation Area. They often serve to soften the street-scene and the impact of buildings. The conversion of front gardens to driveways negatively impacts on the appearance of the street scene when carried out comprehensively with the removal of the whole of the boundary and wide areas of hard landscaping. Parking can often be provided in front gardens sympathetically with the retention of part of the boundary wall, fence or hedge, potentially with a gate, and with the retention of planting to soften and screen views of parked cars.

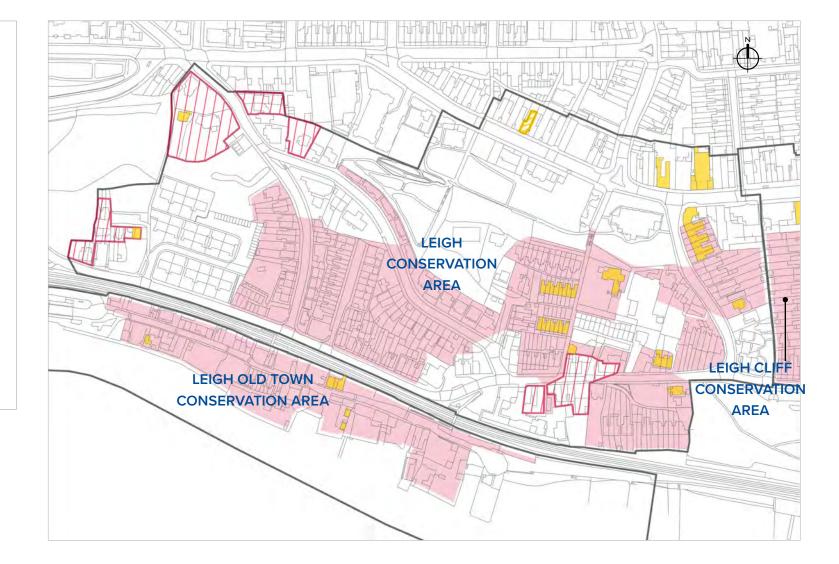
Map M: Recommended Article 4 Direction and Proposed Locally Listed Buildings

- Conservation Area
 Boundary
- Existing Article 4
- Recommended Article4 Direction
- Locally Listed Building
- Locally Listed Building designated as part of this Appraisal

6.3.66 No.57 Broadway West (shown on Map M) was recommended for consideration for the Local List during the Appraisal process and has been designated as a Locally Listed Building.

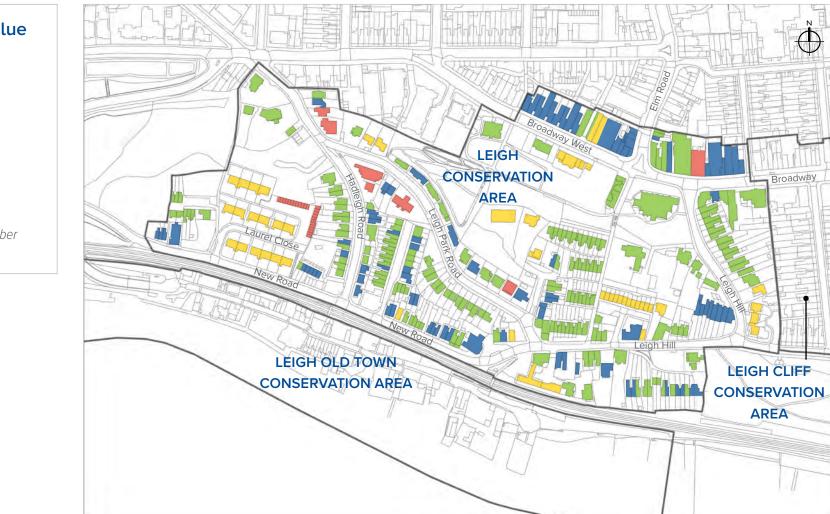
Map N: Building Value

- Conservation Area Boundary
- Positive
- Positive*
- Neutral
- Negative

These values are shown on Map N on the following page.

Buildings can be negative by reasons such as mass, design, materials or siting. Unsympathetic alterations can have the effect of moving a building down a grade. Similarly, reversal of such alterations could restore its original character and move it up a grade.

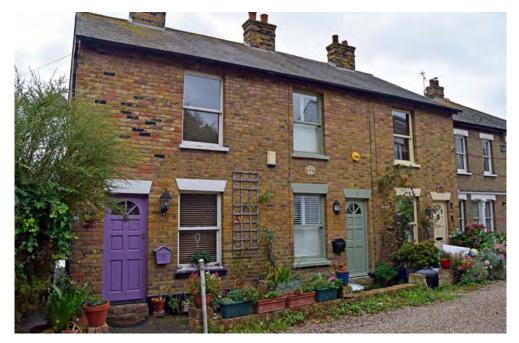
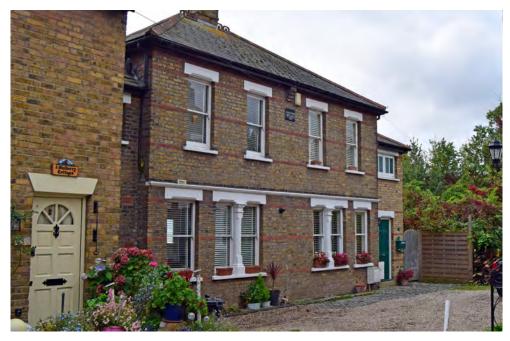
Address	Value	Designation
Fairlight, Brookfield and Clifton Cottages	Positive	Proposed Article 4

Row of three two-storey cottages, each two bays wide. Stock brickwork with painted stone details above and around windows. Mostly original timber sash windows but some good replacements. Timber doors are possibly replacements but sympathetic. Names of the cottages are carved in lintels above the doors.

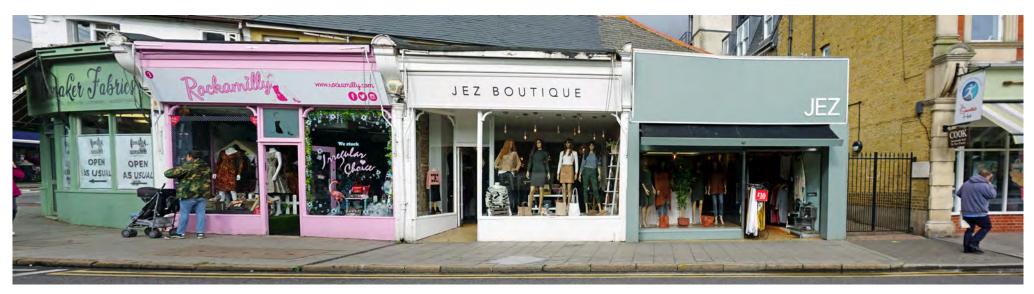
Address	Value	Designation
1-7 Broadway, 'Dressmaker	Nos.1-5: Positive	N/A
Fabrics'; 'Rockabilly'; 'Jez	No.7: Positive*	
Boutique'; 'Jez'

Row of four shop fronts (the one to the left is an extension of the shop front of Dressmaker Fabrics on Elm Road). Single storey, flat roof. Nos.1-5 all have traditional shop fronts (Nos.3-5 probably original) with stall risers, corbels and appropriately sized fascias. No.7 is neat but has undergone remodelling so the fascia is oversized. This could be improved with one of a more traditional size.

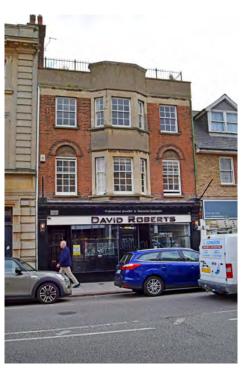
Three-storey, three-window bay frontage in brick with rendered projecting central canted bay, and rendered parapet to roof. Probably 1920s. Nice arches turned in tile over the outermost first floor windows. Timber sashes.

Traditional shop front remains and has been renovated.

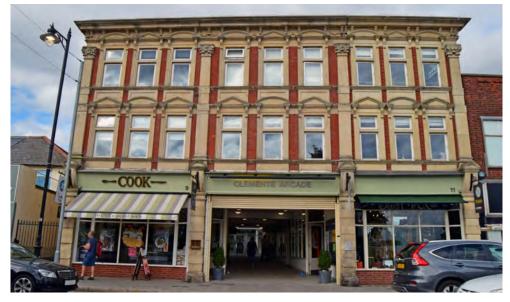
Clements Arcade represents a change of scale to three-storey. A handsome façade in red brick with stone dressings fronts a stock brick building. Righthand third of the building is a good quality modern replica. Modern flat roofed penthouse built on rear range. An alleyway formed between the two main shop-fronts is lined with small shops making a total of 10 units, extending out to the rear, creating a lively and pleasant space. An airconditioning unit on the side elevation has been covered with boarding though the appearance of this could be improved.

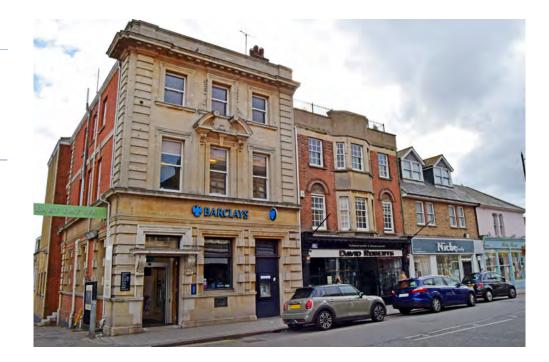
Address	Value	Designation
10 Broadway 'Barclays Bank'	Positive	N/A

A three-storey stone façade in a neo- Renaissance style, flank wall in red brickwork, extended to rear in stocks. Timber sash windows to upper floors. Metal windows and door frames to ground floor, though reasonably sympathetic. Elegant and grand.

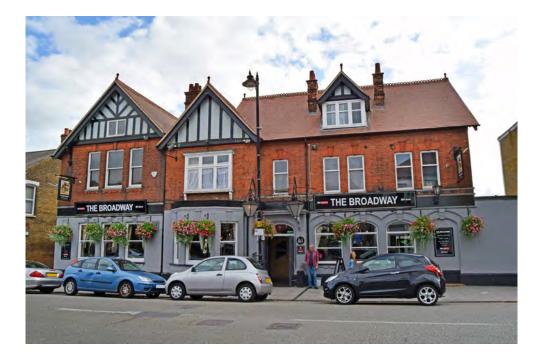
Address	Value	Designation
12 Broadway 'The Broadway'	Positive	N/A

Purpose built former coaching inn apparently of 1896 when it was licensed. Grey painted brick to ground floor, red brick above, false half timbering in the two prominent gables, original timber windows are a mix of sashes and casements, stock brick sides and back where there are modern flatroofed extensions, red tiled roofs with decorative ridge tiles, timber double doors. The interior retains something of its original character. The building's distinctive and well designed façade is long and is a major feature of this end of Broadway. The fascias for the pub signs are appropriate in terms of scale but a more sympathetic material, such as timber, would be better than the current plastic signs. Hanging baskets along façade look pleasant and soften the front.

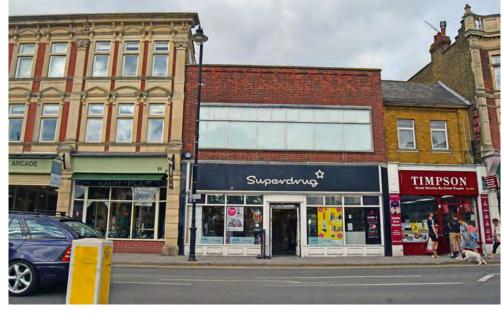
Nineteenth century, stock brick, slate roofs, replacement uPVC windows. The first floor is a twentieth century infill. Traditional shop front is let down by unattractive advertising signs, this could be improved with more discreet signage.

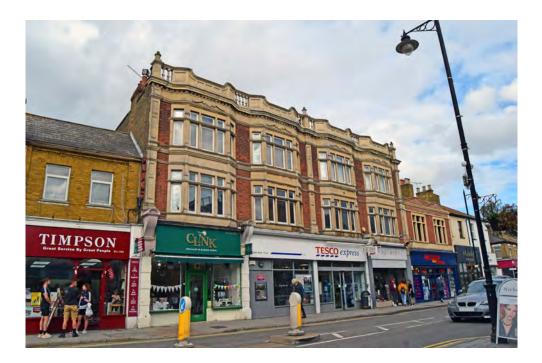
Address	Value	Designation
21a, 21-23, 23a, 'Click'; 'Tesco'; 'Just Cheek'	Positive*	Locally listed

A return to three-storey scale. Handsome façade with four canted window bays, red brick with limestone dressings, parapet with balustrade, sides in stock brick. Timber casement windows. Roof not visible. Probably 1920s. Grander than Clements Arcade but the fascias have been enlarged, suppressing the original appearance of the shop fronts and disrupting their relationship with the elevation above them.

Shop front to No.21a is traditional but that to Nos.21 to 23a are less so, particularly No.21-23 (Tesco) which has an inappropriately large fascia.

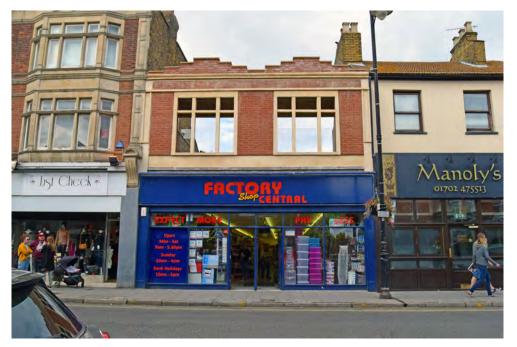
19th-century, two-storey cream and white painted render to first floor, concrete tiles to hipped roof. No.35, Vanessa Shoes, has inappropriate uPVC windows.

Vanessa Shoes has a pleasant updated modern shopfront in white and the chamfered fascia works well around the corner. Manoly's has updated shop front that is tidy and well maintained but is oversized.

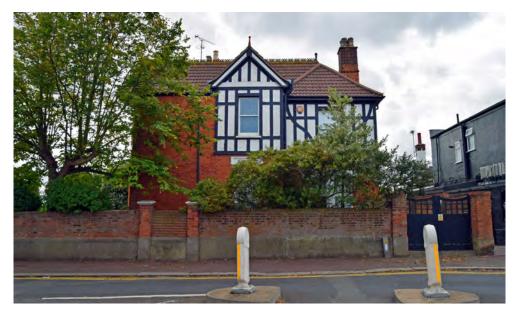
A very large red brick villa at the top of the hill set at an angle to the road. Clay plain tile roof, with decorative ridge tiles. Timber windows are probably original. Much white-painted detail including ornate lintels, string coursing on bay and large timber porch. Half timbered gable with applied black timbers. The brick forecourt is rather bland but this is mitigated by mature planting and the surviving original brick boundary wall, which is important to retain.

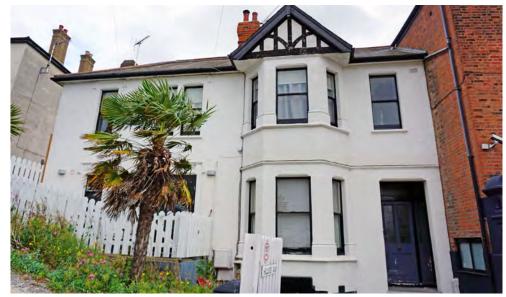
Adjoining No.1 Leigh Park Road is a large late-19th/early 20th century house (now flats), with two storey canted bay window topped with a 'halftimbered' gable above set to the right and front door to the far right. Black painted timber sash windows provide contrast to the white render. Slate roof. Attractive stained glass panels in the timber front door, which is recessed to provide a small porch. The house suffers from some general disrepair and has lost its front boundary making the shabby forecourt unnecessarily obvious.

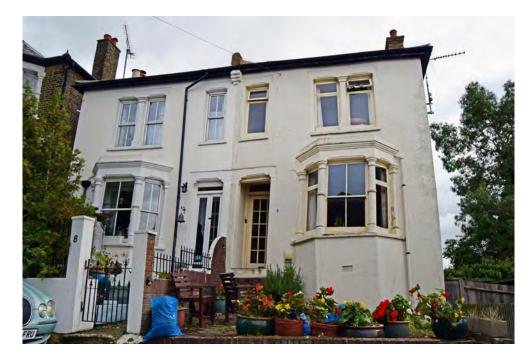
Address	Value	Designation
6 Hillside Road 'Annie Villa' 8 Hillside Road	Positive*	Article 4

A late Victorian or early 20th century two-storey semi-detached pair. No.6 is rendered and painted cream, No.8 is white. Accessed by steps up to a front door recessed into an open porch. Double outer doors have been added to No.8 and door to No.6 is a modern timber door which is mainly glazed. Slate roof and chimneys survive on both. Only one timber sash window survives on front of bay to No.6. The others on No.6 are timber casements and on No.8 are aluminium sash windows.

No.6 appears to be suffering from structural problems clearly visible from the sloping bay window and door case and the long crack running from the bay window to the bottom right hand corner. It is in a poor state of repair and in need of redecoration. Mix of rendered and brick boundary walls with railings.

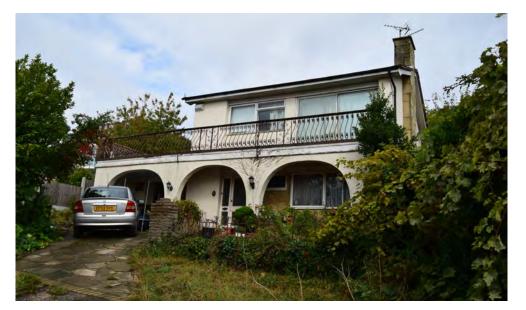
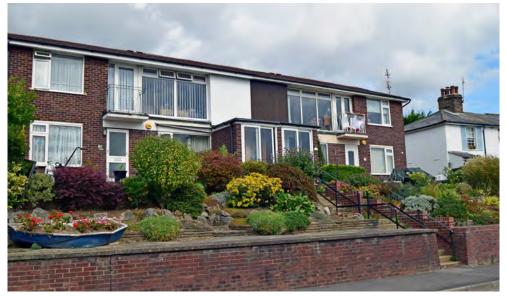
Housing from the 1960s at right angles to Billet Lane, arranged up the slope above New Road. The properties are in three long terraces set above their terraced gardens, which are very well maintained.

Dark brown bricks with large aluminium (?) framed windows, red tile roofs. The high red brick retaining walls for the gardens appears somewhat oppressive and the concrete road, the block of garages, and car park area are unattractive and in poor decorative condition.

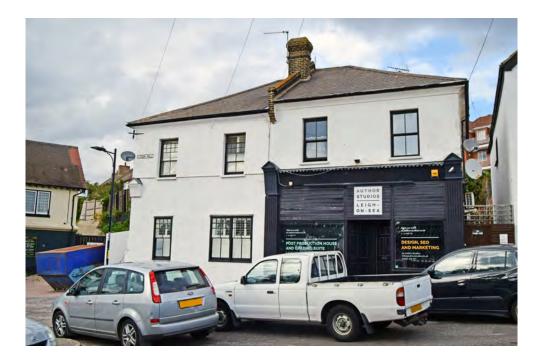
Address	Value	Designation
Leigh Hill 1-3 Leigh Hill	No.1: Positive No.3: Positive*	N/A

Originally built as shops, c.1900, but the left hand unit (Nos.1 and 1A) now residential. Two-storey, render, both white painted, timber sashes painted black (those to No.1 have smaller panes to upper sashes), with a hipped slate roof. Newly block paved parking space between No.1 and The Ship.

No.5 now an office at ground floor level. The pilasters, corbels and fascia of the original shop front have survived and there is a stall riser of sorts. The upper part of the windows has been filled in with timber boarding and the doorway has been replaced with two modern panelled doors. Overuse of black for shop front feels heavy, could be improved with a more appropriate/ softer frontage.

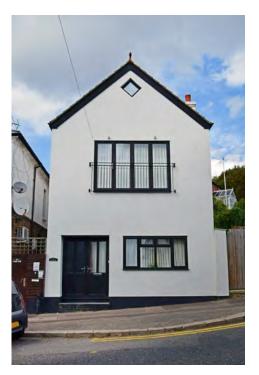
House of c.1900, gable to street. Recently renovated. Rendered and painted white throughout. Minimal frontage with barge boards, door and black uPVC window frames. Black Juliet balcony replaces older balcony. Small square window in gable. Renovation is successful, though a little stark. Could add planting to soften.

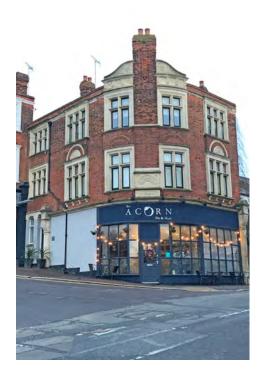
Handsome three storey corner block, red brick with stucco window surrounds. Parapets with decorated pediments, in a Tudor style, dated 1901. Timber frames to windows.

Shop front on ground floor with attractive fascia and multi-paned windows.

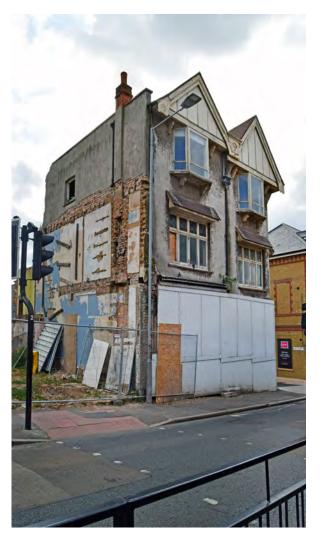
Address	Value	Designation
22-24 Leigh Hill	Positive*	Proposed
		Article 4

Pair of tall three storey shops, each with a timbered gable, rendered below, hopper head dated 1907, windows originally with stained glass in the top lights, some replaced in metal. Attractive buildings, but now very neglected, in a bad state of repair and unoccupied.

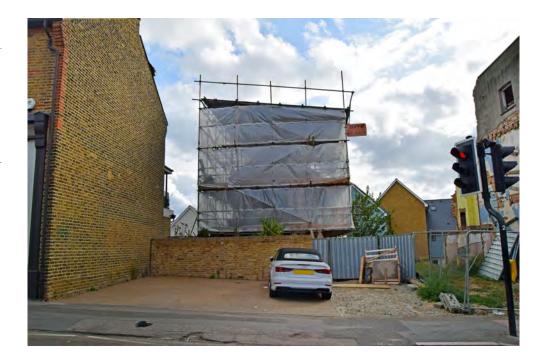
Address	Value	Designation
28 Leigh Hill	Positive*	Grade II
		listed

Dwelling and commercial premises, now house under renovation at time of survey. Late 18th/early 19th century. Weatherboard over timber frame set on brick plinth, gabled slate roof, brick ridge stack. Two-storeys over basement set into slope of hill. Square headed doorways to lower gable end and east elevation. Early 19th century 12-pane sashes set in moulded wood architraves; similar sashes to upper (north)gable end, replacing original loading doors. Former workshop over stable/loosebox to north end.

An unusual survival of a type of building which was once common in the fishing/ship building communities along the riverside.

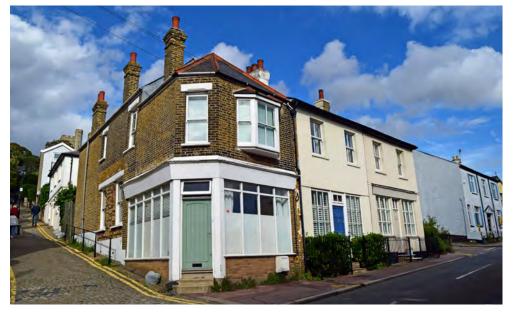
19th-century stock brick properties but Nos.35- 37 have been rendered. Slate roofs. Nos.35-37 are double fronted. All formerly shops with fascias and large shop windows retained, now residential and well kept.

Timber sash windows to upper floors. Shop front No.35 has uPVC at windows at ground floor. Timber panelled doors.

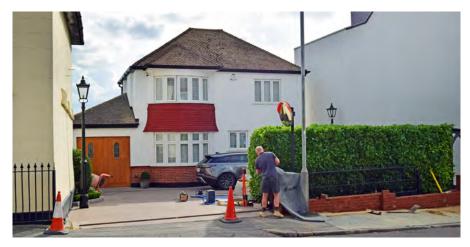
Description 1930s detached house, with a curved bay and white rendered walls with

red brick plinth and around door, tile hanging to curved double height bay window. Timber door set in curved arched recessed porch. Red tile roof in attractive hipped form. Set well back from the road to accommodate a road widening scheme proposed at the time, which did not come to fruition. uPVC windows which are not an appropriate material for the Conservation Area. Timber double garage door to left. To the rear large glazed balconies and balustrades are out of keeping with the character of the Conservation Area.

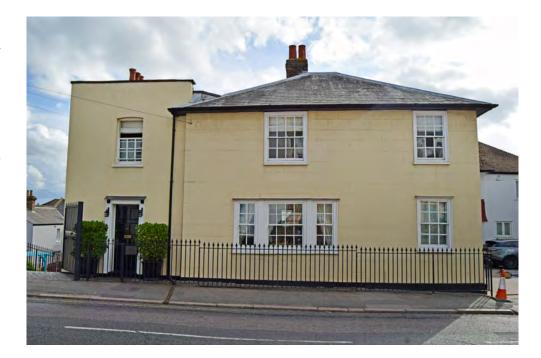
Address	Value	Designation
42 Leigh Hill 'Old Bank House'	Positive	Grade II listed

Eighteenth century timber framed and plastered house, altered and added to in the 19th and 20th centuries. The rear part is weatherboarded. The house stands on steeply sloping ground with two-storeys on the north and threestoreys on the south. A later 19th century brick addition with parapet was built on the east side and a two-storey music room and library was built on the south side (1912–13). The north front has two window range to the original house and one window range to the addition, double-hung timber sashes with glazing-bars. The ground storey has a three-light window. The south addition has a large mullioned and transomed splayed bay rising through two-storeys, with leaded lights. On the east side there is a five-panel door with the upper panel glazed, with panelled architrave and corner roundels with lions heads. Roof slate, hipped.

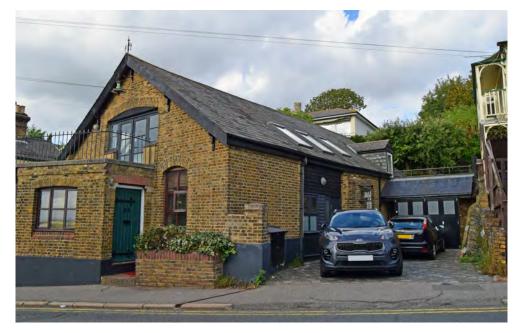
A wide low stock brick building, originally Herschell School, built by Ridley Herschell in the rear garden of Hershell House in the later half of the 19th century to replace the school built by Lady Olivia Sparrow which stood on the site of 21-23 Broadway (now demolished). Later converted to a marine engineer's workshop and now a house. Brown brick, one and a half storeys, slate roof. It has stained timber windows and a timber front door. A spacious cobbled parking court on its east side with garage set back from the road.

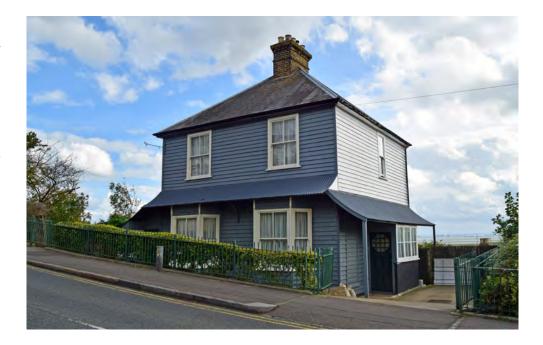
Address	Value	Designation
60-62 Leigh Hill	Positive	Locally listed
		Article 4

Originally a semi-detached pair, now one house. Built in the late 19th century. Attractive weatherboarded building, painted grey to front and cream elsewhere, with a slate roof, well maintained. Original front doors with circle windows. Timber sash windows. Curved tin roof to verandahs on north and west sides.

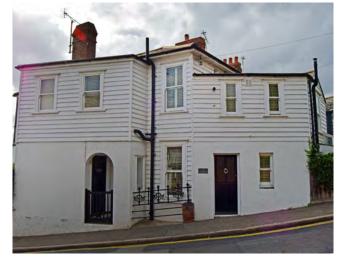
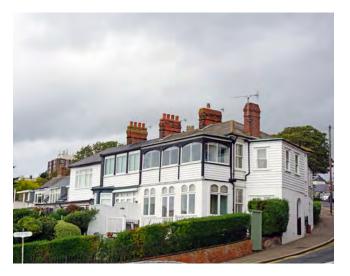
Address	Value	Designation
65-77 Leigh Hill	Positive*	Article 4

A row of much-altered terraced houses. The deeds of No.69 date to 1800. They are set a long way above the east-west part of Leigh Hill, where only their terraced gardens relate to the road. Their backs are much closer to the north-south part of the road where they present a row of typical rear extensions with pitched roofs, to which further flat-roofed and conservatory type extensions have been made, creating an interesting pattern of shapes. Nos.65-69 are three one-and-a-half storey cottages with, to the south, disproportionately large dormers and and large ground floor extensions. Nos.71-77 are two storey. Nos.71 and 73 have ground floor extensions with large picture windows, and have very large replacement first-floor windows. Nos.75-77 have older two storey extensions with balconies above, now glazed in. All the houses were weatherboarded, though not much of this is visible on the south elevations. Slate roofs, apart from No.65 which unusually has pantiles. To their rear, on the north side, there is a parking area directly on the street frontage not enhanced by a large flat-roofed car port. Some properties in need of repainting.

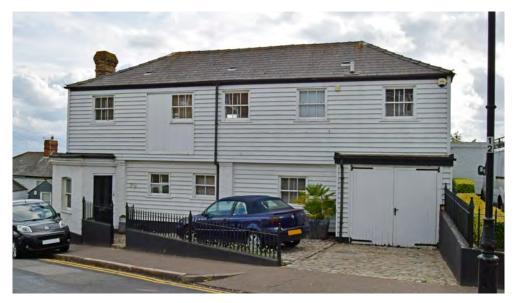
A two-storey white weatherboarded property with timber sash windows and hipped slate roof, a slight jetty at first floor level, integral garage with timber doors, and former first-floor door now mainly blocked in with timber panelling. An old photograph shows the building in use by W. Thorp and Sons building contractors and undertakers. The triangular flat roofed entrance porch in white painted brick is set at the south-east corner. Forecourt paved with granite sets and enclosed by railings.

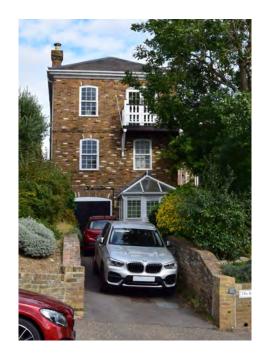
A late 20th century three storey house built of reused stocks, many of which retain white paint, hipped roof, unusual with a somewhat Victorian character, balcony to second floor accessed by uPVC doors. Sash style windows though possibly in uPVC. Let down by uPVC conservatory style entrance porch. Good front garden with brick wall boundary. Driveway to one side.

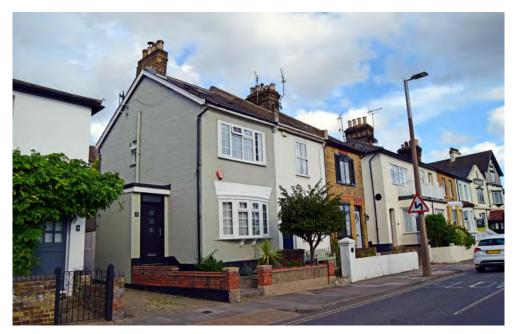
A terrace of four houses, with a lower roof line and round headed doors (none of which preserve their fanlights) and therefore probably older, third quarter of 19th century, with a cottage appearance. Orignially stock brick but now rendered fronts apart from No.9. Timber sash windows, slate roofs. Timber doors, with small canopy added to No.10 which is not unsympathetic. Stock brick boundary walls (not painted) with engineering brick copings and picket gates.

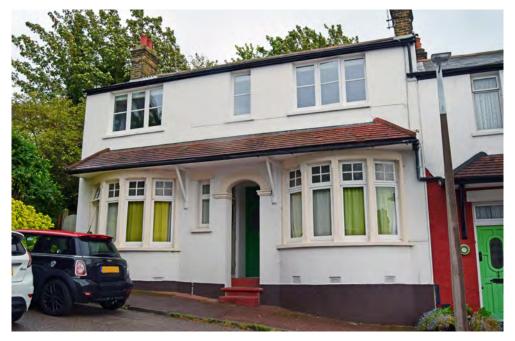
Slightly more substantial than those on the other side of the road and probably later although with similar construction. The design is a single fronted version of No.17 with canopy, rounded bay and casement windows. Nos.19 and 20 remain unrendered. Original timber casement windows to all No.20 and ground floor of No.19. First floor of No.19 windows have been replaced with inappropriate louvered glass. Inappropriate aluminium window frames to No.18. All replacement timber doors.

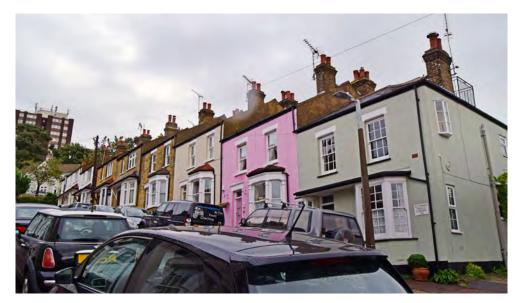
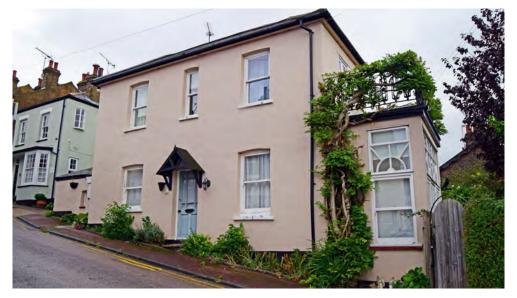
A double fronted property that appears detached from the street but is in fact attached to No.3 Ray Cottages at the rear. Cream render has covered the bricks but the slate roof and chimney survive.

The windows have been replaced with sashes (double glazed?). Single storey mono-pitch roofed extension to the north but the small orangery to the south is an attractive feature with sunburst pattern glazing. Timber and glazed door with canopy over. There is some nice mature planting surrounding the southern end of the building.
